July 30, 2014

RE: PG&E Supplemental Information Report & Materials

Carmel Gas Incident – Summary Timeline

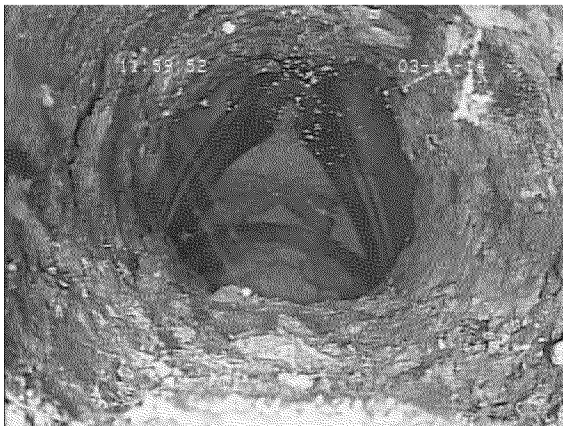
Figure 5. Collapsed main and offset joint

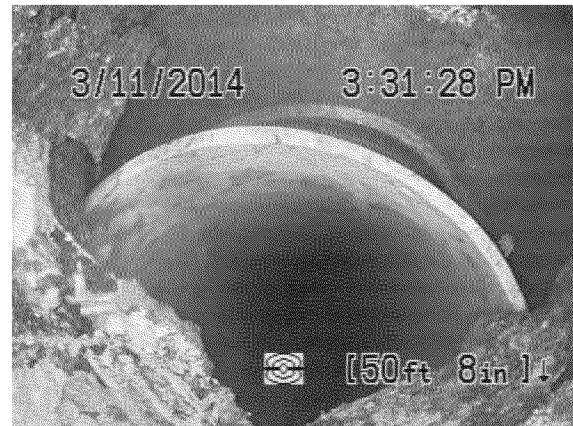
Figure 6. Offset joint 50 ft. from entry on property

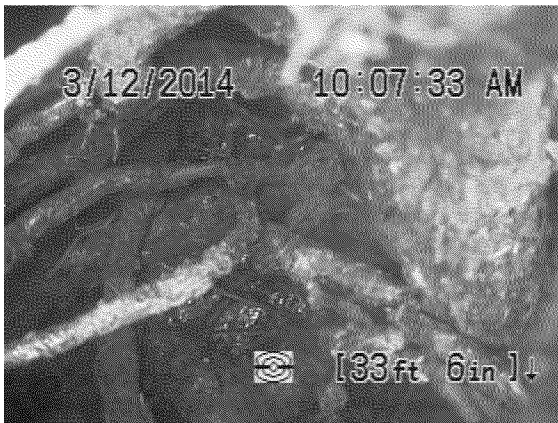
Figure 9. Lateral blocked by roots

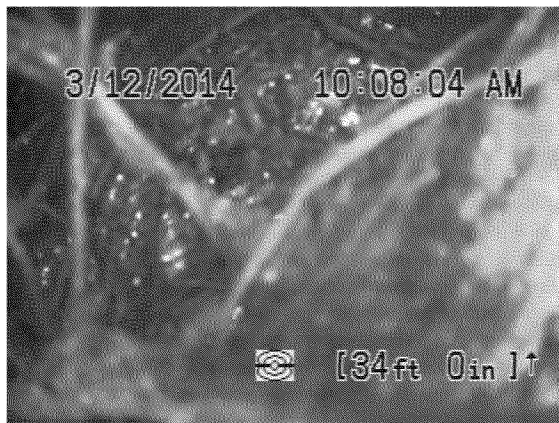
Figure 10. Roots over shiny apparent cap
