July 30, 2014

RE: PG&E Supplemental Information Report & Materials

Pacific Gas and Electric (PG&E) retained Exponent Failure Analysis Associates (Exponent) to conduct a failure analysis investigation of a gas leak and subsequent explosion on March 3, 2014 in Carmel-by-the-Sea (Carmel), California. Exponent's report was submitted to PG&E on April 25, 2014, and discussed at a City Council Meeting at Carmel city offices on May 6, 2014. Subsequent to that meeting, PG&E requested that Exponent supplement its report to address specific questions raised at the meeting. This supplemental report includes the following:

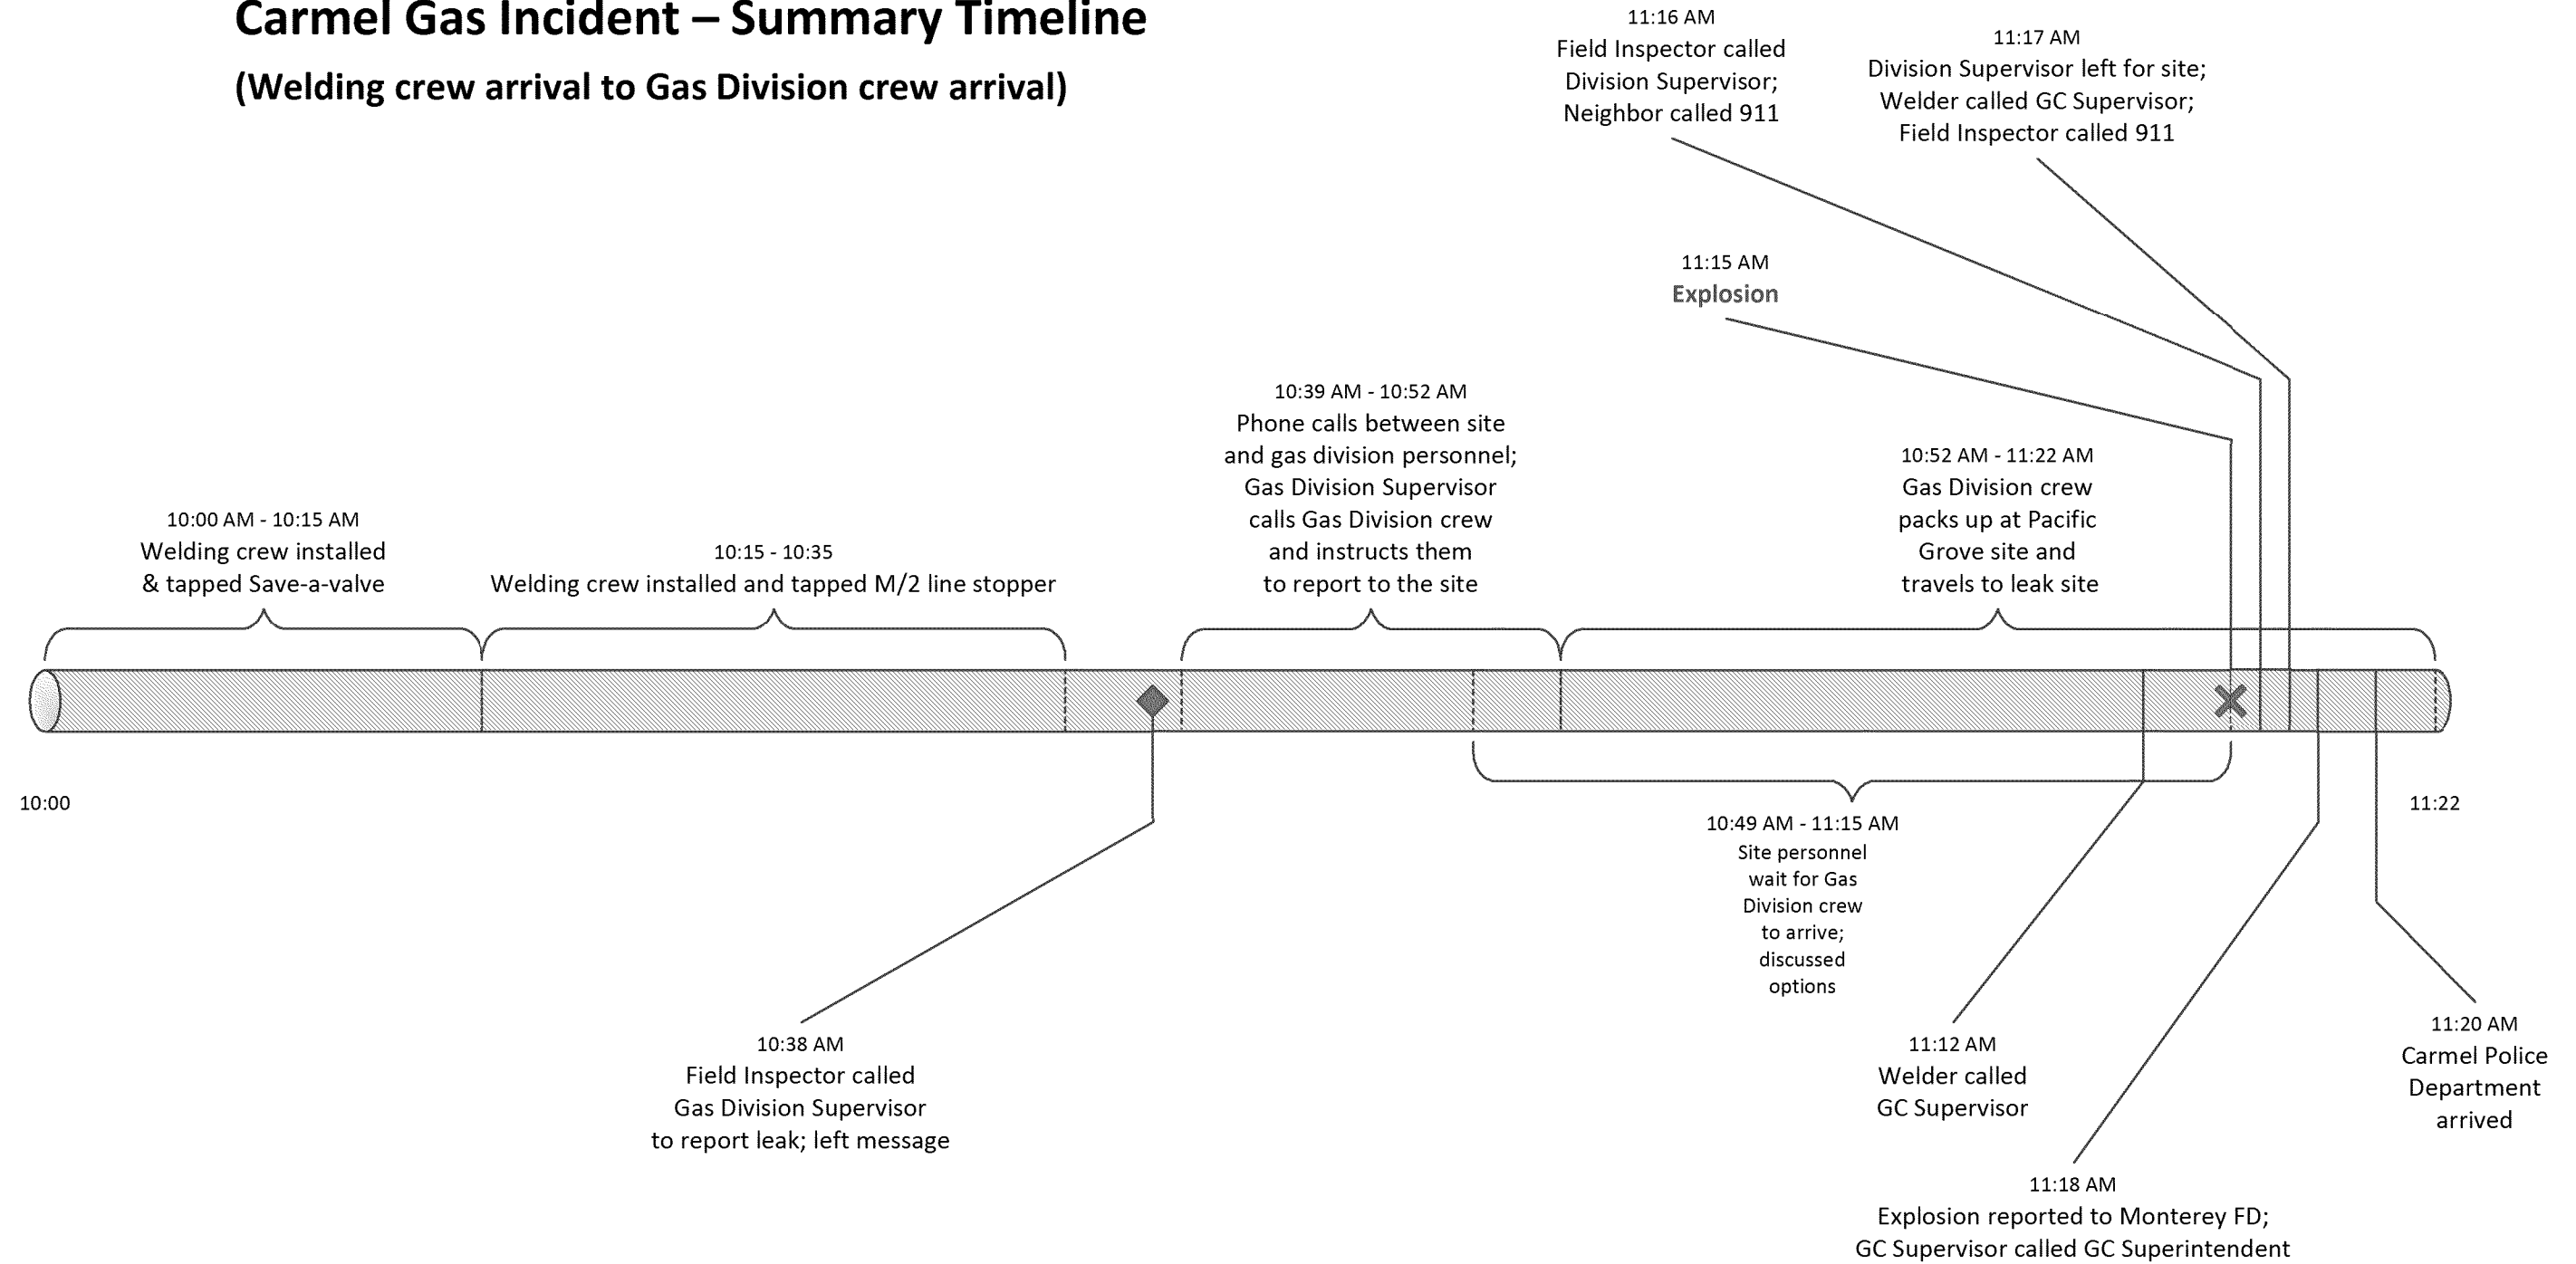
Carmel Gas Incident – Summary Timeline

(Welding crew arrival to Gas Division crew arrival)

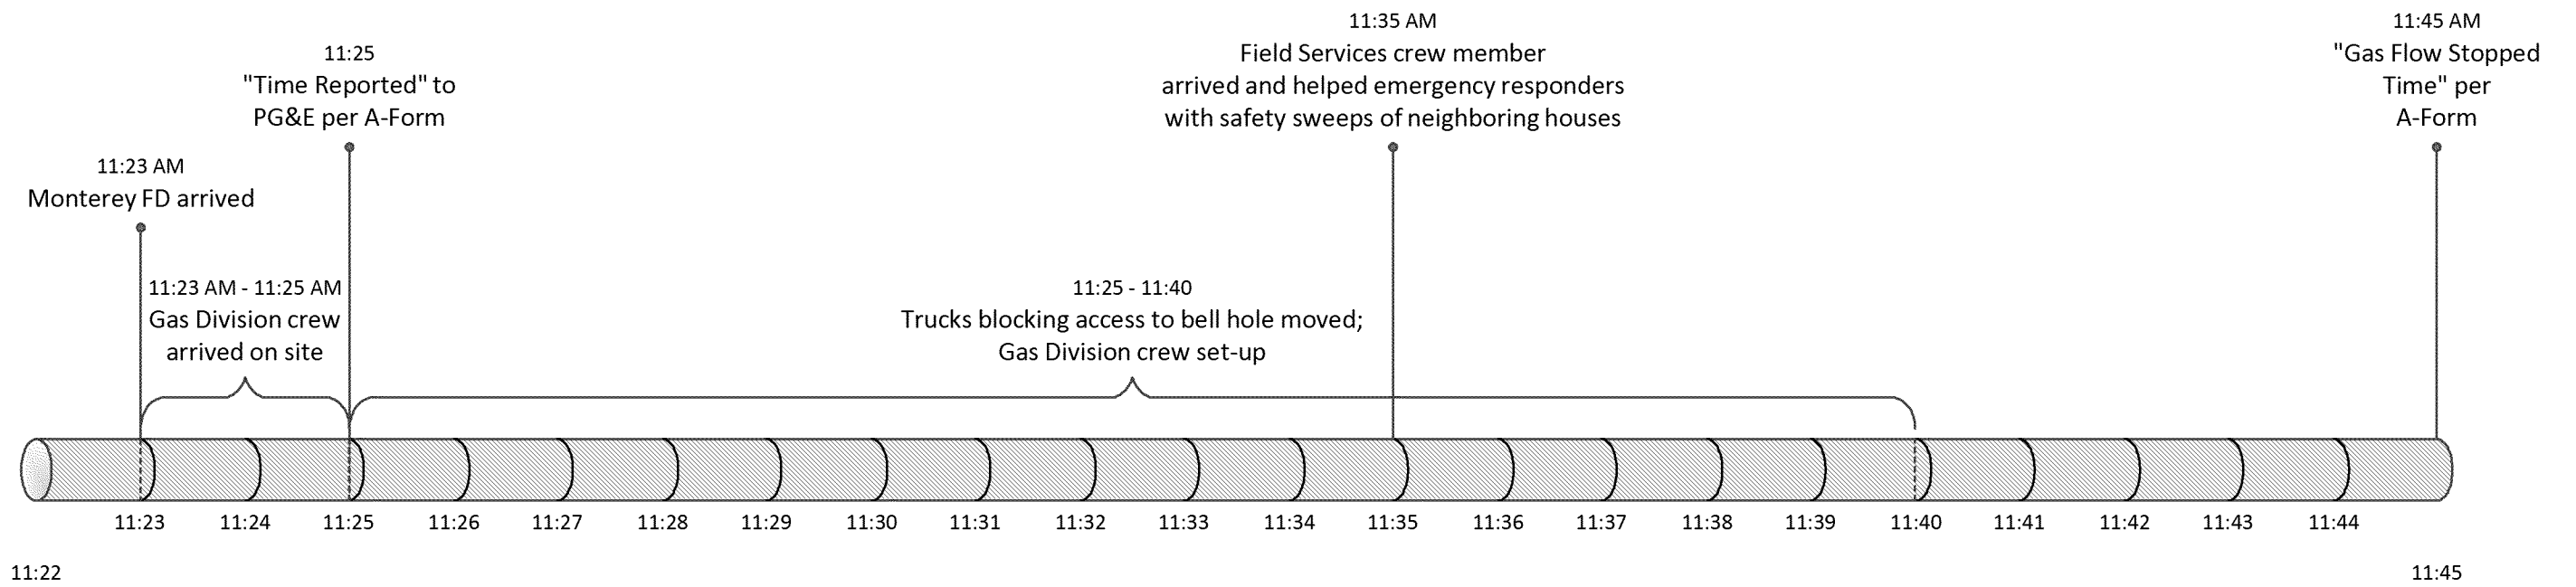
Carmel Gas Incident – Summary Timeline

(Monterey Fire Department arrival to Gas Flow Stopped)

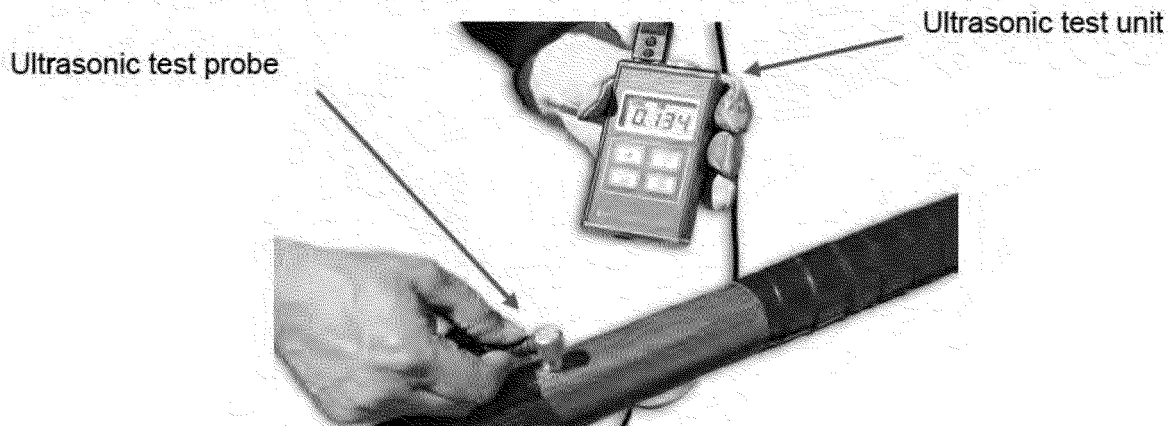
Figure 1. Check Pipeline Wall Thickness

It is recommended to clean steel pipeline in the area to be ultrasonic tested to bare metal AND perform multiple ultrasonic tests in various locations to insure accurate wall thickness measurements.

- 1.4 Check steel pipeline wall thickness with an ultrasonic tester. Ensure the wall thickness **does not exceed 0.280**. Refer to Figure 1; "Check Pipeline Wall Thickness" below.

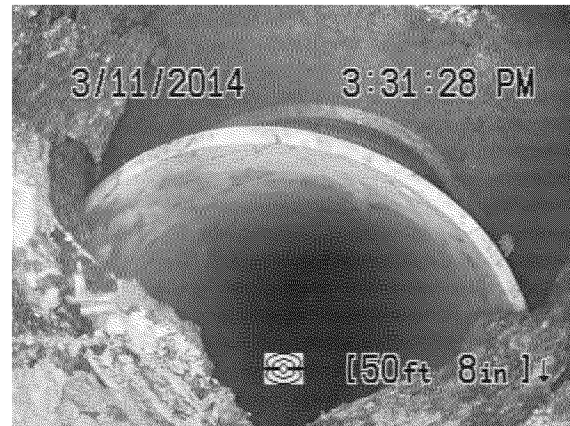
Figure 6. Offset joint 50 ft. from entry on property
