**INVESTIGATION REPORT
OF THE
JUNE 19, 2012 FATALITY AT THE
KERN POWER PLANT OWNED BY
PACIFIC GAS AND ELECTRIC COMPANY**

**PREPARED BY THE SAFETY AND ENFORCEMENT DIVISION
ELECTRIC SAFETY AND RELIABILITY BRANCH**

**SAN FRANCISCO
AUGUST 2014**

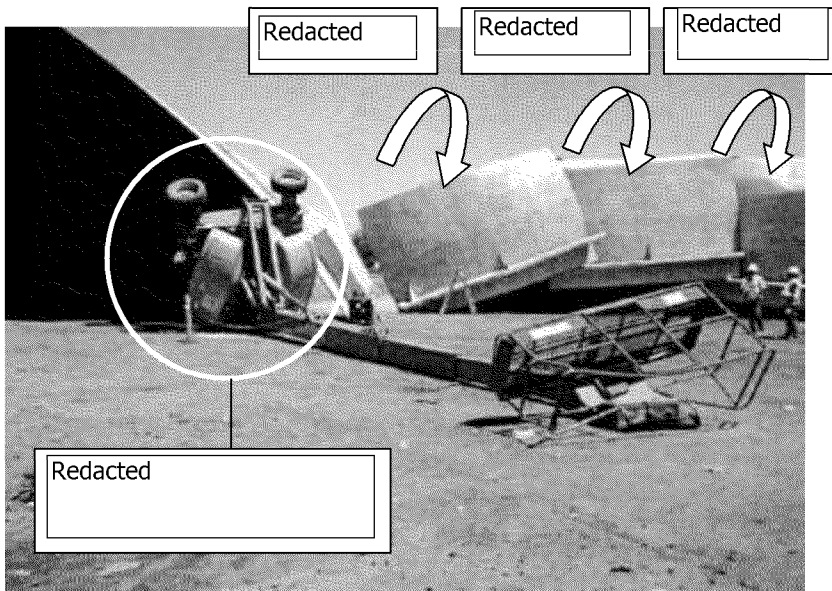
On the following day, workers began to demolish Fuel Oil Tank #1 (Figure 4). The 80,000-barrel tank was approximately 40 feet tall and 120 feet in diameter. From inside the tank, two workers stood on elevated man lifts to torch-cut the top half of the 40-foot-high tank wall in 20-foot-high sections. Once the workers finished a vertical section cut, a third worker in an excavator pushed the top wall section from outside the tank to fold it into the tank, reducing the tank section height by half (Figure 5).

Figure 5: Overturned man lift inside Fuel Oil Tank #1.

The crew used this method to cut down three sections. On the fourth section, the superintendent stepped away and told the torch cutters to rest, expecting the crew would not resume work until his return. The crew resumed work before the superintendent returned. The torch cutter who sustained the fatal injuries made a vertical cut just above the rectangular tank access opening cut the previous day. The torch cutter signaled completion of the cut, and the excavator pushed in. But this time, not only did the newly cut section fold in, but the portion of the tank wall from which the section was

cut collapsed inward as well. The collapsing wall struck the man lift carrying the torch cutter. The lift overturned and fell to the ground. The other workers stopped the project immediately. An ambulance transported the worker to a local hospital. The worker did not survive the injuries.² PG&E reported the incident to ESRB on June 19, 2012, at 5:35 pm.³
