**INVESTIGATION REPORT  
OF THE  
JUNE 19, 2012 FATALITY AT THE  
KERN POWER PLANT OWNED BY  
PACIFIC GAS AND ELECTRIC COMPANY**

**PREPARED BY THE SAFETY AND ENFORCEMENT DIVISION  
ELECTRIC SAFETY AND RELIABILITY BRANCH**

**SAN FRANCISCO  
AUGUST 2014**

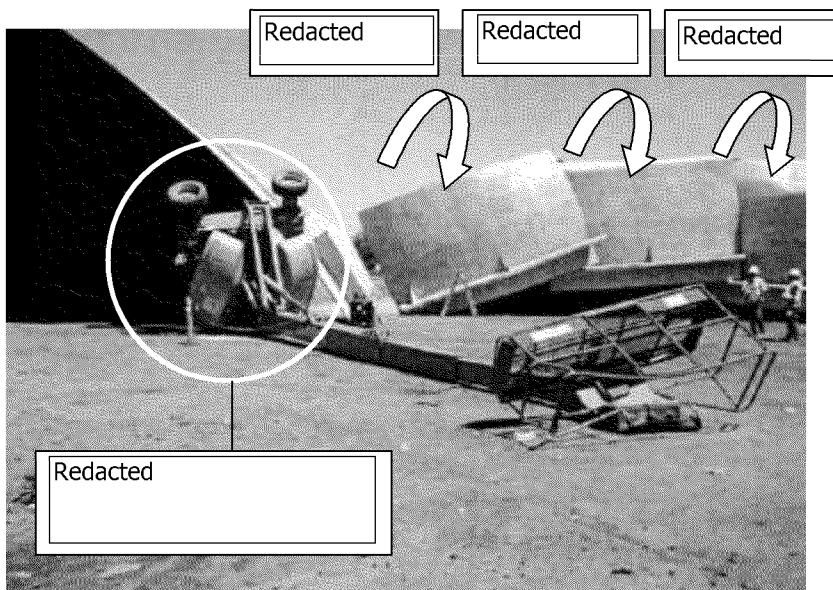
Figure 5: Overturned man lift inside Fuel Oil Tank #1.

The crew used this method to cut down three sections. On the fourth section, the superintendent stepped away and told the torch cutters to rest, expecting the crew would not resume work until his return. The crew resumed work before the superintendent returned. The torch cutter who sustained the fatal injuries made a vertical cut just above the rectangular tank access opening cut the previous day. The torch cutter signaled completion of the cut, and the excavator pushed in. But this time, not only did the newly cut section fold in, but the portion of the tank wall from which the section was

cut collapsed inward as well. The collapsing wall struck the man lift carrying the torch cutter. The lift overturned and fell to the ground. The other workers stopped the project immediately. An ambulance transported the worker to a local hospital. The worker did not survive the injuries.<sup>2</sup> PG&E reported the incident to ESRB on June 19, 2012, at 5:35 pm.<sup>3</sup>
