**INVESTIGATION REPORT
OF THE
JUNE 19, 2012 FATALITY AT THE
KERN POWER PLANT OWNED BY
PACIFIC GAS AND ELECTRIC COMPANY**

**PREPARED BY THE SAFETY AND ENFORCEMENT DIVISION
ELECTRIC SAFETY AND RELIABILITY BRANCH**

**SAN FRANCISCO
AUGUST 2014**

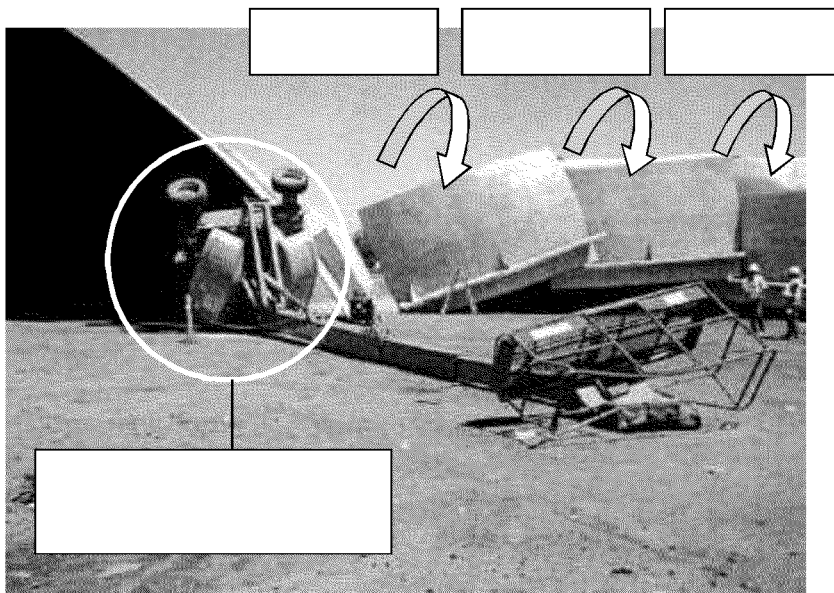
On the following day, workers began to demolish Fuel Oil Tank #1 (Figure 4). The 80,000 -barrel tank was approximately 40 feet tall and 120 feet in diameter. From inside the tank, two workers stood on elevated man lifts to torch -cut the top half of the 40 -foot-high tank wall in 20 -foot-high sections. Once the workers finished a vertical section cut, a third worker in an excavator pushed the top wall section from outside the tank to fold it into the tank, reducing the tank section height by half (Figure 5).

Figure 5: Overtumed man lift inside Fuel Oil Tank #1.

The crew used this method to cut down three sections. On the fourth section, the superintendent stepped away and told the torch cutters to rest, expecting the crew would not resume work until his return. The crew resumed work before the superintendent returned. The torch cutter who sustained the fatal injuries made a vertical cut just above the rectangular tank access opening cut the previous day. The torch cutter signaled completion of the cut, and the excavator pushed in. But this time, not only did the newly cut section fold in, but the portion of the tank wall from which the section was

cut collapsed inward as well. The collapsing wall struck the man lift carrying the torch cutter. The lift overturned and fell to the ground. The other workers stopped the project immediately. An ambulance transported the worker to a local hospital. The worker did not survive the injuries.² PG&E reported the incident to ESRB on June 19, 2012, at 5:35 pm.³
