California Public Utilities Commission

**INVESTIGATION REPORT
OF THE
JUNE 19, 2012 FATALITY AT THE
KERN POWER PLANT OWNED BY
PACIFIC GAS AND ELECTRIC COMPANY**

**PREPARED BY THE SAFETY AND ENFORCEMENT DIVISION
ELECTRIC SAFETY AND RELIABILITY BRANCH**

**SAN FRANCISCO
AUGUST 2014**

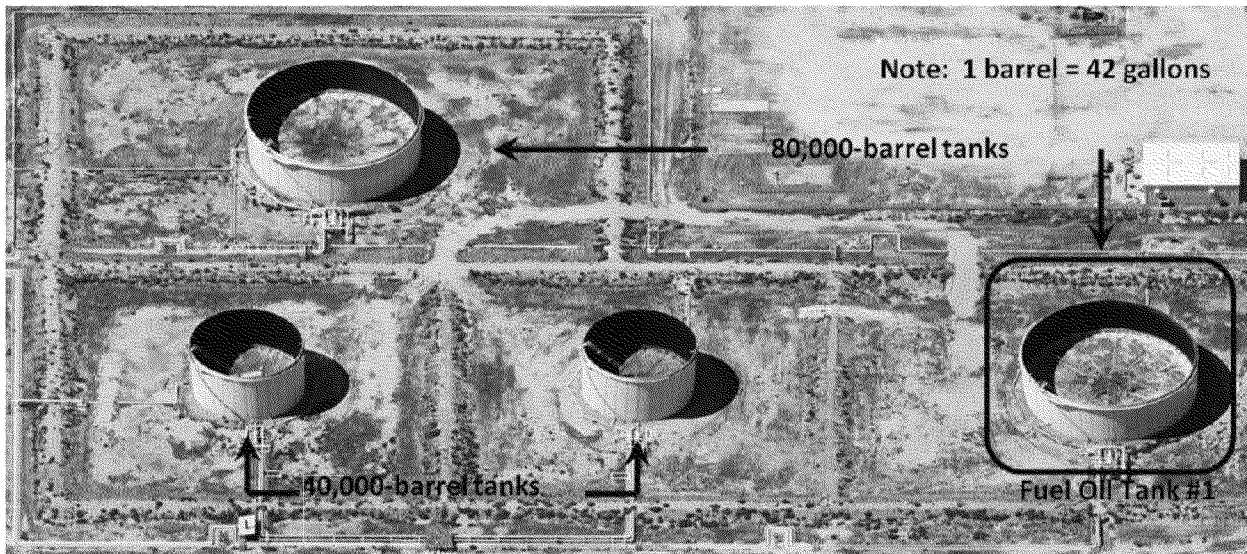
Figure 4: Fuel oil tank farm at Kern Power Plant. *Source: Google Maps.*

On the following day, workers began to demolish Fuel Oil Tank #1 (Figure 4). The 80,000-barrel tank was approximately 40 feet tall and 120 feet in diameter. From inside the tank, two workers stood on elevated man lifts to torch-cut the top half of the 40-foot-high tank wall in 20-foot-high sections. Once the workers finished a vertical section cut, a third worker in an excavator pushed the top wall section from outside the tank to fold it into the tank, reducing the tank section height by half (Figure 5).

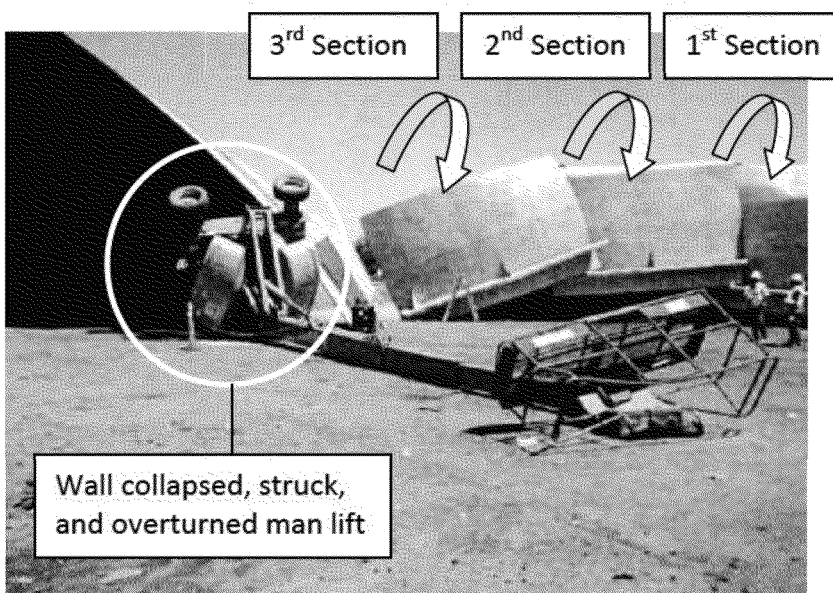
Figure 5: Overturned man lift inside Fuel Oil Tank #1.

The crew used this method to cut down three sections. On the fourth section, the superintendent stepped away and told the torch cutters to rest, expecting the crew would not resume work until his return. The crew resumed work before the superintendent returned. The torch cutter who sustained the fatal injuries made a vertical cut just above the rectangular tank access opening cut the previous day. The torch cutter signaled completion of the cut, and the excavator pushed in. But this time, not only did the newly cut section fold in, but the portion of the tank wall from which the section was

cut collapsed inward as well. The collapsing wall struck the man lift carrying the torch cutter. The lift overturned and fell to the ground. The other workers stopped the project immediately. An ambulance transported the worker to a local hospital. The worker did not survive the injuries.² PG&E reported the incident to ESRB on June 19, 2012, at 5:35 pm.³

The BV report discussed the position of the man lift, the orientation of the man lift wheels, and the location of the torch cut above the tank access opening as contributing factors to the incident, but failed to provide technical evidence to support an apparent implied assumption that changes to the orientation of the man lift, wheels, or location of the torch-cut would have prevented the incident. At the same time, the perception that orientation of the man lift and wheels is important to safety indicates a hazard that was inadequately managed. BV described wheel orientation as important in that the man lift would roll back if struck, with no discussion of hazard assessment or mitigation strategies, such as ensuring that the weakened tank walls were adequately supported and workers were clear of the area during hazardous operations. If the man lift’s position, wheel orientation and torch-cut locations are indeed critical to safety, the written work plans should describe such hazards and appropriate pre-emptive protections, and workers should be formally trained on those safety concerns and certified by a safety officer in advance of the tank demolition.
