RE: PG&E Supplemental Information Report & Materials

Pacific Gas and Electric (PG&E) retained Exponent Failure Analysis Associates (Exponent) to conduct a failure analysis investigation of a gas leak and subsequent explosion on March 3, 2014 in Carmel-by-the-Sea (Carmel), California. Exponent's report was submitted to PG&E on April 25, 2014, and discussed at a City Council Meeting at Carmel city offices on May 6, 2014. Subsequent to that meeting, PG&E requested that Exponent supplement its report to address specific questions raised at the meeting. This supplemental report includes the following:

Carmel Gas Incident – Summary Timeline

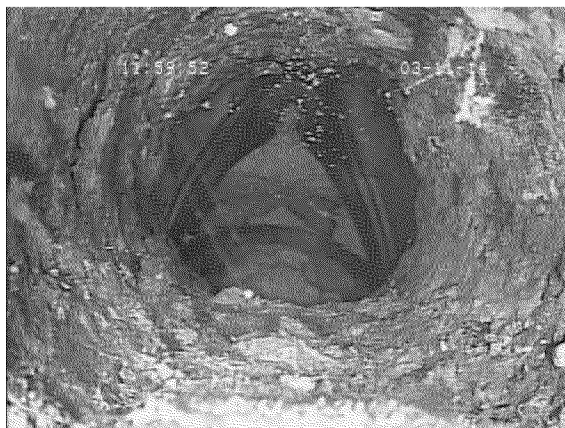
Figure 5. Collapsed main and offset joint

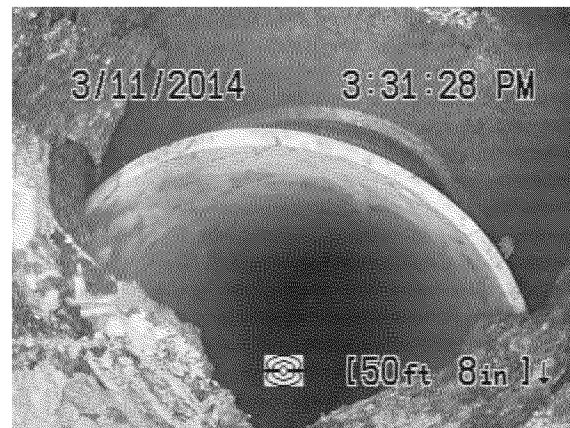
Figure 6. Offset joint 50 ft. from entry on property

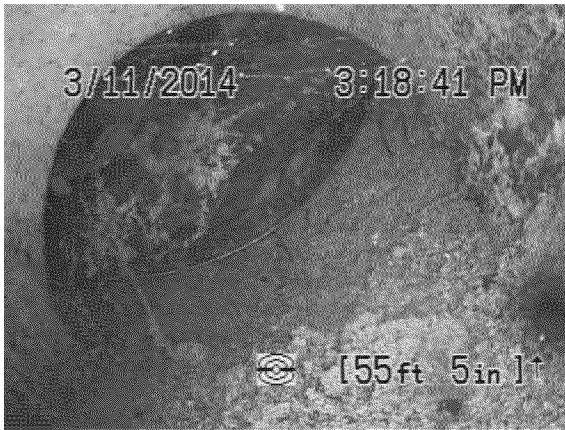
Figure 7. Lateral bend 55 ft. from entry

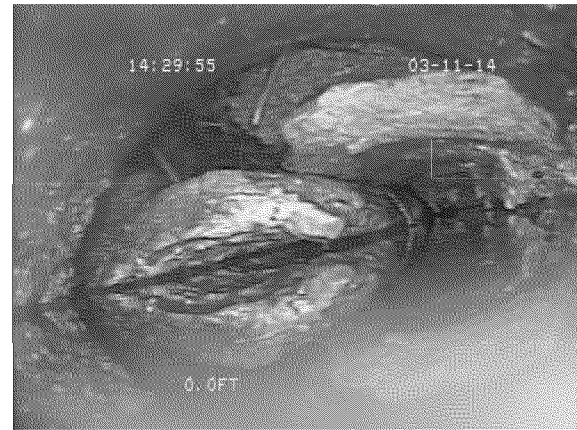
Figure 8. Collapsed main and water in sag

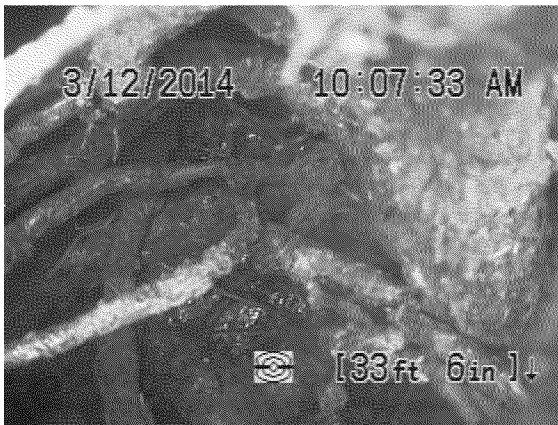
Figure 9. Lateral blocked by roots

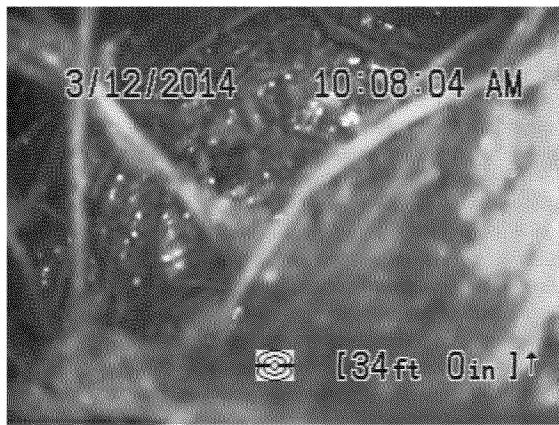
Figure 10. Roots over shiny apparent cap
