**INVESTIGATION REPORT
OF THE
JUNE 19, 2012 FATALITY AT THE
KERN POWER PLANT OWNED BY
PACIFIC GAS AND ELECTRIC COMPANY**

**PREPARED BY THE SAFETY AND ENFORCEMENT DIVISION
ELECTRIC SAFETY AND RELIABILITY BRANCH**

**SAN FRANCISCO
AUGUST 2014**

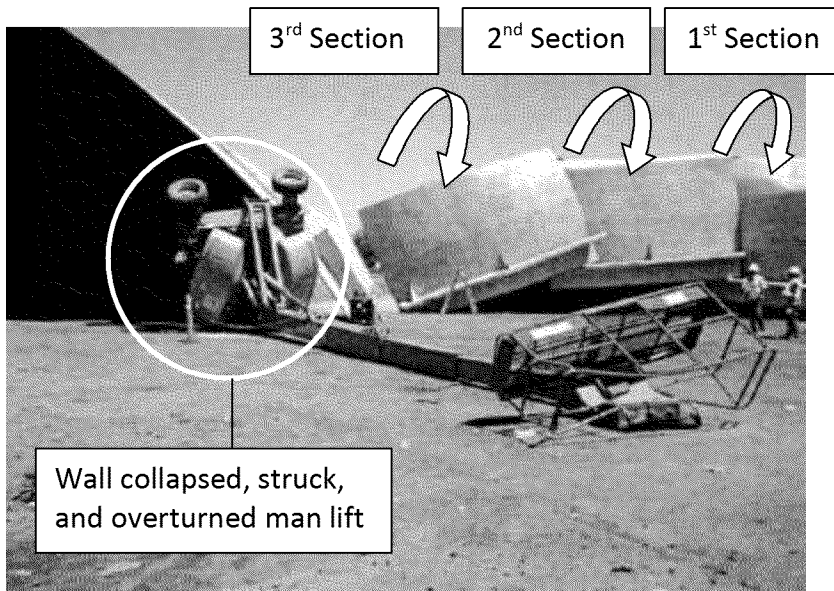
Figure 5: Overturned man lift inside Fuel Oil Tank #1.

The crew used this method to cut down three sections. On the fourth section, the superintendent stepped away and told the torch cutters to rest, expecting the crew would not resume work until his return. The crew resumed work before the superintendent returned. The torch cutter who sustained the fatal injuries made a vertical cut just above the rectangular tank access opening cut the previous day. The torch cutter signaled completion of the cut, and the excavator pushed in. But this time, not only did the newly cut section fold in, but the portion of the tank wall from which the section was

cut collapsed inward as well. The collapsing wall struck the man lift carrying the torch cutter. The lift overturned and fell to the ground. The other workers stopped the project immediately. An ambulance transported the worker to a local hospital. The worker did not survive the injuries.² PG&E reported the incident to ESRB on June 19, 2012, at 5:35 pm.³
