California Public Utilities Commission

**INVESTIGATION REPORT  
OF THE  
JUNE 19, 2012 FATALITY AT THE  
KERN POWER PLANT OWNED BY  
PACIFIC GAS AND ELECTRIC COMPANY**

**PUBLIC REPORT**

**PREPARED BY THE SAFETY AND ENFORCEMENT DIVISION  
ELECTRIC SAFETY AND RELIABILITY BRANCH**

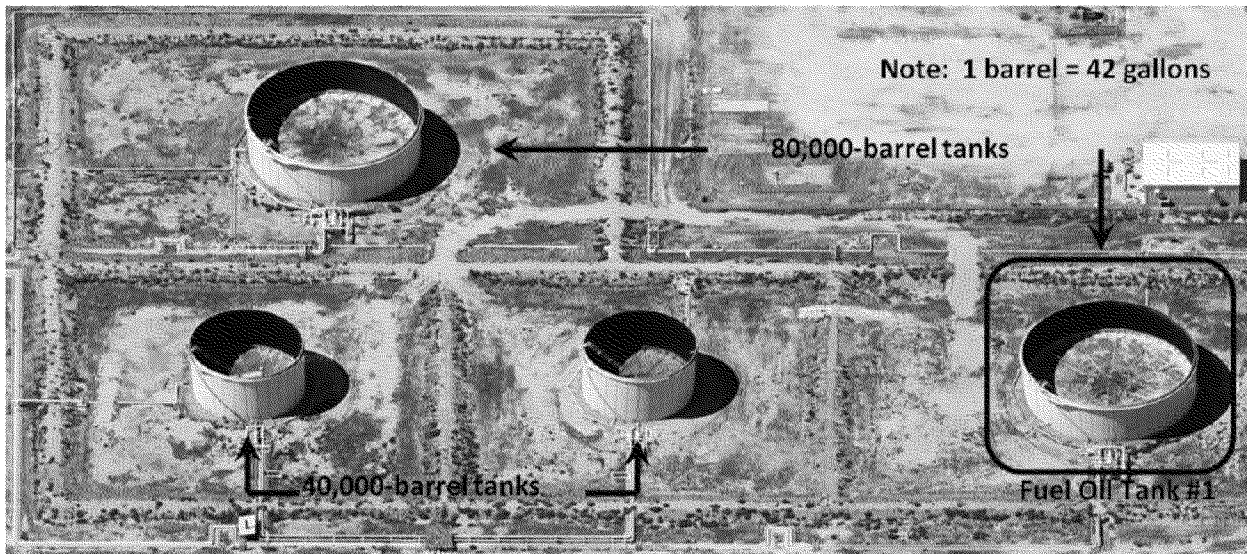
Figure 4: Fuel oil tank farm at Kern Power Plant. *Source: Google Maps.*

On the following day, workers began to demolish Fuel Oil Tank #1 (Figure 4). The 80,000-barrel tank was approximately 40 feet tall and 120 feet in diameter. From inside the tank, two workers stood on elevated man lifts to torch-cut the top half of the 40-foot-high tank wall in 20-foot-high sections. Once the workers finished a vertical section cut, a third worker in an excavator pushed the top wall section from outside the tank to fold it into the tank, reducing the tank section height by half (Figure 5).

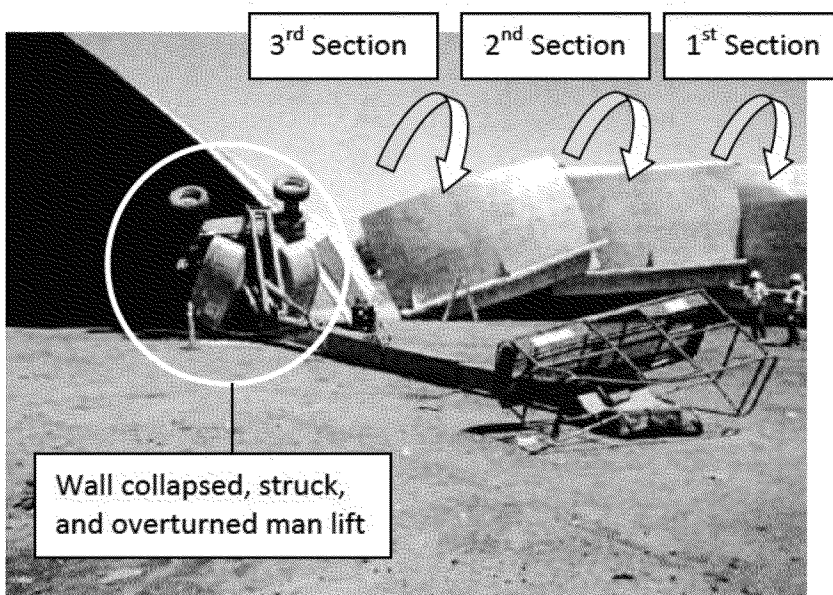
Figure 5: Overturned man lift inside Fuel Oil Tank #1.

The crew used this method to cut down three sections. On the fourth section, the superintendent stepped away and told the torch cutters to rest, expecting the crew would not resume work until his return. The crew resumed work before the superintendent returned. The torch cutter who sustained the fatal injuries made a vertical cut just above the rectangular tank access opening cut the previous day. The torch cutter signaled completion of the cut, and the excavator pushed in. But this time, not only did the newly cut section fold in, but the portion of the tank wall from which the section was

cut collapsed inward as well. The collapsing wall struck the man lift carrying the torch cutter. The lift overturned and fell to the ground. The other workers stopped the project immediately. An ambulance transported the worker to a local hospital. The worker did not survive the injuries.<sup>2</sup> PG&E reported the incident to ESRB on June 19, 2012, at 5:35 pm.<sup>3</sup>
