**Root Cause Analysis Report:
Worker Fatality
PG&E - Kern Power Plant Demolition
Bakersfield, CA**

Location of Incident: Kern Power Plant, Bakersfield, California
Date of Incident: Tuesday, June 19, 2012, approximately 9:20 a.m.
Type of Incident: Worker fatality; struck by collapsing tank wall

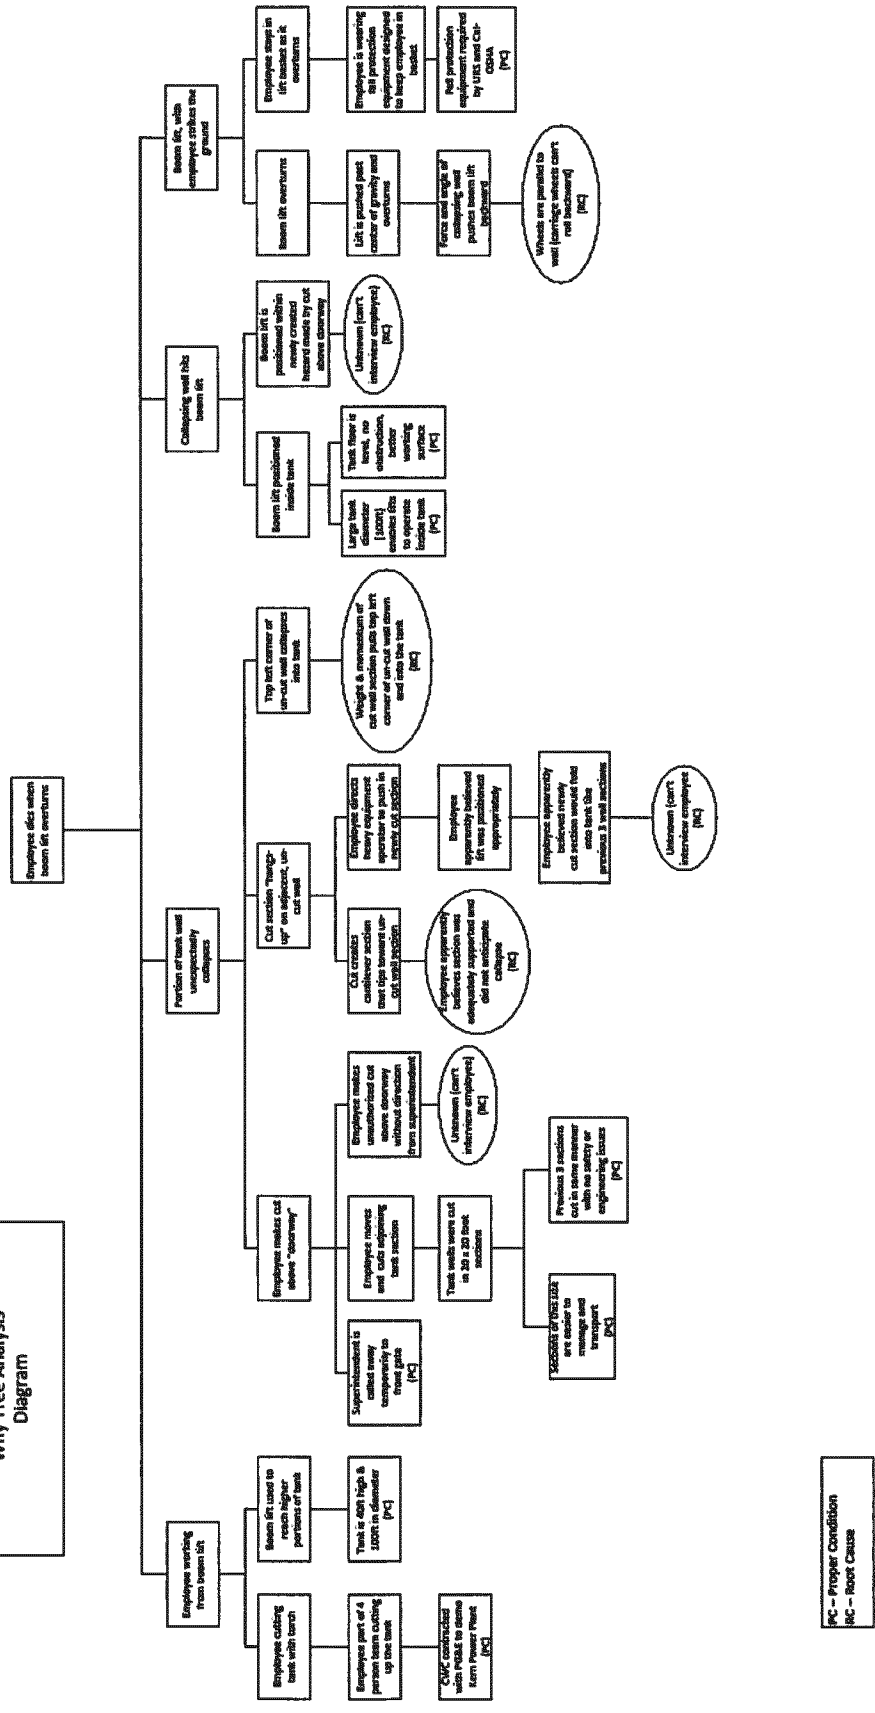
Figure 2
PG&E Kern Fatality
Why Tree Analysis
Diagram

PC - Proper Condition
BC - Root Cause

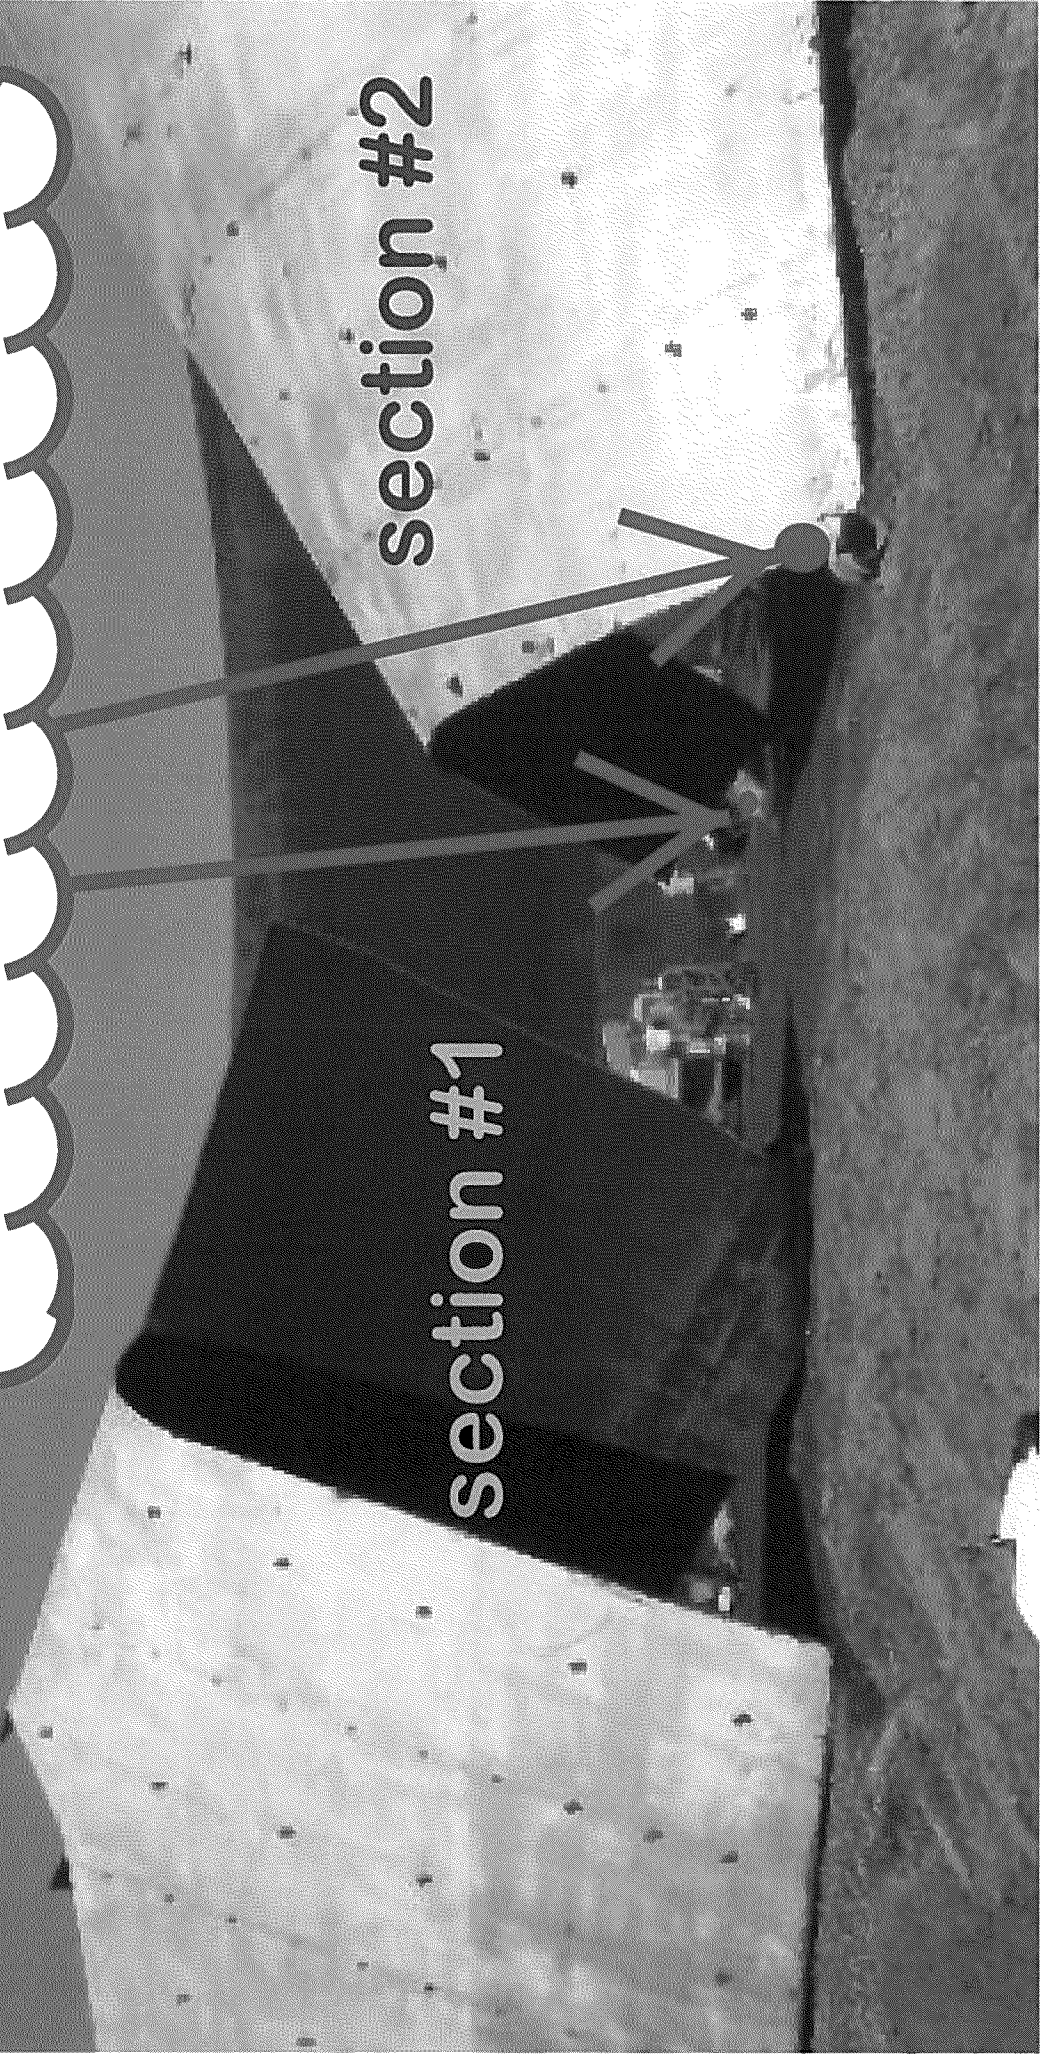
#2

Connection points for griphoist cables

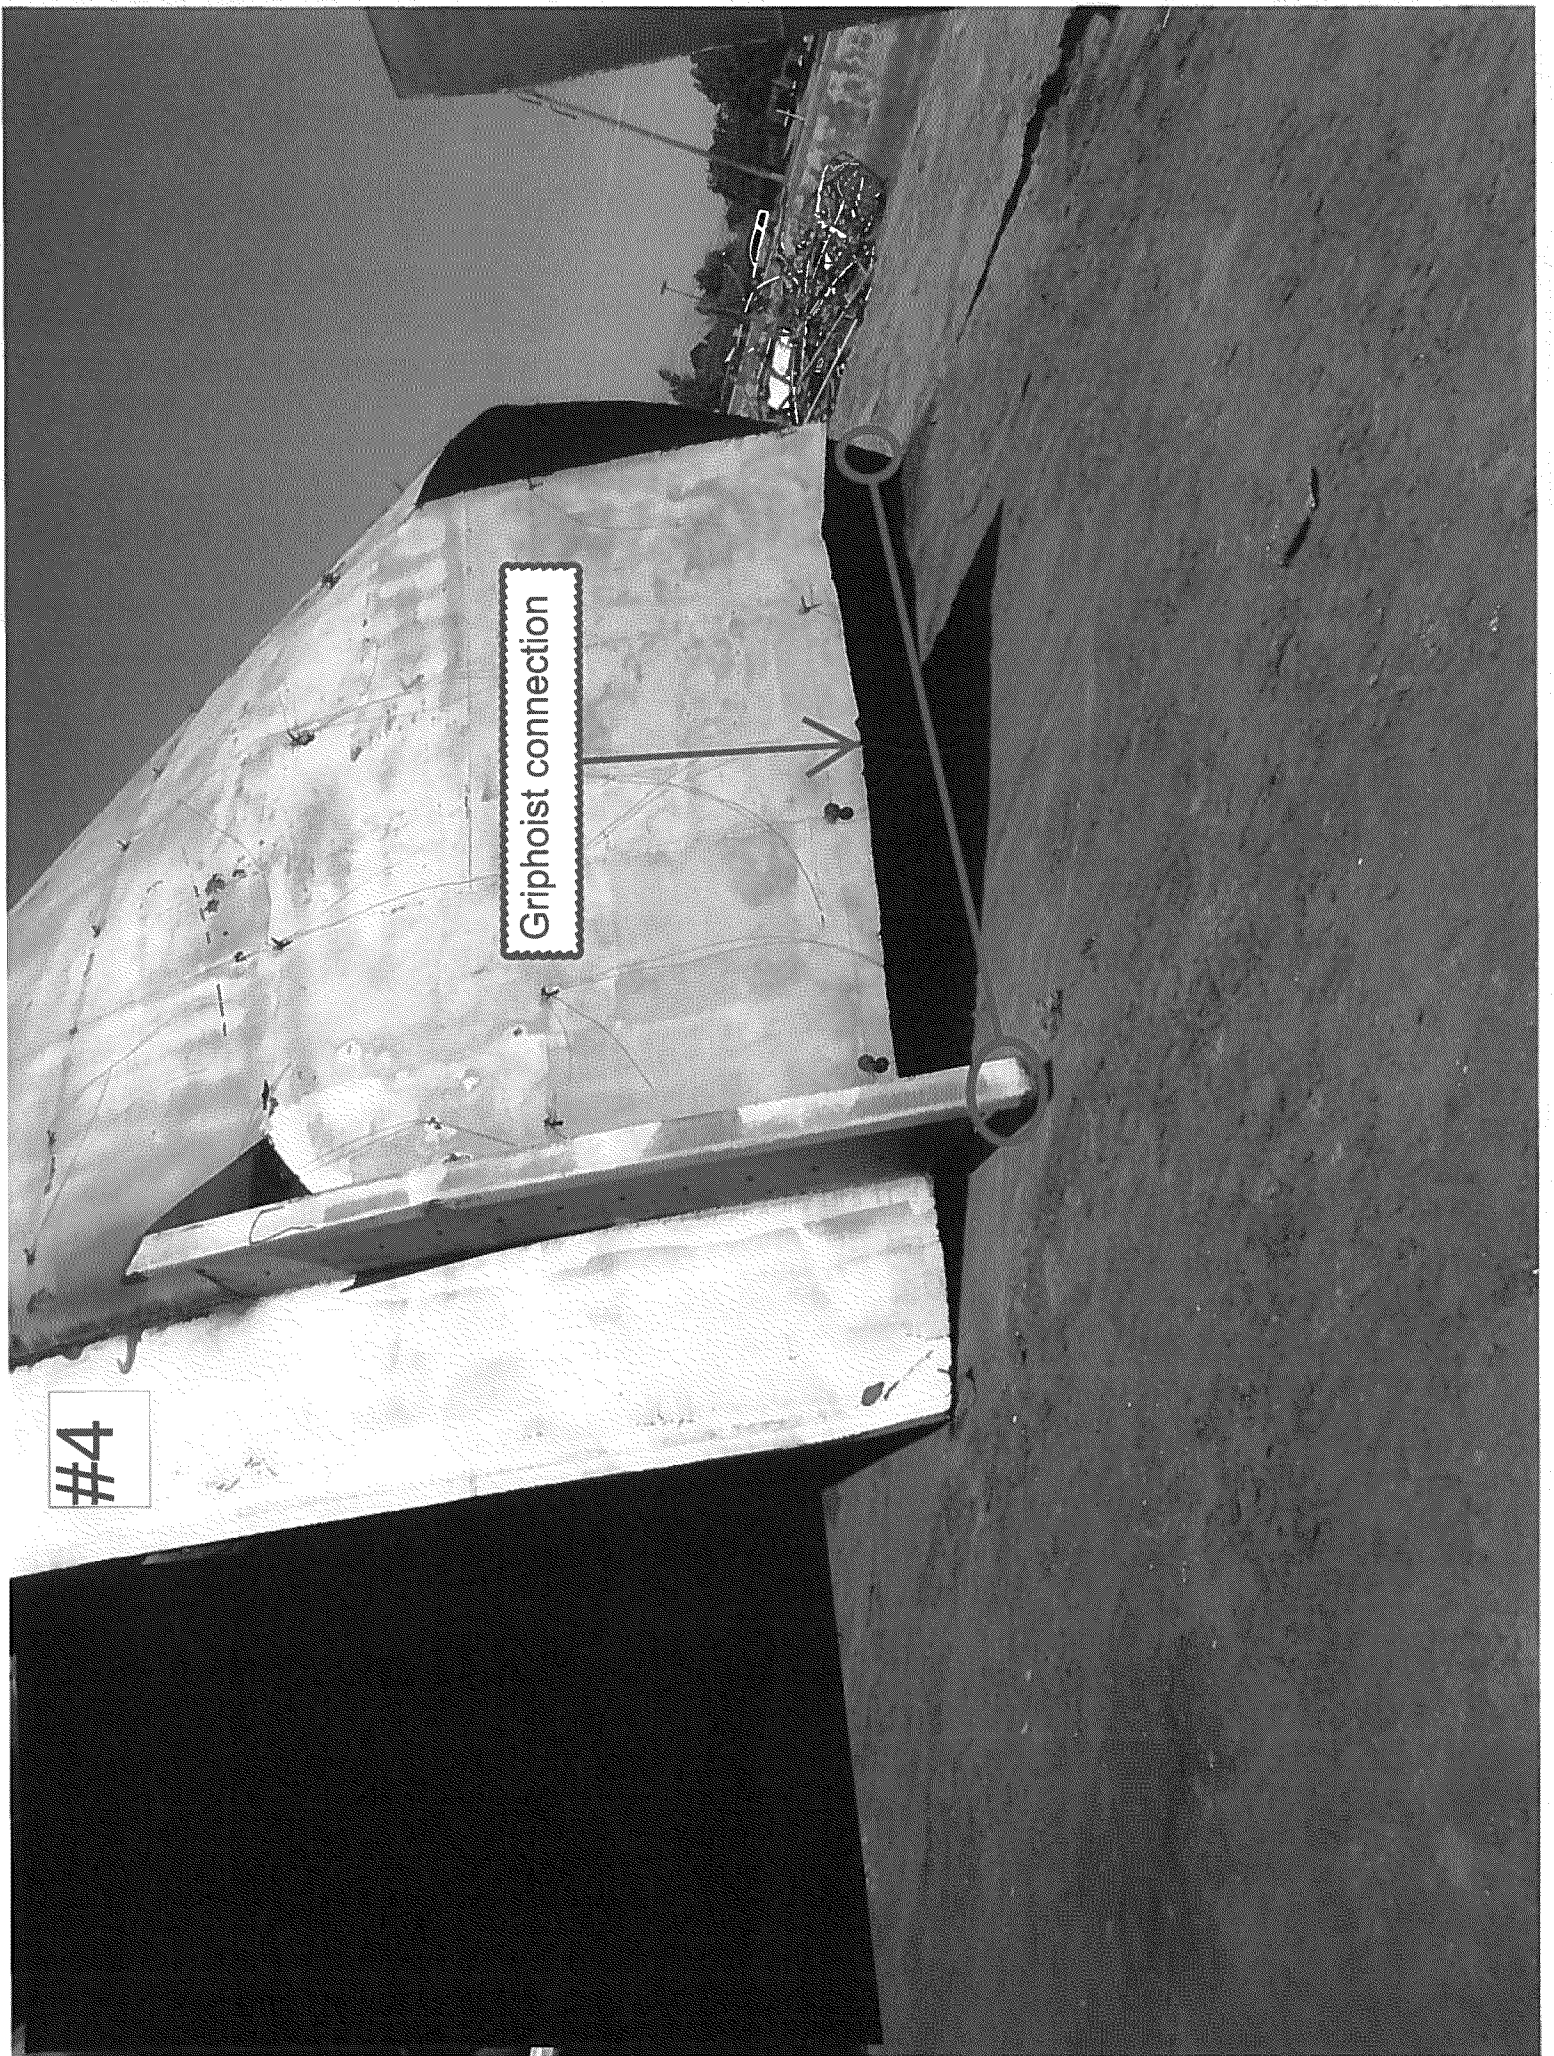
#3

grip hoist cable connection point to failed section @ stiffener plate

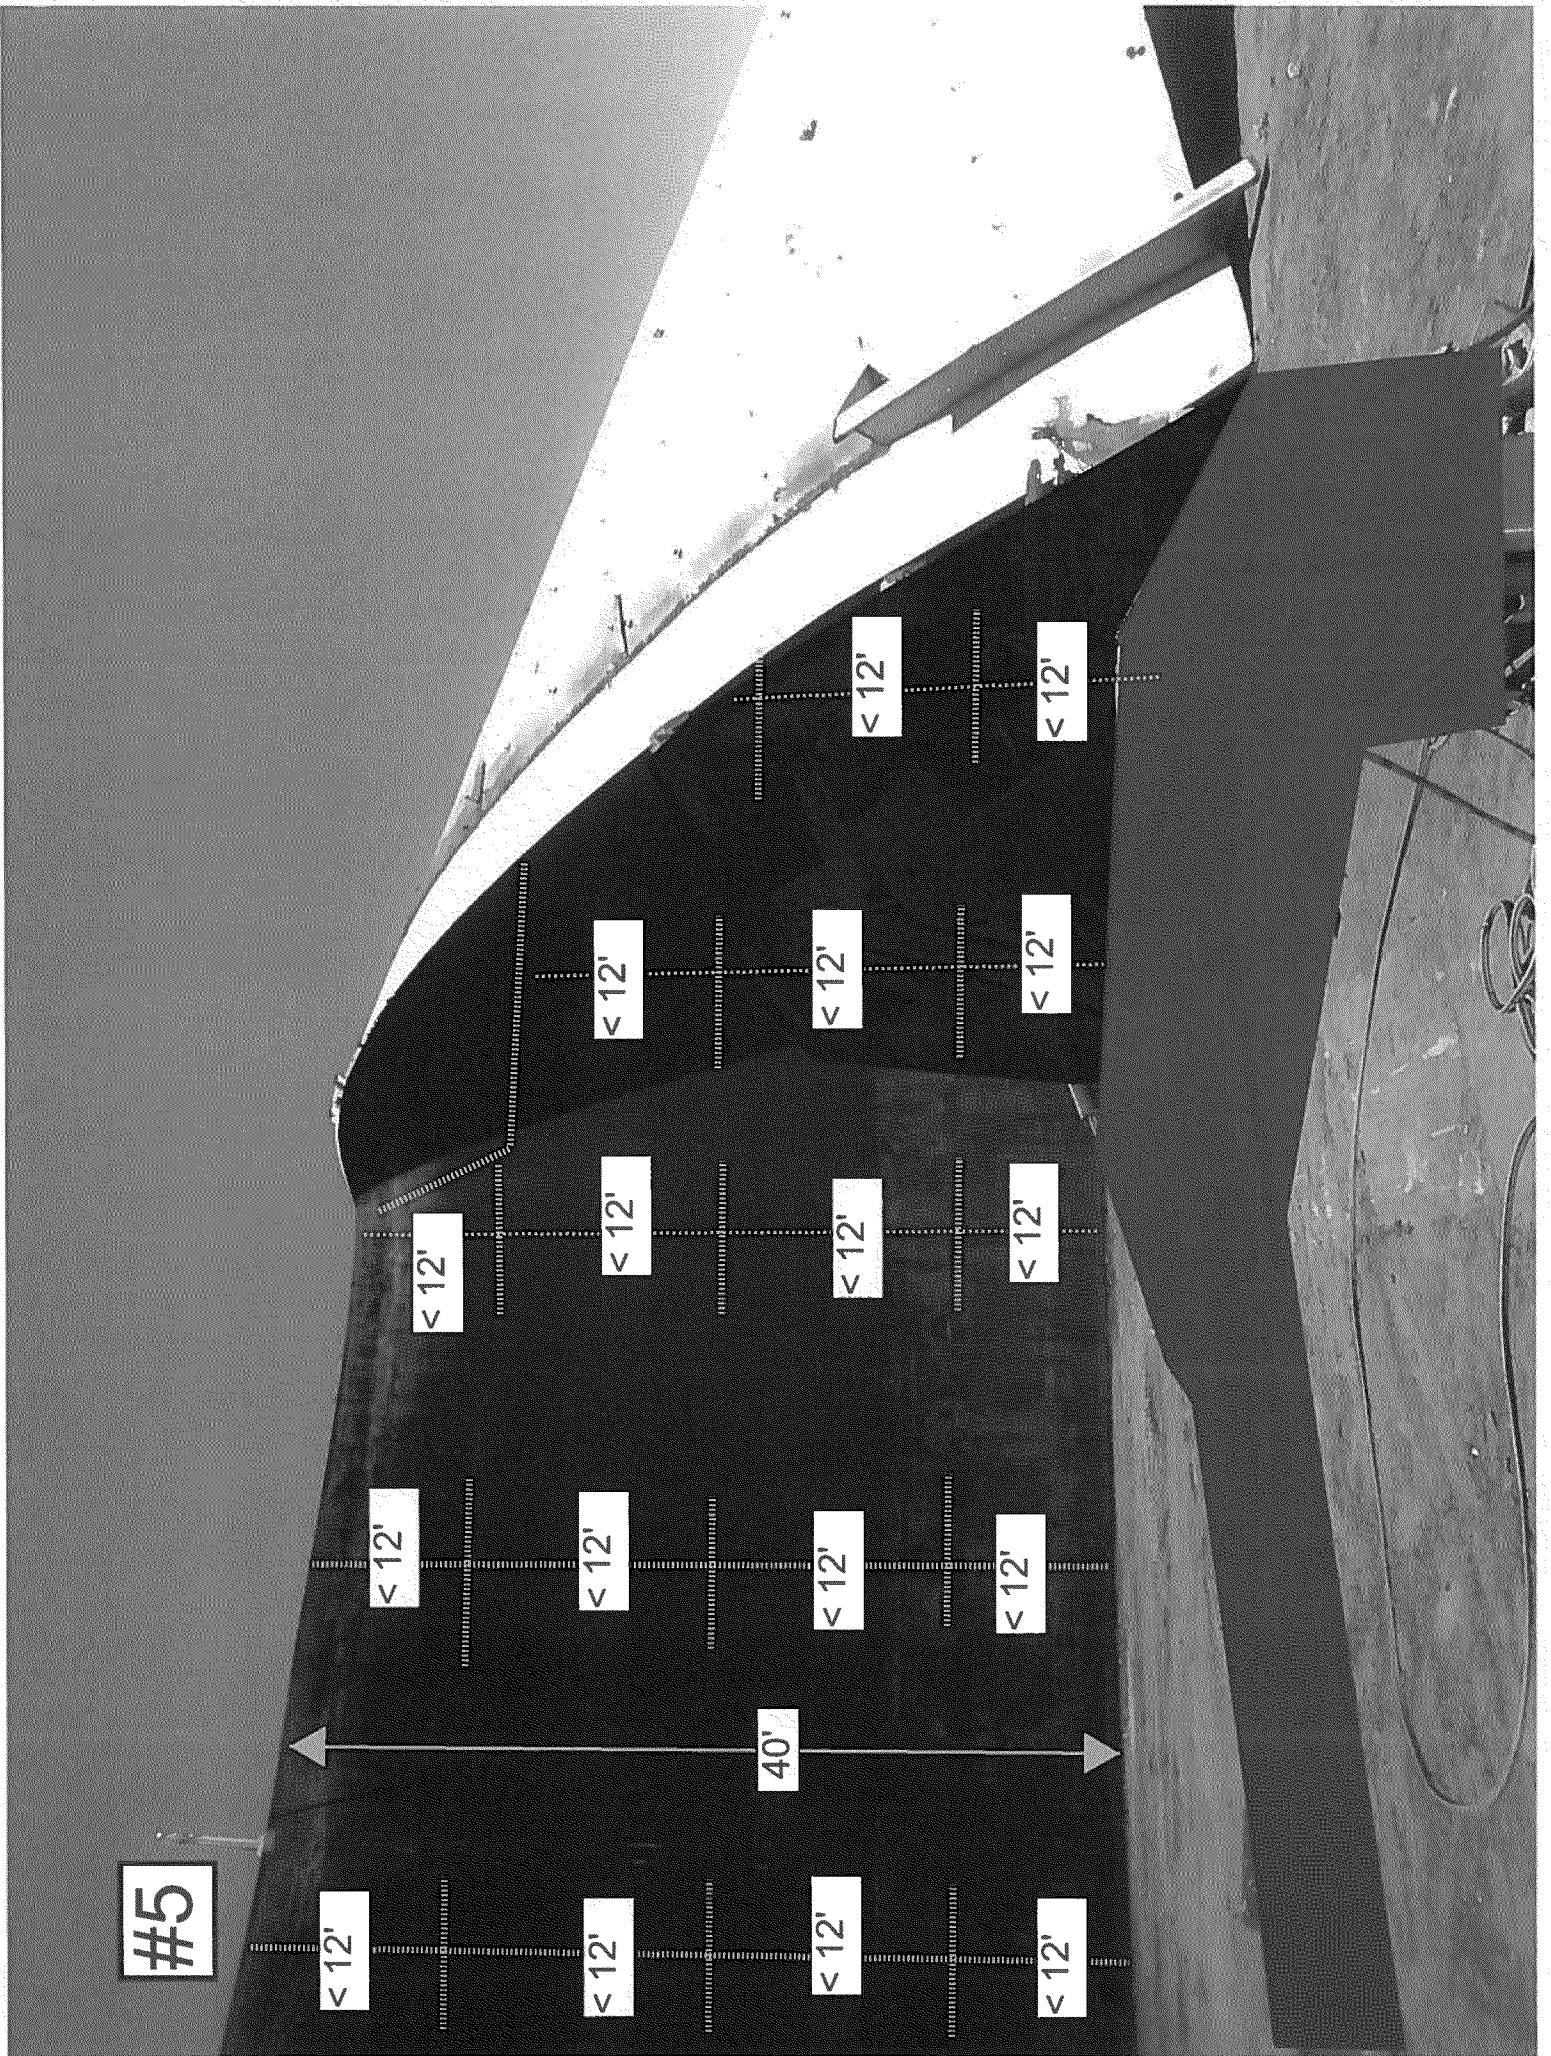
#4

Griphoist connection

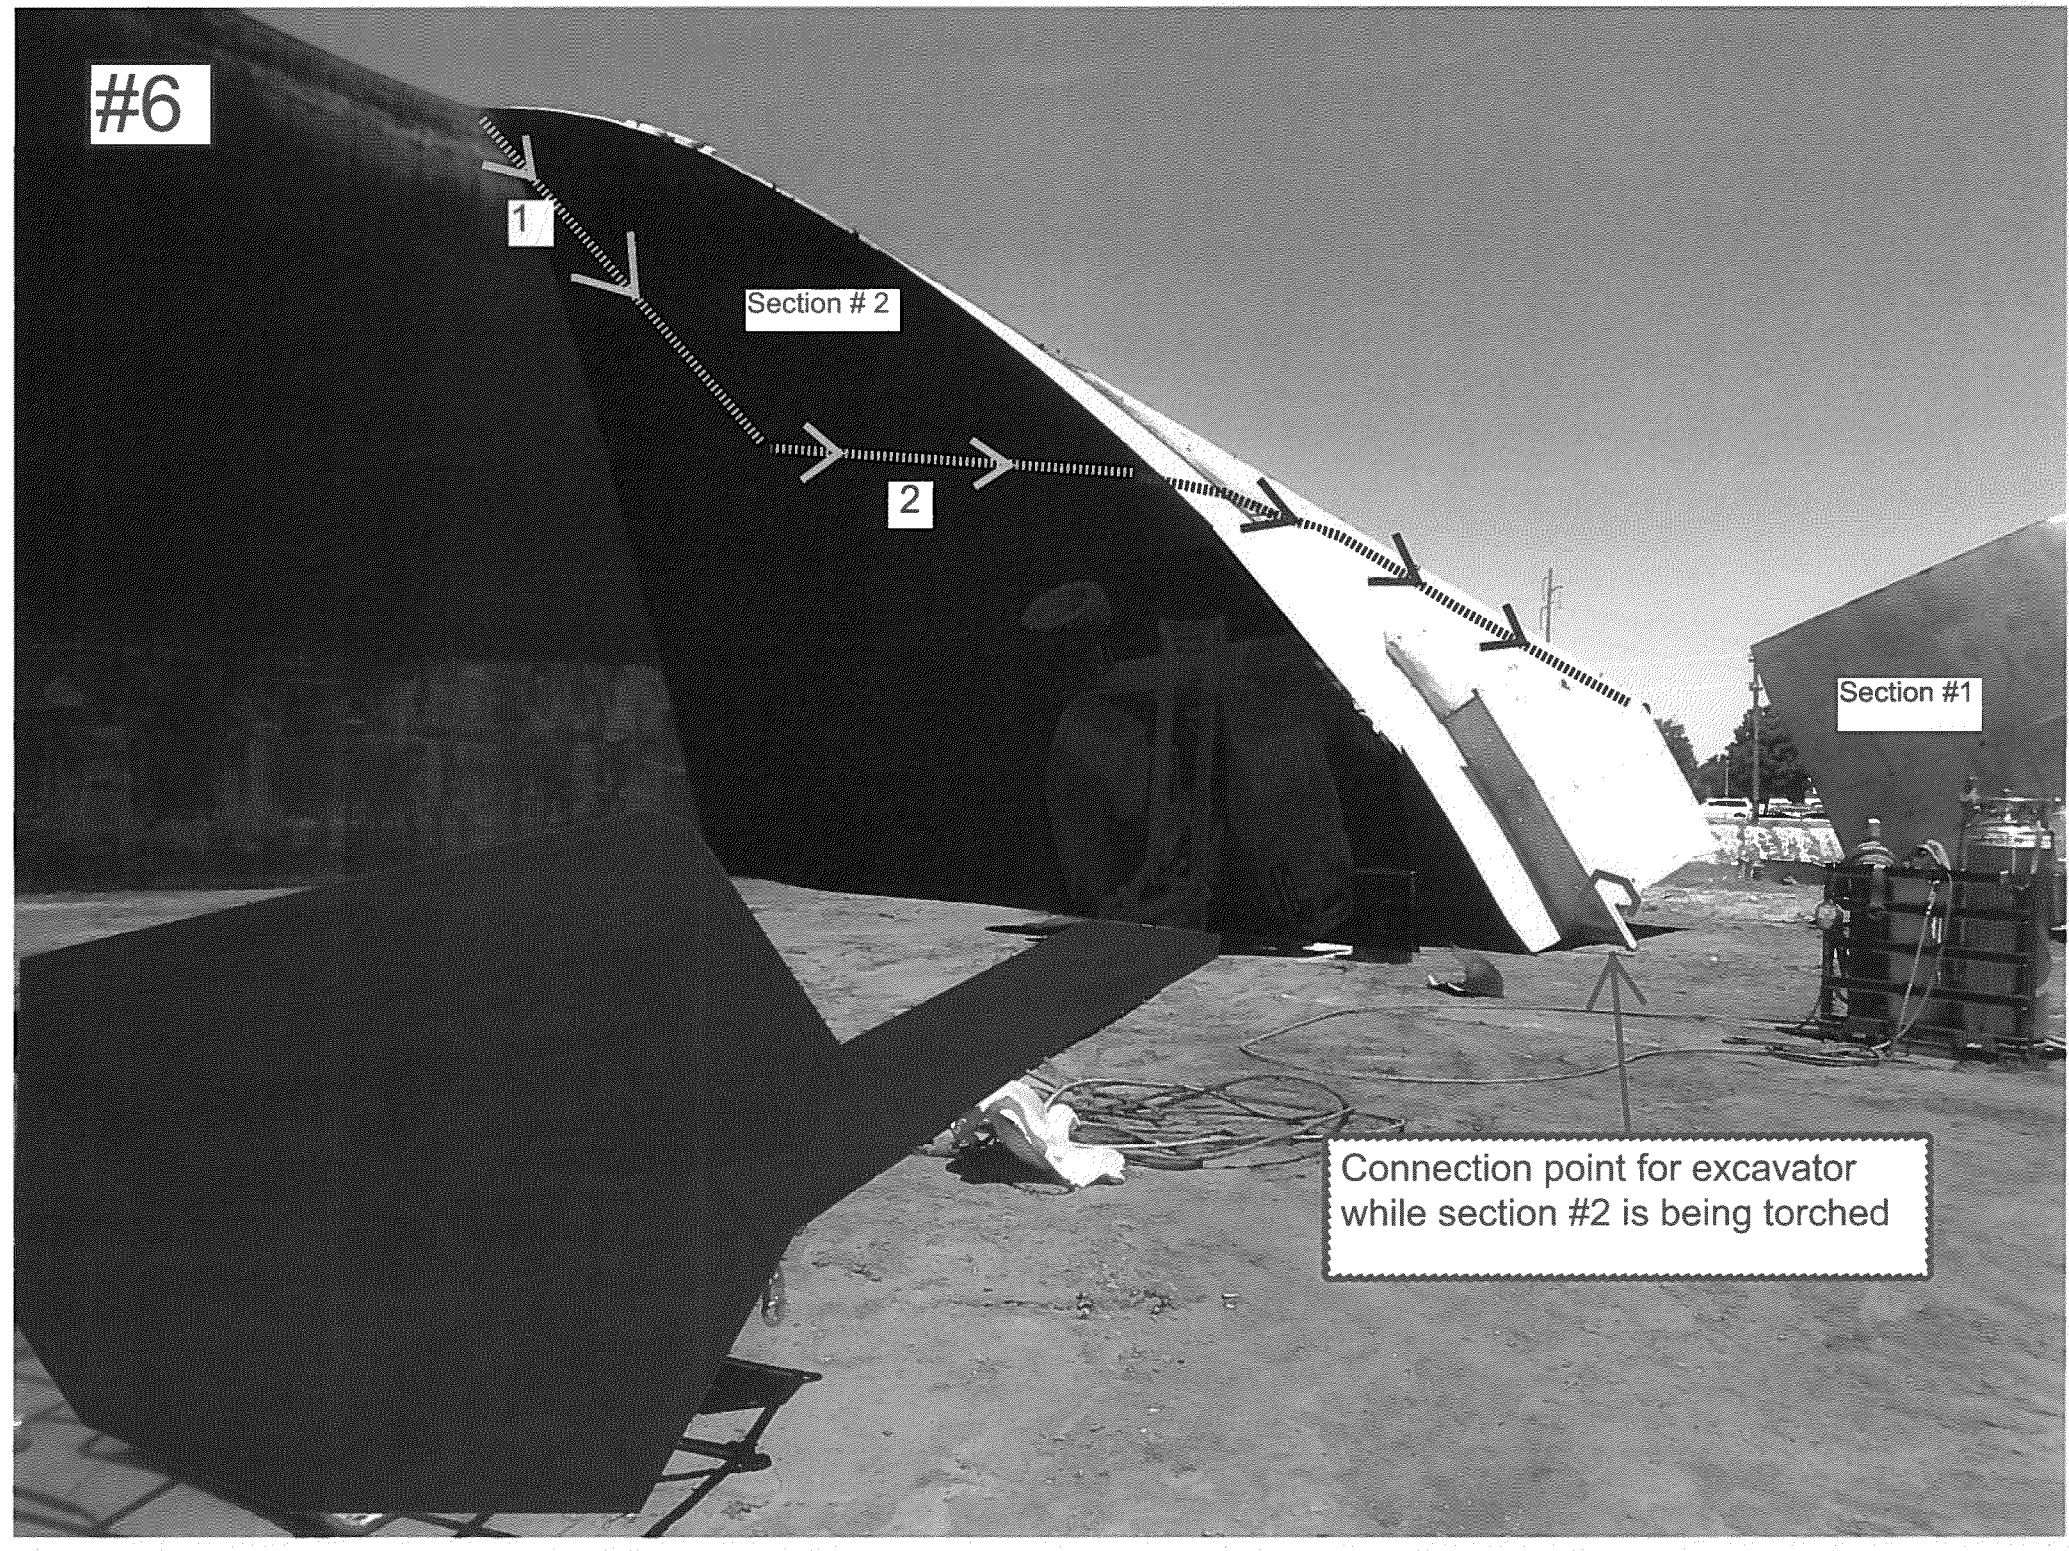
Connection point for excavator while section #2 is being torched

3. A grapple mounted excavator will remove fallen section #1 to a processing area.
4. The excavator will then re-position to the interior of the tank and secure the grapple to the stiffener plate as indicated in photo #6. This will stabilize section #2 while the curvature is removed by torching.

5. Torch man will work from boom lift positioned outside section #2 of the tank and begin torch cutting along cut line 1 down to ring #3 of the tank.
6. Torching will continue laterally along ring #3 as illustrated with line 2 of photo #6 through to the north end of the section.
