Supplemental Information for Performing AC Inspection of HPR-Type Stations

Identification of Atmospheric Corrosion

Measuring Level of Corrosion

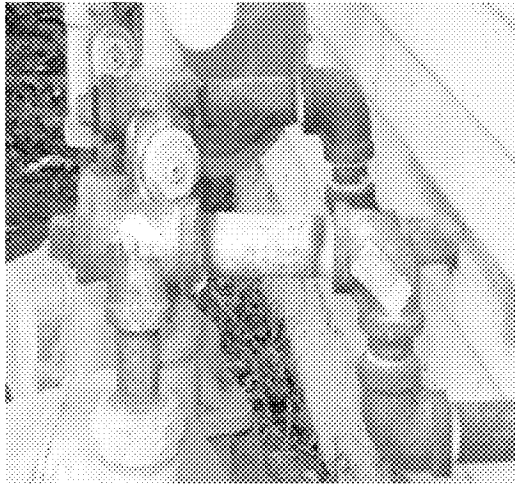
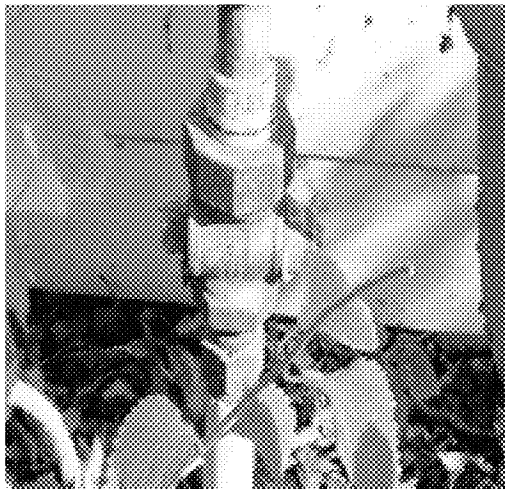
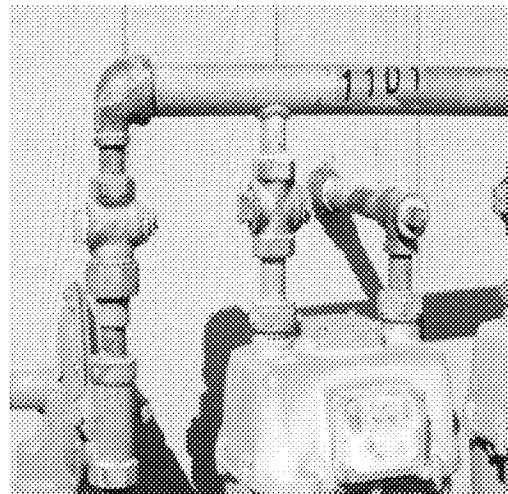
Oxidation/Surface Rust is a common occurrence, and does not require any action. Below are examples of oxidation or surface rust:

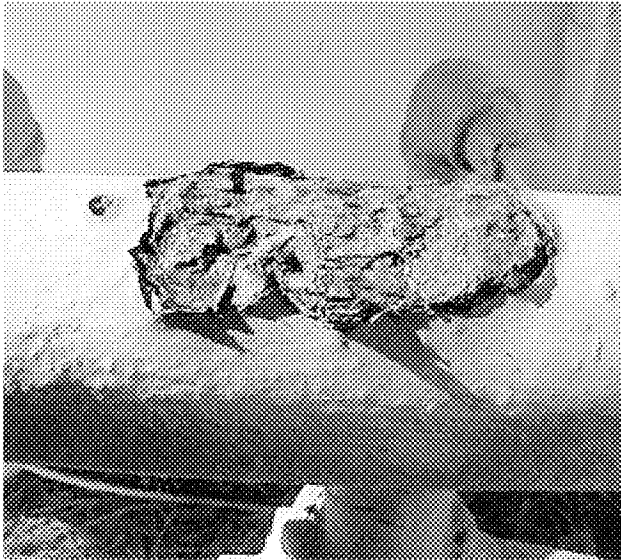
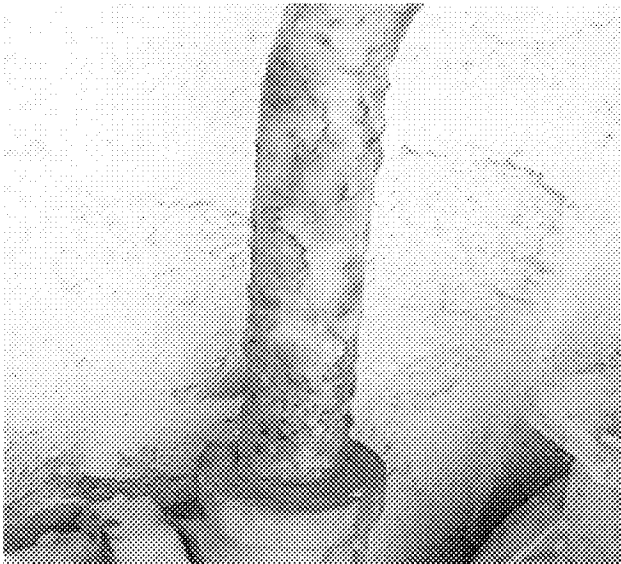
Atmospheric Corrosion compromises the integrity of the pipe, as it diminishes wall thickness of pipe. It consists of scaling, pitting, and/or blistering. Below are examples of atmospheric corrosion conditions that may require repairs:

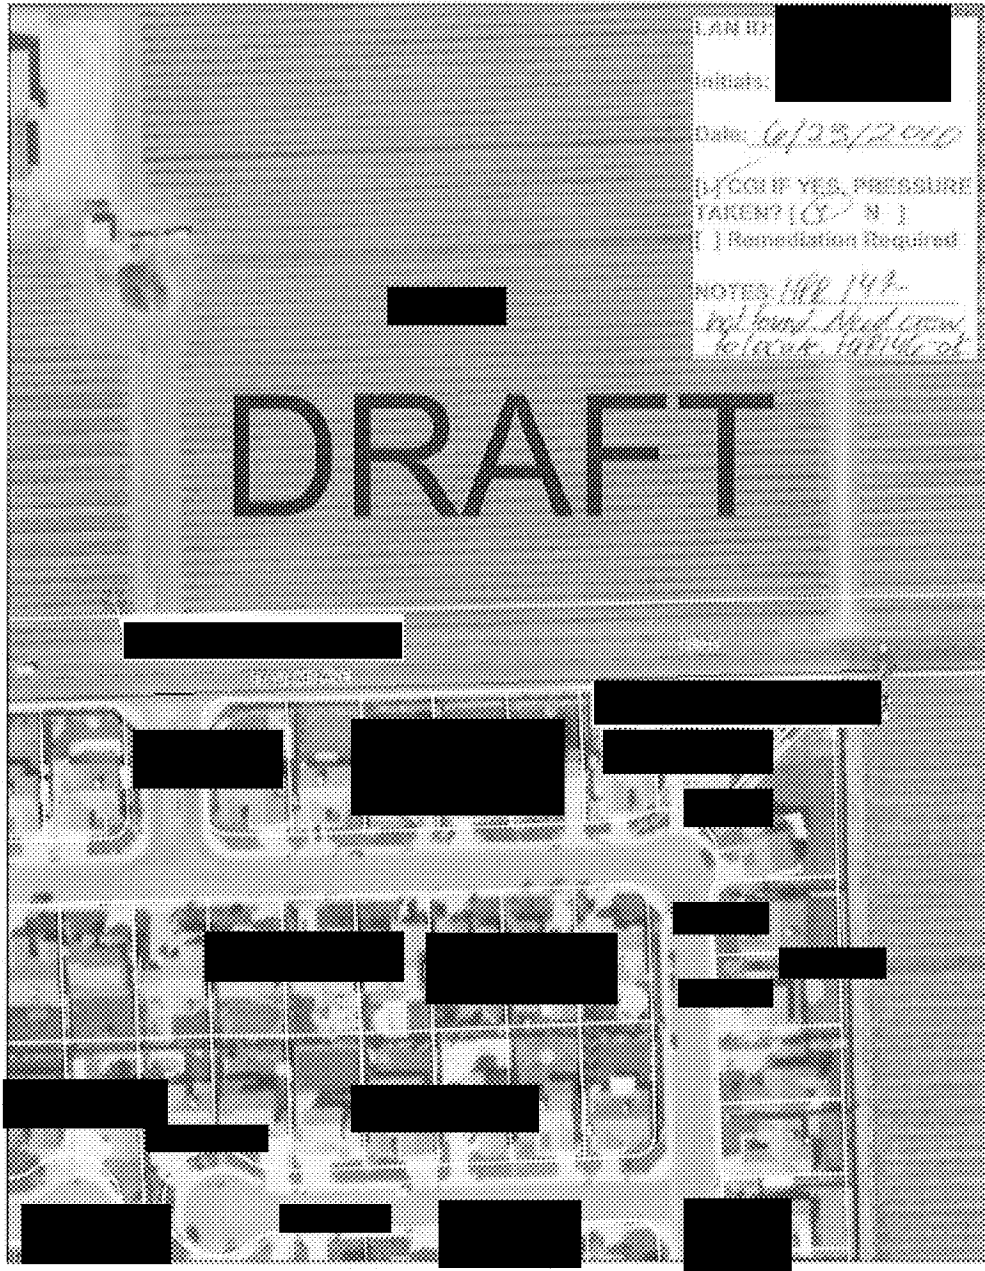
LAN ID: [REDACTED]
Initials: [REDACTED]
Date: 6/23/2010
 YES IF YES, PRESSURE
TAKEN? ()
 Remediation Required
NOTES: 100, 142
not found. Check around
to locate. 100146.01
