Form H: Direct Examination Data Sheet - Page 1 of 10

<u>DA/ILI</u>	<u>DA</u>	<u>ILI</u>
Route Number: 191-1	N-Segment: 191-2013	ILI Log Distance: N/A
Examination Date: 4/30/2013	IMA Number: N/A	RMP-11 Ref. Section: N/A
Mile Point: 35.82		Reference Girth Weld: N/A
Examination Performed By: Denise Ebright	Region Number: 1	Distance From Girth Weld: N/A
PG&E Project Manager: Adam Abraham	Subregion # (ICDA): N/A	
Approved By: Brenda McKay	Stationing: 34+36	
Order Number: 41821294

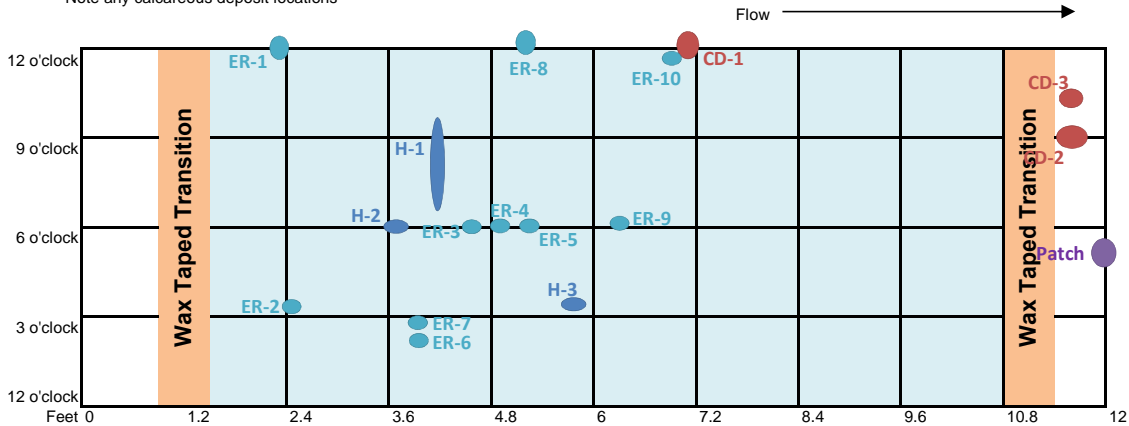
1.9 Map of Coating Degradation*: Zero Reference Point: U/S Edge of Inspection Area
 *Note any calcareous deposit locations

Comments: Ten existing repairs, 3 areas of coating disbondment (coating damage not through coating), 3 holidays and 1 patch found. Plastic tape coating from 0'-1' / 11'-12' and Protal 7200 from 1'-11' from U/S edge, with Wax Taped transitions.

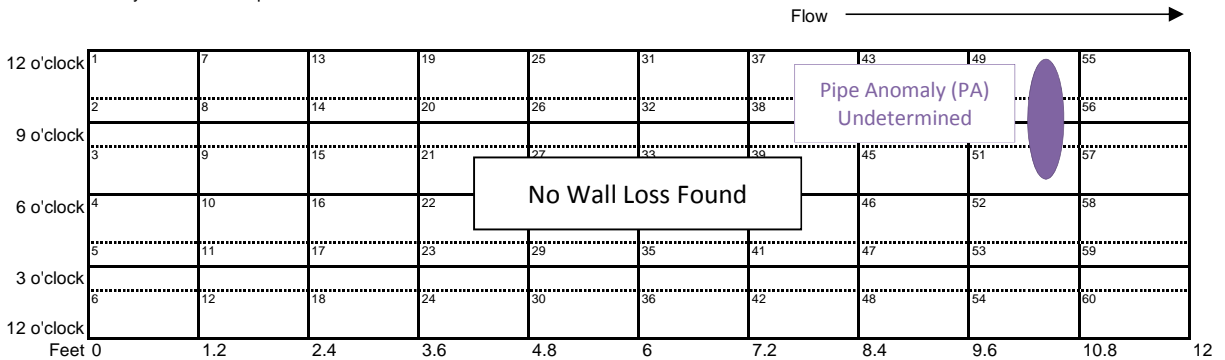
2.8 Overview Map of Corroded Area*:
 *See Pit Depth Measurement Grid for additional Information **Zero Reference Point:** U/S Edge of Inspection Area
 *Note any calcareous deposits.

2.4 Damage Found:
 Corrosion Damage? Yes No Mechanical Damage? Yes No
 Other Damage: One pipe anomaly found, after PG&E performed testing, unable to determine type of defect.

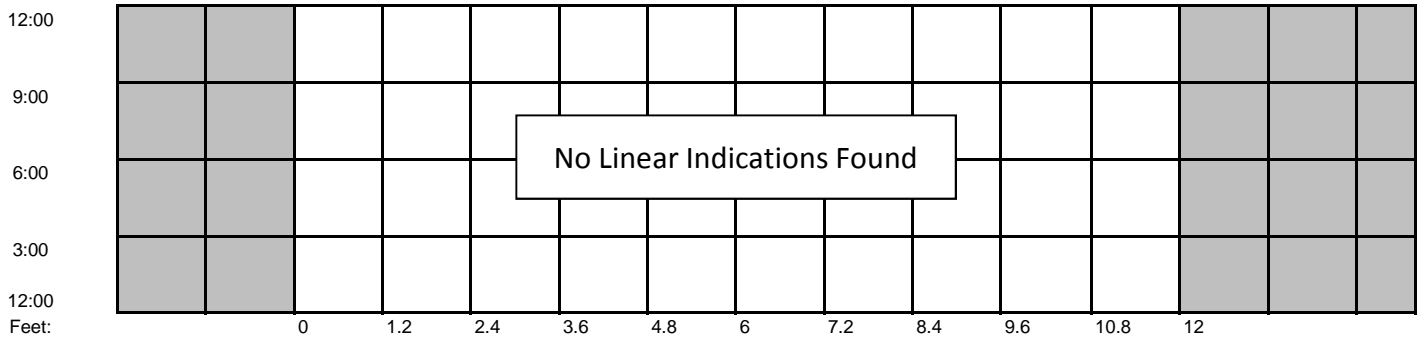
Map of Magnetic Particle Indications:

Notes: A wet fluorescent Magnetic Particle Exam was performed, no indications were found.
