Form H: Direct Examination Data Sheet - Page 1 of 10

<u>DA/ILI</u>	<u>DA</u>	<u>ILI</u>
Route Number: 191-1	N-Segment: 191-2013	ILI Log Distance: N/A
Examination Date: 5/9/2013	IMA Number: N/A	RMP-11 Ref. Section: N/A
Mile Point: 14.18-14.71		Reference Girth Weld: N/A
Examination Performed By: Nicholas Mortenson	Region Number: 1	Distance From Girth Weld: N/A
PG&E Project Manager: Robert Liddicoat	Subregion # (ICDA): N/A	
Approved By: Brenda McKay	Stationing: 25+00	
Order Number: 41821294

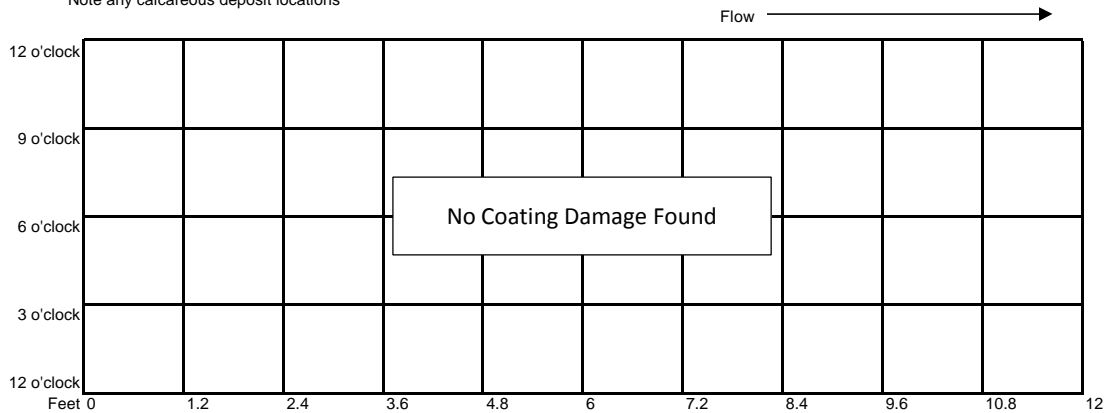
1.9 Map of Coating Degradation*: Zero Reference Point: U/S Edge of Inspection Area

Comments: Coating was found to be in good condition, with no holidays or disbondment present.

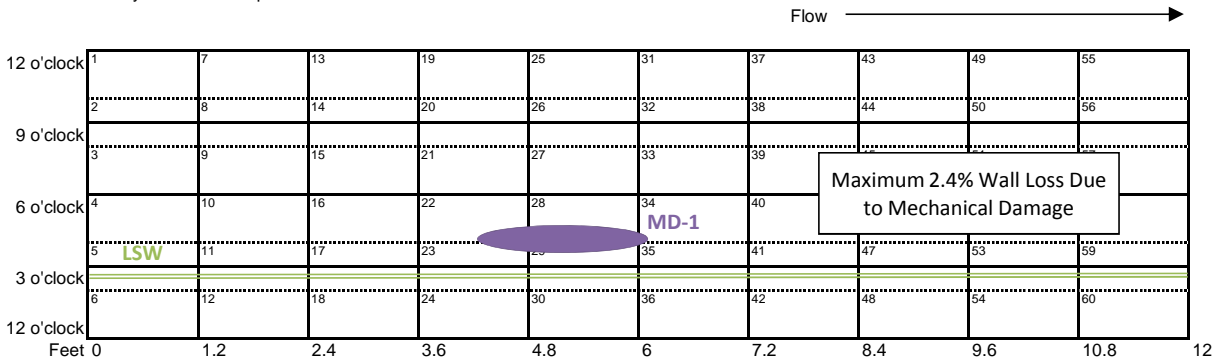
2.8 Overview Map of Corroded Area*:
 *See Pit Depth Measurement Grid for additional Information **Zero Reference Point:** U/S Edge of Inspection Area
 *Note any calcareous deposits.

2.4 Damage Found:
 Corrosion Damage? Yes No Mechanical Damage? Yes No
 Other Damage: One area of mechanical damage was present with a maximum wall loss of 2.4%.

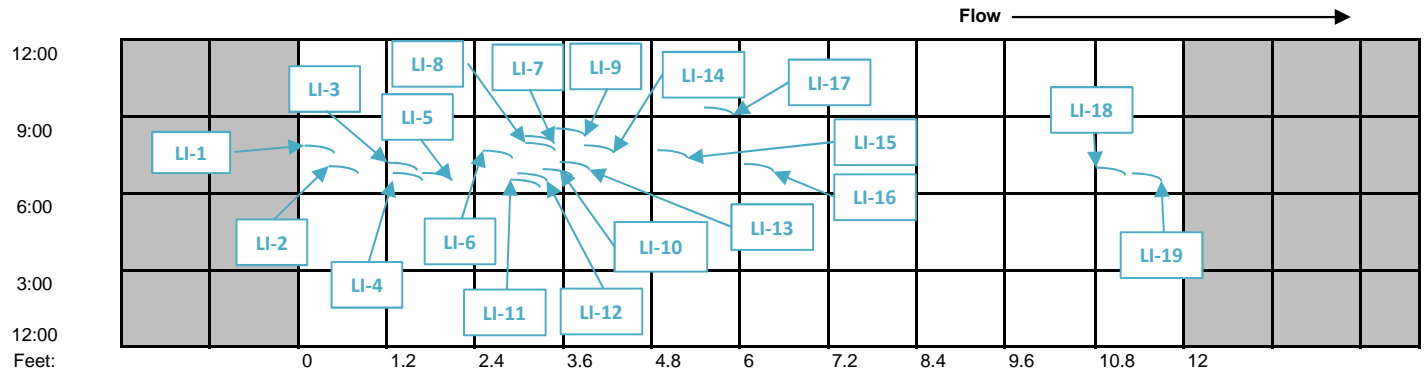
Map of Magnetic Pa

Notes: Magnetic Particle Exam was performed finding 19 linear indications, all indications were removed by means of buffing. The majority of the indications were in the 8:00 - 9:00 area of the pipe and appear to be mill marks or manufacturing marks.

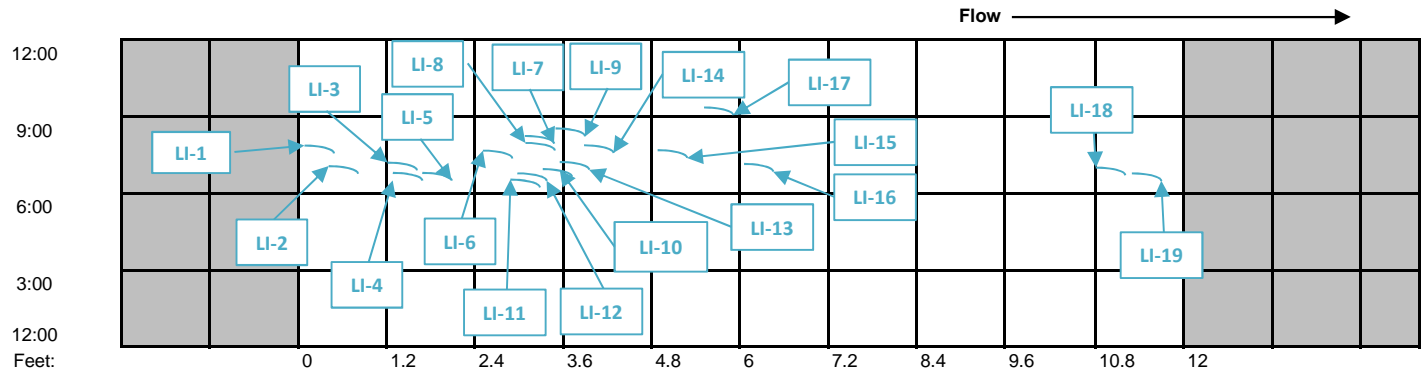
Map of Magnetic Particle Indications:

Notes: Magnetic Particle Exam was performed finding 19 linear indications, all indications were removed by means of buffing. The majority of the indications were in the 8:00 - 9:00 area of the pipe and appear to be mill marks or manufacturing marks.
