Form H: Direct Examination Data Sheet - Page 1 of 10

<u>DA/ILI</u>	<u>DA</u>	<u>ILI</u>
Routed Number: 191-1	N-Segment: 191-2013	ILI Log Distance: N/A
Examination Date: 5/7/2013	IMA Number: N/A	RMP-11 Ref. Section: N/A
Mile Point: 35.83	Region Number: 1	Reference Girth Weld: N/A
Examination Performed By: Denise Ebright	Subregion # (ICDA): N/A	Distance From Girth Weld: N/A
PG&E Project Manager: Adam Abraham	Stationing: 35+20	
Approved By: Brenda McKay		
Order Number: 41821294

Misc. Comments/Information: Site is located inside the [redacted]. Center of inspection was staked and site was marked out. Location was verified with provided GPS coordinates. A PG&E representative was on site to locate 12" line. On 04/29/2013, David He was on site to evaluate due to the location between two concrete vaults, 44" apart. Excavation began on 05/01/2013; the entire site was excavated by hand. On 05/03/2013, pipe was exposed to springline. A concrete support was found near the D/S edge, and there were 5 taps and valves connected to the pipe. David He and Adam Abraham performed a site visit to determine scope of inspection. On 05/04/2013, David He gave approval to continue excavation, to remove co

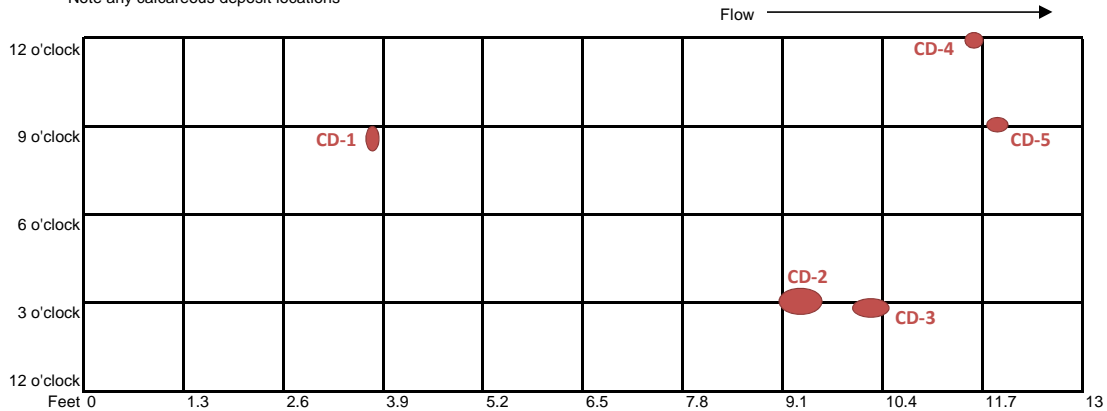
1.9 Map of Coating Degradation\*: Zero Reference Point: U/S Edge of Inspection Area

Comments: Coating was found to be in fair condition, with 5 areas of coating disbondment (coating damaged, not through to pipe surface). Holiday testir found a total of 11 holidays on the 5 taps.

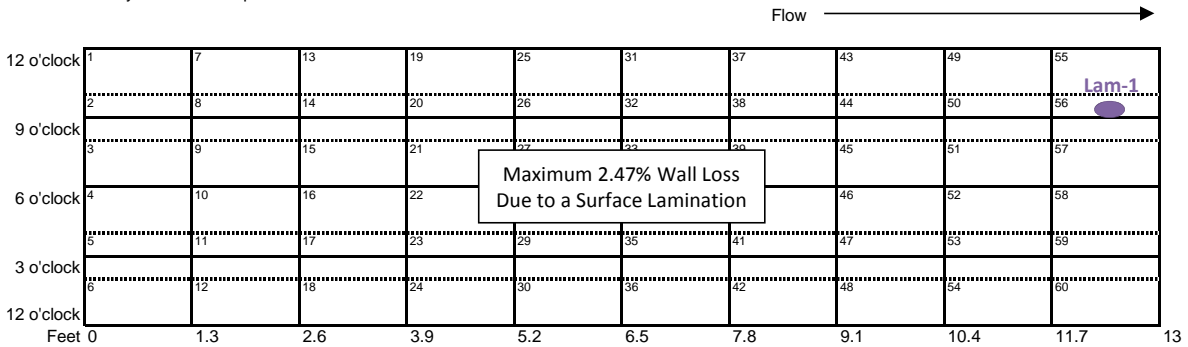
2.8 Overview Map of Corroded Area\*  
 \*See Pit Depth Measurement Grid for additional Information Zero Reference Point: U/S Edge of Inspection Area  
 \*Note any calcareous deposits.

2.4 Damage Found:  
 Corrosion Damage?  Yes  No Mechanical Damage?  Yes  No  
 Other Damage: One surface lamination found with a maximum depth of 0.010" or 2.47% wall loss. Lamination was buffed out by Jim Aird, removing a total 6.9% wall (from local UT 0.405" to 0.377").

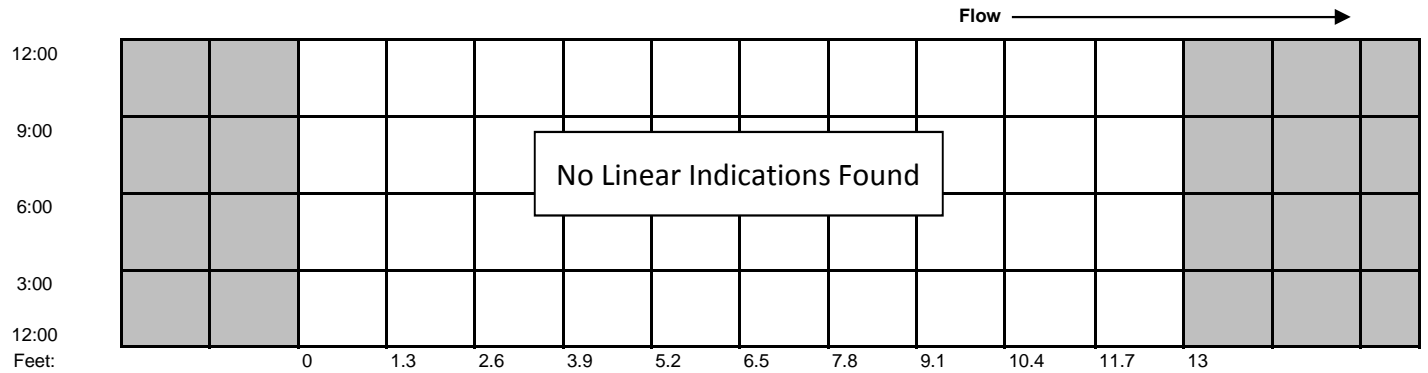
Map of Magnetic Particle Indications:

Notes: Magnetic Particle Exam was performed finding no linear indications.

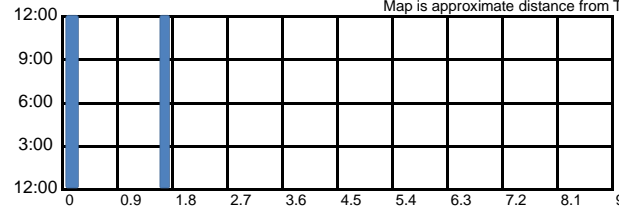
MAP OF COATING DEGRADATION

NO.	FEET FROM REFERENCE	O'CLOCK	MAX LENGTH (IN.)	MAX CIRC EXTENT (IN.)
H-1	0'1"	All	2	Full Circumference
H-2	1'7"	All	1	Full Circumference

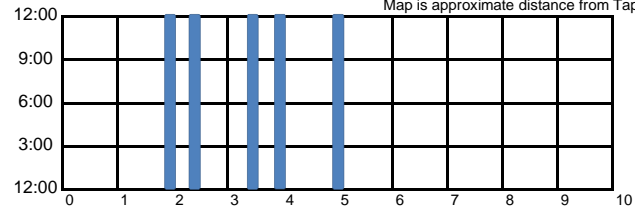
MAP OF COATING DEGRADATION

NO.	FEET FROM REFERENCE	O'CLOCK	MAX LENGTH (IN.)	MAX CIRC EXTENT (IN.)
H-3	5'0"	All	2	Full Circumference
H-4	5'7"	All	3	Full Circumference
H-5	5'7"	All	3	Full Circumference
H-6	5'7"	All	3	Full Circumference
H-7	5'7"	All	3	Full Circumference

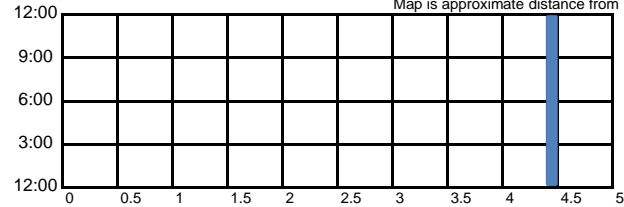
MAP OF COATING DEGRADATION

NO.	FEET FROM REFERENCE	O'CLOCK	MAX LENGTH (IN.)	MAX CIRC EXTENT (IN.)
H-8	7'7"	All	3	Full Circumference

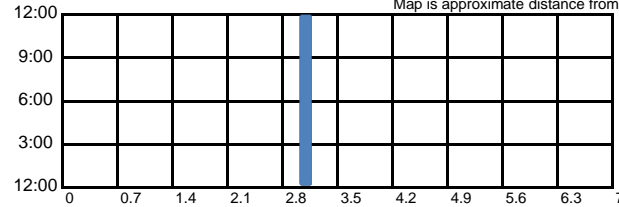
MAP OF COATING DEGRADATION

NO.	FEET FROM REFERENCE	O'CLOCK	MAX LENGTH (IN.)	MAX CIRC EXTENT (IN.)
H-9	10'2"	All	3	Full Circumference
