Form H: Direct Examination Data Sheet - Page 2 of 10

<u>DA/ILI</u>	<u>DA</u>	<u>ILI</u>
Route Number: 3010-01	N-Segment: 191-2013	ILI Log Distance: N/A
Examination Date: 4/30/2013	IMA Number: N/A	RMP-11 Ref. Section: N/A
Mile Point: 0.53 - 0.65	Region Number: 2	Reference Girth Weld: N/A
Examination Performed By: Nicholas Mortenson	Subregion # (ICDA): N/A	Distance From Girth Weld: N/A
PG&E Project Manager: Adam Abraham	Stationing: 4+49	
Approved By: Brenda McKay		
Order Number: 41821294

MAGNETIC PARTICLE EXAMINATION DATA SHEET

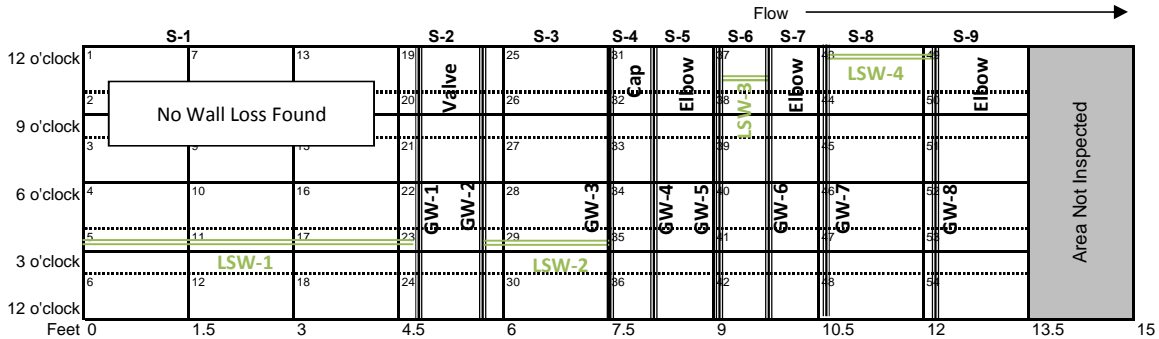
2.8 Overview Map of Corroded Area\*:  
 \*See Pit Depth Measurement Grid for additional Information Zero Reference Point: U/S Edge of Inspection Area  
 \*Note any calcareous deposits.

2.4 Damage Found:  
 Corrosion Damage?  Yes  No Mechanical Damage?  Yes  No  
 Other Damage: No damage found during inspection.

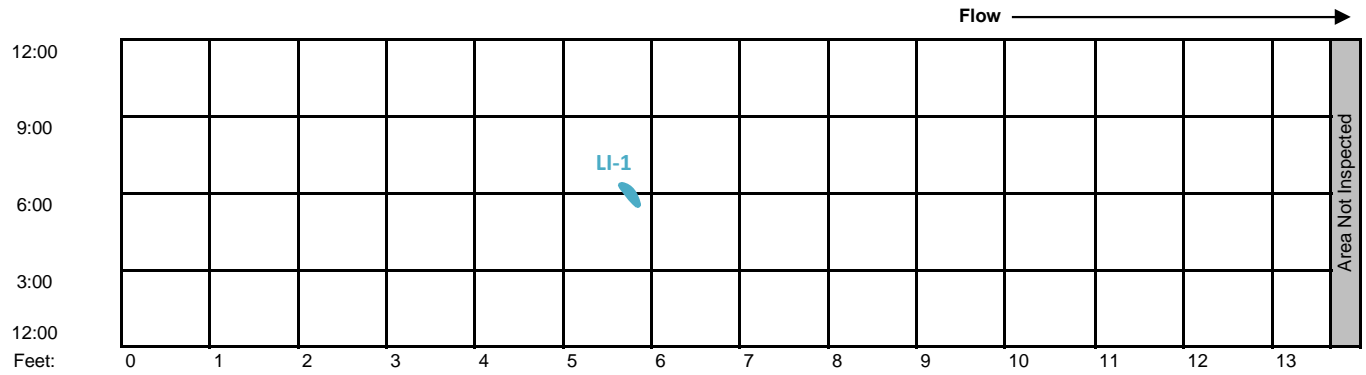
Map of Magnetic Particle Indications:

Table with 7 columns: Ind No., Axial Position, Circumferential Position, Indication Length, Wall Thickness before Softpad, Wall Thickness after Final Softpad, Indication Removed (Yes, No). Row 1: LI-1, 5'9", 6:00, 3.5", 0.410" - 0.510", 0.398" - 0.511", Yes.

Notes: Magnetic Particle Exam was performed, finding 1 linear indication. Indication is 3.5" long by 0.5" wide, located at the 6:00 position on the valve. Joel (ATS) attempted to remove LI-1 by buffing, but the indication became larger and began to peel up from the outer surface of the parent metal. Due to the rounded edges of the valve it was very difficult to obtain an accurate reading with UT. Mike Ballard (PG&E) performed Shear Wave UT, finding multiple indications under the surface of the original indication. Kevin Rawlins (ATS) attempted to perform RT but was unable since the wall thickness of the valve and the pipe configuration it was impossible to make out any of the indications found during UT and MT inspections. On 5/21/13, ATS continued buffing until the indication was removed. Due to the issues obtaining an accurate UT read, it was not possible to provide an accurate percentage of wall removed during buffing.
