**AN INDEPENDENT, FULL SCOPE
ROOT CAUSE INVESTIGATION OF
SAN FRANCISCO
DECEMBER 8, 1998 OUTAGE**

(Interim Report)

AN INDEPENDENT, FULL SCOPE ROOT CAUSE INVESTIGATION OF THE SAN FRANCISCO DECEMBER 8, 1998 ELECTRICAL POWER OUTAGE

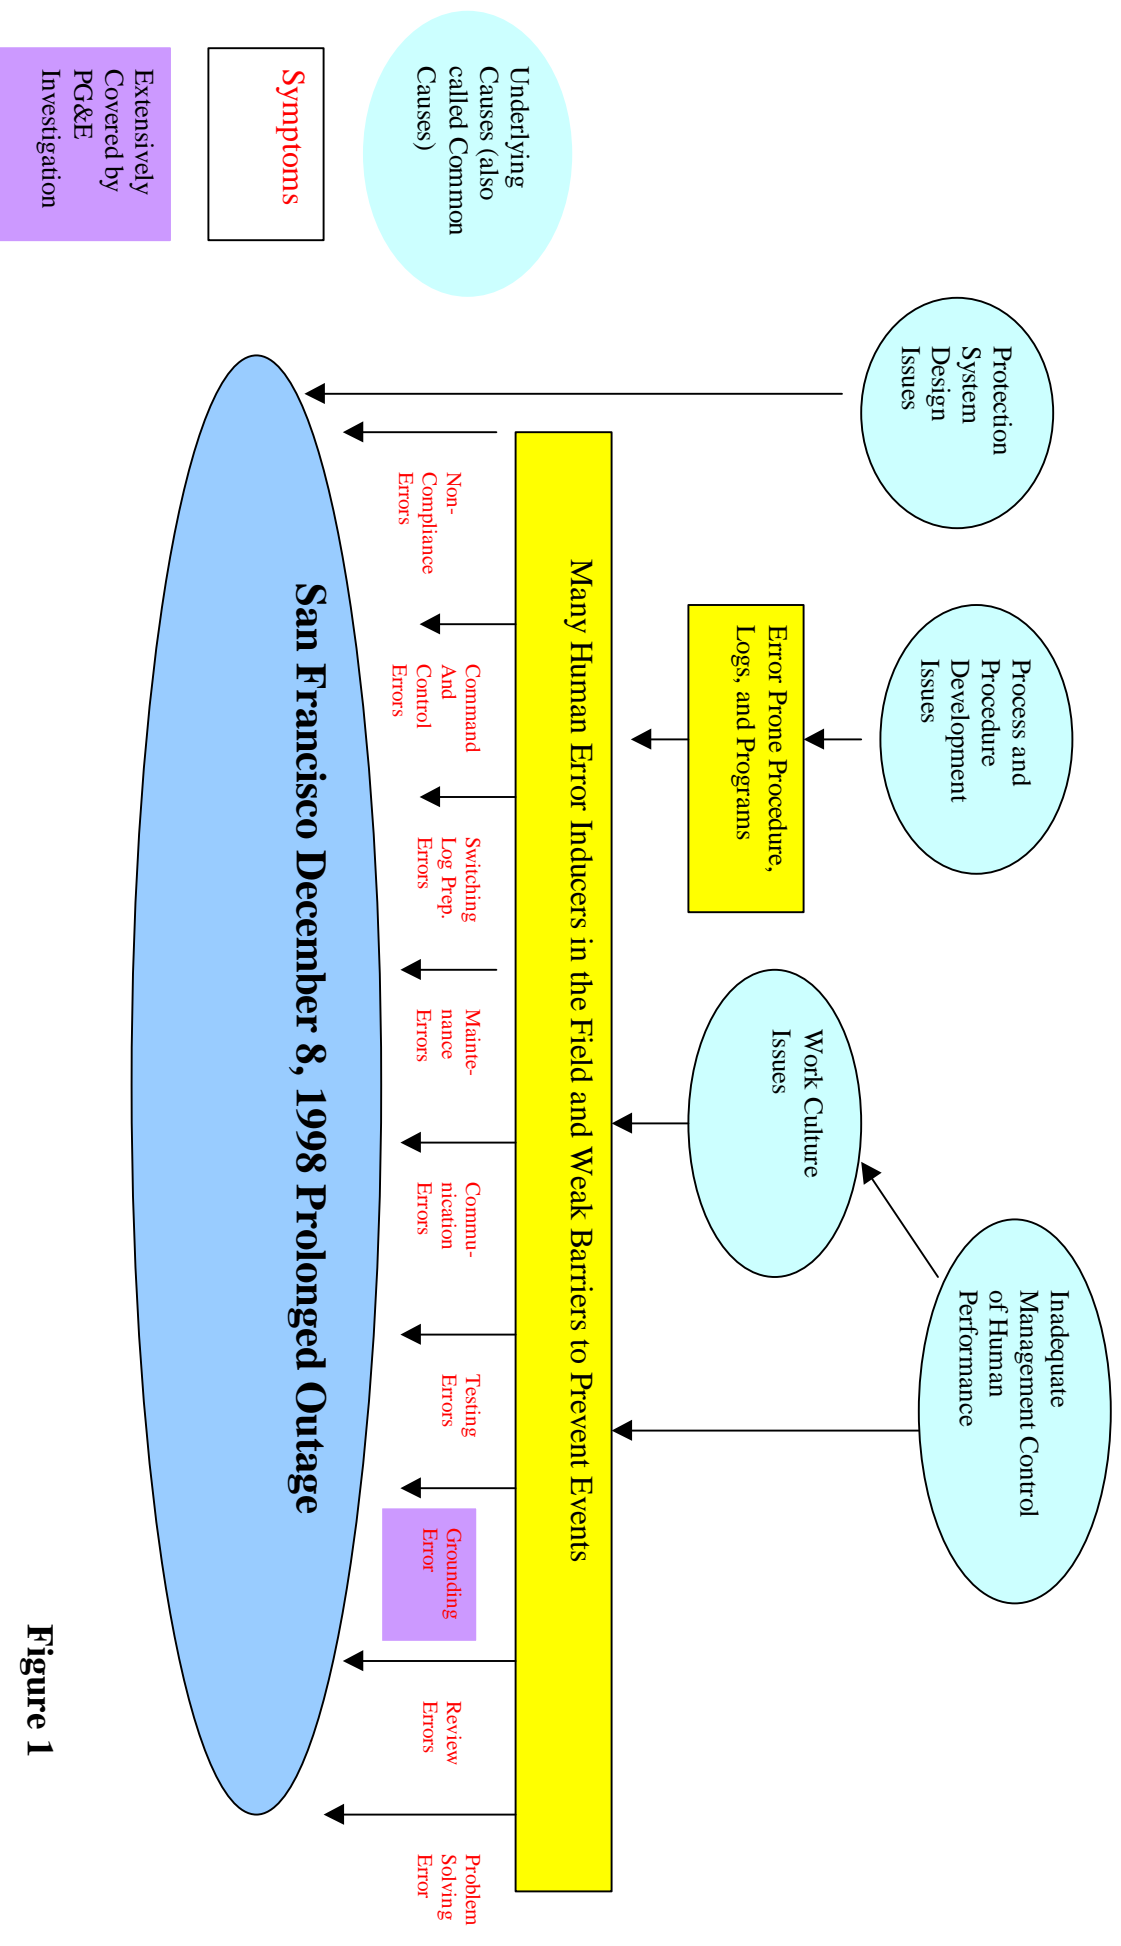
Figure 1

Based on its investigation into PG&E's processes and management system, the investigation team found that the human errors resulting in the failure to remove grounds that initiated the December 8, 1998 outage are symptoms of several underlying causes (or OFIs). *These underlying causes are:*

- (1) *inadequate management control of human performance in the field;*
- (2) *error-prone procedure (and switching log) preparation and development process;*
and,
- (3) *vulnerability in the existing electrical protection systems, which make them less capable of preserving San Francisco's critical load in the event of faults with large voltage fluctuations.*

UNLESS UNDERLYING CAUSES ARE ADDRESSED, THE RECURRENT IS DIFFICULT TO PREVENT. THE NEXT OUTAGE MAY BE INITIATED FROM ERRORS UNRELATED TO GROUNDING REMOVAL...

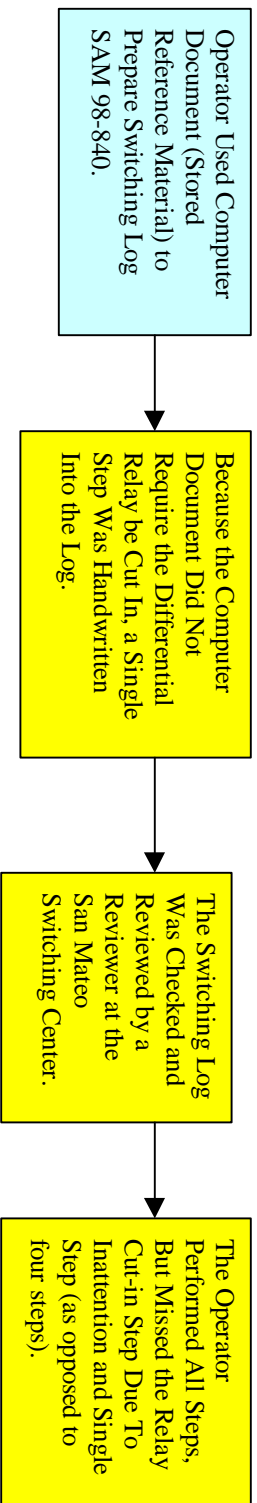
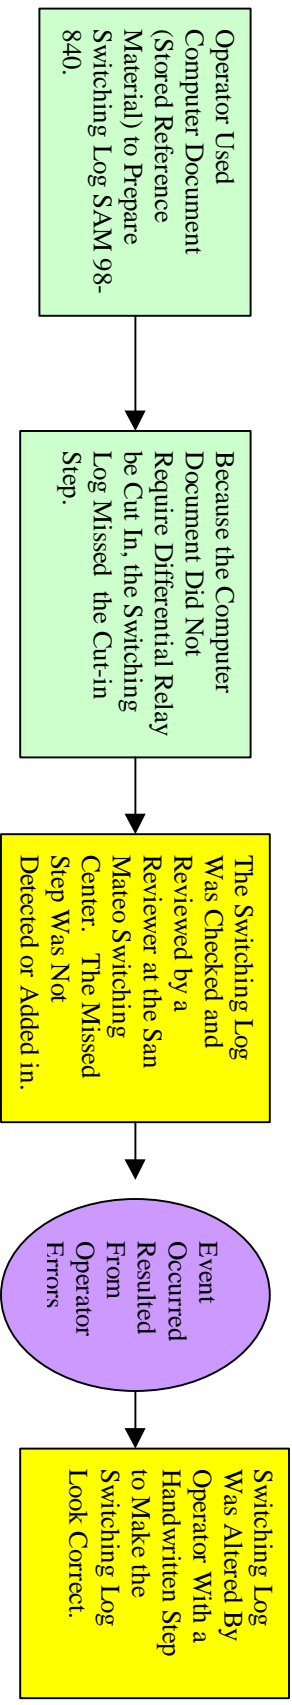
Figure 11

PG&E reported that the main reason related to the failure to cut in the differential relay was that the operator at the San Mateo switching center missed the cut-in instructions in the switching log. Contrary to PG&E's report, the investigation team believes that the underlying cause of the failure to cut in the differential current relay was error proneness of the switching log preparation process, rather than operator errors in failing to follow the switching log that returned the Bus 2 Section D to service. The investigation team believes that the cut-in step noted in the switching log was not there during the switching operation and was falsified into the switching log after the switching error was made and after the initiation of the electrical faults. Therefore, the underlying cause for the failure to cut in the differential relay was related to inadequate switching log preparation, not an operator error.

INVALIDATION OF REPORTED SWITCHING LOG ACTIVITIES

PG&E REPORTED....

THE INVESTIGATION TEAM BELIEVES...

1	CREW	REPORT'S	OFF THE	#2 115 KV BUS #2 SECT D, ALL MEN AND CROSS IN THE CLEAR READY TO RESTORE BUS NORMAL EXCEPT THAT 657, 659 WILL REMAIN OPEN TAGGED HOL				
2	SAN MATEO	CHK	602	OPEN IN YARD	0714			0710
3		RTKCLOSE	623	CCAL				0806
4		CHK	402	OPEN IN YARD				0810
5		CHK	401	CLOSED IN YARD				0811
6		RTKCLOSE	403	CCAL				0812
7		RTKCLOSE	SECT D	# 2-115KV BUS POTS/SB PHASE KNIFE BLADE)				0809
		CHK	402	DO NOT OPEN SCADA COUT				0813
8		CHK	402	BREAKER FAILURE C/M				0814
10		CHK	402	SEL SW DEV # 121167H-BPD IF ON OFF POS				0815
11		CHK	402	SEL SW DEV # 121167H-BPD IF ON OFF POS				0815
12		RTKCLOSE	402	CLOSED ENERGIZING # 2-115KV BUS SECT D				0815
13		PLACE	SECT D	115KV BUSES DIFF SEL SW ON POS 2				
14		TEST	SECT D	ALL LAMPS LIT IN 115KV BUS DIFF CAB

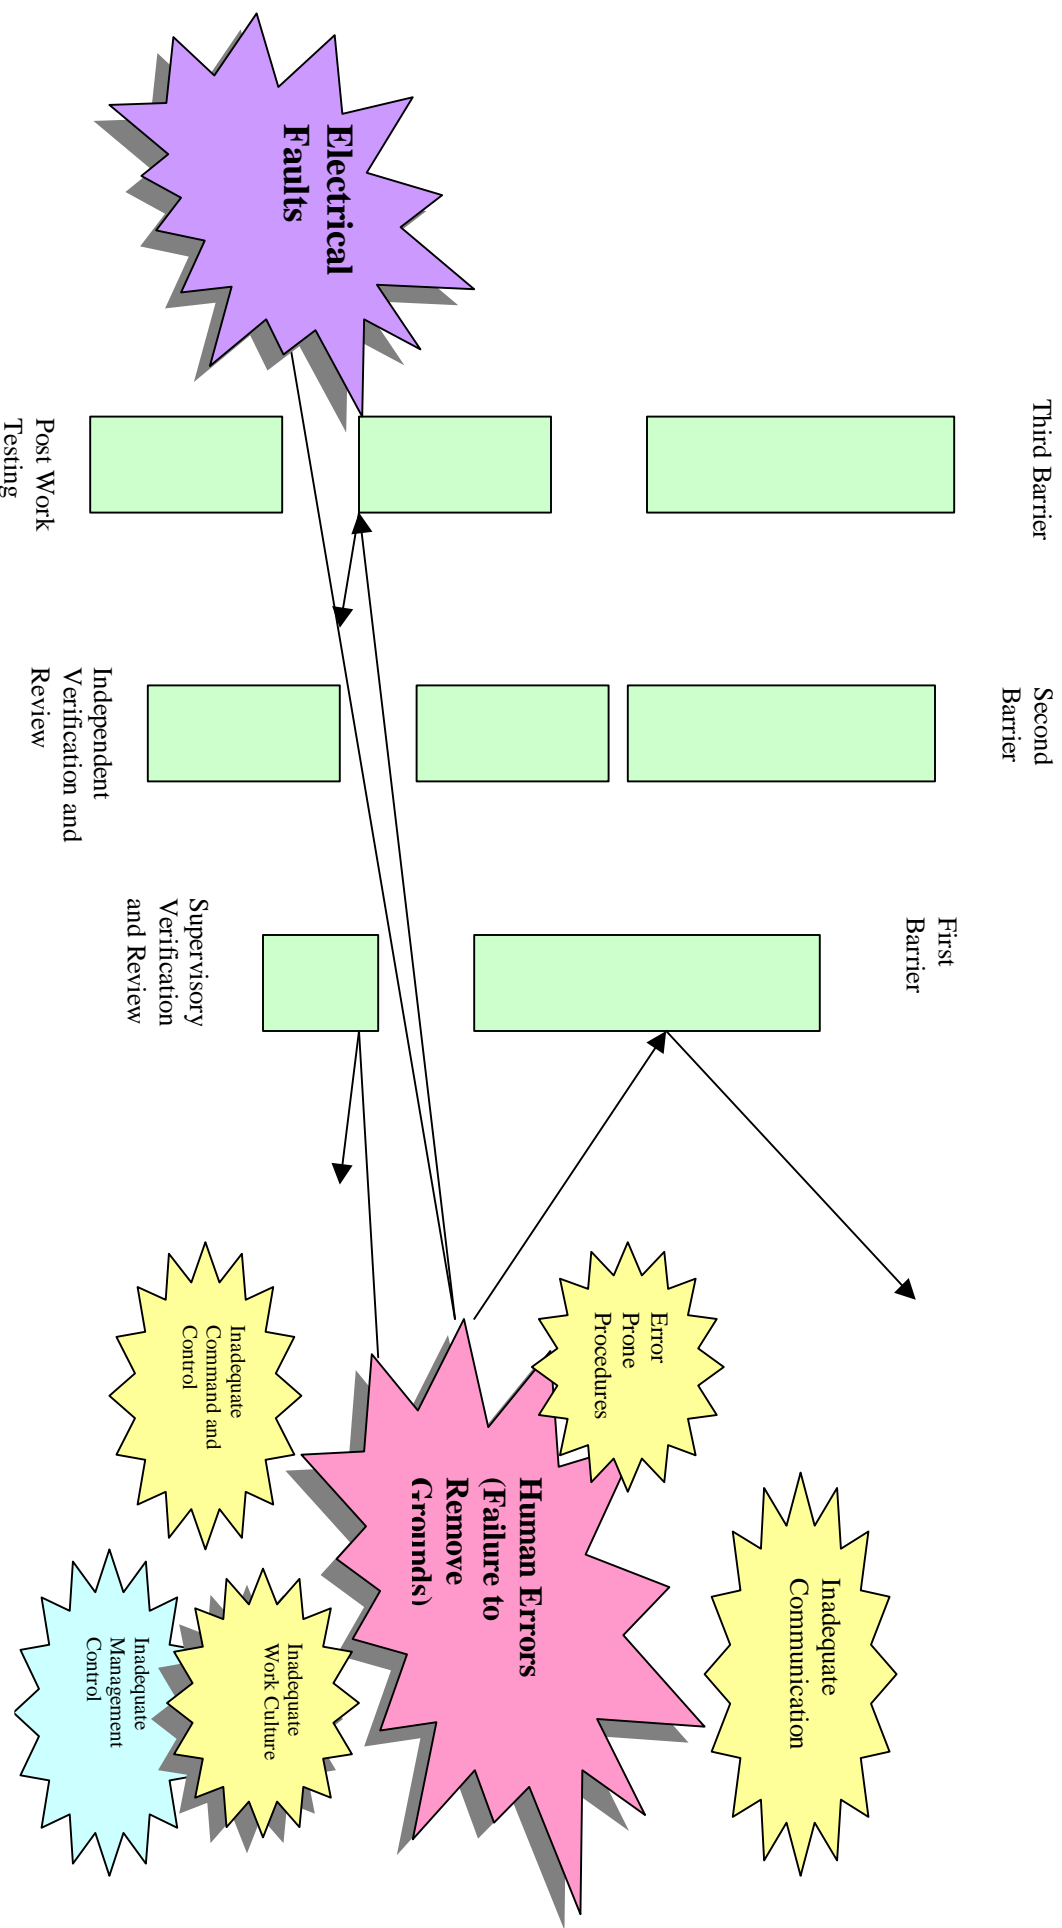
Figure 14

- Inadequate supervisory skills to command and control field work (OFI-1)
- Error prone work culture that tends to bypass procedures and work practice requirements (OFI-2)
- Lack of a positive means to track and count grounds installed and removed (OFI-3)
- Inadequate independent review process to verify field work (OFI-4)
- Inadequate post-work testing procedure that allowed the electrical bus to return to service before finding unremoved grounds (OFI-5).
- Inadequate attention to critical operation and critical equipment (OFI-6)

EVENT INITIATION BY HUMAN ERRORS INVOLVING FAILURE TO REMOVE GROUNDS

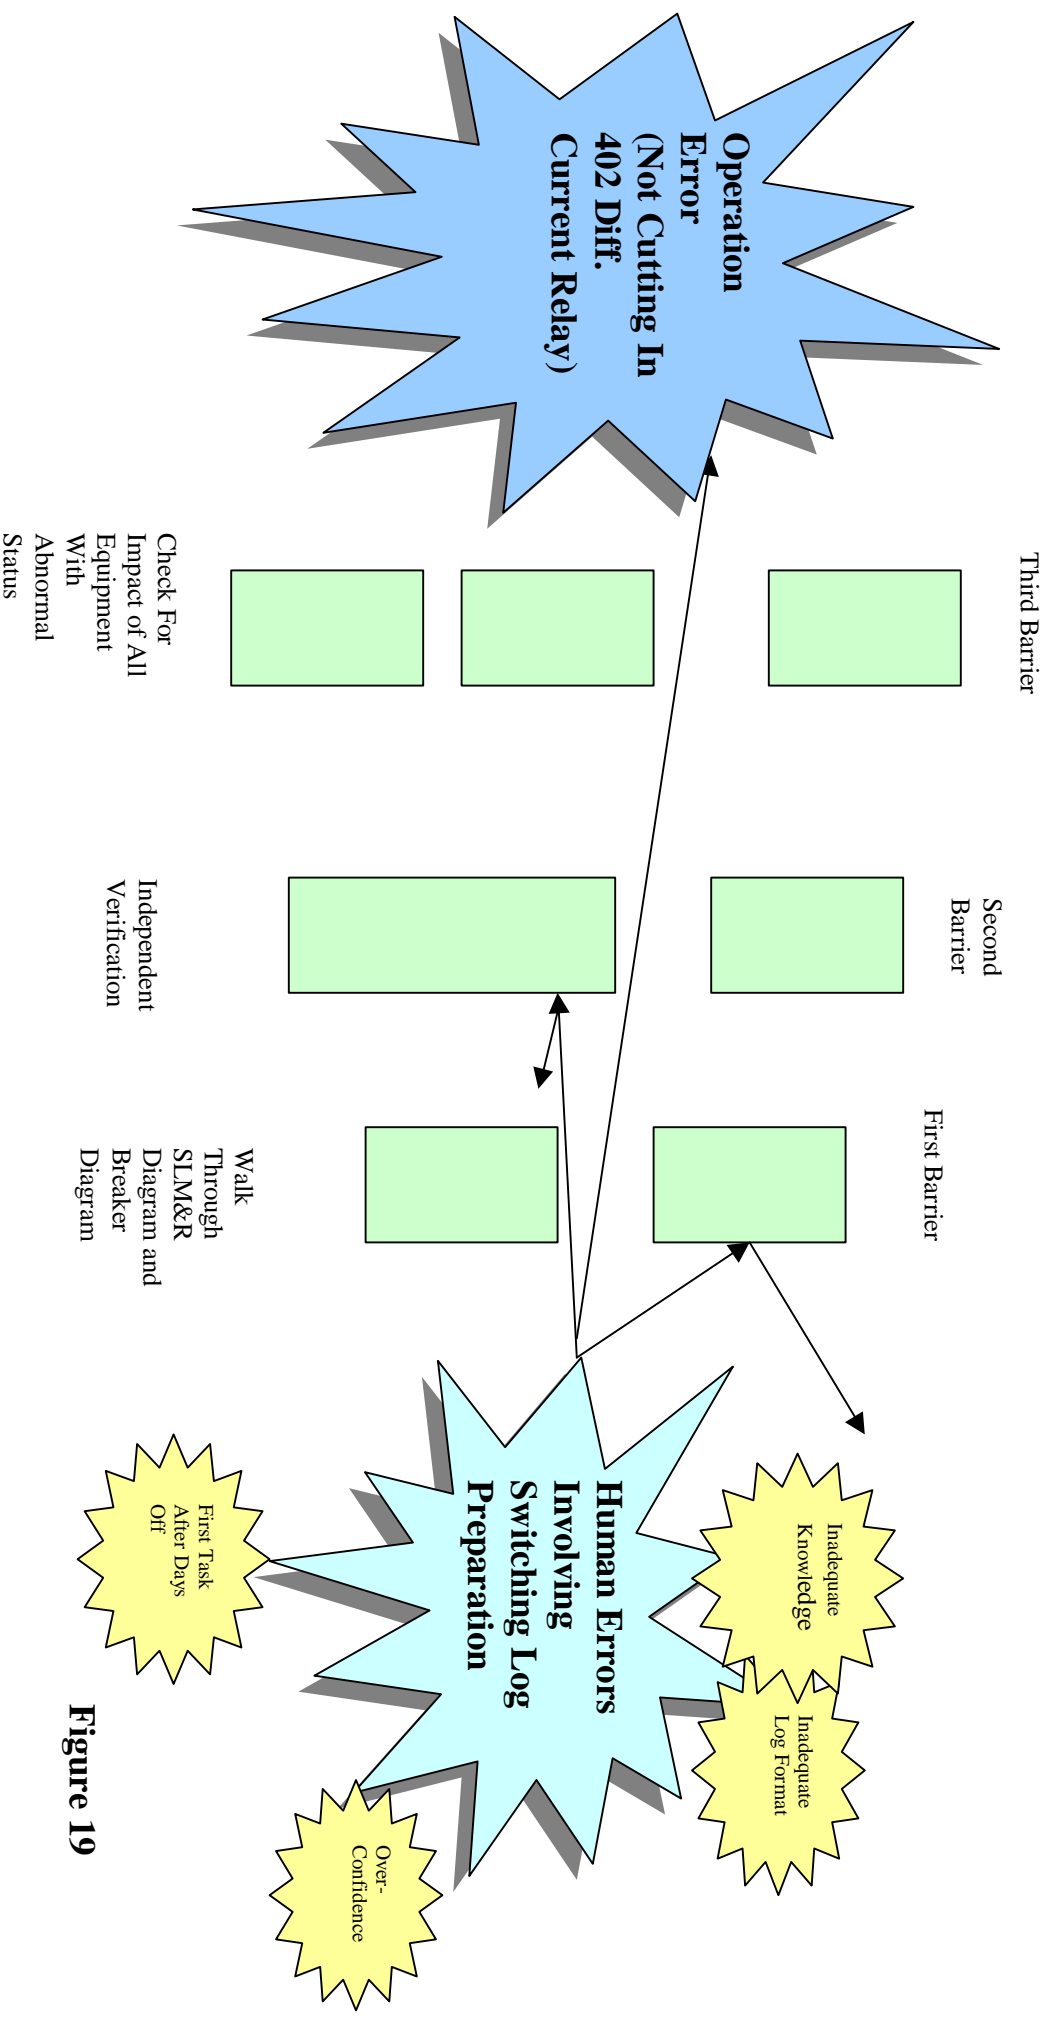
Figure 19

HUMAN ERRORS INVOLVED IN DEFEATING PROTECTION SYSTEM FOR LOCAL CLEARING

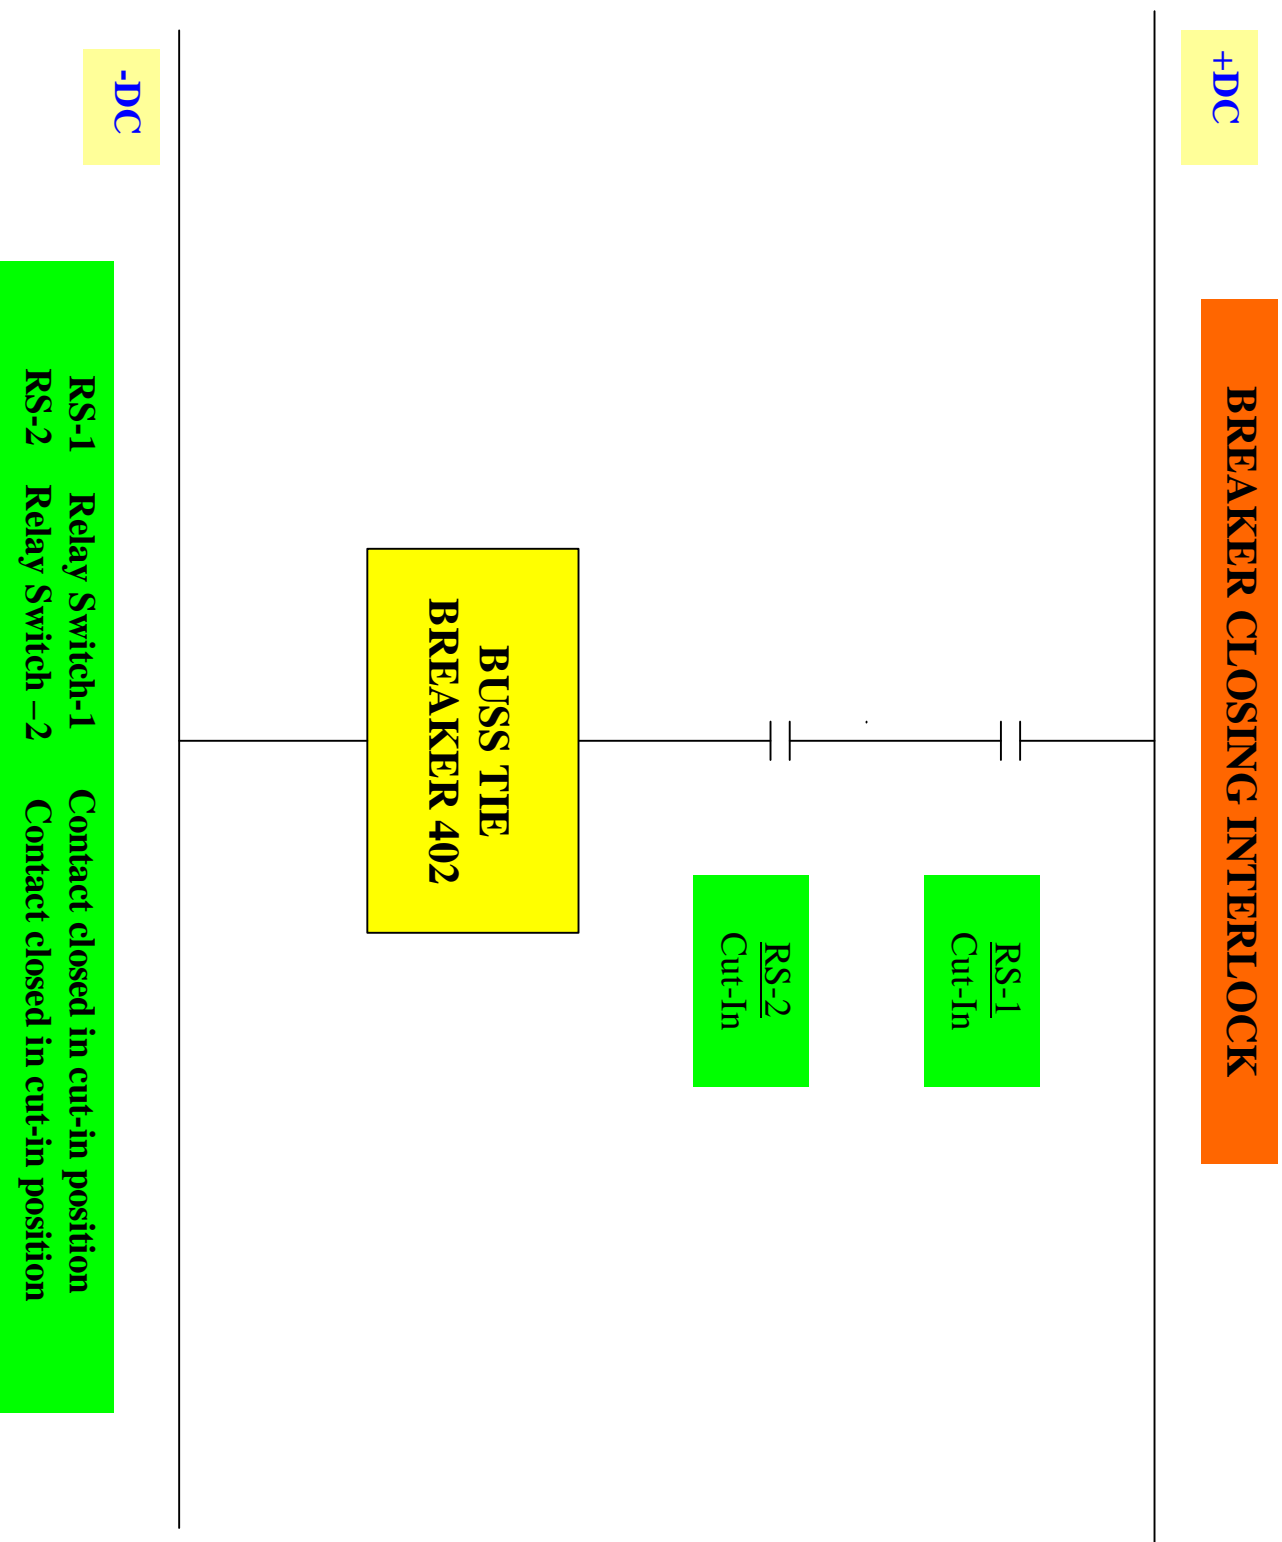
Figure 20

RS-1 Relay Switch-1 **Contact closed in cut-in position**
RS-2 Relay Switch -2 **Contact closed in cut-in position**

It is recommended that PG&E implement an interlock system that ensures that the differential relay is cut in before closing the bus breaker to energize the bus. A suggested interlock scheme is shown in **Figure 20**. This interlock system should also be implemented at other critical substations in which bus faults may result in San Francisco outages. (Recommendation OFI-8.1)

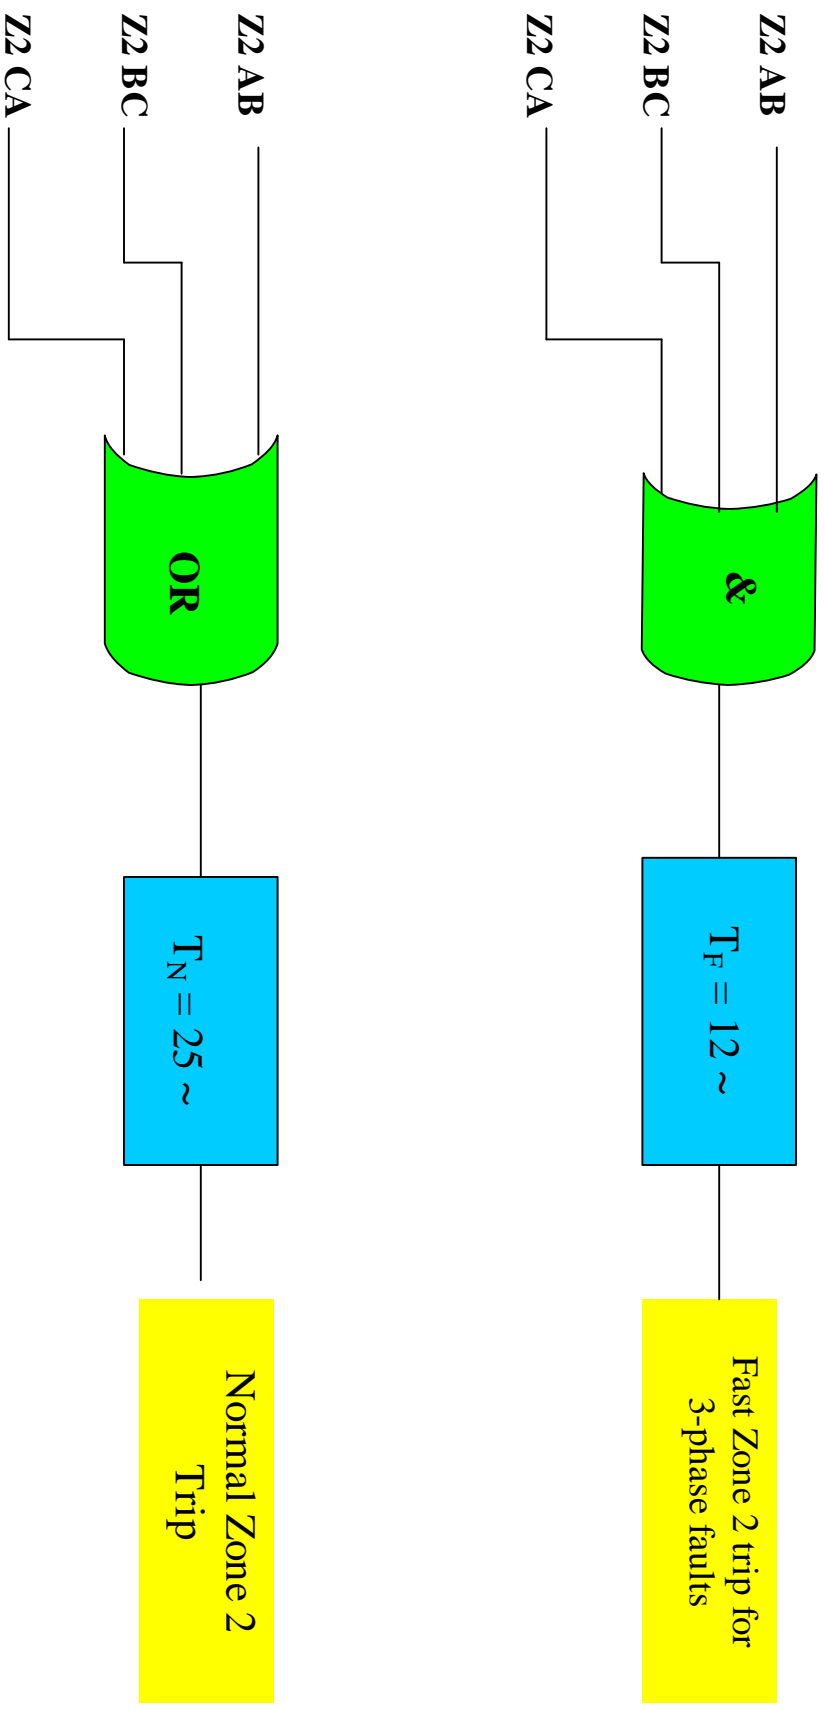
Figure 21

PROGRAMMABLE LOGIC SETTINGS FOR DIGITAL DISTANCE RELAYS

It is recommended that PG&E replace the Zone 2 directional overcurrent relays with digital time triggered relays with a response time of 15 cycles for three-phase faults. **Figure 21** shows a recommended design for Zone 2 fast acting relay. (Recommendation OFI-9.1)

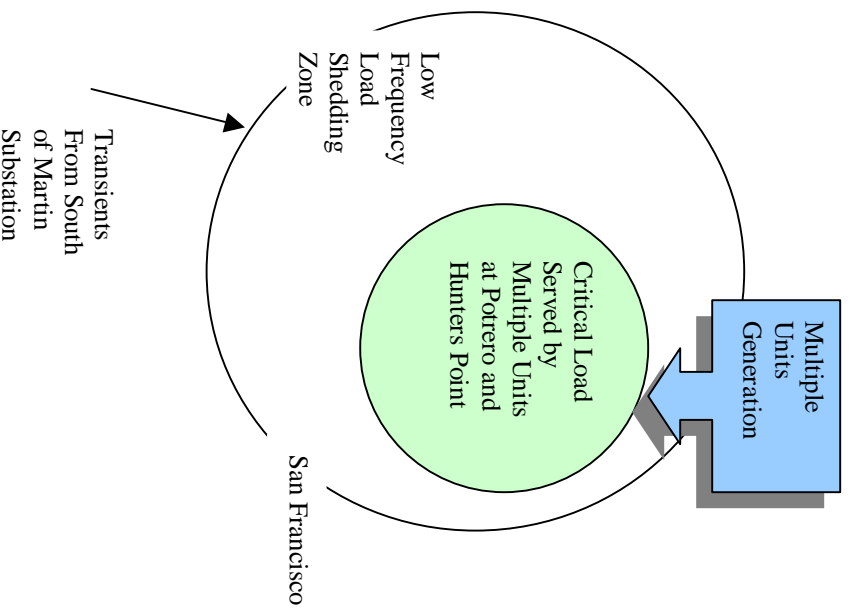
Limitations of Current SFOC

- Low voltage transients may trip the generation and defeat the system.
- Loss of generation from other causes (such as earthquake, setpoint mis-setting, or equipment malfunctions) in conjunction with low frequency transients may defeat the system.

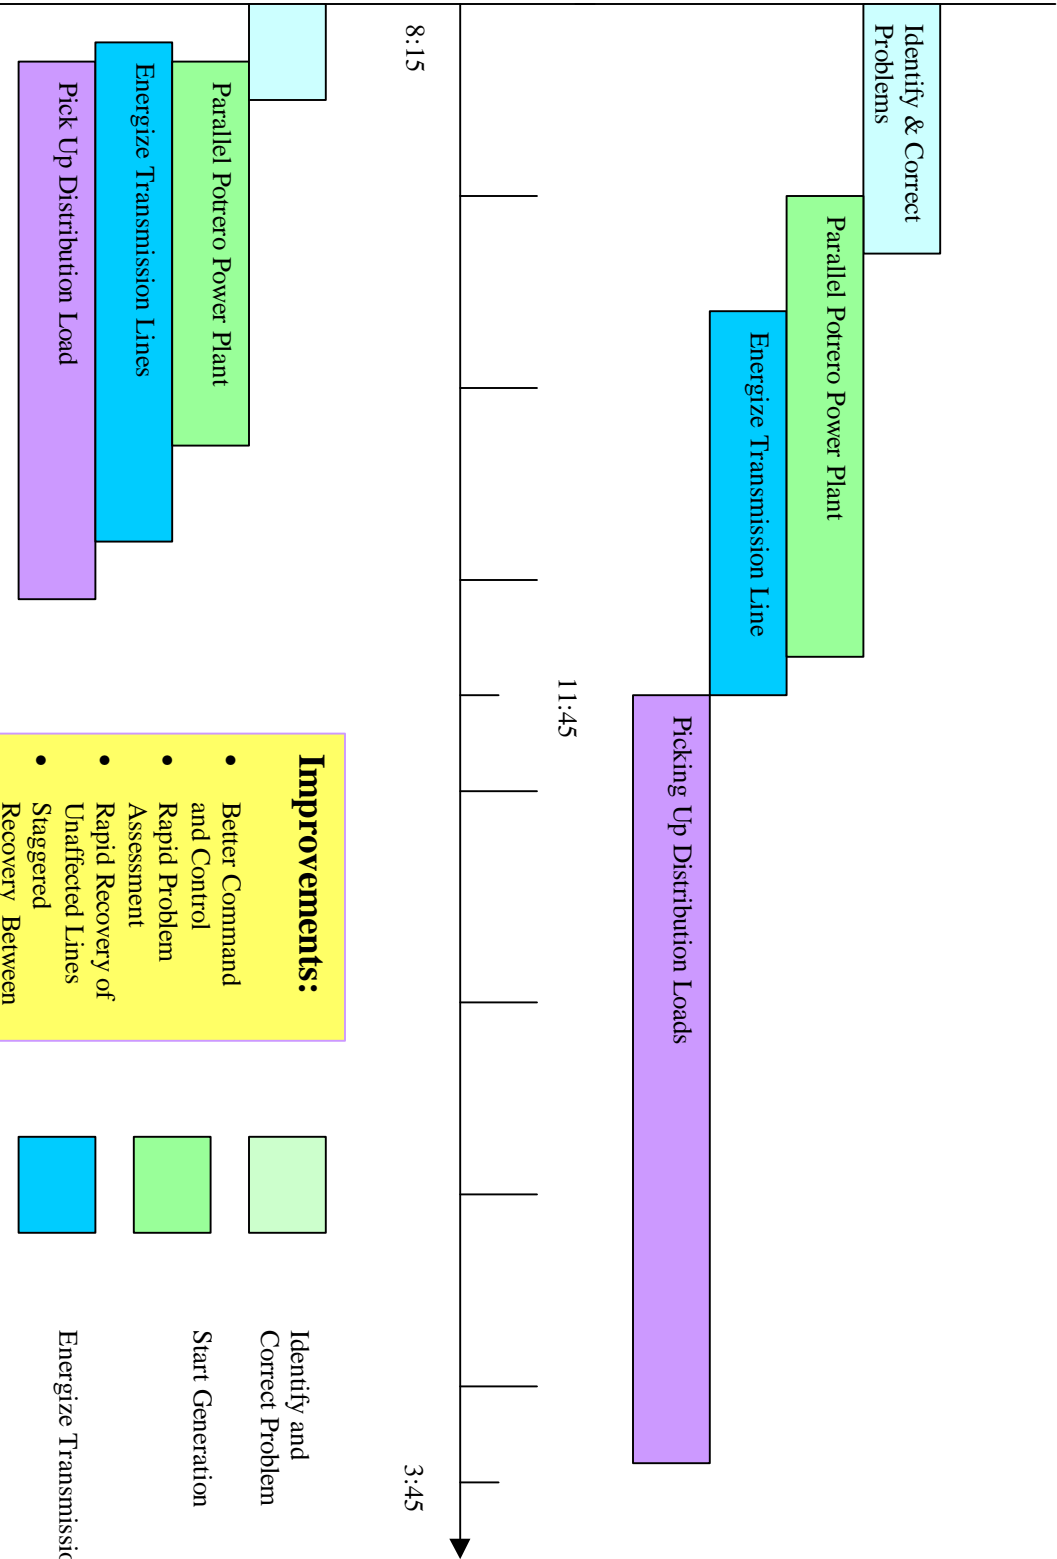
Figure 25

What Happened On December 8

- Improvements:**
- Better Command and Control
 - Rapid Problem Assessment
 - Rapid Recovery of Unaffected Lines
 - Staggered Recovery Between Transmission and Distribution
 - Reliable Equipment Performance

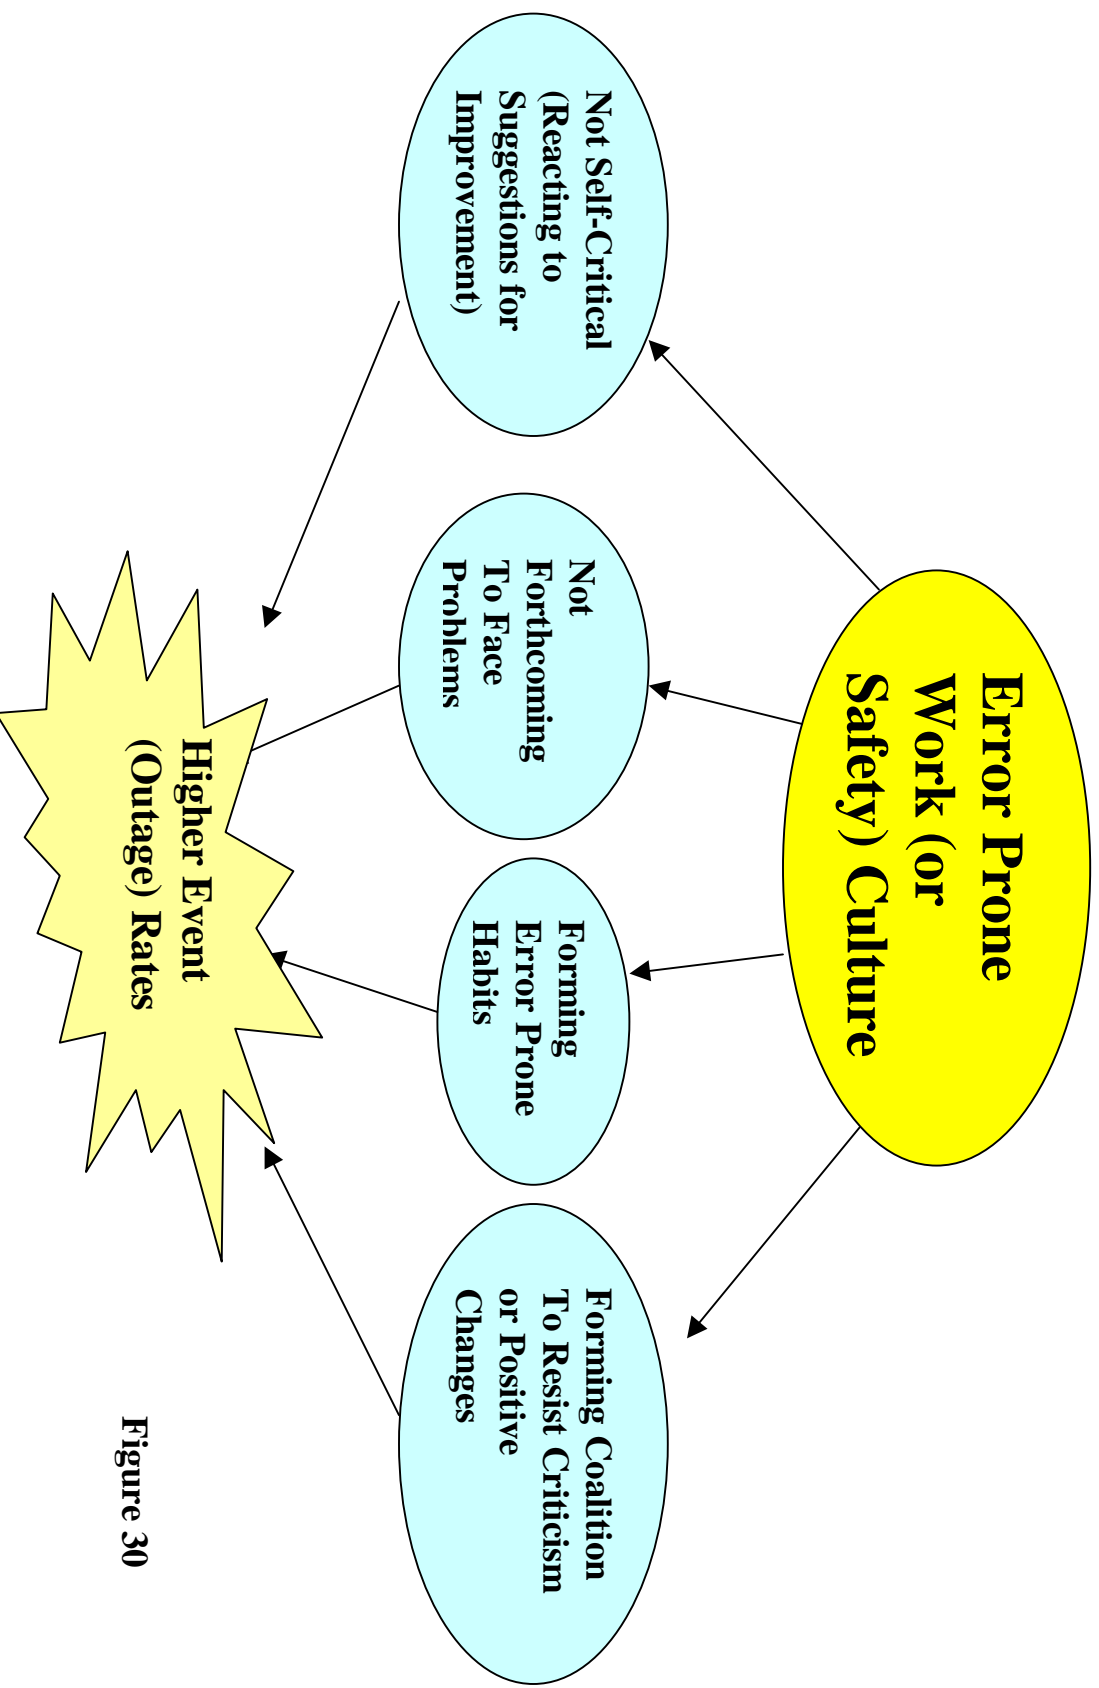
Figure 30

- After the outage, the San Mateo operators decided to falsify a switching log. They were not forthcoming or self-critical regarding the errors they made that initiated the outage.
- The PG&E investigation did not cover problematic areas in the work culture or management system. Instead, its investigation focused on human errors made by workers.
- Even though it was required by PG&E's senior management to use the repeat-back technique to avoid communication errors, it was not used by the TOC or SMSC throughout the event. This means that a habit of not using the repeat-back

**ERROR PRONE WORK CULTURE MAY
RESULT IN AN INCREASING RATE OF
EVENTS (OR OUTAGES)...**

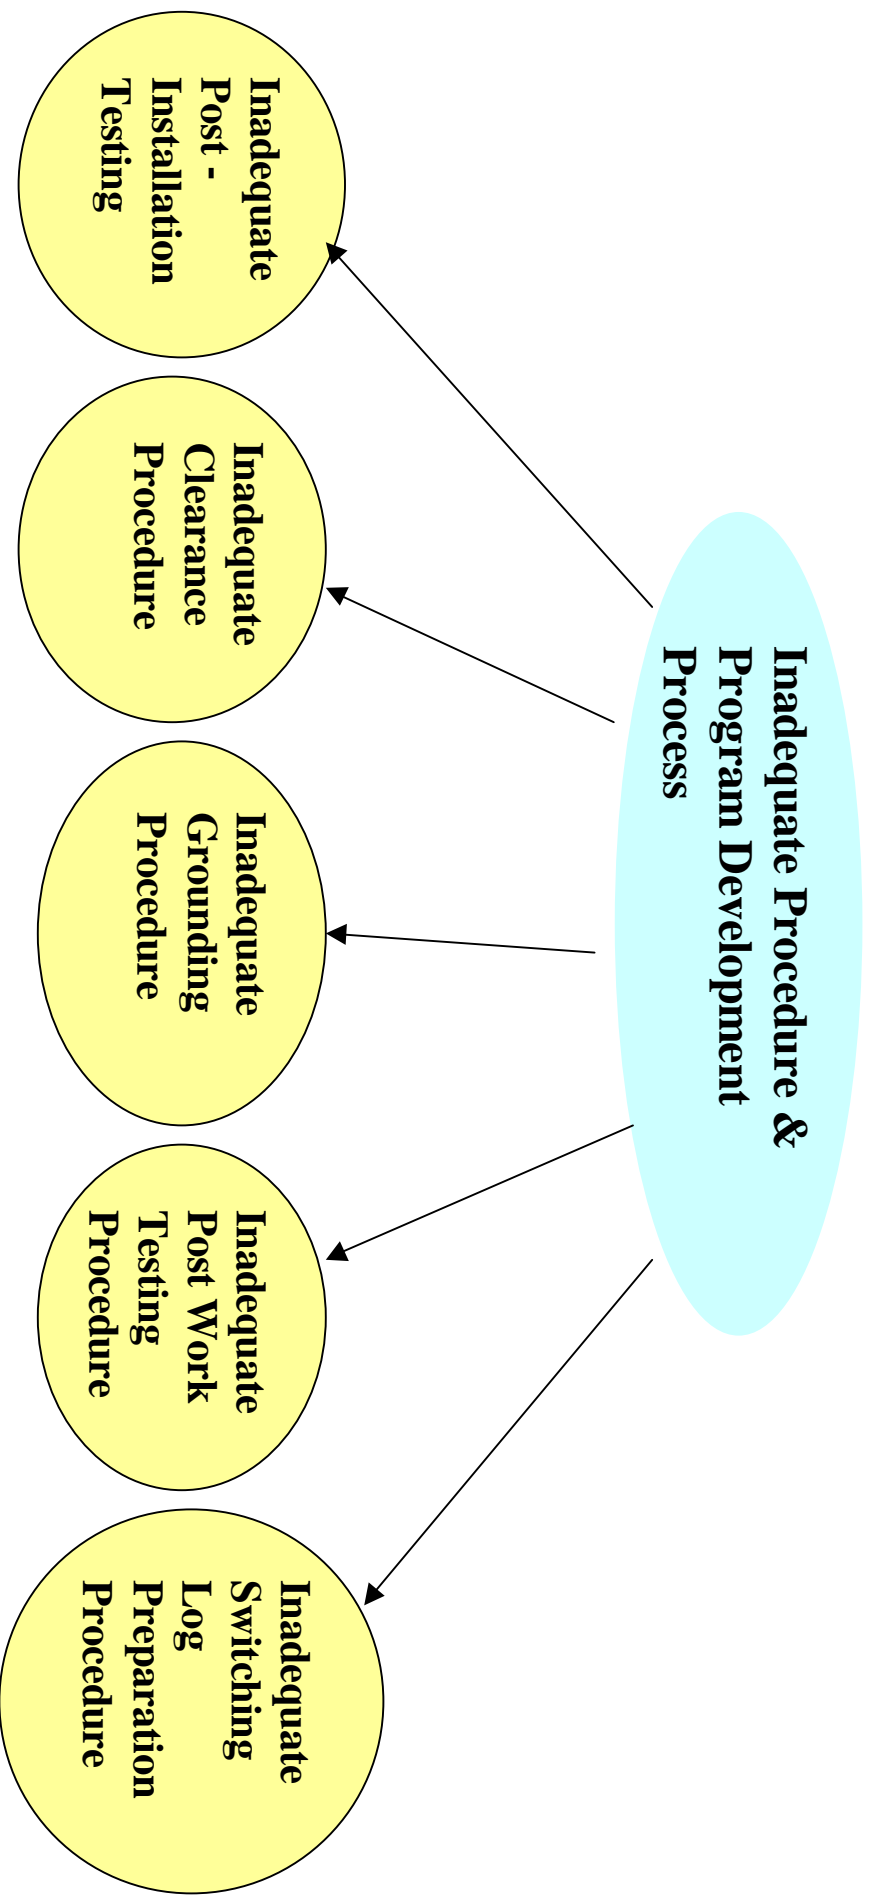
Figure 31

INADEQUATE PROCEDURE DEVELOPMENT PROCESS IS AN UNDERLYING CAUSE FOR MANY PROBLEMS...

- The program allows the operators to use previously used switching logs and to modify them for new application without pointing out and compensating for the human error traps (such as check for changes, configuration changes, assumptions, etc.).
