**AN INDEPENDENT, FULL SCOPE
ROOT CAUSE INVESTIGATION OF
SAN FRANCISCO
DECEMBER 8, 1998 OUTAGE**

(Interim Report)

AN INDEPENDENT, FULL SCOPE ROOT CAUSE INVESTIGATION OF THE SAN FRANCISCO DECEMBER 8, 1998 ELECTRICAL POWER OUTAGE

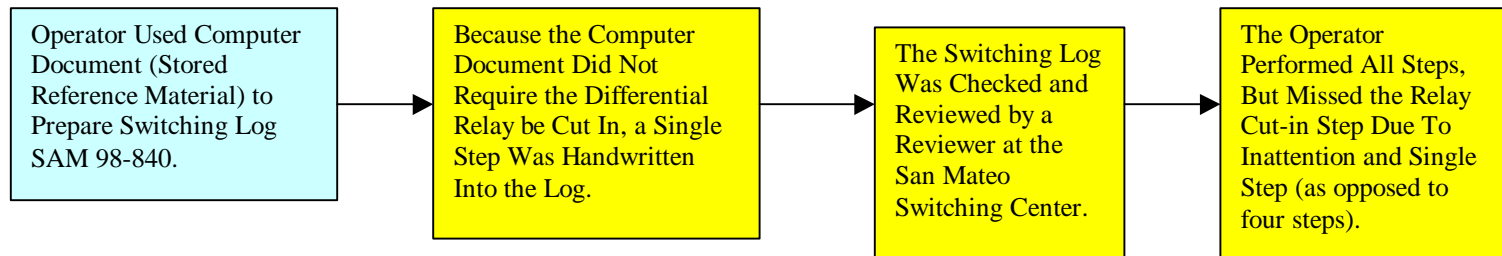
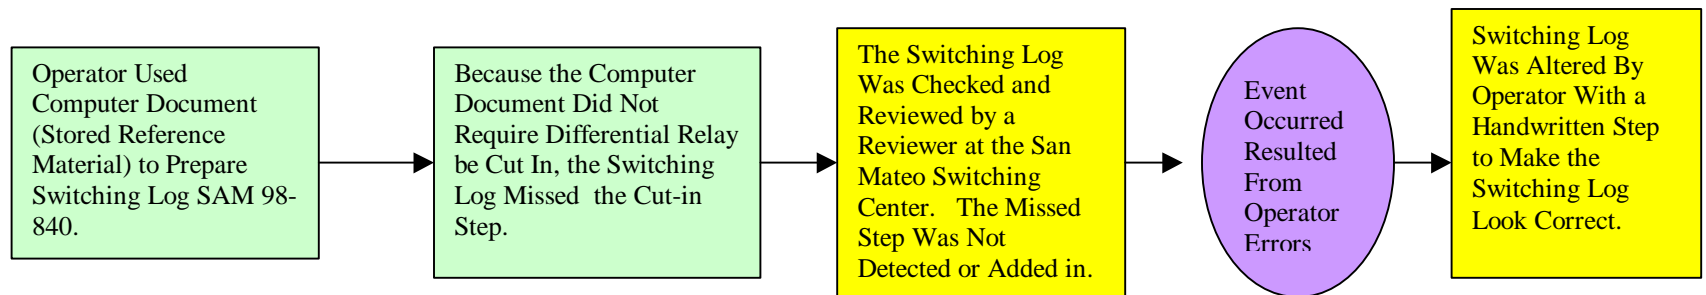
Figure 11

PG&E reported that the main reason related to the failure to cut in the differential relay was that the operator at the San Mateo switching center missed the cut-in instructions in the switching log. Contrary to PG&E's report, the investigation team believes that the underlying cause of the failure to cut in the differential current relay was error proneness of the switching log preparation process, rather than operator errors in failing to follow the switching log that returned the Bus 2 Section D to service. The investigation team believes that the cut-in step noted in the switching log was not there during the switching operation and was falsified into the switching log after the switching error was made and after the initiation of the electrical faults. Therefore, the underlying cause for the failure to cut in the differential relay was related to inadequate switching log preparation, not an operator error.

INVALIDATION OF REPORTED SWITCHING LOG ACTIVITIES

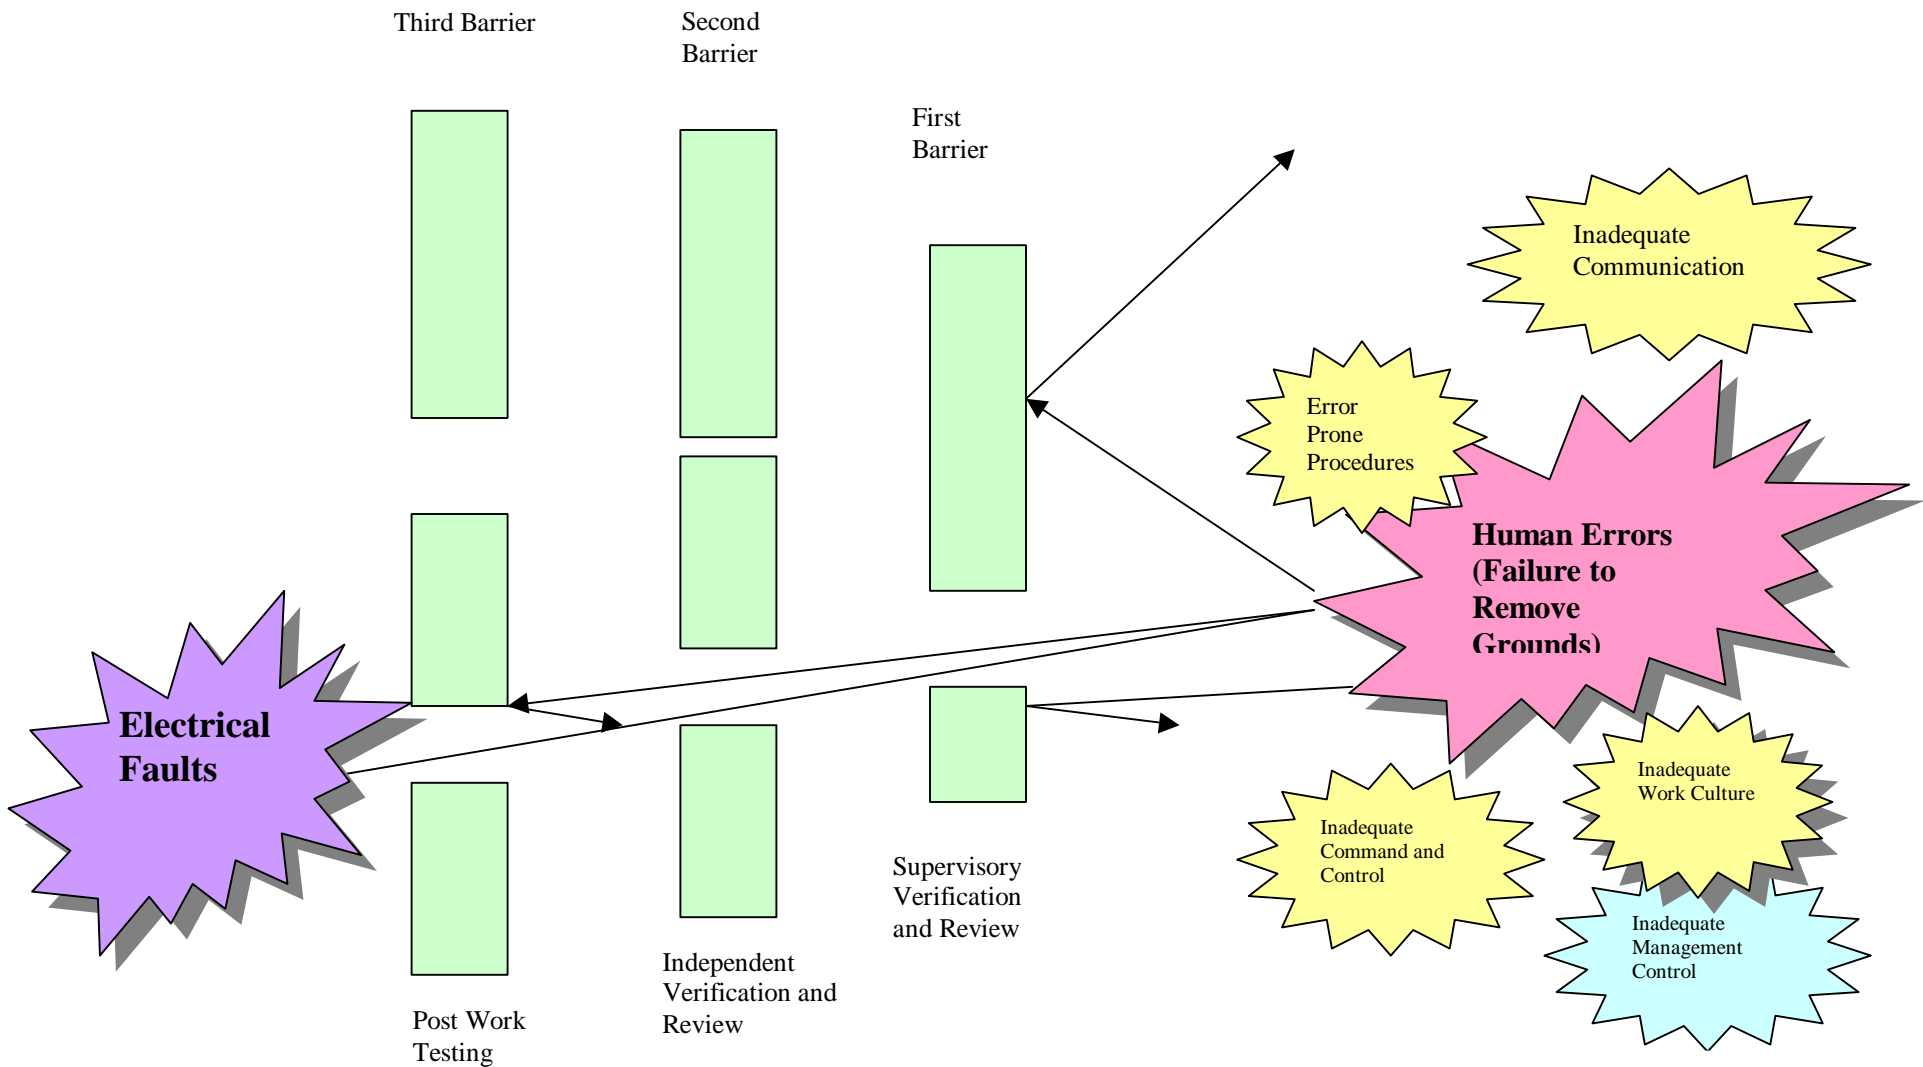
Figure 14

- Inadequate supervisory skills to command and control field work (OFI-1)
- Error prone work culture that tends to bypass procedures and work practice requirements (OFI-2)
- Lack of a positive means to track and count grounds installed and removed (OFI-3)
- Inadequate independent review process to verify field work (OFI-4)
- Inadequate post-work testing procedure that allowed the electrical bus to return to service before finding unremoved grounds (OFI-5).
- Inadequate attention to critical operation and critical equipment (OFI-6)

EVENT INITIATION BY HUMAN ERRORS INVOLVING FAILURE TO REMOVE GROUNDS

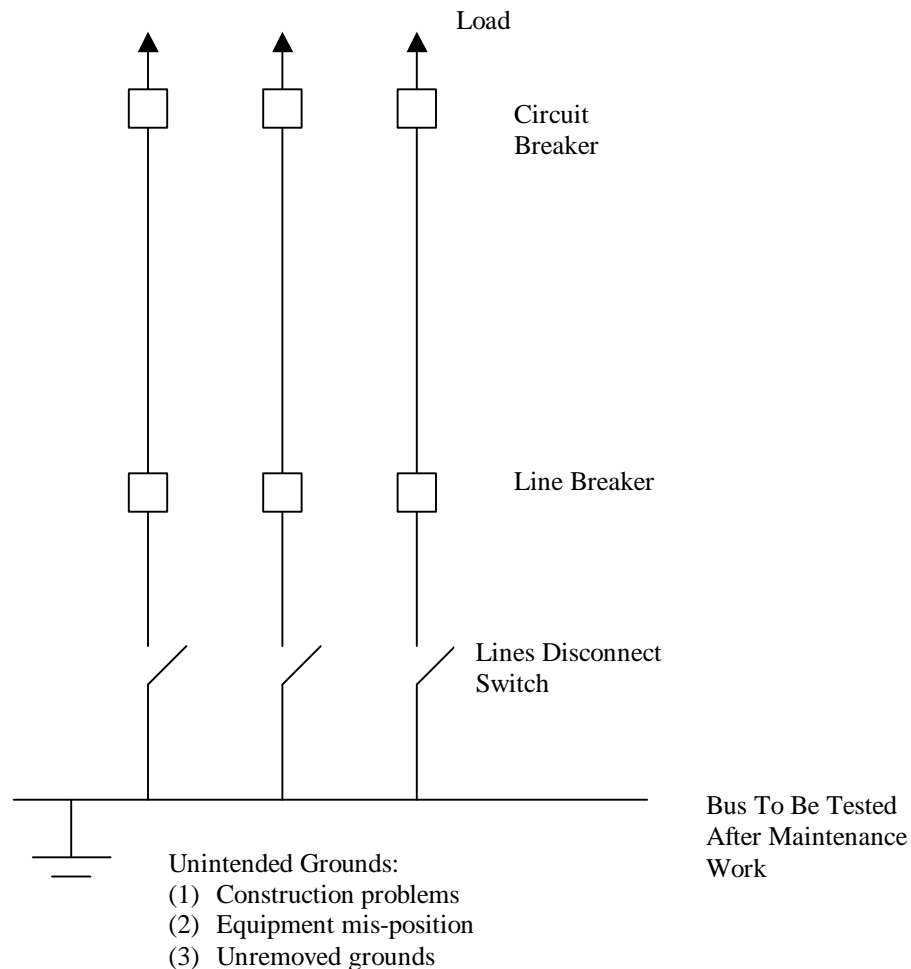
BUS TESTING STRATEGY (AN EXAMPLE) TO DETECT UNINTENDED GROUNDS

Moreover, it is recommended that PG&E review its test program to ensure there were no other exceptions that, if allowed, could lead to unexpected equipment failures. (Recommendation OFI-4.2)

- (1) Select a lightly loaded line in which the circuit breaker is proven to work from a previous test.
- (2) Trip the circuit breaker in the lightly loaded line.
- (3) Close line disconnect Switch.
- (4) Close line breaker to energize the line.
- (5) If there are unintended grounds on the bus, the circuit breaker will trip off.

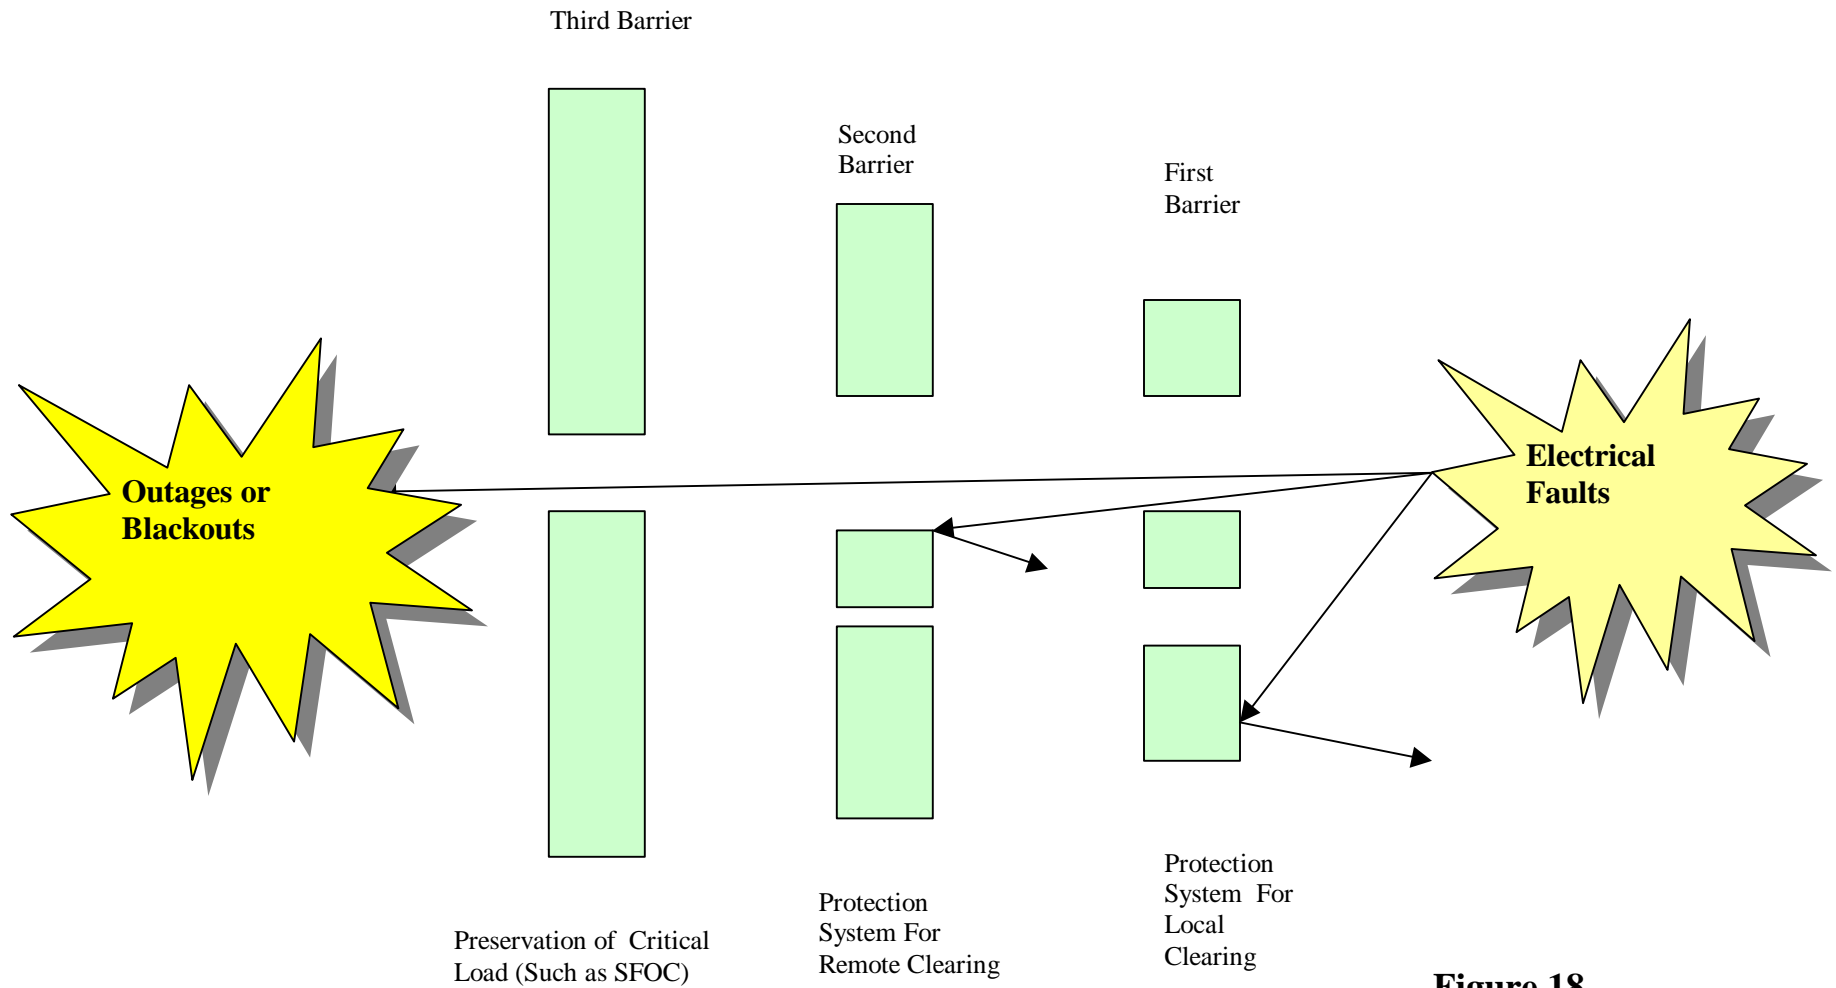
Figure 18

- Error prone switching log preparation process (OFI-6)
- Error prone work culture that is not self critical or forthcoming with problems (OFI-7)
- Inadequate protection system for local clearing (OFI-8)
- The protection system for distant clearing is not designed for fast clearing of bus faults (OFI-9)
- Current San Francisco Operating Criteria (SFOC) not designed to preserve critical load against disturbance of large voltage fluctuations or loss of generation after islanding (OFI-10)

CONSEQUENCE CONTAINMENT OF ELECTRICAL FAULTS

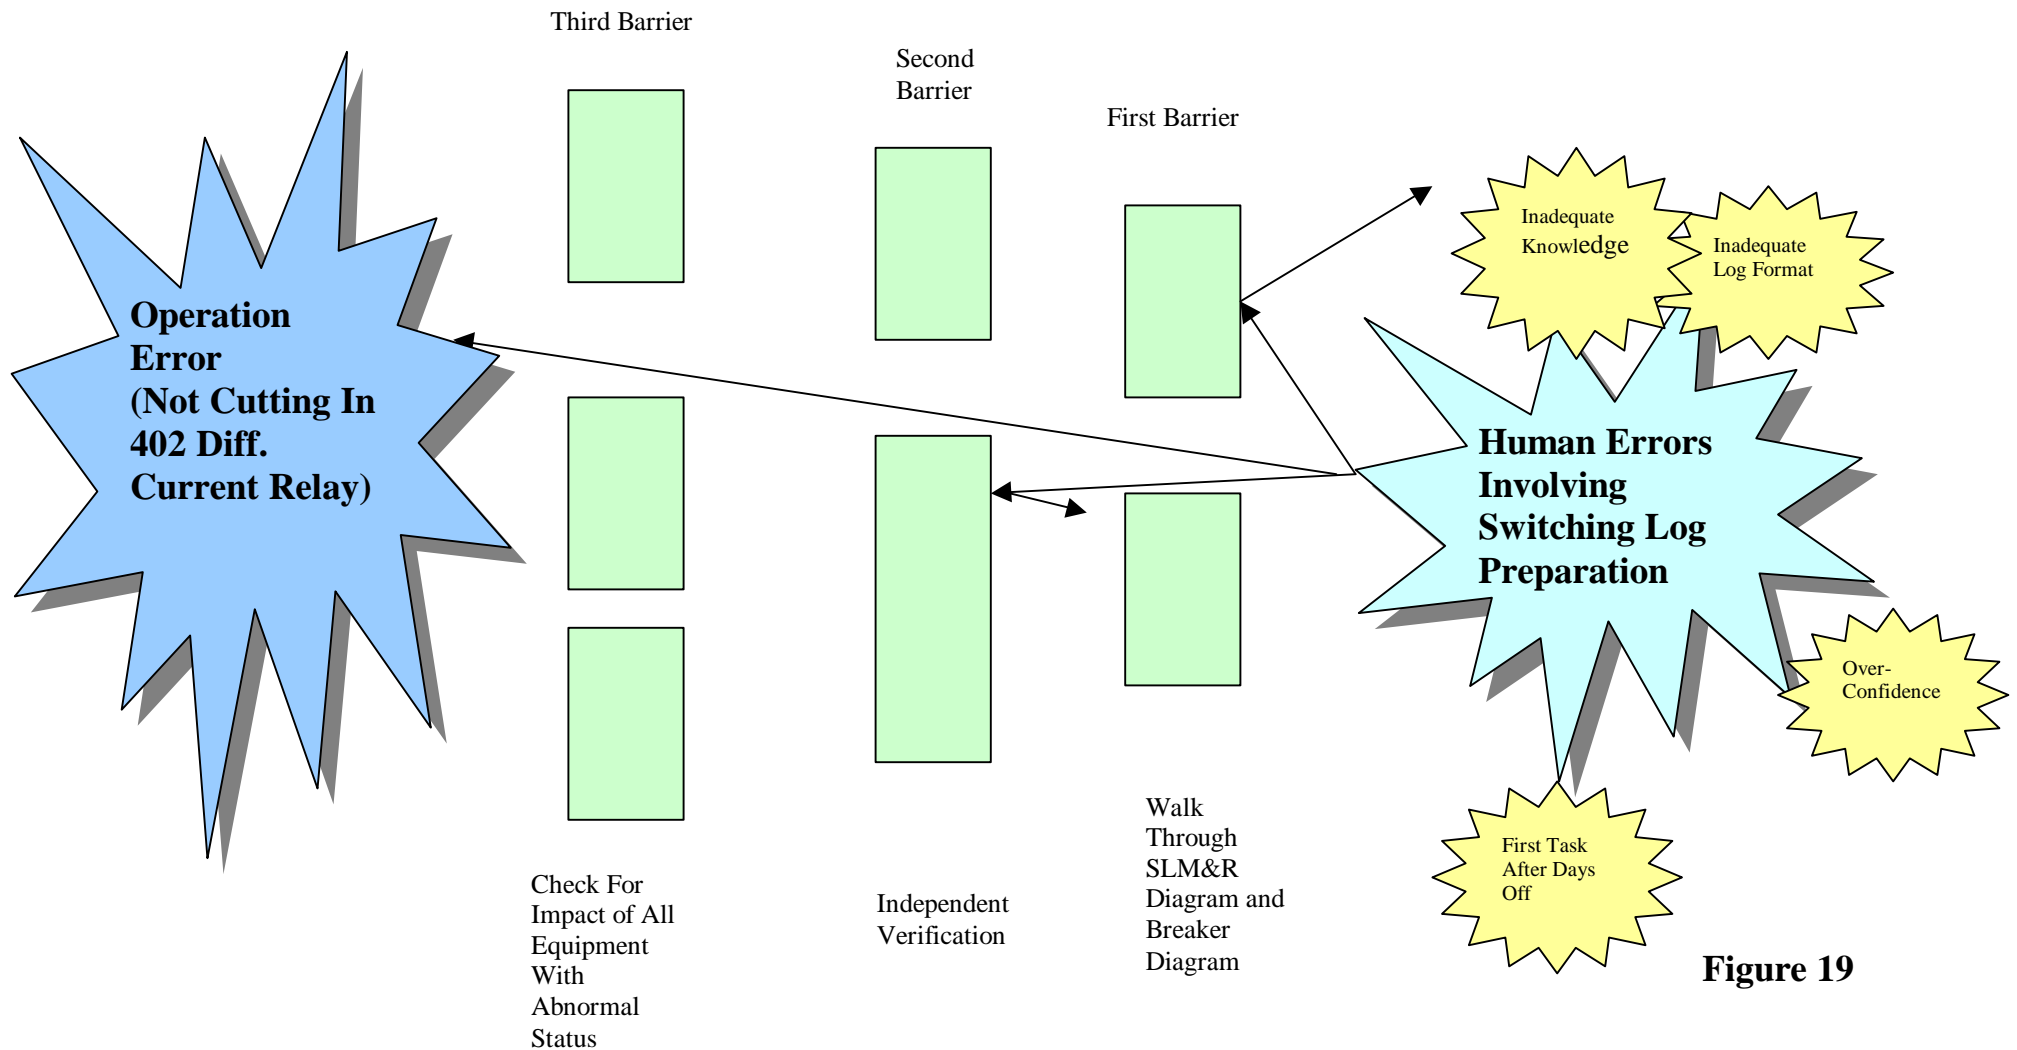
Figure 19

HUMAN ERRORS INVOLVED IN DEFEATING PROTECTION SYSTEM FOR LOCAL CLEARING

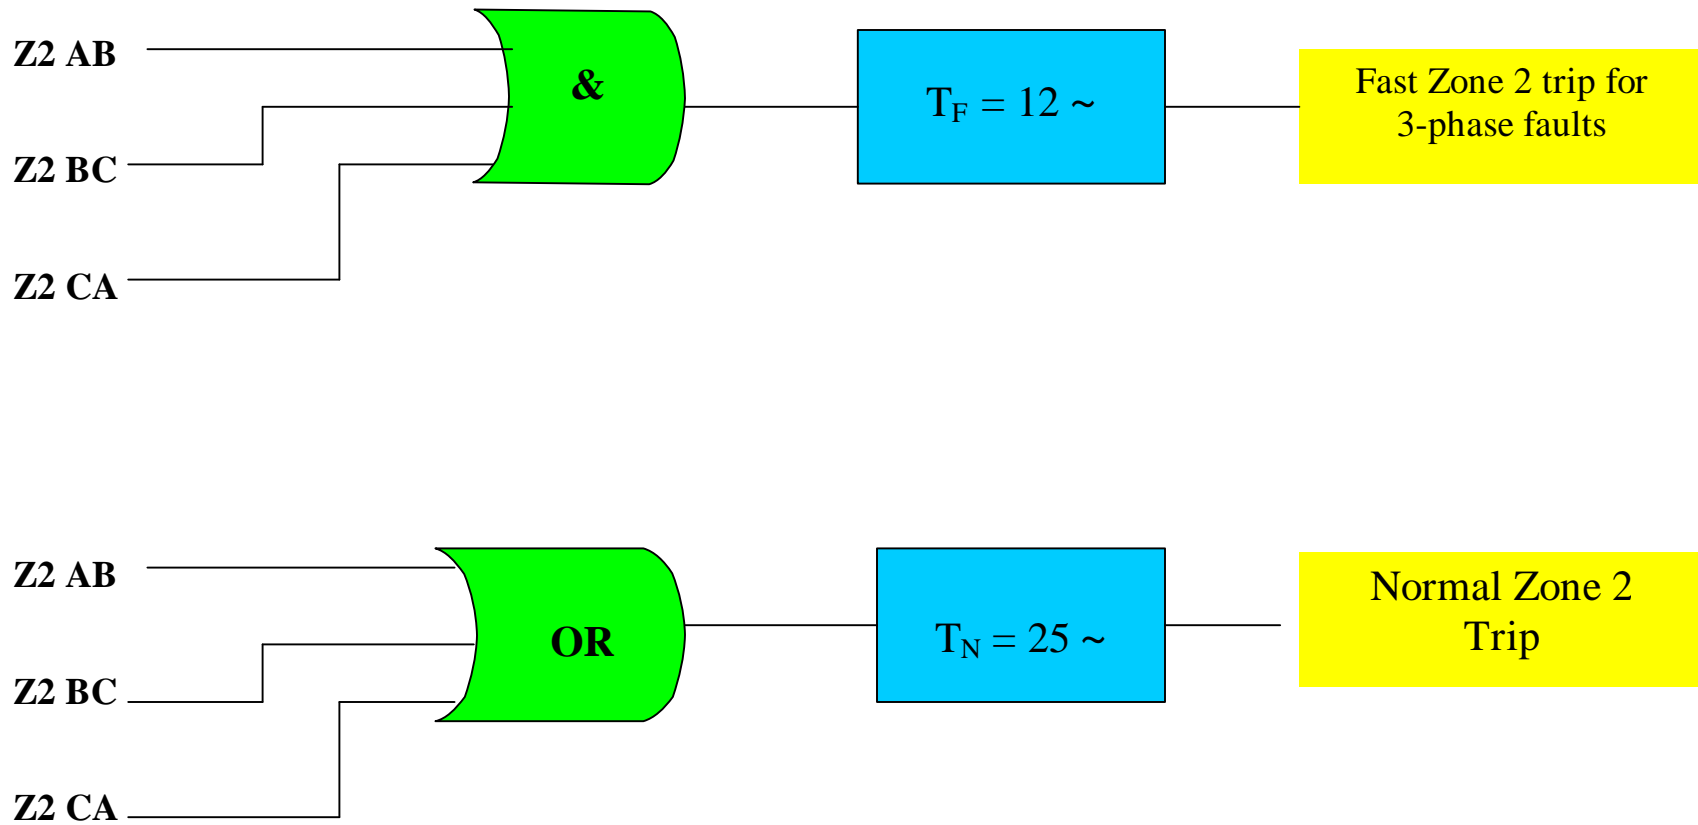
Figure 21

PROGRAMMABLE LOGIC SETTINGS FOR DIGITAL DISTANCE RELAYS

It is recommended that PG&E replace the Zone 2 directional overcurrent relays with digital time triggered relays with a response time of 15 cycles for three-phase faults. **Figure 21** shows a recommended design for Zone 2 fast acting relay. (Recommendation OFI-9.1)

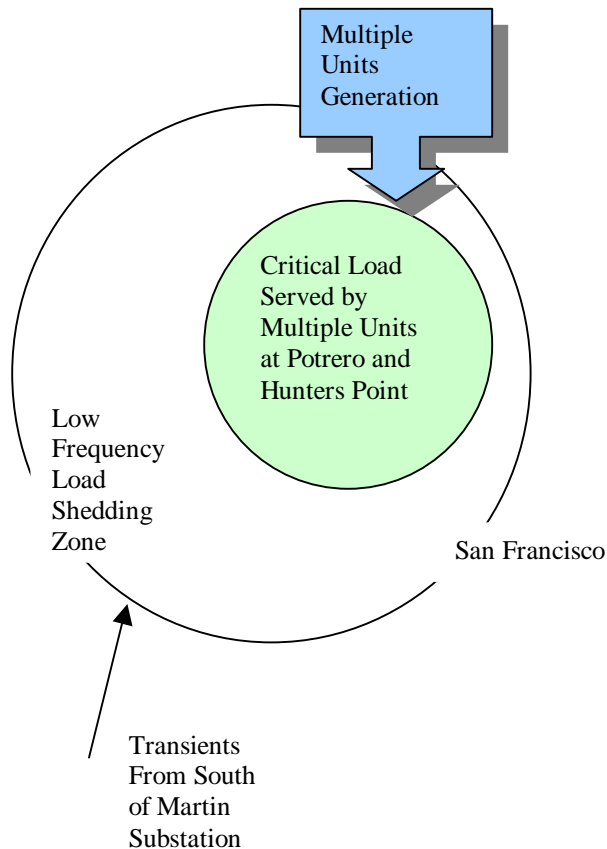
CURRENT SYSTEM

Limitations of Current SFOC

- **Low voltage transients may trip the generation and defeat the system.**
- **Loss of generation from other causes (such as earthquake, setpoint mis-setting, or equipment malfunctions) in conjunction with low frequency transients may defeat the system.**

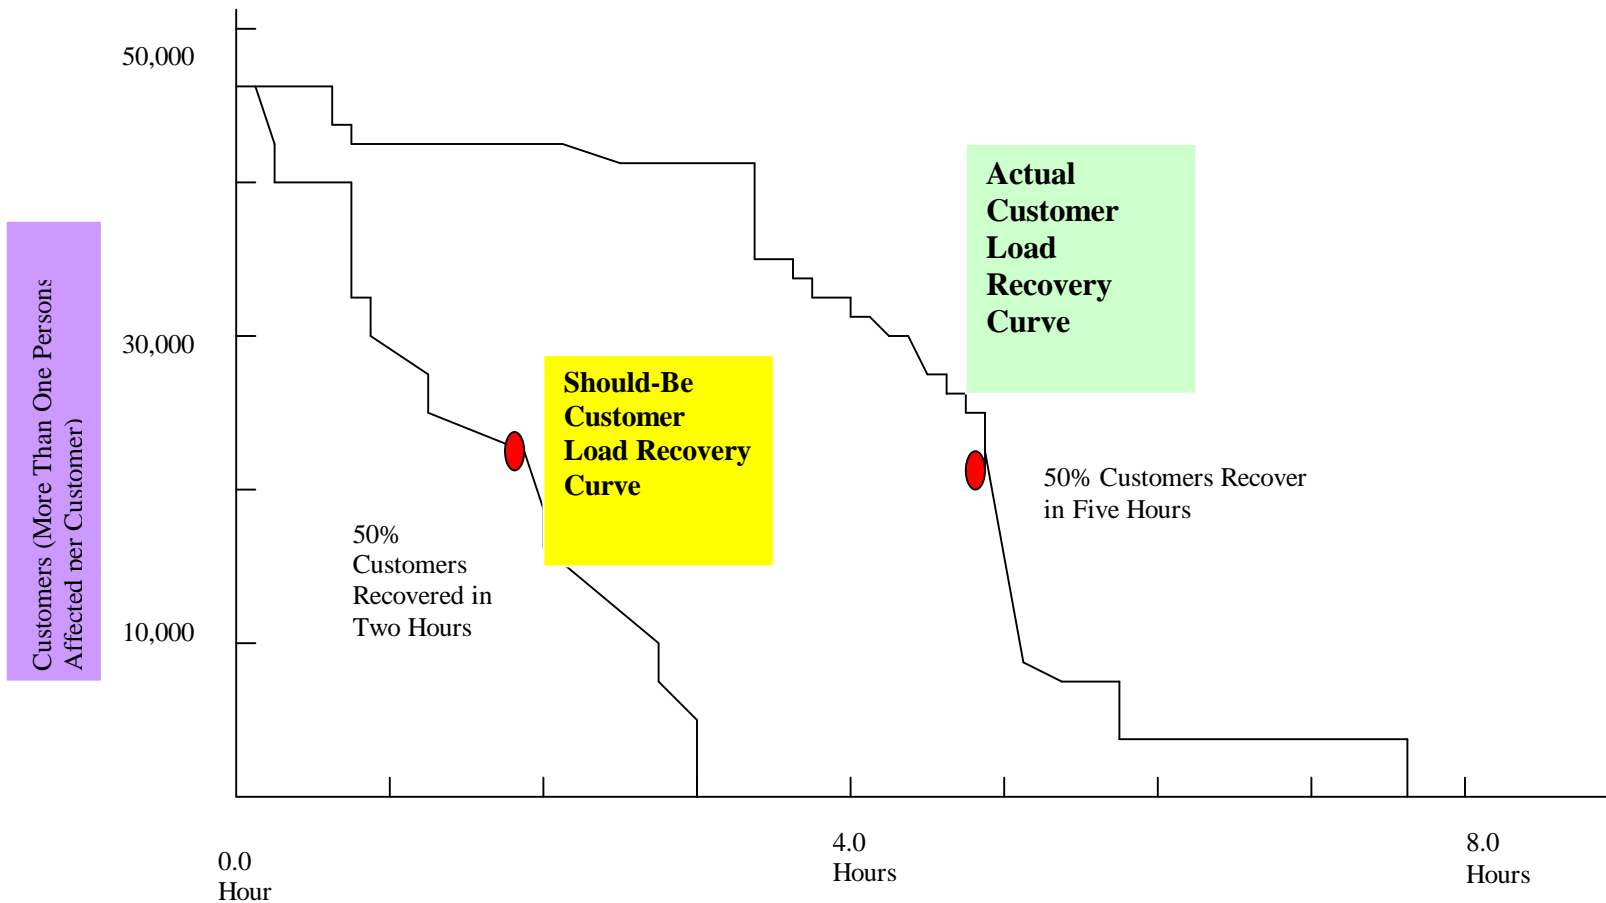
Figure 26

ACTUAL VERSUS SHOULD-BE RECOVERY TIME
