## PROJECT MEMORANDUM SCE – VIEJO SYSTEM PROJECT

To: Jensen Uchida, CPUC
From: Vida Strong, Aspen Project Manager
Date: March 15, 2005
Subject: Weekly Report #32: March 6 – March 12, 2005.
CPUC Environmental Monitor (EM): Christopher Meyer

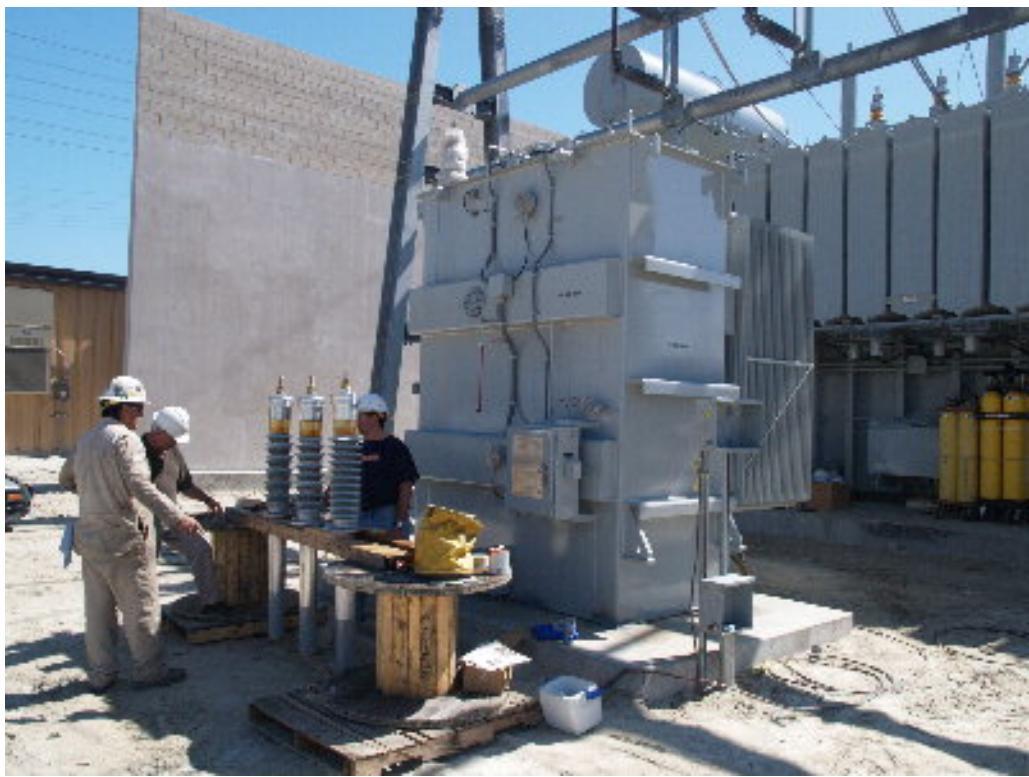
- 2. The grounding transformers have been set for both A-bank transformers (see Figure 1). Crews continued to test the panels throughout the substation site after installation. The technicians tested each connection on the panels to verify the panels were correctly fabricated at the factory.

Figure 1 – The grounding transformers for the A-bank transformers have been set on pads and will be connected to the system shortly.

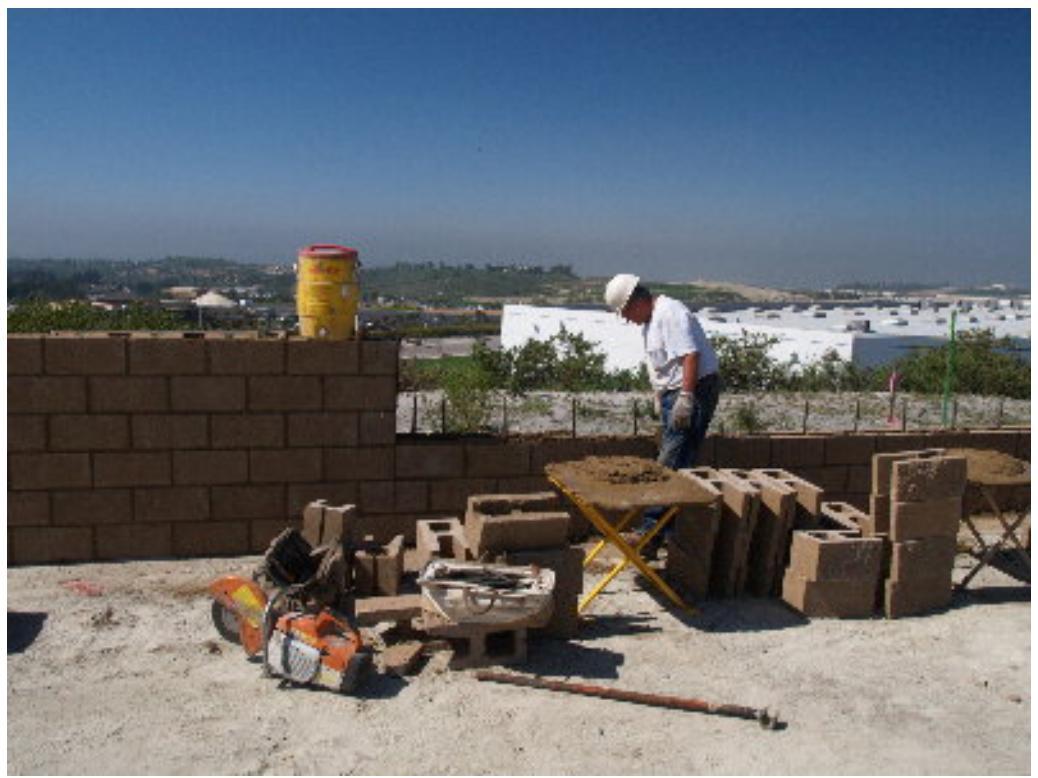
- 3. Union has completed the excavation and pouring of the foundation for the block wall that will eventually surround the substation site. SCE increased the width of the foundation for increased stability in the wall. A specialized crew worked to set the concrete blocks during the site visit (see Figure 2). The wall will be grouted to approximately 3 feet in elevation; however, the crews were not able to proceed with the grouting while awaiting an inspection by the city.

**Figure 2** – A specialized crew set the concrete blocks on the west side of the substation during the site visit.

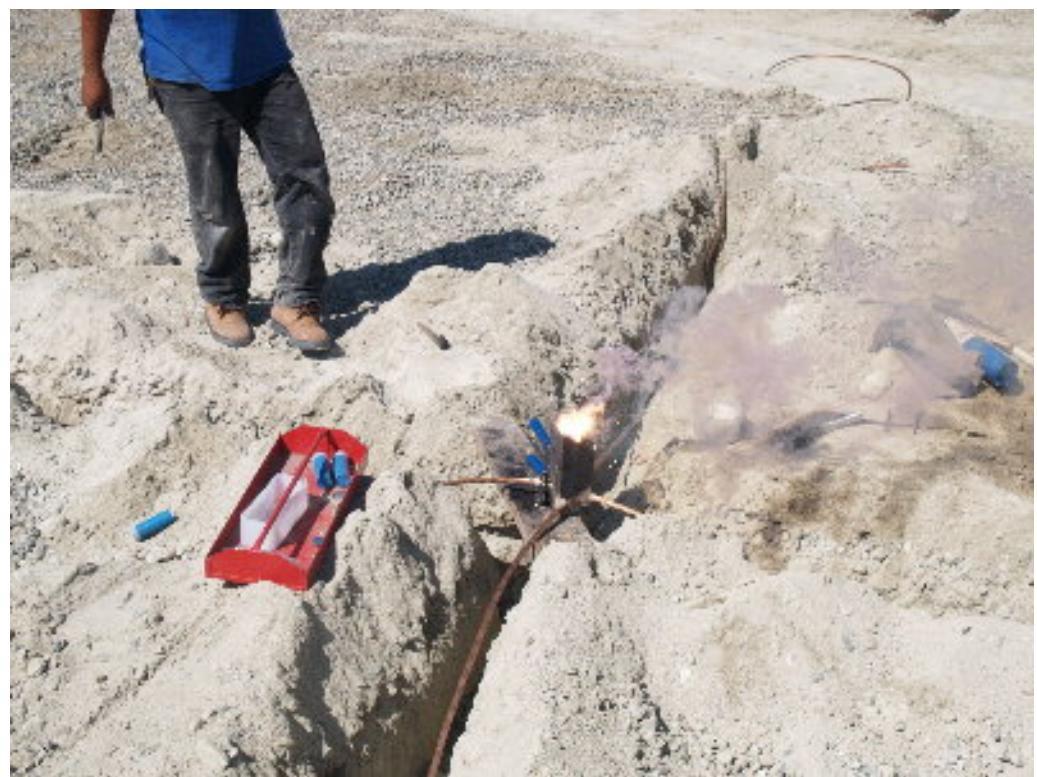
- 4. Several small crews worked throughout the substation site to connect foundations to the grounding grid and make final connections in the system. A special mold is used to fuse the copper grounding wires. A small metal disk is placed over the wires in the mold to be fused and a powder charge is added. A reactive powder is added last to create the heat to melt the disk over the copper cables (see Figure 3).

**Figure 3** – A small crew worked to fuse connections on the grounding grid that runs throughout the substation site.

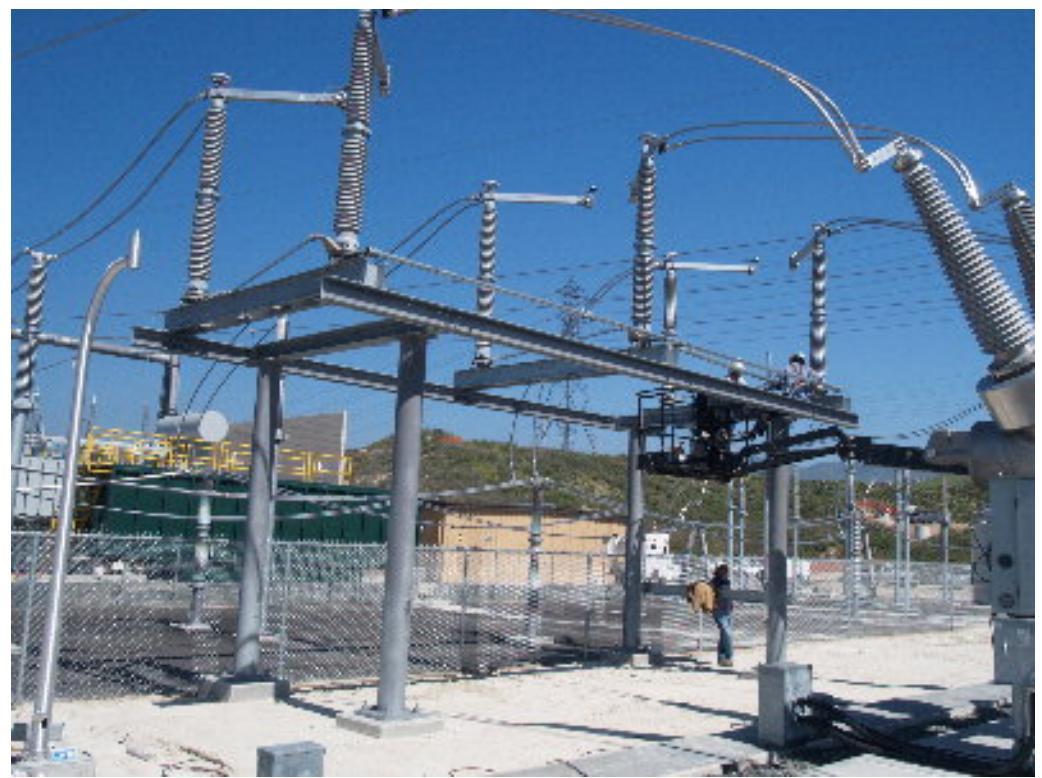
- 5. A small crew worked to adjust the disconnect switches on the 220 kV section of the substation site (see Figure 4). The disconnect switches can only be operated manually from a crank located below the switches. The bars that are attached to the crank need to be adjusted so that the switches align properly while in the closed position.

**Figure 4** – A small crew worked to adjust the disconnect switches on the 220 kV portion of the substation site.

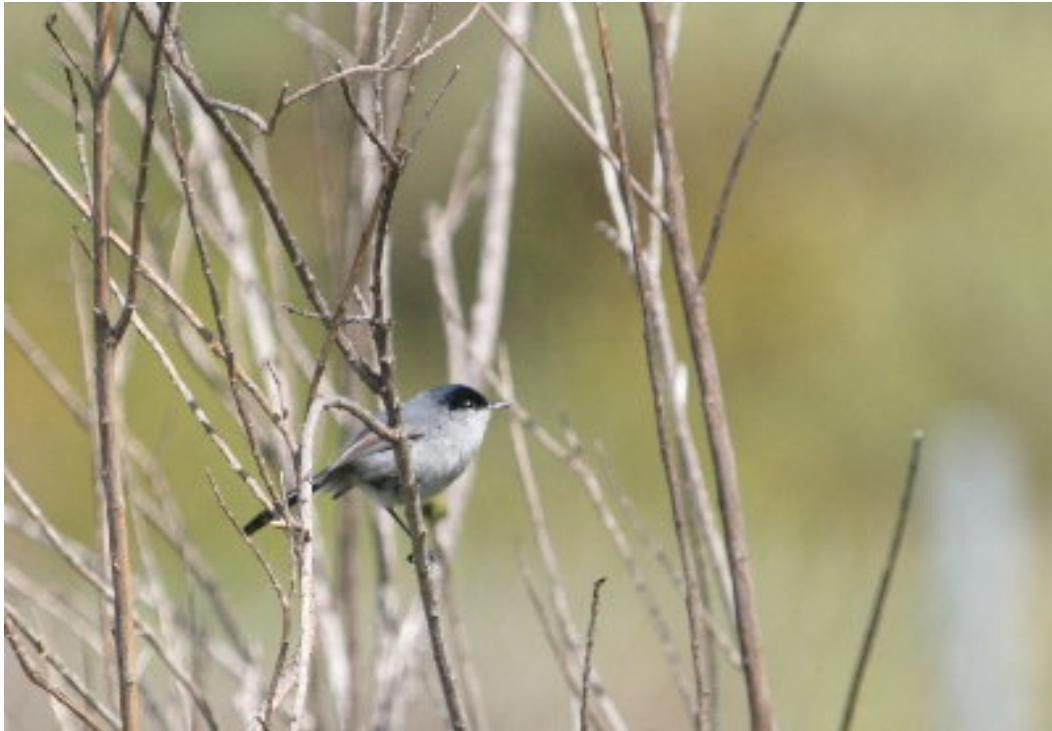
Several birds were noted in the habitat adjacent to the 220 kV right-of-way, including a gnatcatcher with breading plumage (see Figure 5). No construction work was occurring in the vicinity.

Figure 5 – Nesting behavior was noted in the habitat adjacent to the 220 kV transmission line right-of-way.

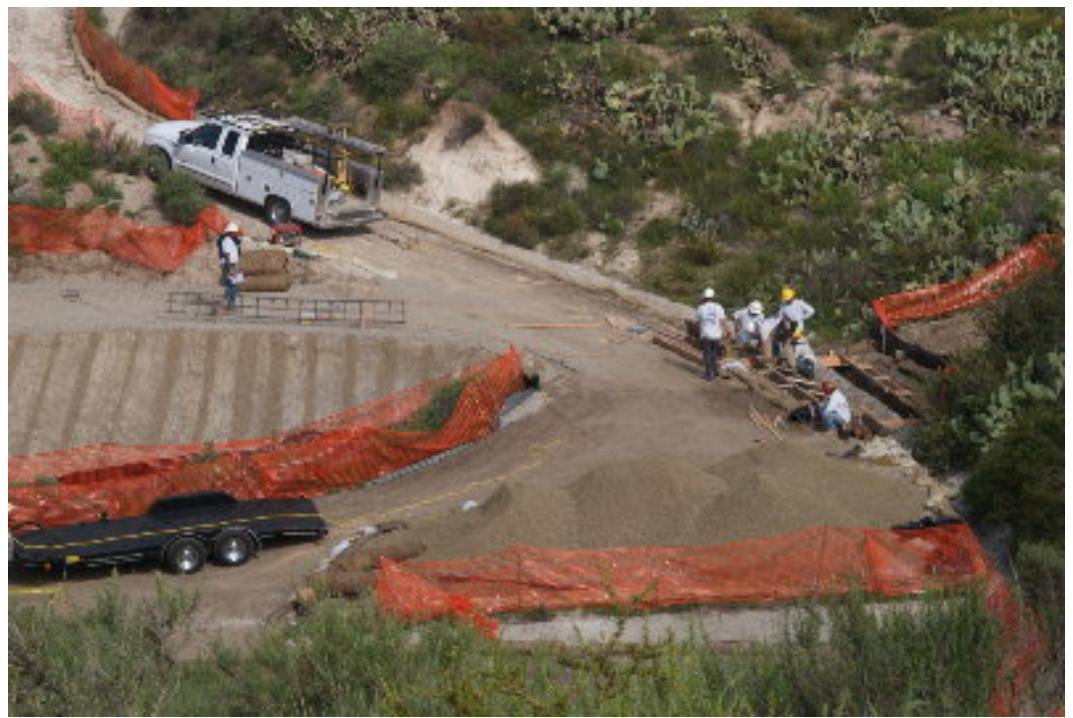
1. Inland Valley Construction prepared the forms to pour the two sections of v-ditch along the access road on the 66 kV segment above the substation site (see Figure 6). The concrete truck arrived later in the morning to start the pours at the prepared forms.

**Figure 6** – Crews worked to build forms for the v-ditches on the 66 kV section of the project. Jute netting has been placed on the slopes of the complete steel pole pads.
