PROJECT MEMORANDUM SCE – VIEJO SYSTEM PROJECT

To: Jensen Uchida, CPUC
From: Vida Strong, Aspen Project Manager
Date: August 17, 2005
Subject: Weekly Report #54, August 7 – August 13, 2005.
CPUC Environmental Monitor (EM): Christopher Meyer

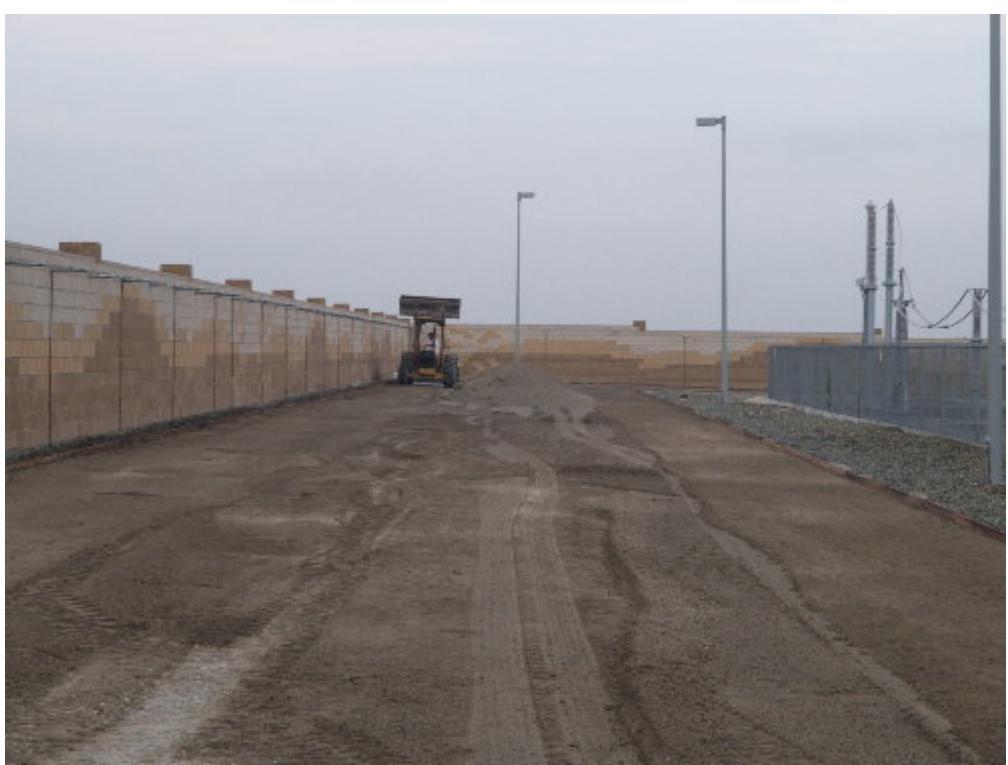
- 1. The road contractor had an operator working with a skip loader to complete final grading of base material for the roads within the substation site in preparation for paving (see Figure 1). The roads around the edges of the site will receive base prior to the asphalt and the roads crossing through the site will receive an extra 2 inches of asphalt instead of base rock. A backhoe was used to place rock on the apron on the roads prior to placing asphalt. A water truck was on-site for the work during the site visit (see Figure 2). Between the light rain and the use of the water truck, no fugitive dust issues were noted during the site visit. No work was occurring on paving during the site visit and asphalt paving is schedule for Saturday.

Figure 1 – The paving contractor spread base on the roadways within the substation prior to paving.

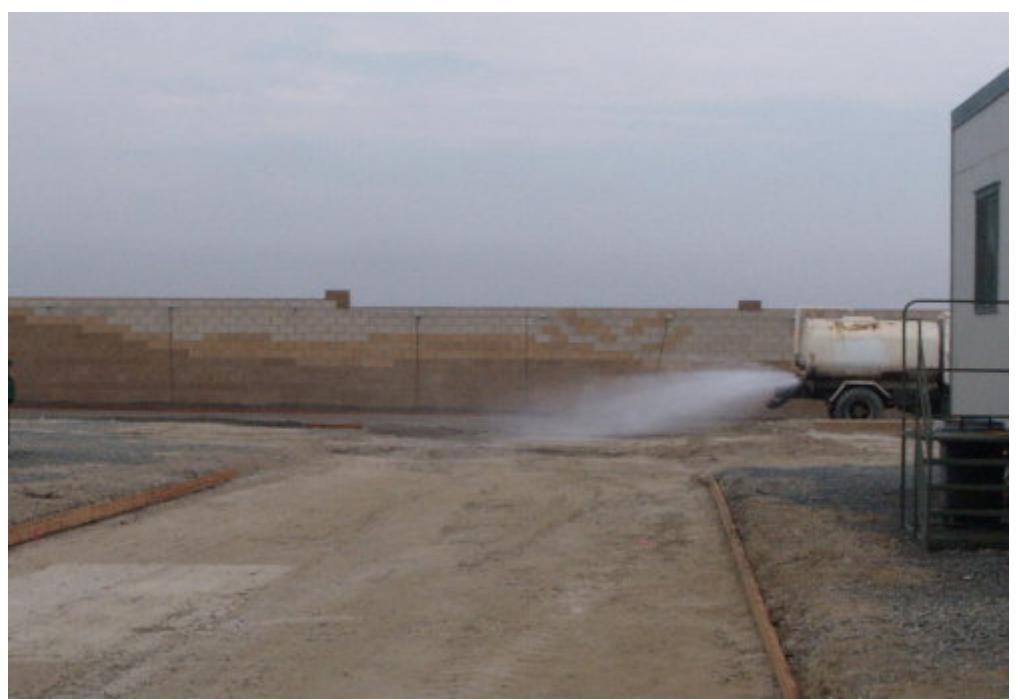
Figure 2 – A water truck was used to control dust during the site visit.

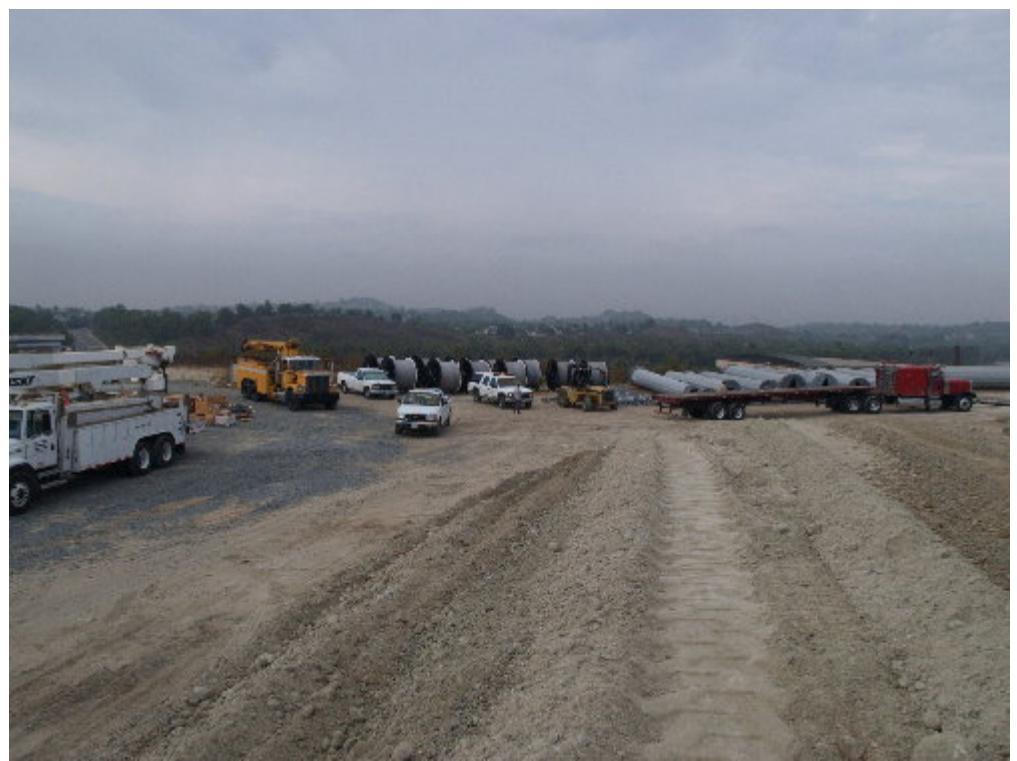
- 1. An SCE transmission line crew worked within the substation site and laydown area to load materials in preparation for work on other transmission lines. Storm and accident damage to other SCE infrastructure caused crews to work on these emergency repairs instead of on the Viejo 66 kV transmission line (see Figure 3).

Figure 3 – An SCE transmission line crew worked to load equipment from the staging area.

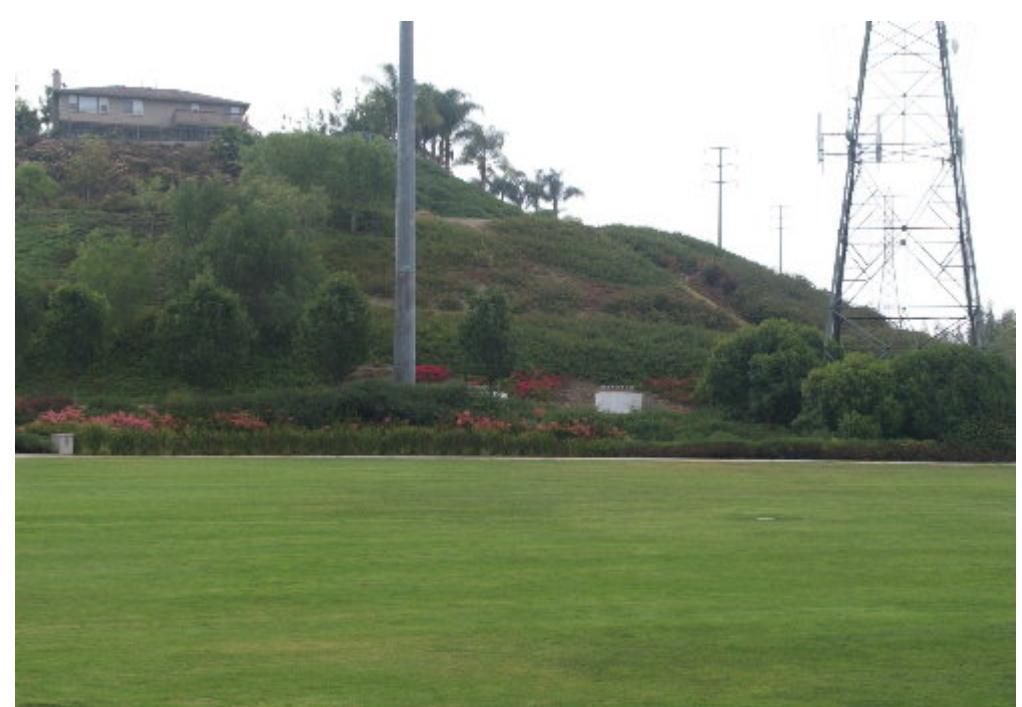
- 2. The foundations within and adjacent to Olympiad Park have been poured and are awaiting the setting of H-structures (see Figure 4). Work may resume on erecting the steel poles the week of August 22nd. Access to the right-of-way passed through a portion of the park and SCE will restore the access according to the previous agreement with the park. Some of the small irrigation lines adjacent to Structure 2 have been damaged and the flow of water leaking from the system has created minor erosion down the access road. The concrete v-ditch adjacent to the access road was cleaned of debris and sediment. The concrete path crossed by the access route was damaged by the heavy equipment and may require repair and/or improvement.

Figure 4 – Completed foundations at Olympiad Park.
