CALIFORNIA PUBLIC UTILITIES COMMISSION Safety and Enforcement Division Electric Safety and Reliability Branch

Incident Investigation Report

Incident Number: E20171009-02

Utility: Pacific Gas and Electric Company (PG&E)

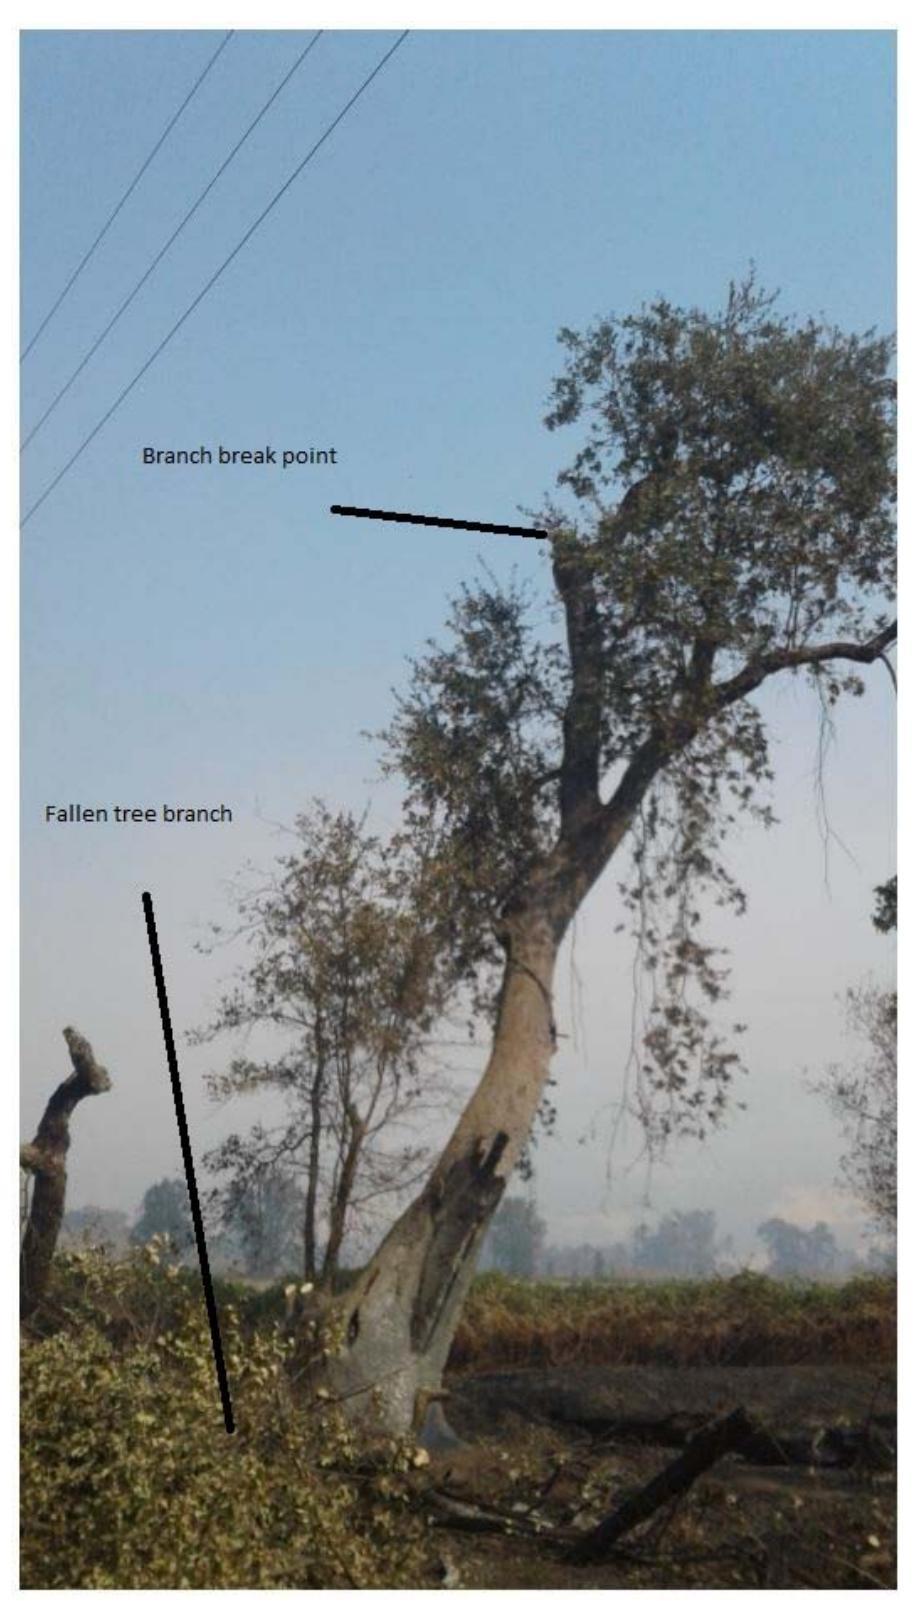
On October 9, 2017, PG&E filed an Electric Safety Incident Report concerning an incident that occurred approximately 500 feet east of 13801 North Busch Road in Potter Valley. At this location, the Potter Valley-Mendocino 60 kV transmission line is mounted on the east side of the steel lattice structures. When PG&E arrived at the incident location, PG&E observed a branch from a green, healthy California White Oak/Valley Oak tree had broken and was lying on the ground beneath. (Figure 4) The tree branch was one foot in diameter and approximately nineteen feet long. (Figure 5) The branch had broken into two different sections. The break at the end of the branch appeared to match the break at the top of the oak tree. The oak tree was approximately six feet in diameter and approximately forty feet tall. The tree was rooted approximately 15 feet from the transmission conductors and had a lean away from the conductors.

Figure 4. Fallen Valley Oak tree branch and break point at 13801 North Busch Road

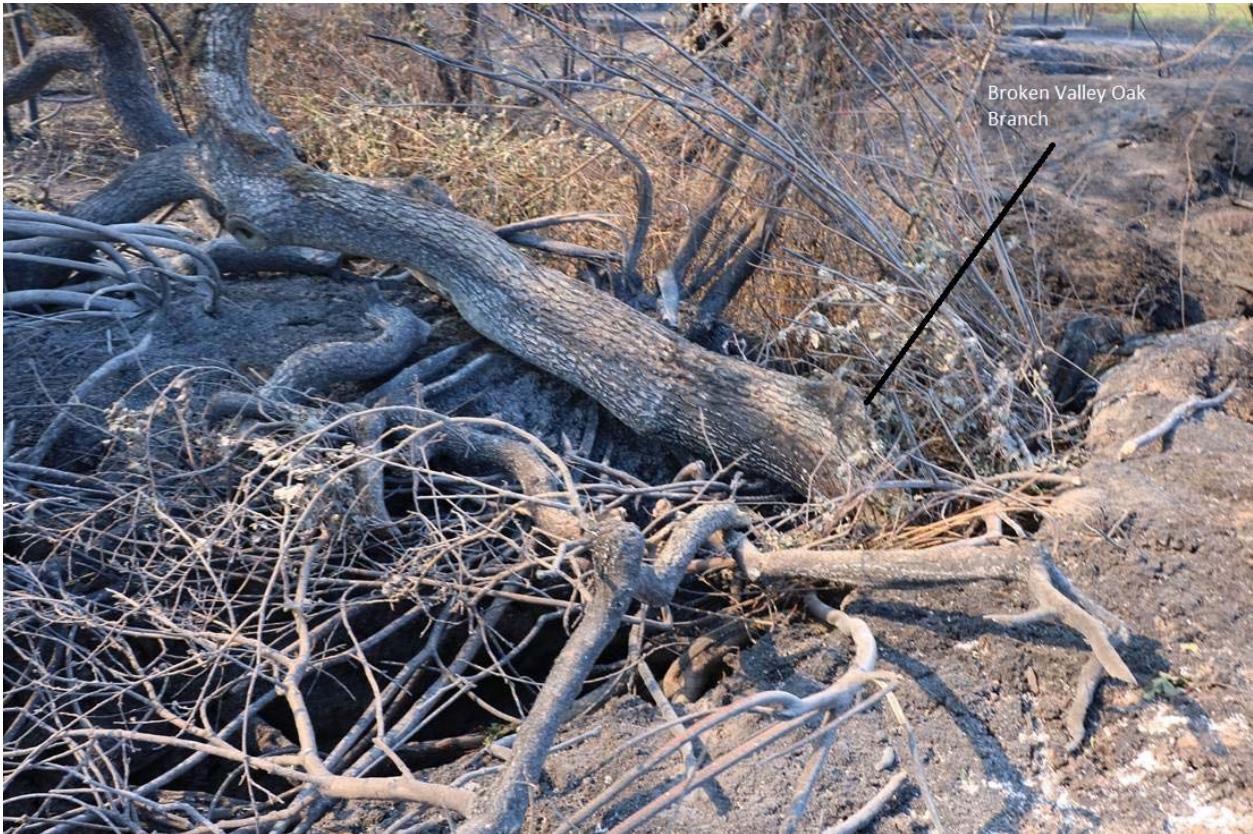
Figure 5. Broken Valley Oak branch on the ground

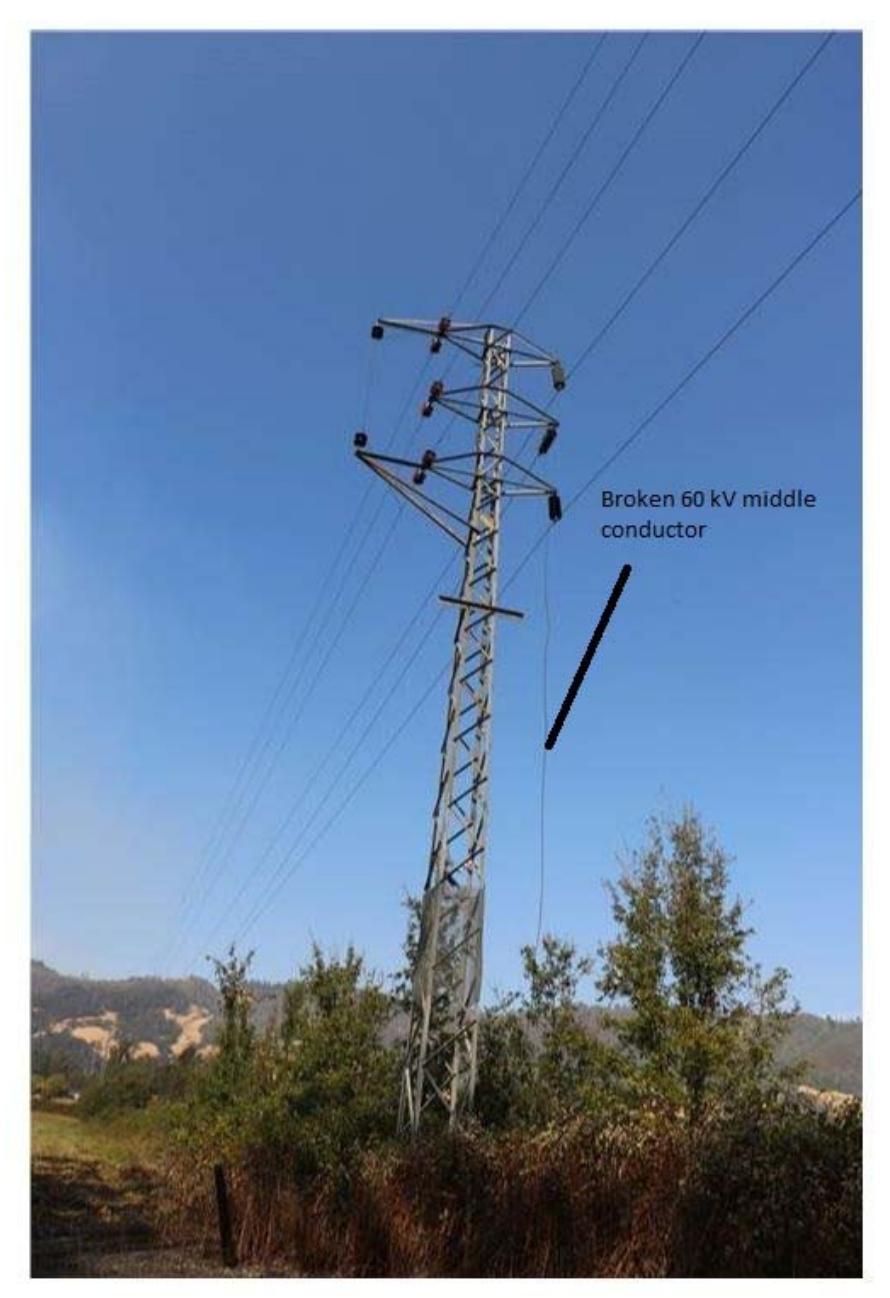
PG&E observed the middle conductor of the Potter Valley-Mendocino 60 kV transmission line had broken and was on the ground. (Figure 6) The other two transmission conductors were intact and did not fall to the ground. The "underbuild" of the Potter Valley 1105 12 kV distribution conductors were mounted on the west side of the steel lattice structures. All three of these distribution conductors were also intact.

Figure 6. Broken 60 kV conductor at incident tower (Source: CAL FIRE)

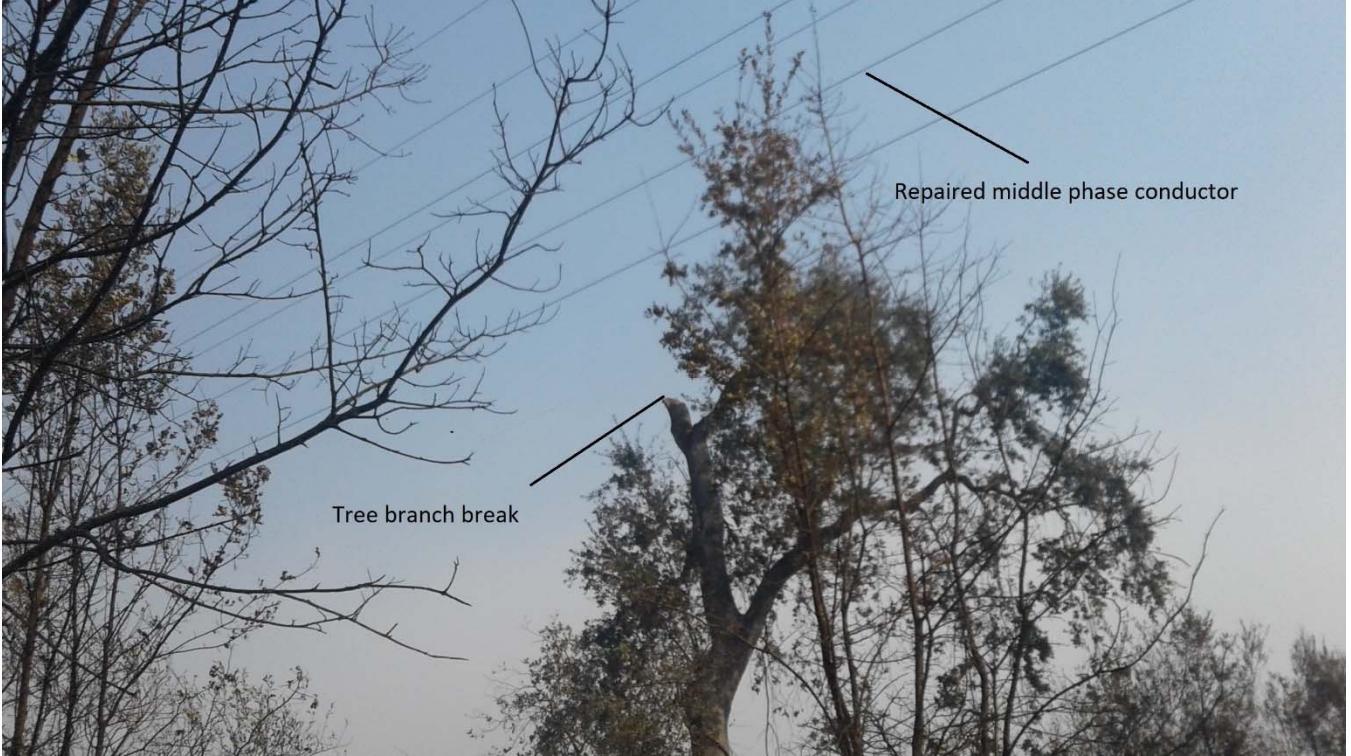
Figure 9. Repaired middle phase 60 kV conductor

PG&E got clearance from CAL FIRE the day before, October 11, 2017 to access the incident site. PG&E repaired the broken transmission conductor on October 11, 2017. PG&E provided the work order notification LC#113723033³² to document the repair. (Figure 9)

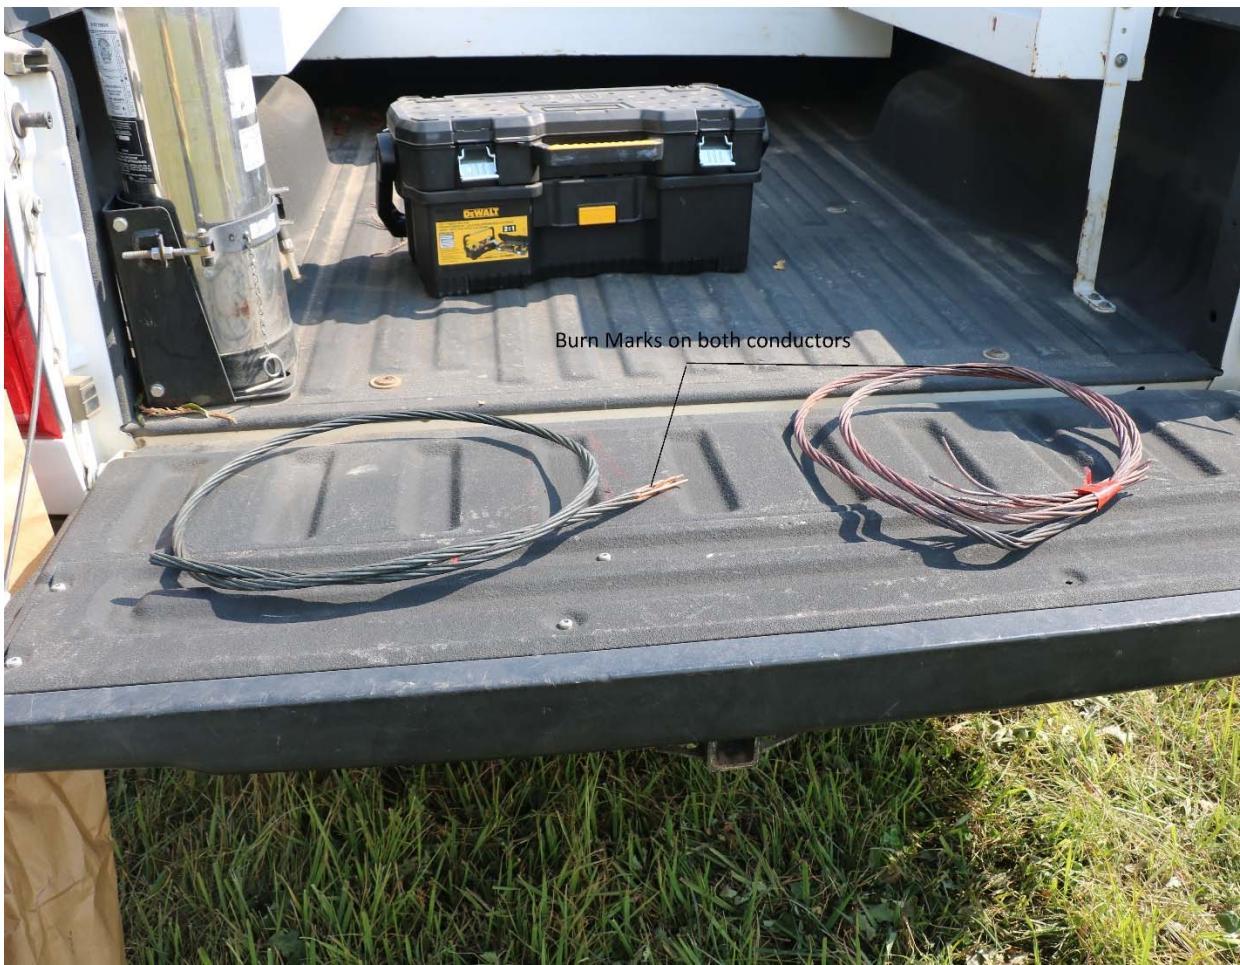
On June 29, 2018, SED met with CAL FIRE to review evidence collected by CAL FIRE and discuss the Redwood Incident. SED met with CAL FIRE Battalion Chief Ryan Smith and Fire Captain Eric Bettger. Captain Bettger showed SED the evidence he collected at this location. He stated he had asked PG&E to cut two sections of the broken middle phase conductor. He collected a 9-foot, 2-inch section of the 60 kV conductor from the south section of the line and a 6-foot, 6-inch section of the same conductor from the north section. The two sections had burn marks that were related to the tree conductor contact. (Figure 10)

Figure 10. Burn marks found on both sections of conductors from incident tree contact (Source: CAL FIRE)

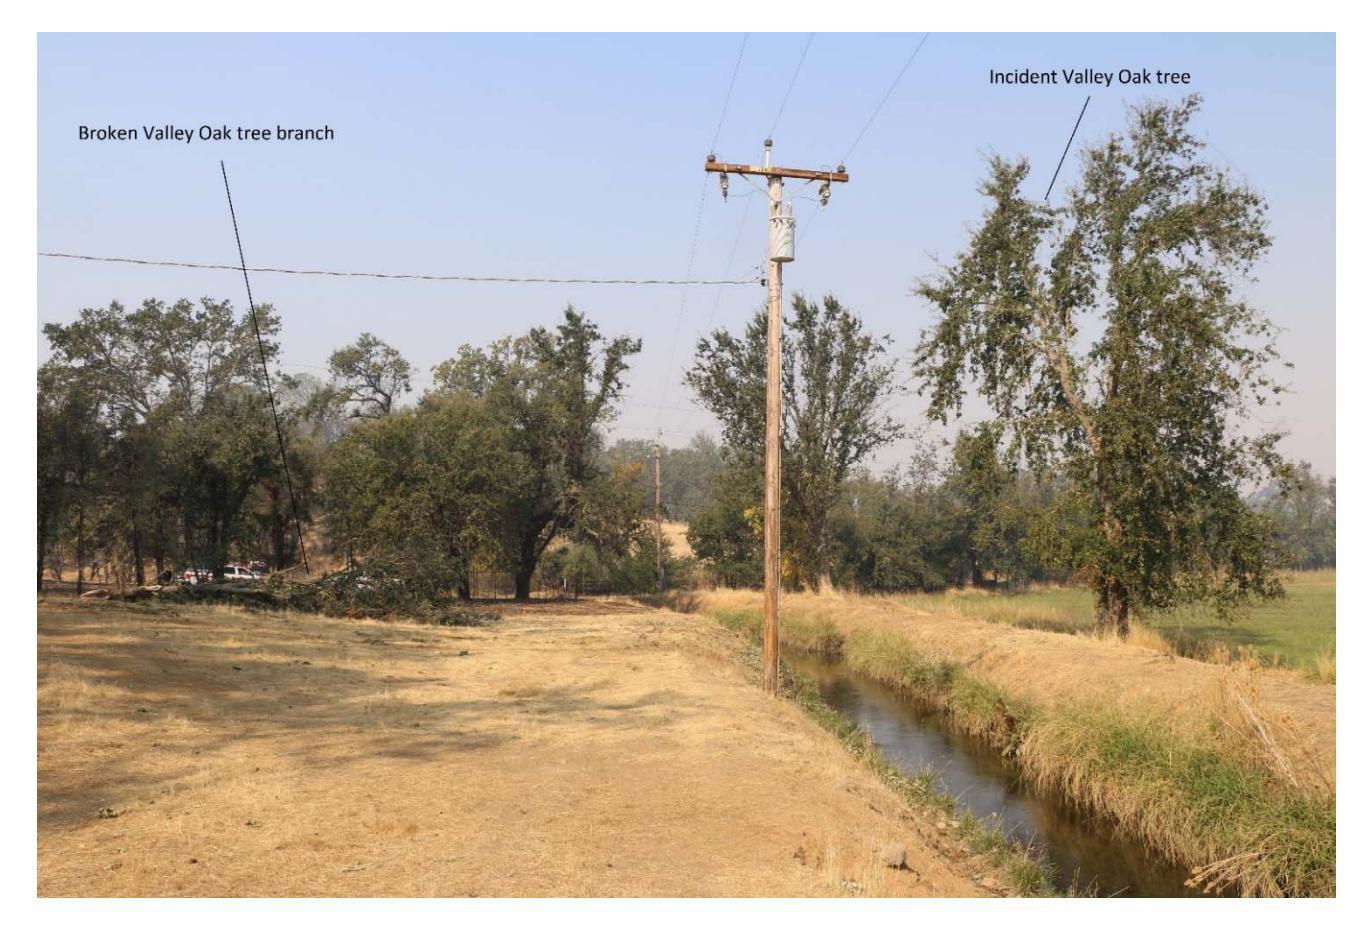
him there was a fire separate from the one that was at 1380 N. Busch Road. He followed the firefighter to the 9100 Main Street incident location where Captain Bettger observed a burned area near the bank of a canal. He investigated further and saw pieces of fulgurite on the ground near the bank. Above the pieces of fulgurite were three distribution conductors. The east conductor appeared to have a newer copper conductor spliced with the existing conductor. Just south of the fire was a tree branch that broke from an oak tree located on the east bank of the irrigation canal. He noticed that there were drag marks from where the tree branch had originally fallen. The branch appeared to match the tree located on the east side of the canal. The branch was approximately 45 feet, 8 inches long and was 14 inches in diameter. (Figure 11) Captain Bettger concluded his investigation by collecting a 4-foot, 6-inch piece of 12 kV conductor with 3-inch splice, 26 pieces of fulgurite, and a 4 ½ inch section of 12 kV conductor with fulgurite for evidence.

Figure 11. Broken branch from incident Valley Oak tree at 9100 Main Street (Hawn Creek Road) (Source: CAL FIRE)

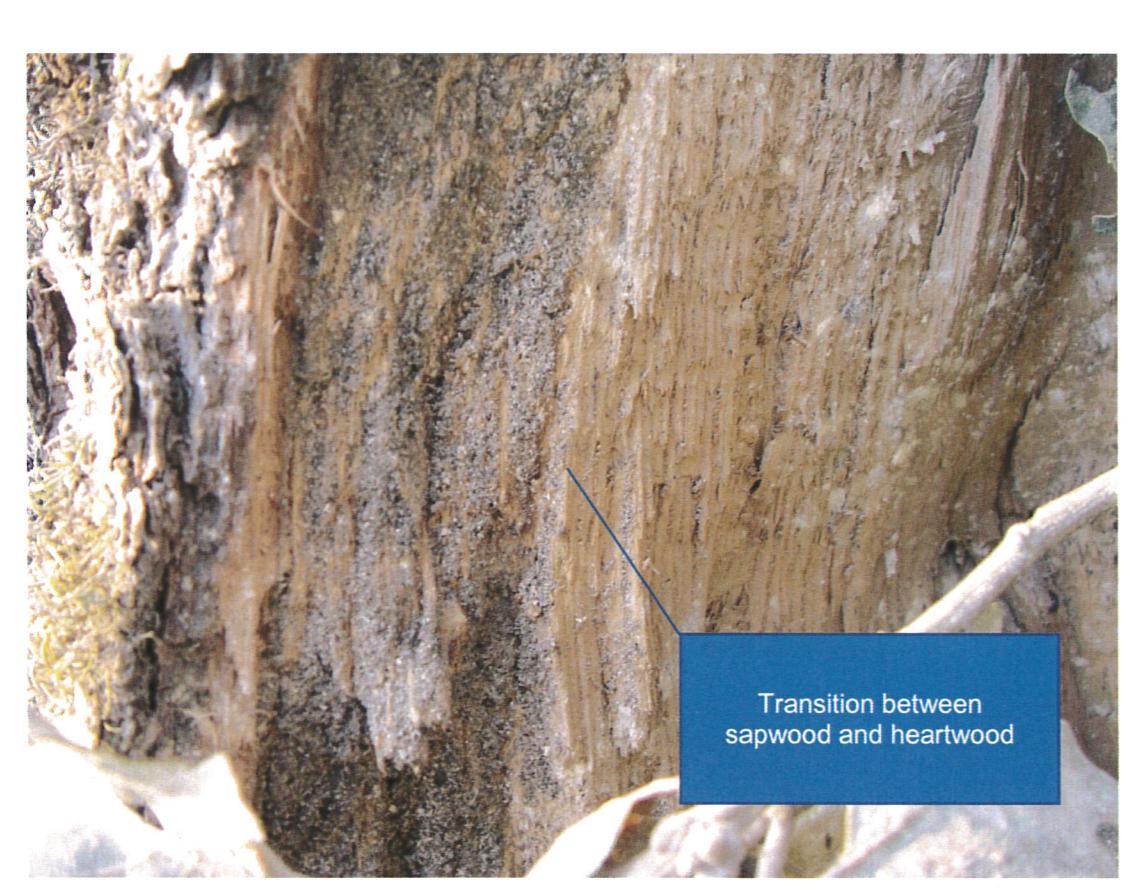
5 Picture #2: Closeup of end of scaffold branch showing ash clinging to sapwood.

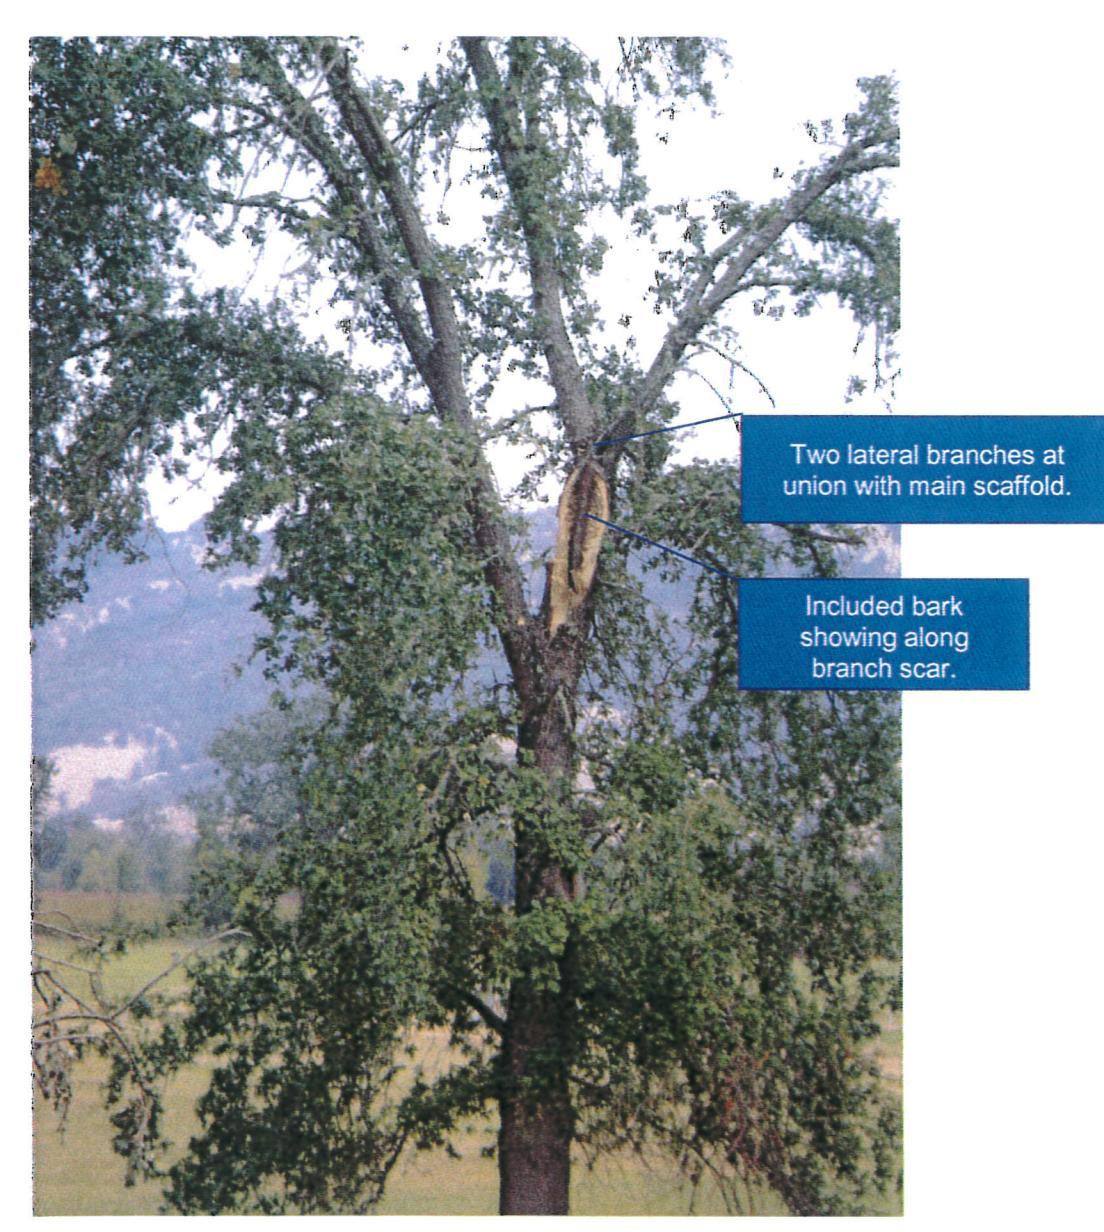
13 Picture #1: Showing branch scar at intersection of two lateral branches.

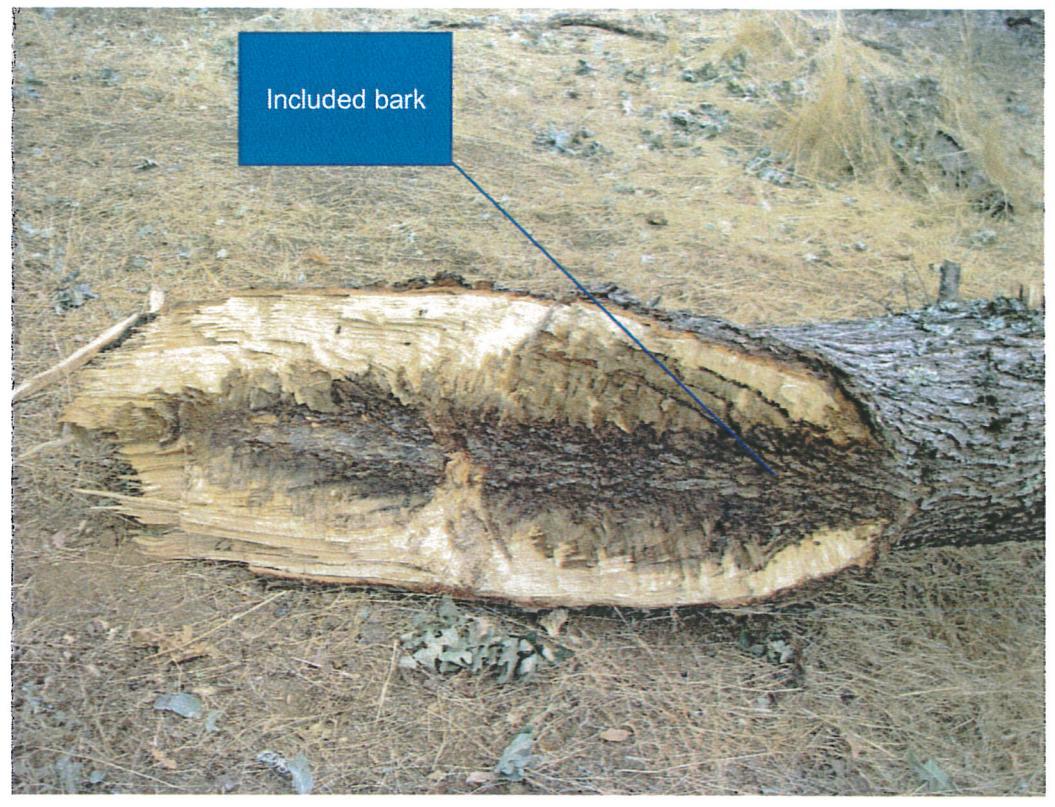
- Picture #2: Branch end of main scaffold branch showing included bark.

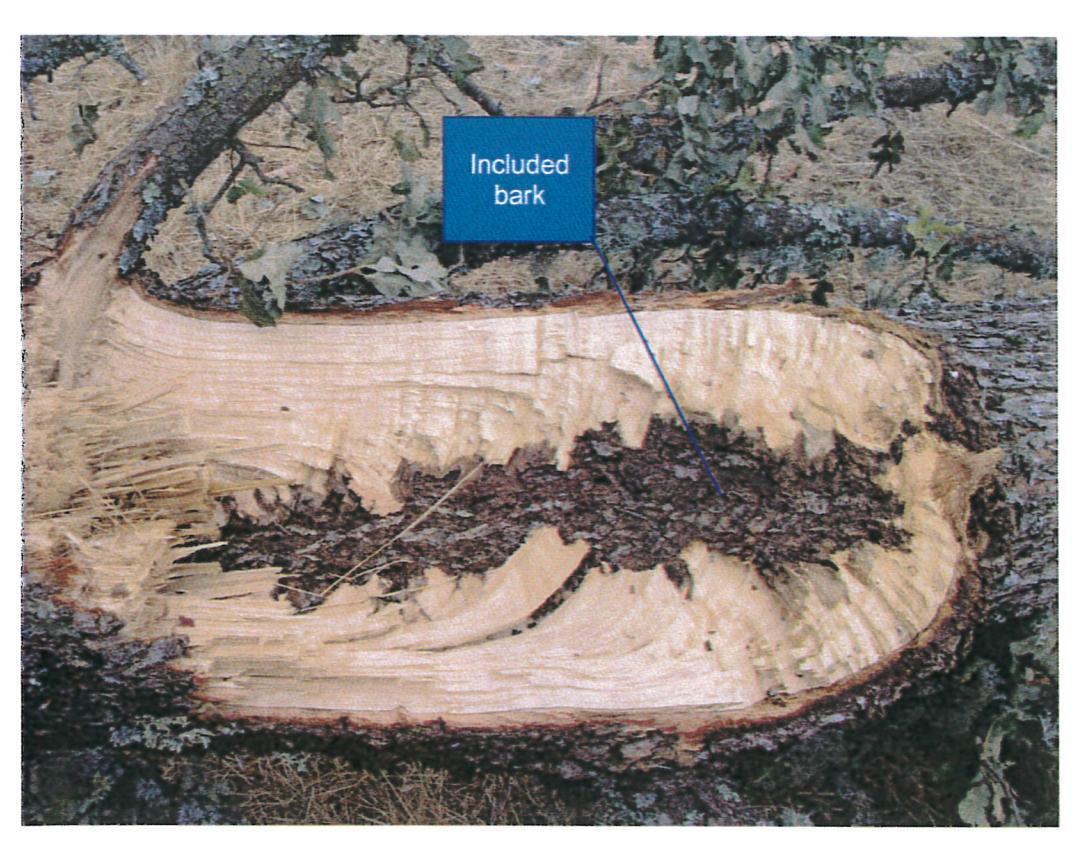
Picture #3: Branch scar of lateral branch showing included bark.
