CALIFORNIA PUBLIC UTILITIES COMMISSION Safety and Enforcement Division Electric Safety and Reliability Branch

Incident Investigation Report

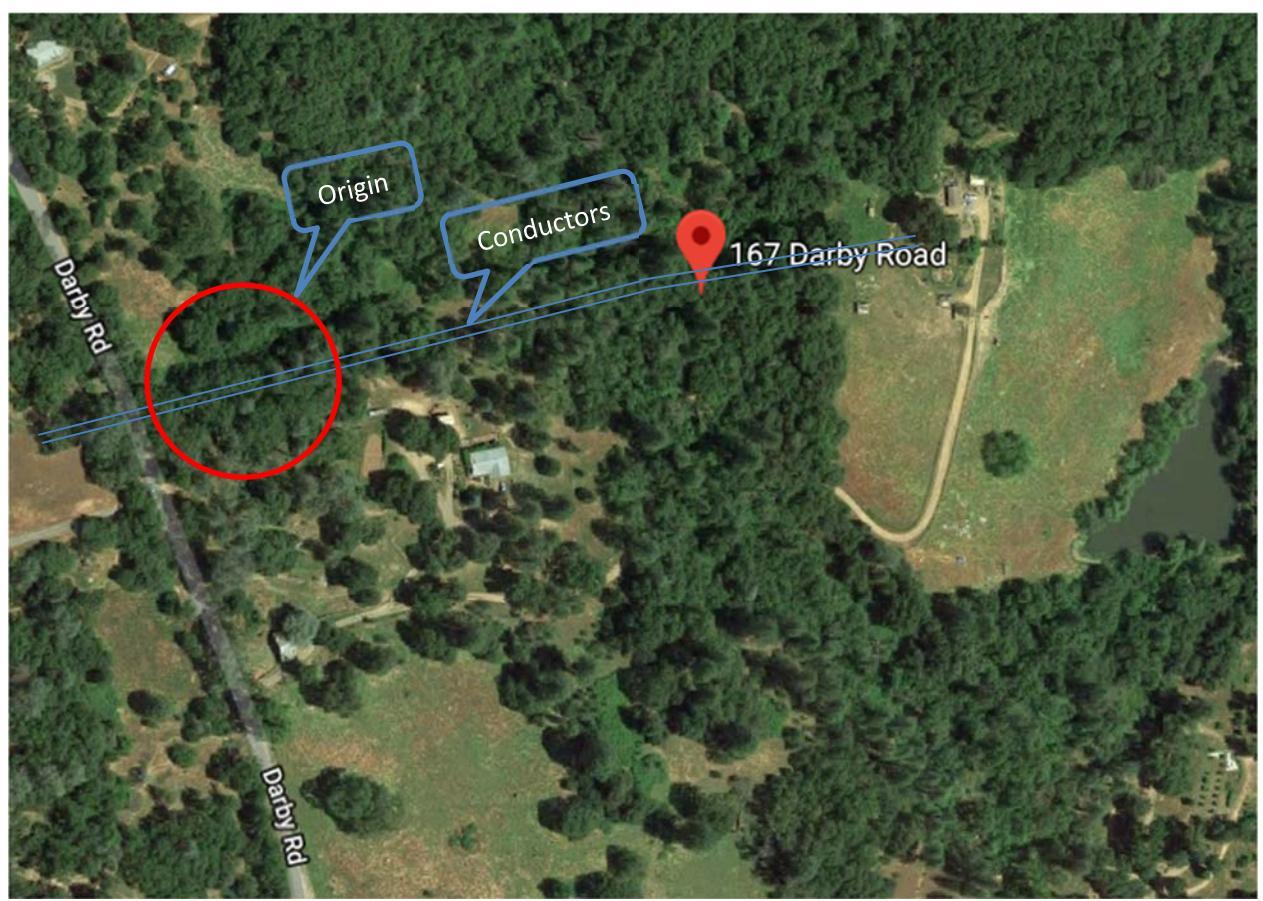
Figure 1: Fire Origin/ Incident Location (Source: Google Maps)

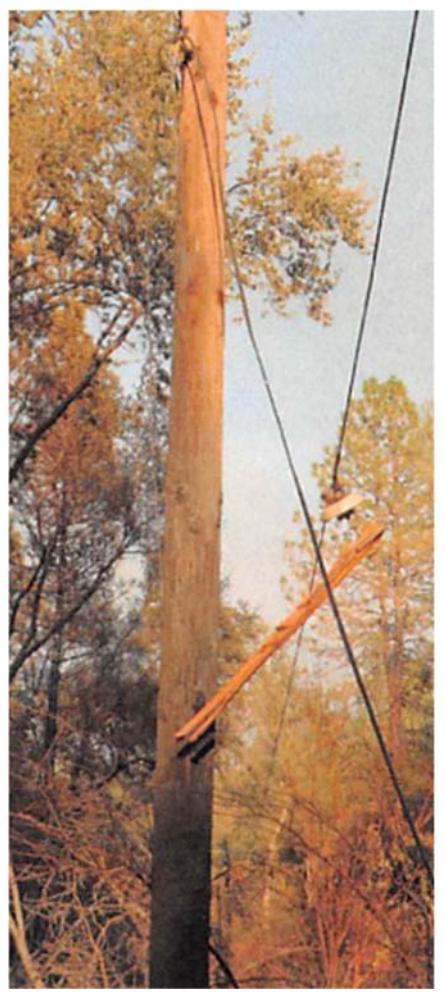
Figure 2: Subject Pole (Source: CAL FIRE)

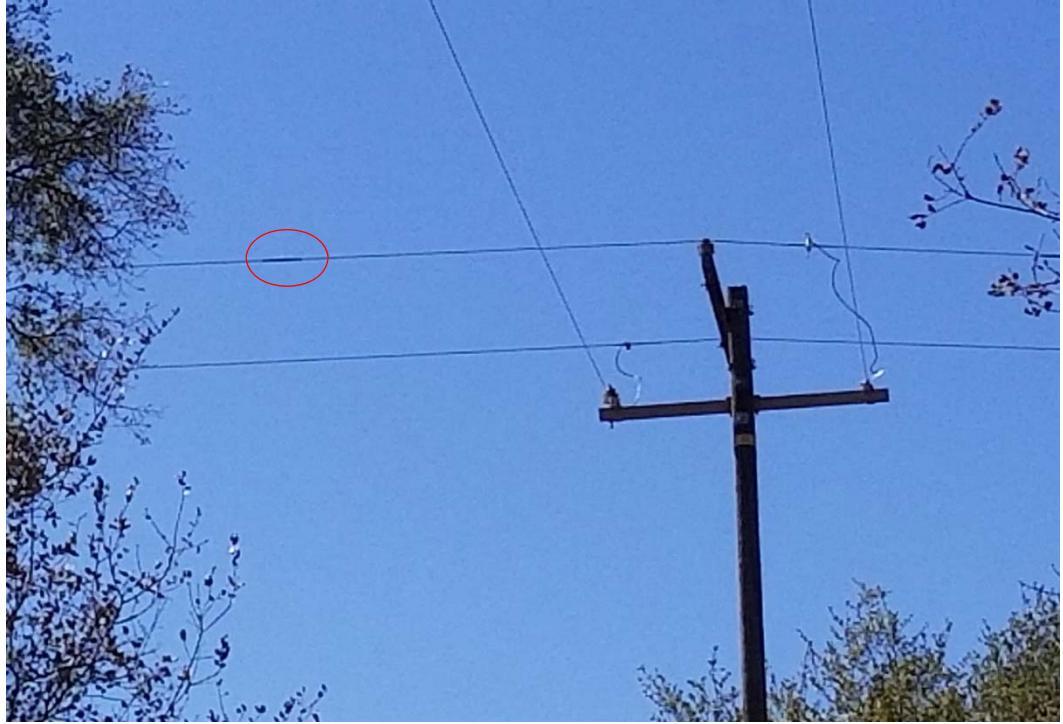
Figure 6: Splice Two

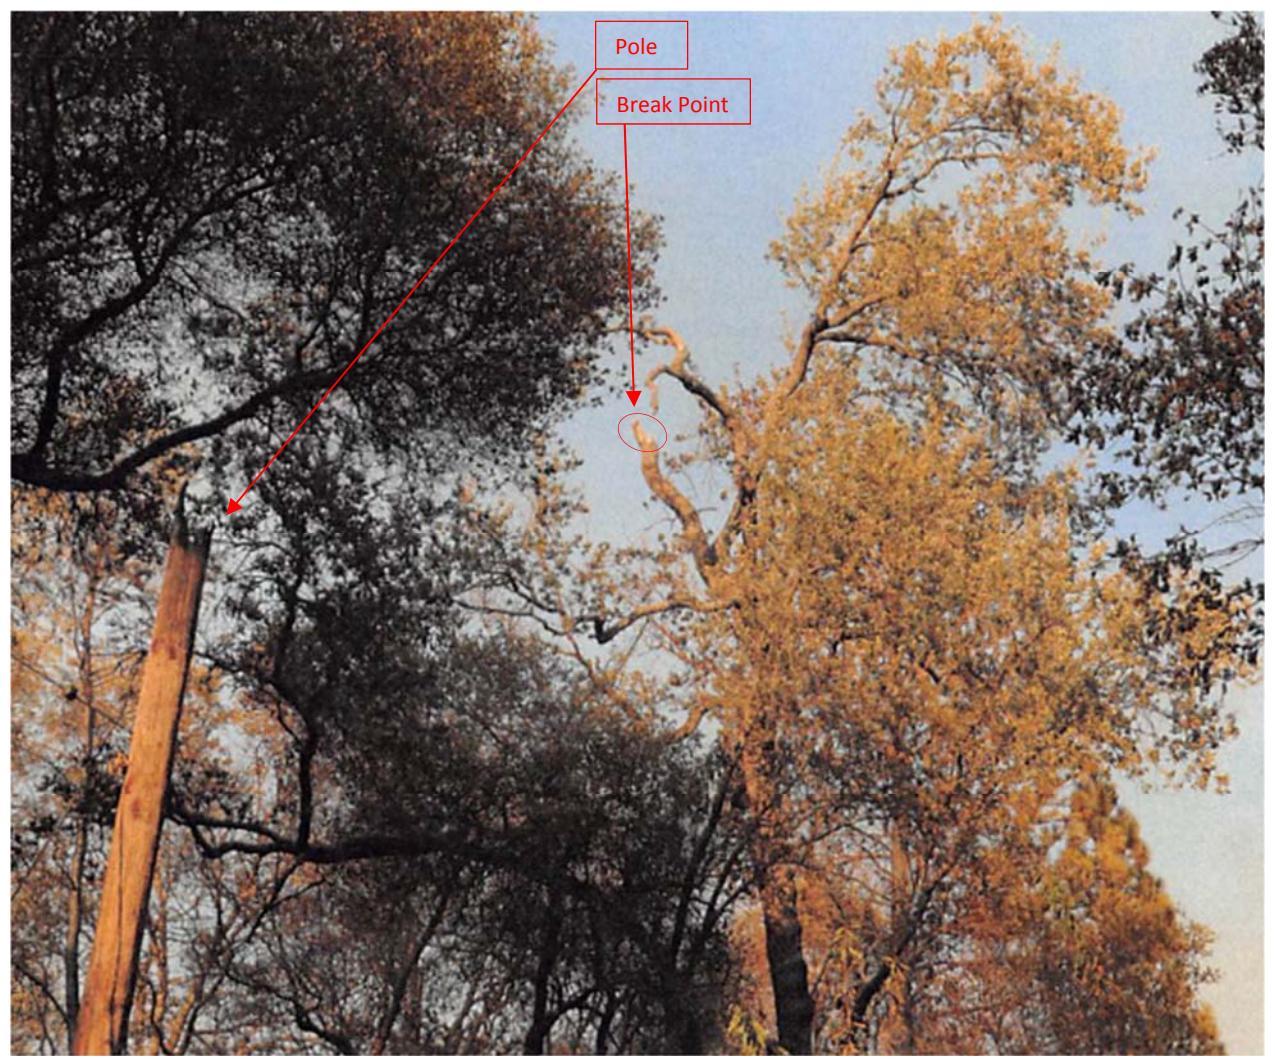
Figure 10: Subject Pole and Tree (Source: CAL FIRE)

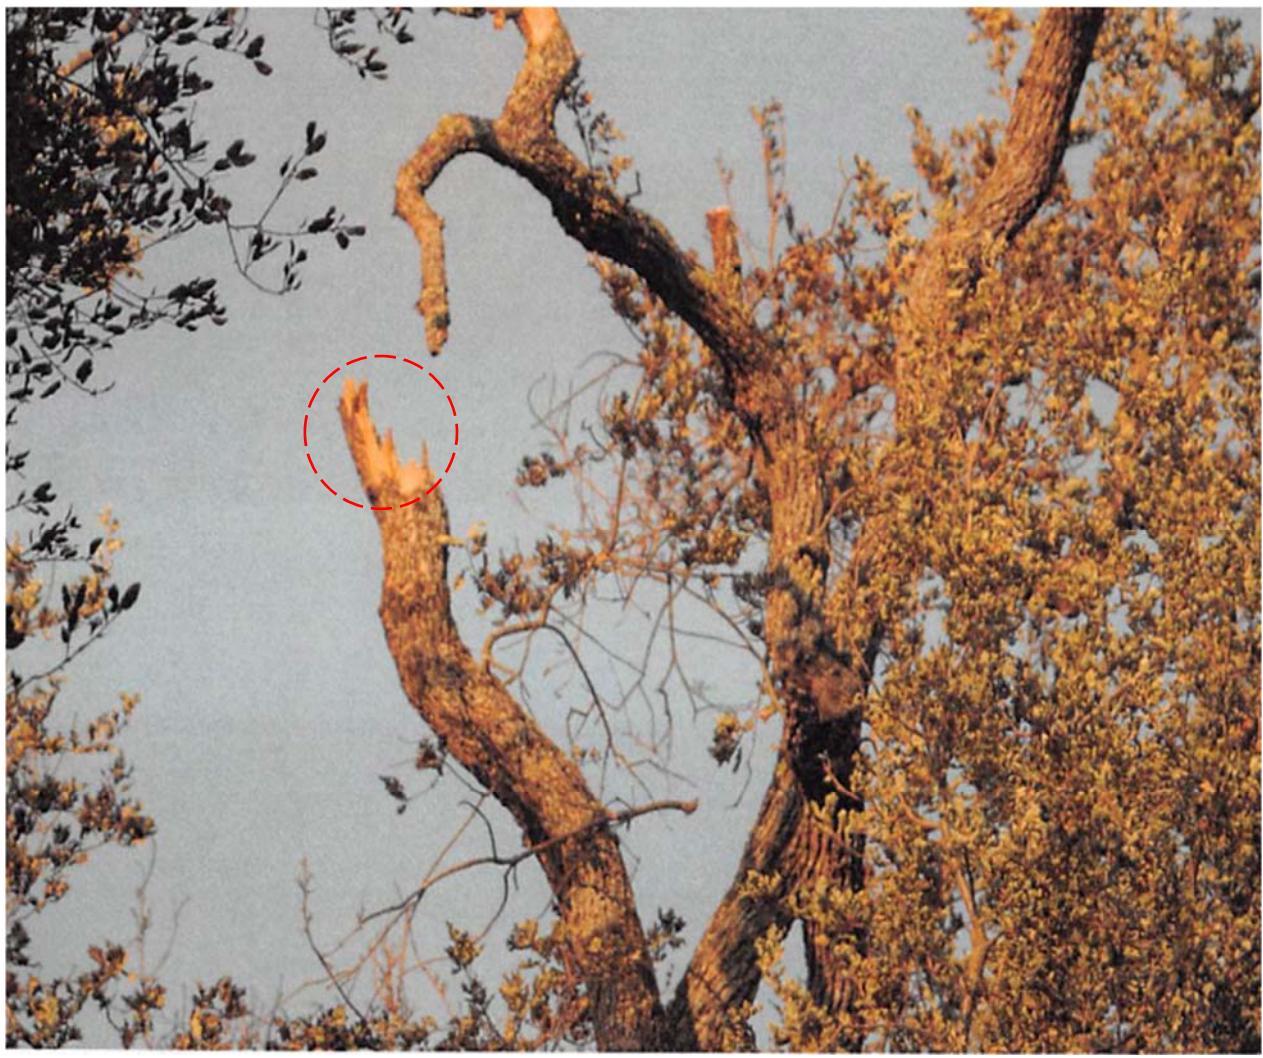
Figure 11: Enlarged View of Break Point (Source: CAL FIRE)

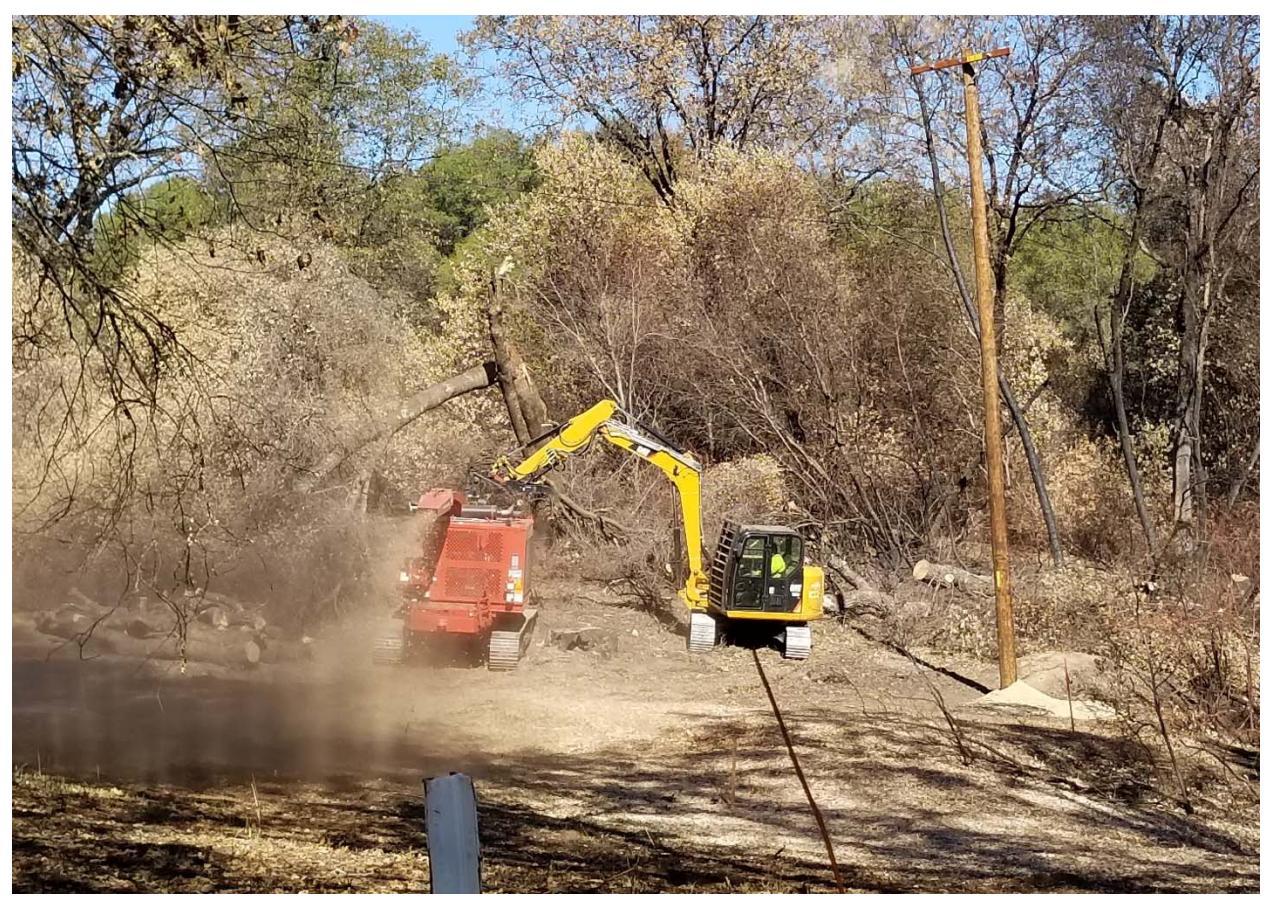
Figure 12: Mountain Enterprises Inc. conducting hazard tree mitigation

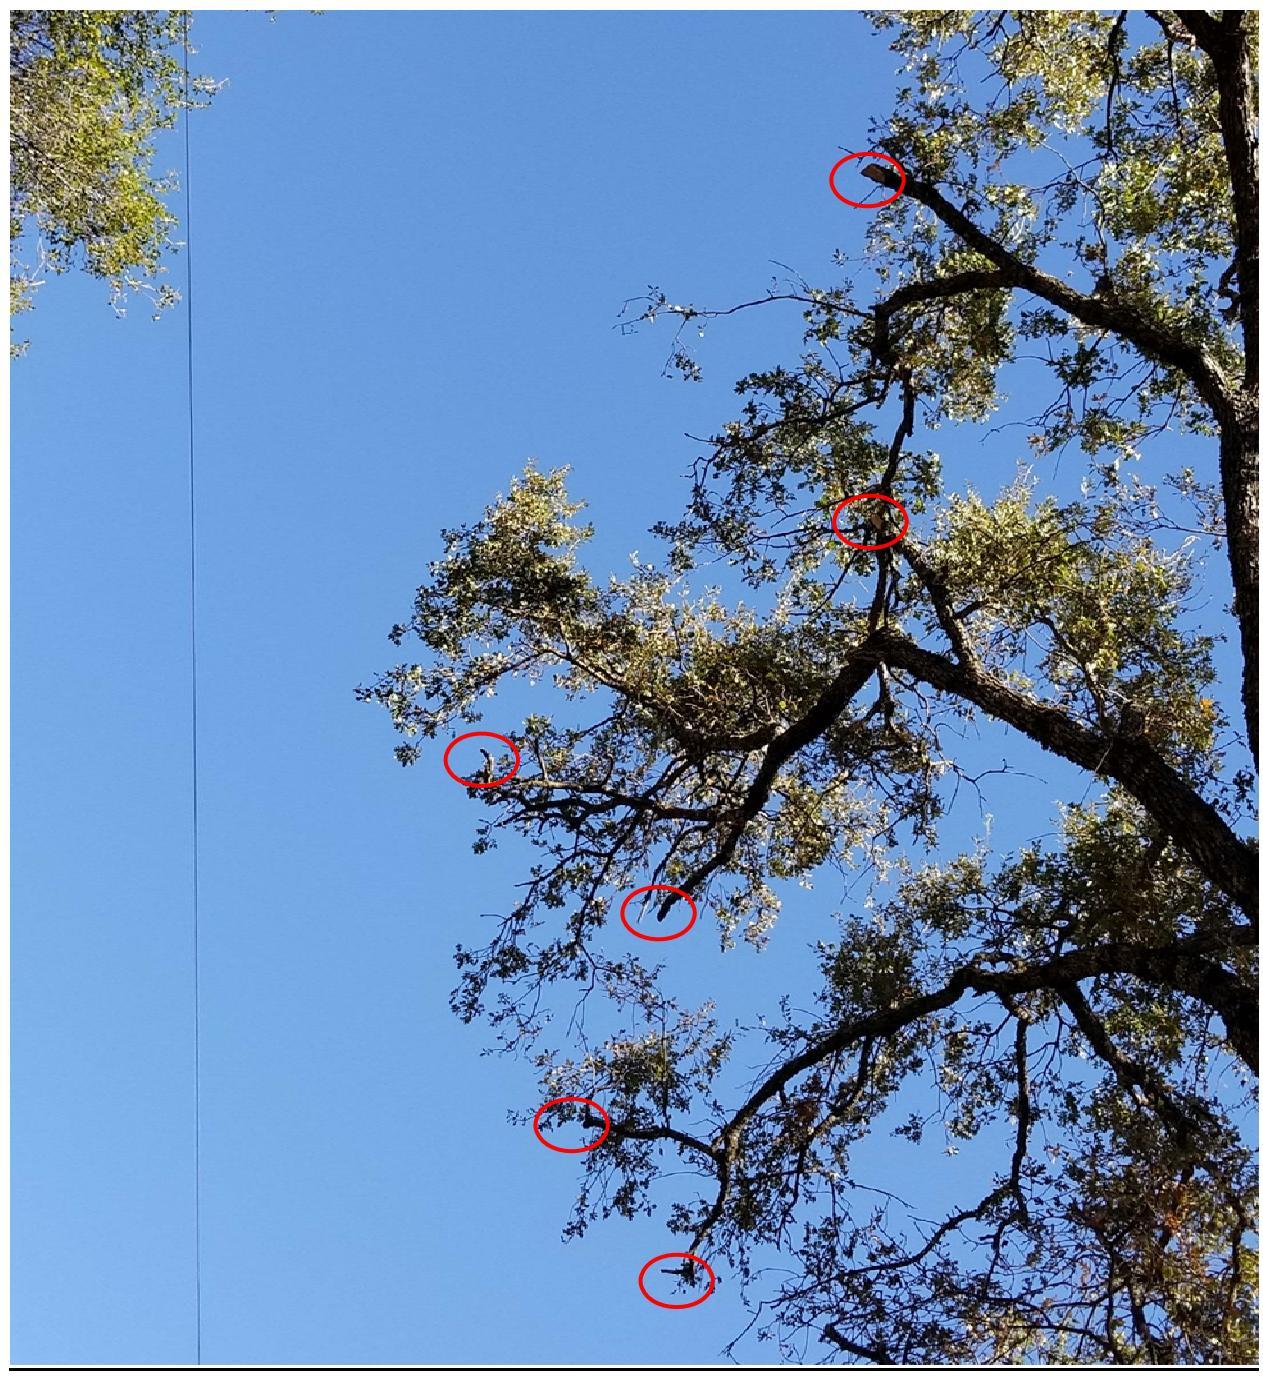
Figure 13: Clean cuts on tree branches near incident conductor span

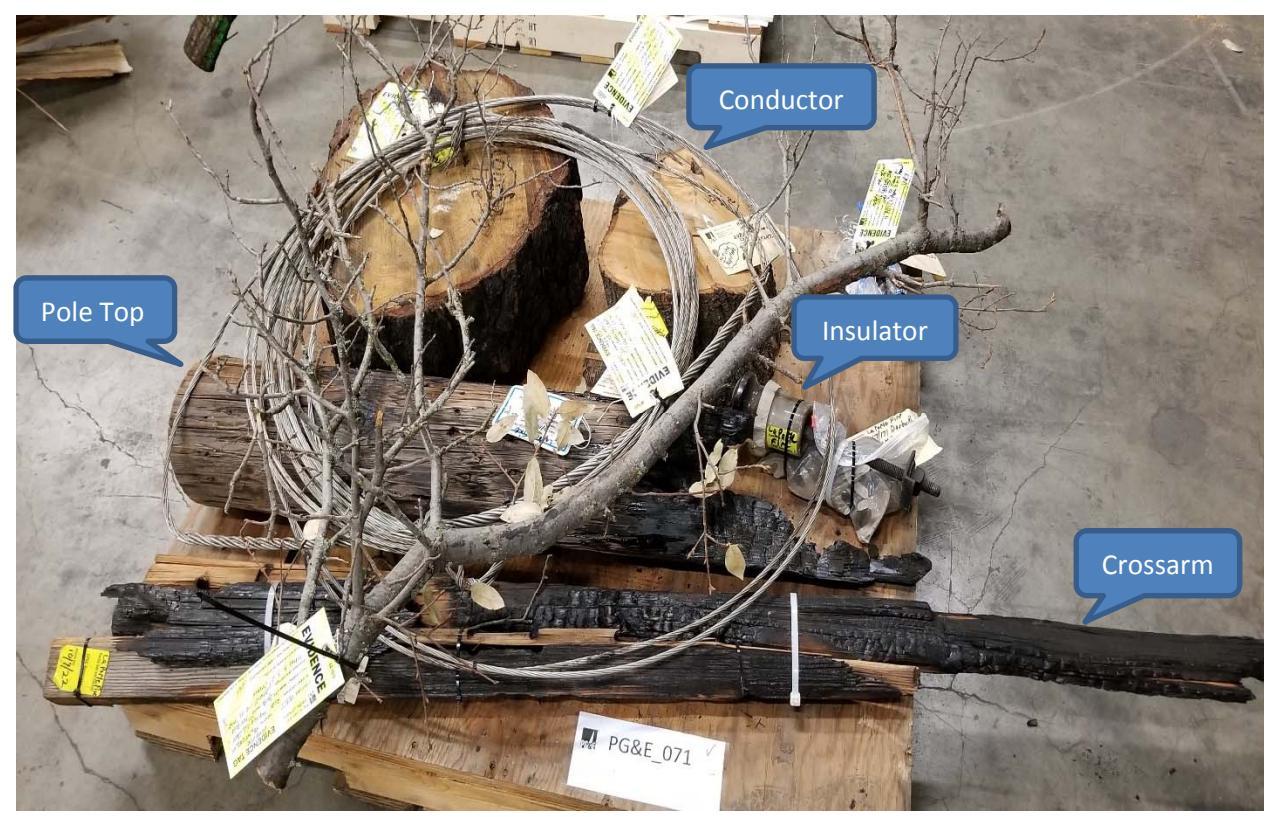
Figure 14: La Porte Evidence

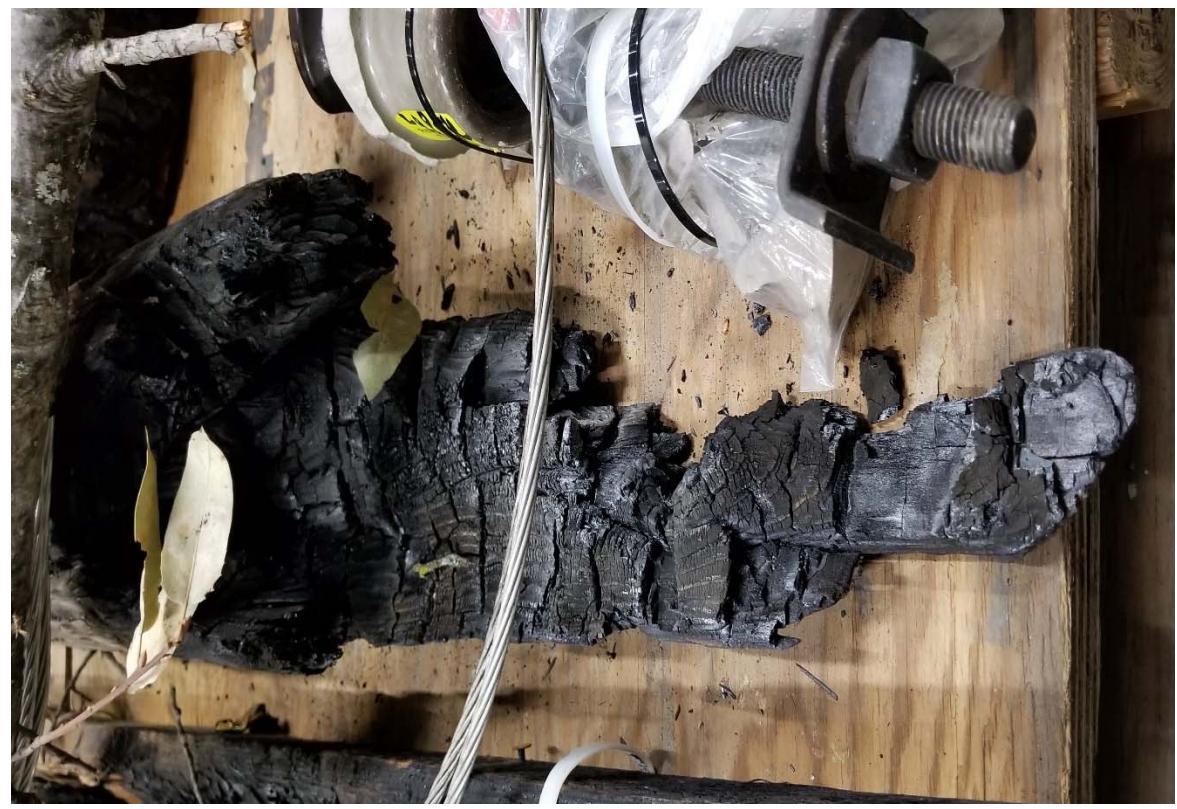
Figure 16: Top Portion of Burnt Pole Top

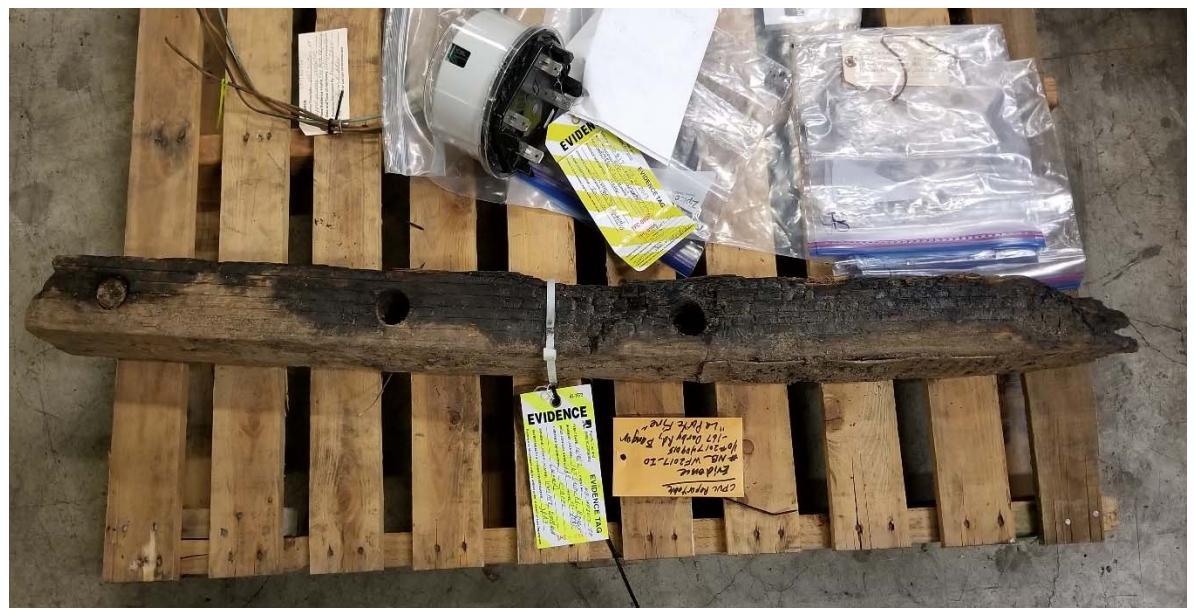
Figure 17: Partially Broken and Burnt Crossarm

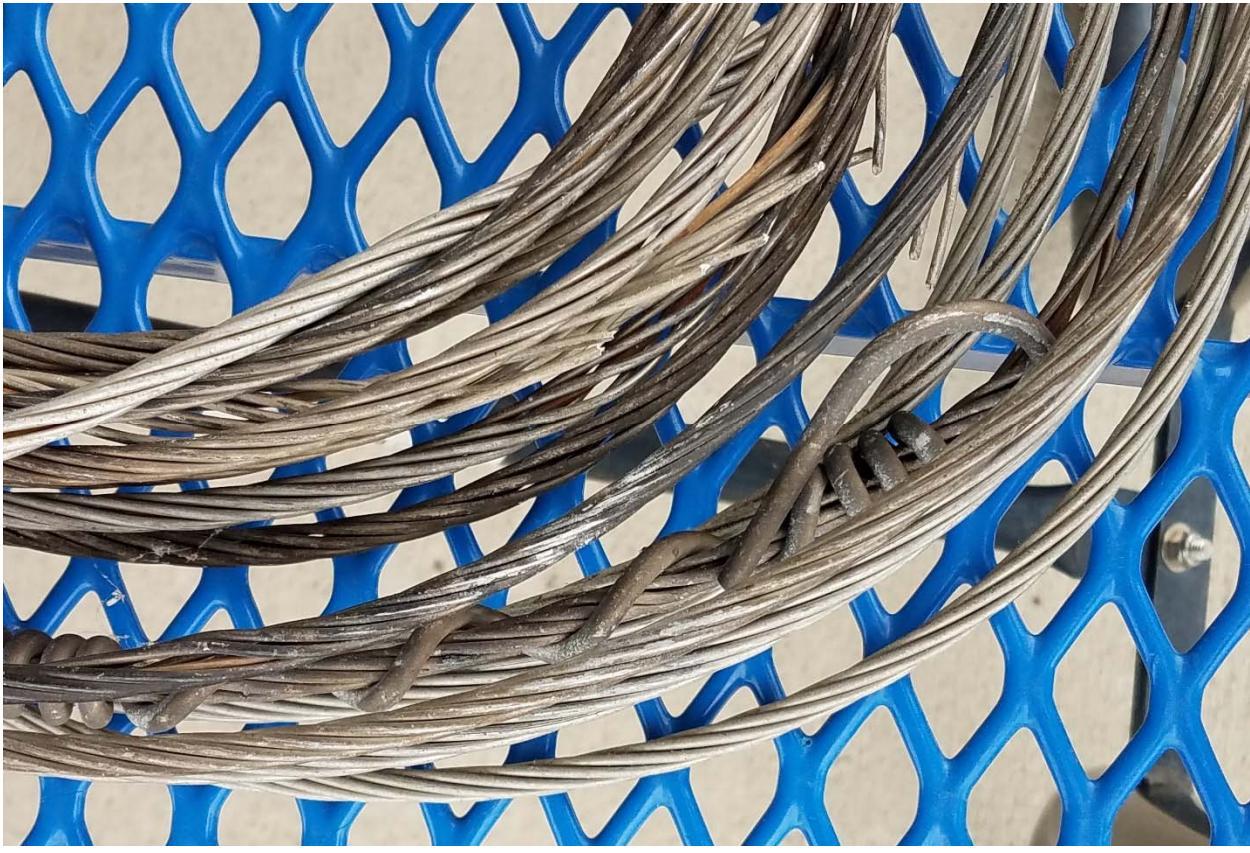
Figure 18: Burn Marks on Subject Conductor

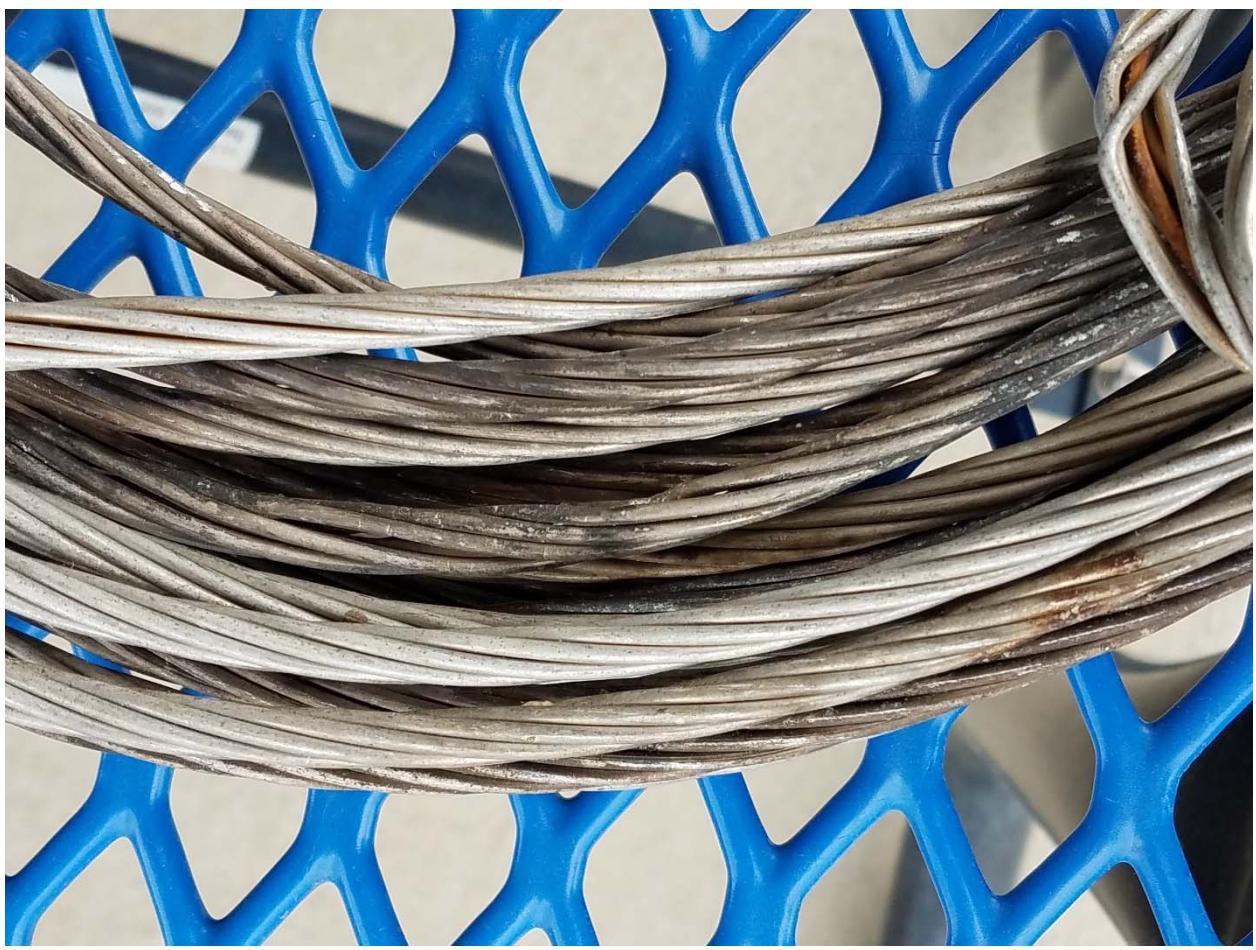
Figure 19: Burn Marks on Subject Conductor

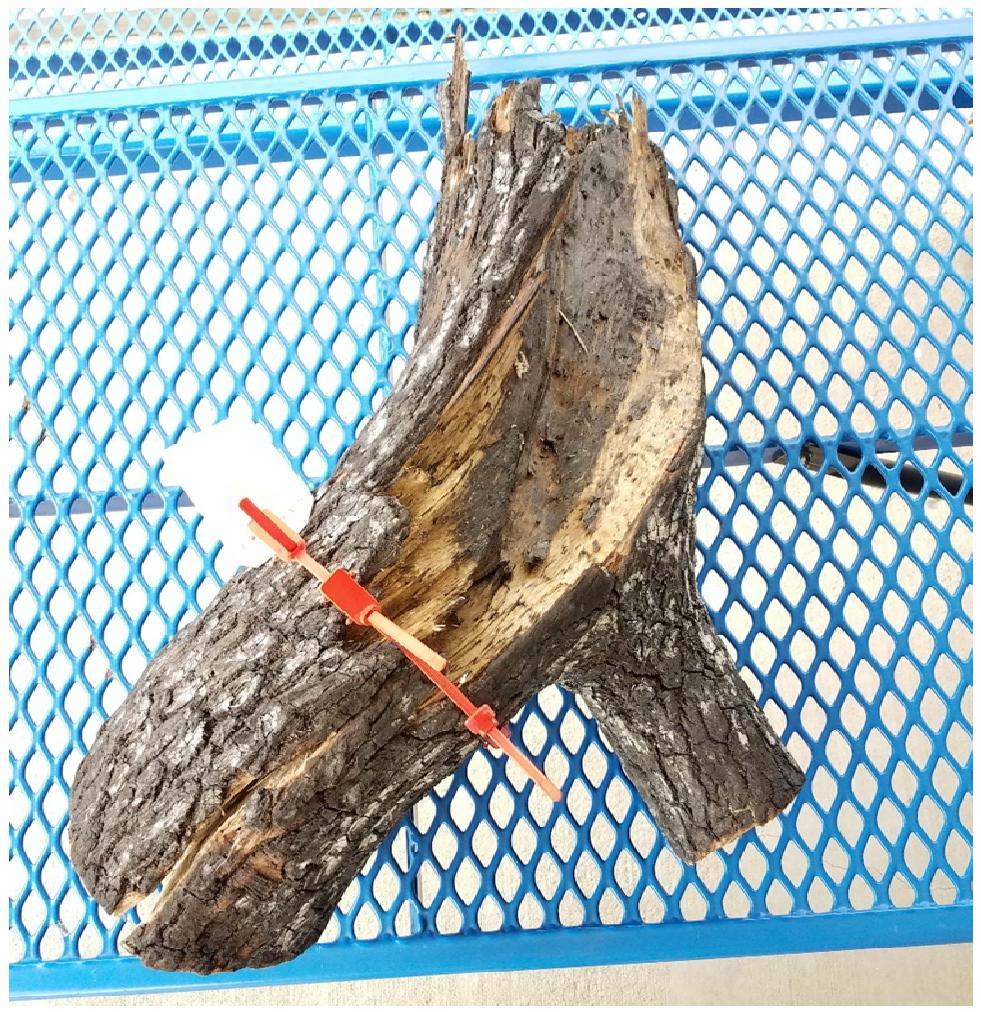
Figure 20: Subject Limb

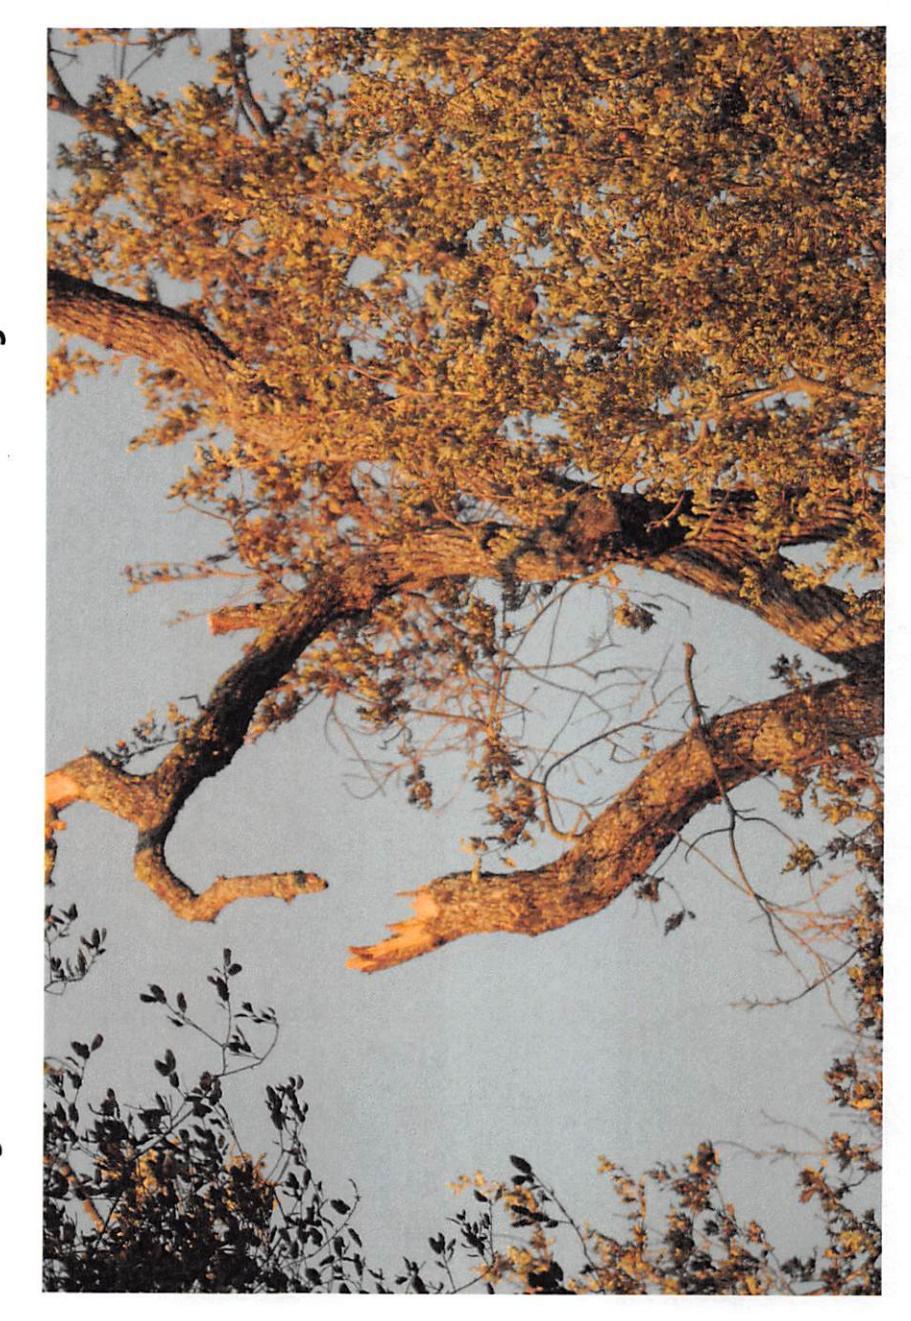
Photograph 6 Close up broken limb

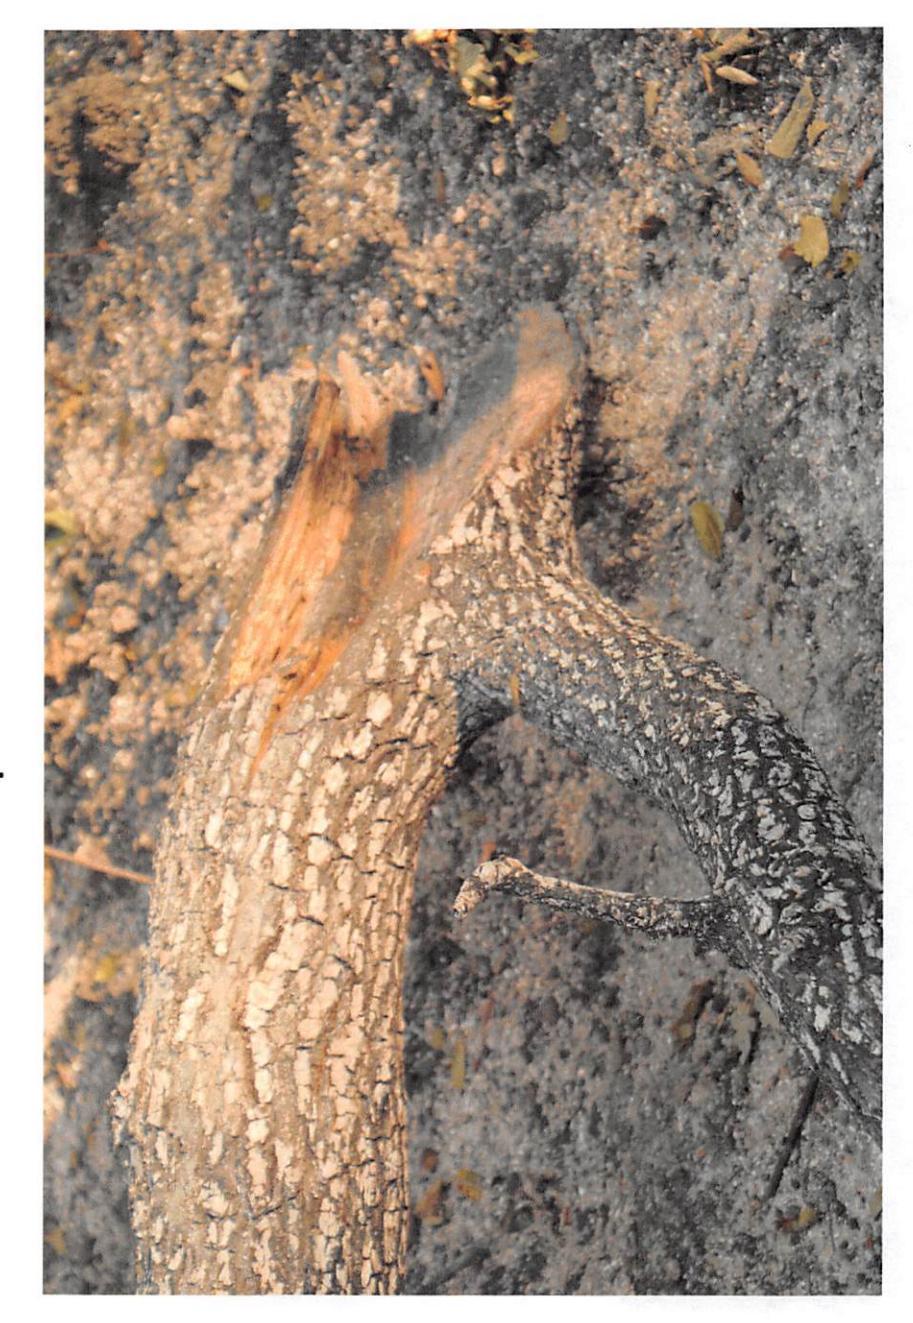
Photograph 7 Broken oak limb in GOA

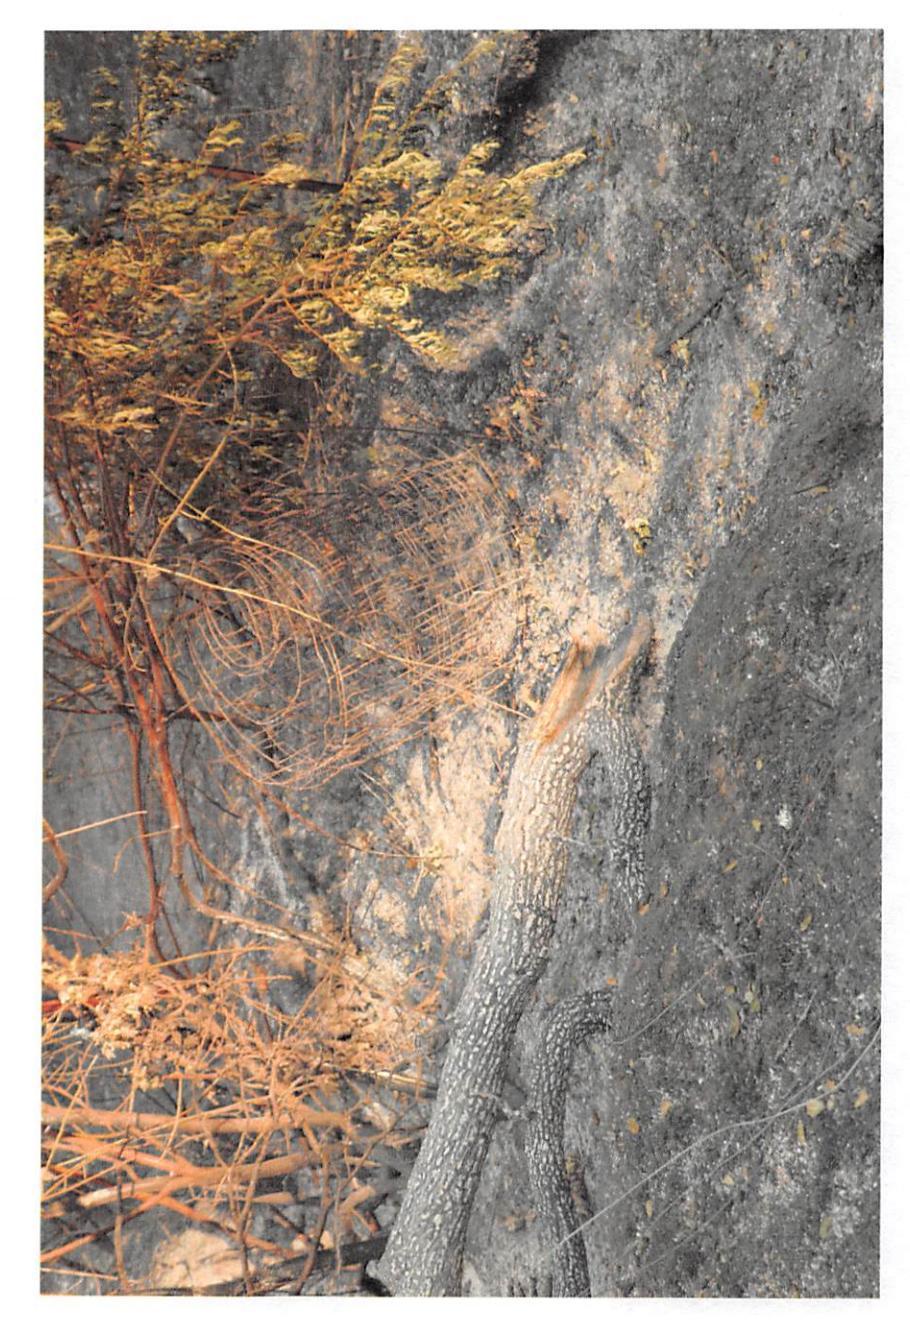
Photograph 8 close up view of broken cross arm

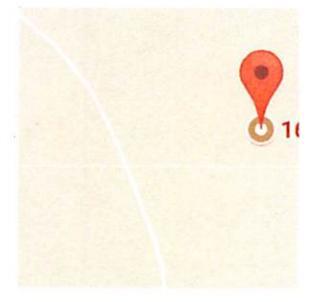
Image capture: Apr 2012 © 2018 Google

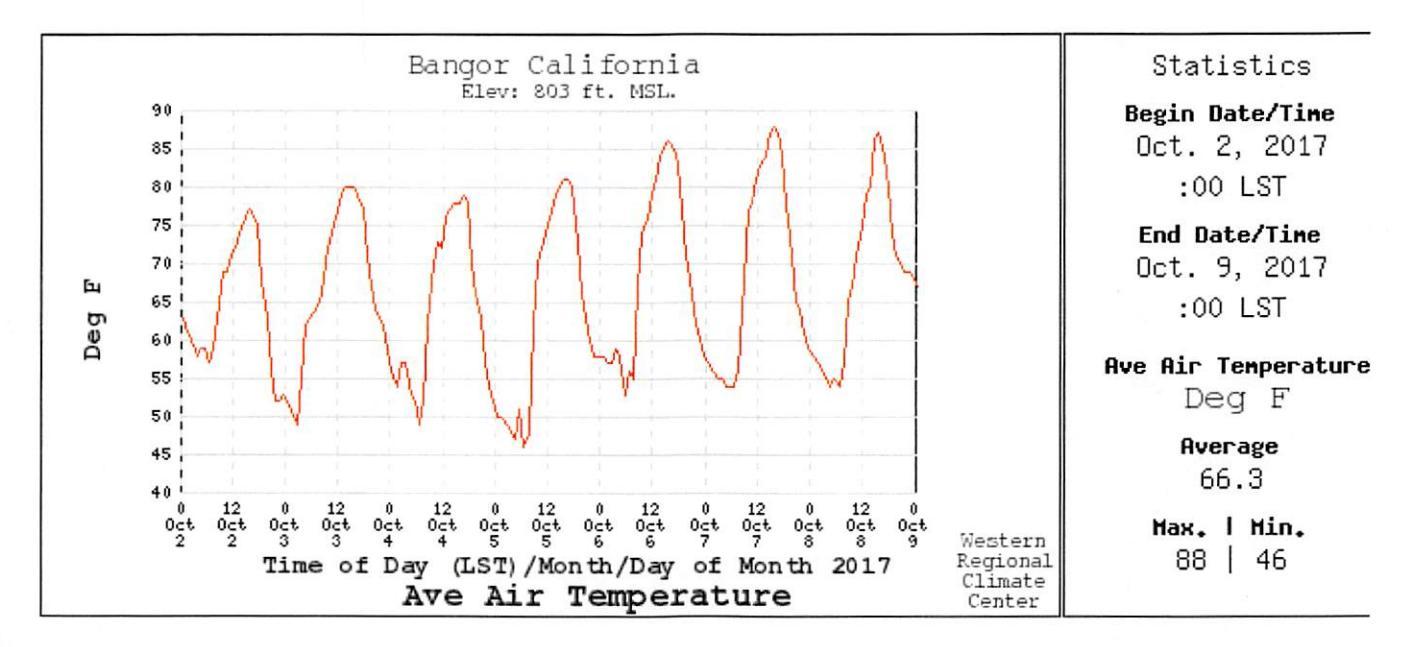
Ave Relative Humidity
