CALIFORNIA PUBLIC UTILITIES COMMISSION Safety and Enforcement Division Electric Safety and Reliability Branch

Incident Investigation Report

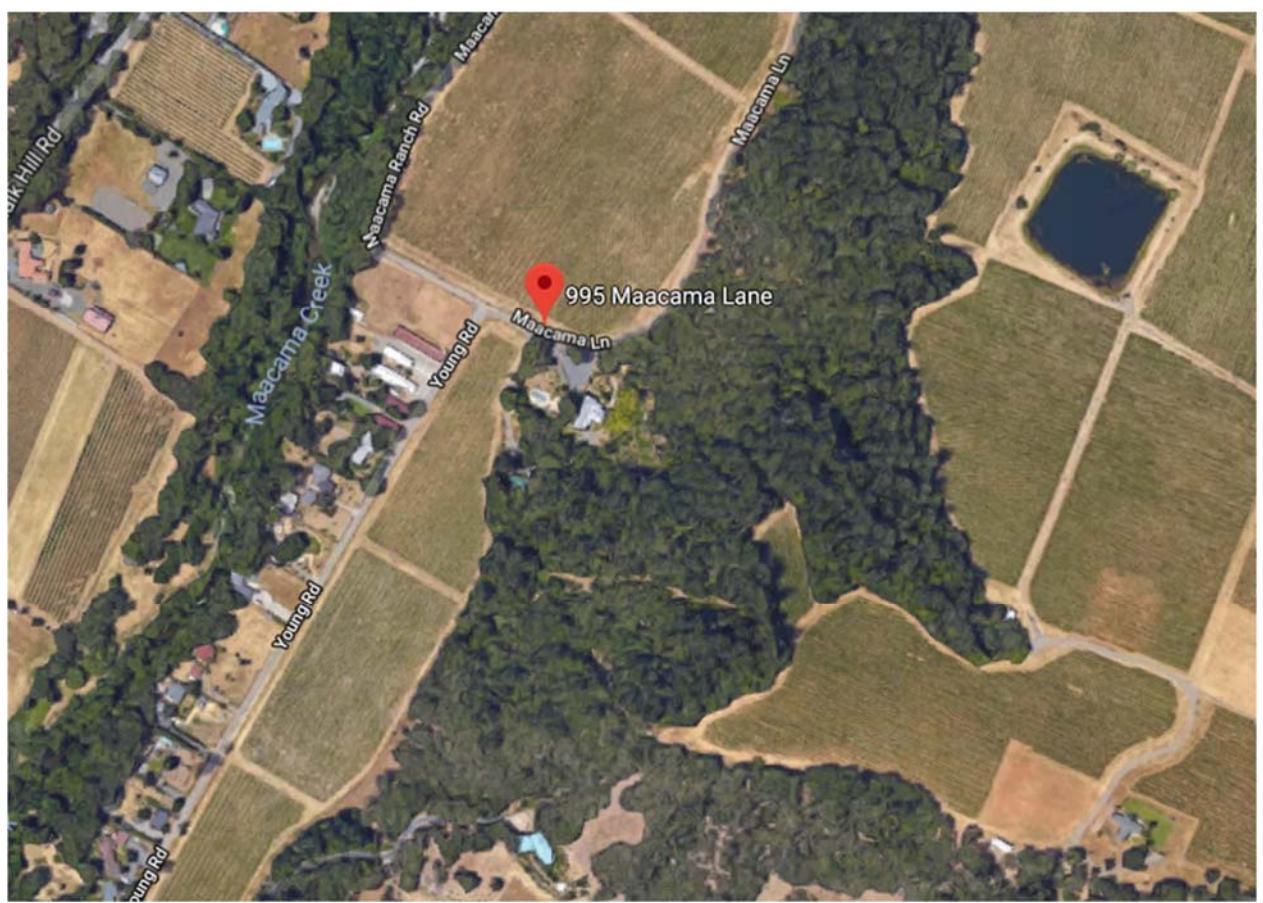
Figure 1: Incident Location (Source: Google Maps)

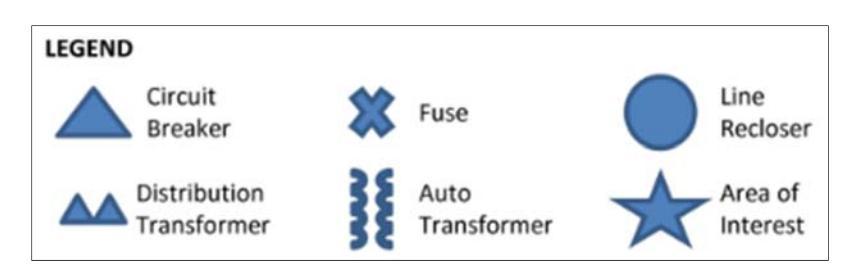
Figure 3: Legend for the single-line diagram. (Source: PG&E)

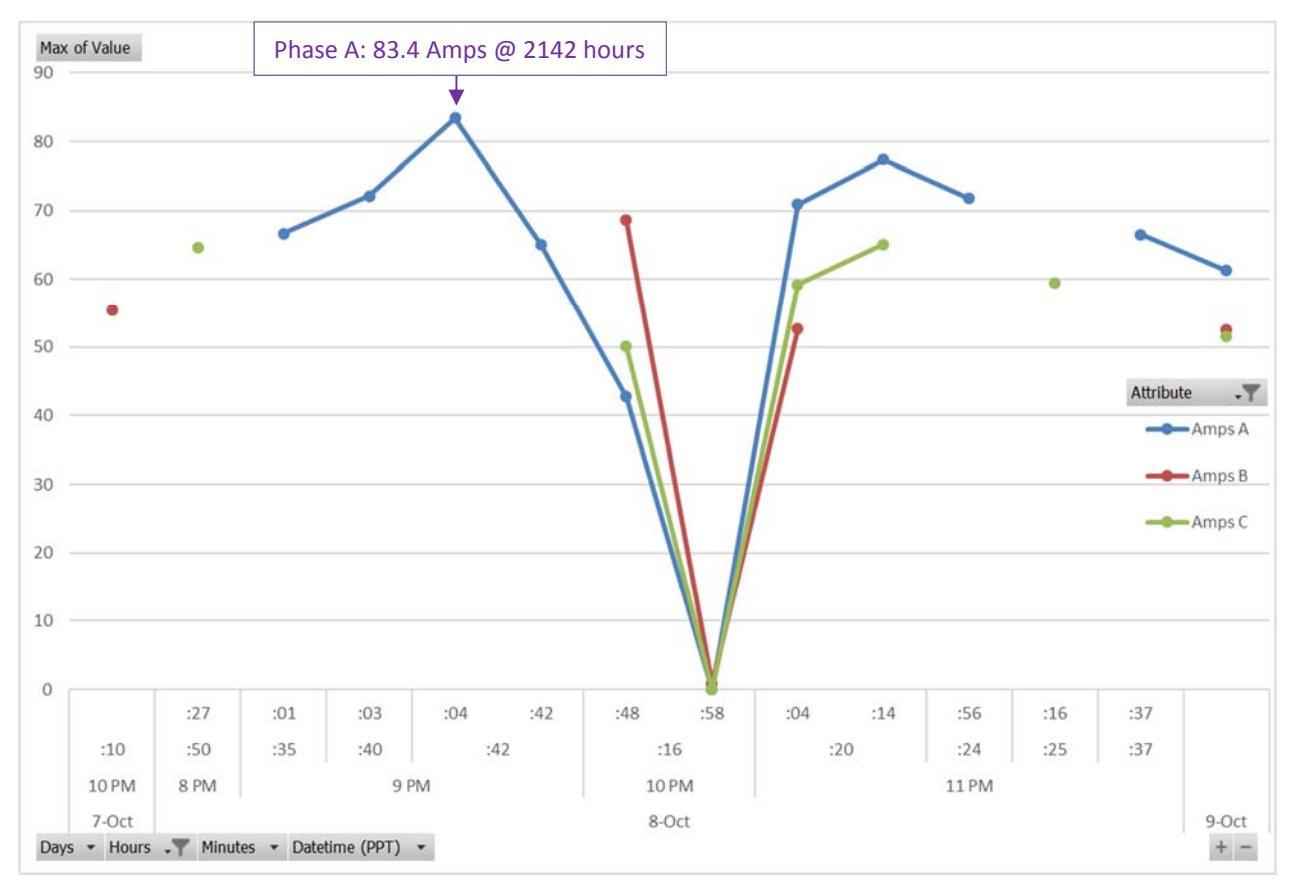
Figure 4: SCADA plot of the load data recorded at LR 4522 on October 8, 2017 from 2000 to 2400 hours.
