**CALIFORNIA PUBLIC UTILITIES COMMISSION**  
**Safety and Enforcement Division**  
**Electric Safety and Reliability Branch**

**Incident Investigation Report**

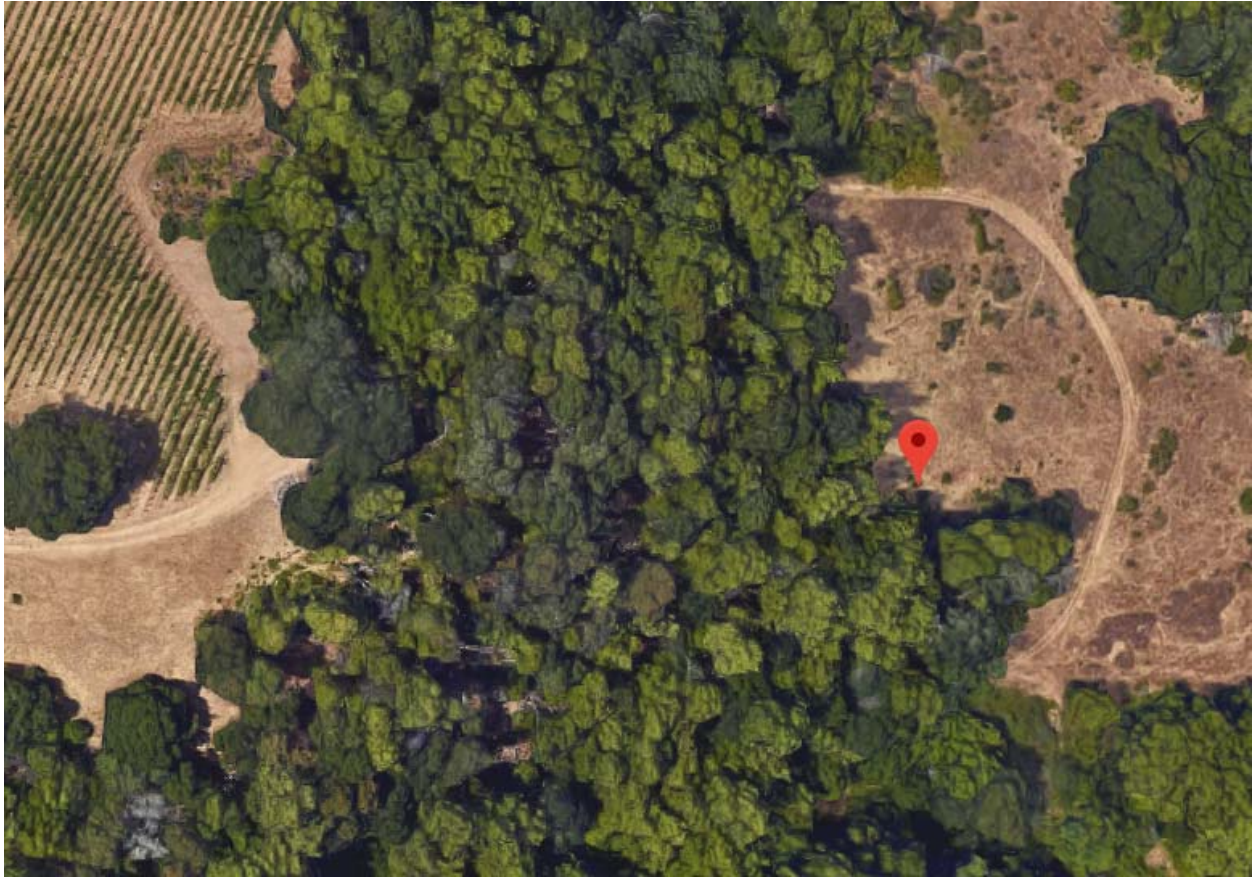
**Figure 1:** Approximate ignition point/location of the fire via Google Maps (GPS Location: 38.310548, -122.370661).

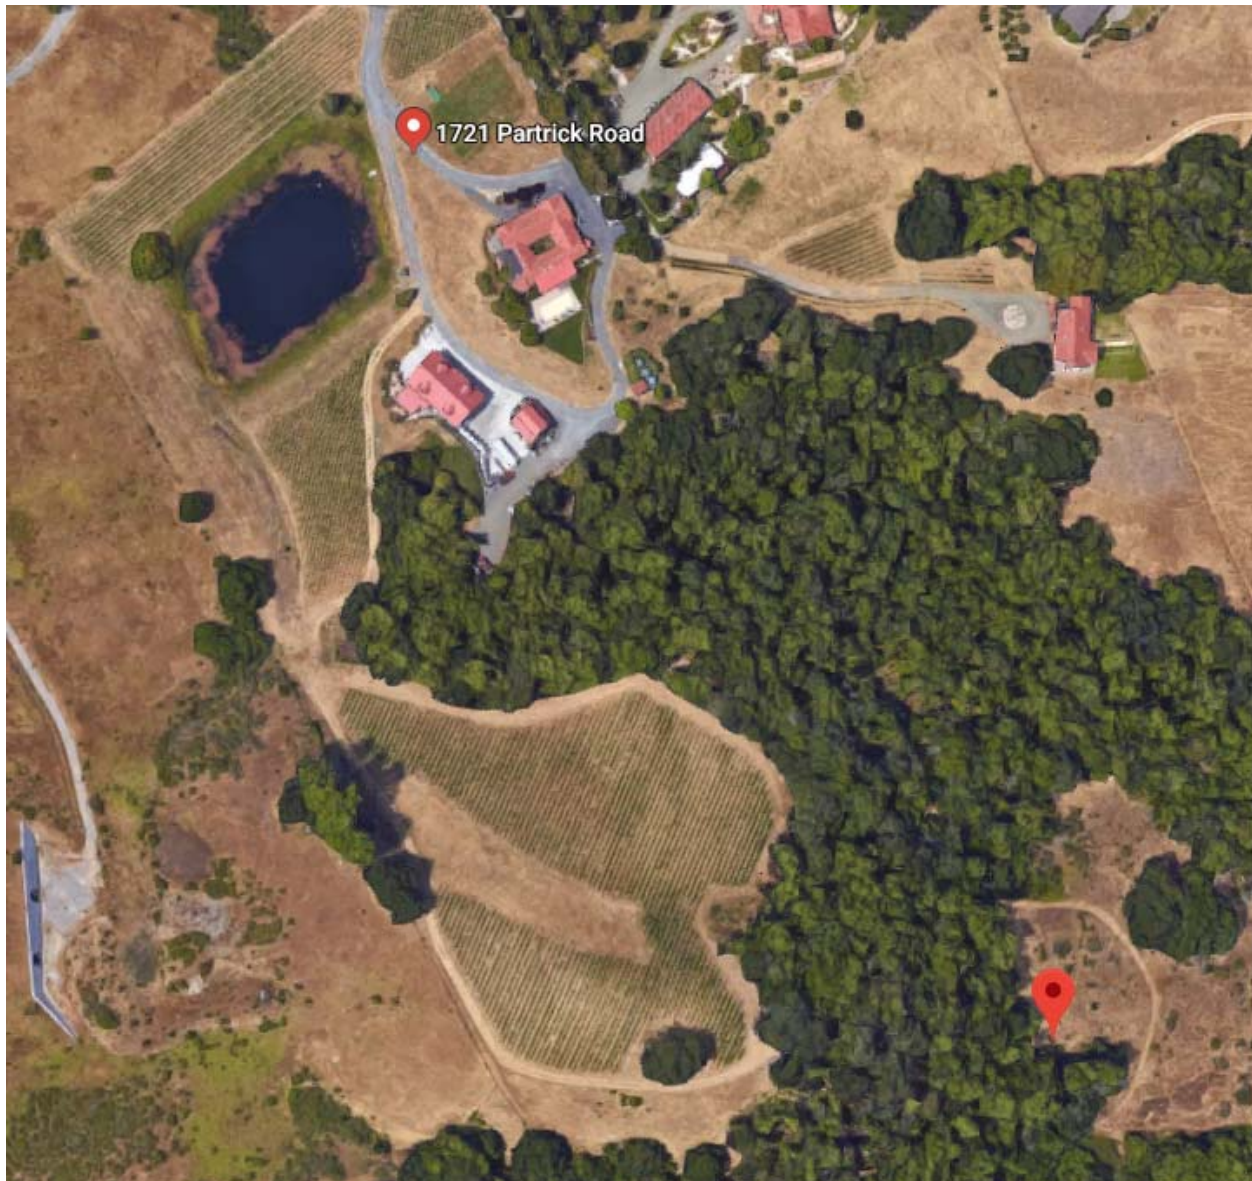
**Figure 2:** Location relative to 1721 Partrick Road, via Google Maps.

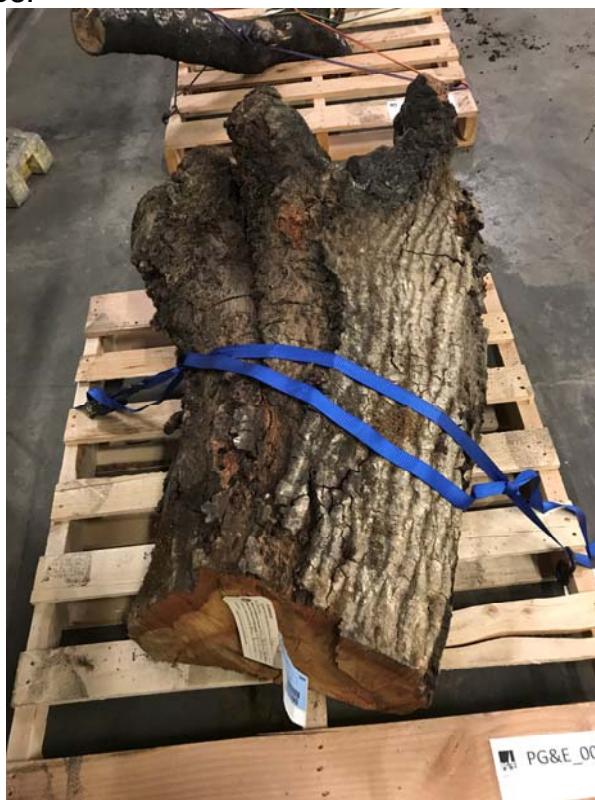
**Figure 6:** Portion of the incident tree PG&E took in possession on November 8, 2017.

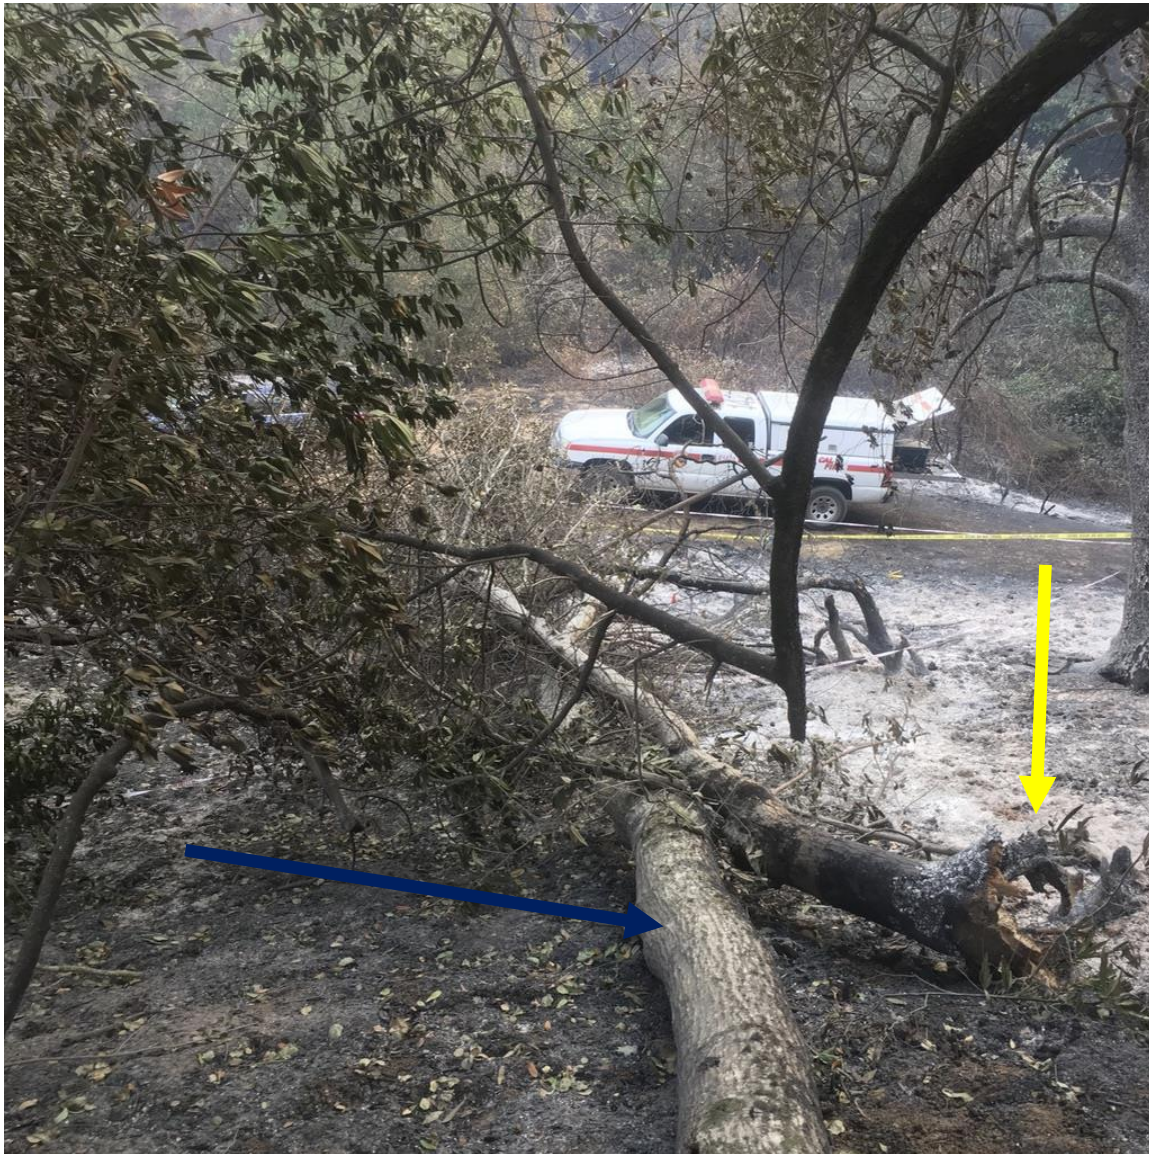
- Failure site and subject tree (blue arrow)
- The yellow arrow points to another oak tree with decayed heartwood (hollow) downslope seen in Photo 3.

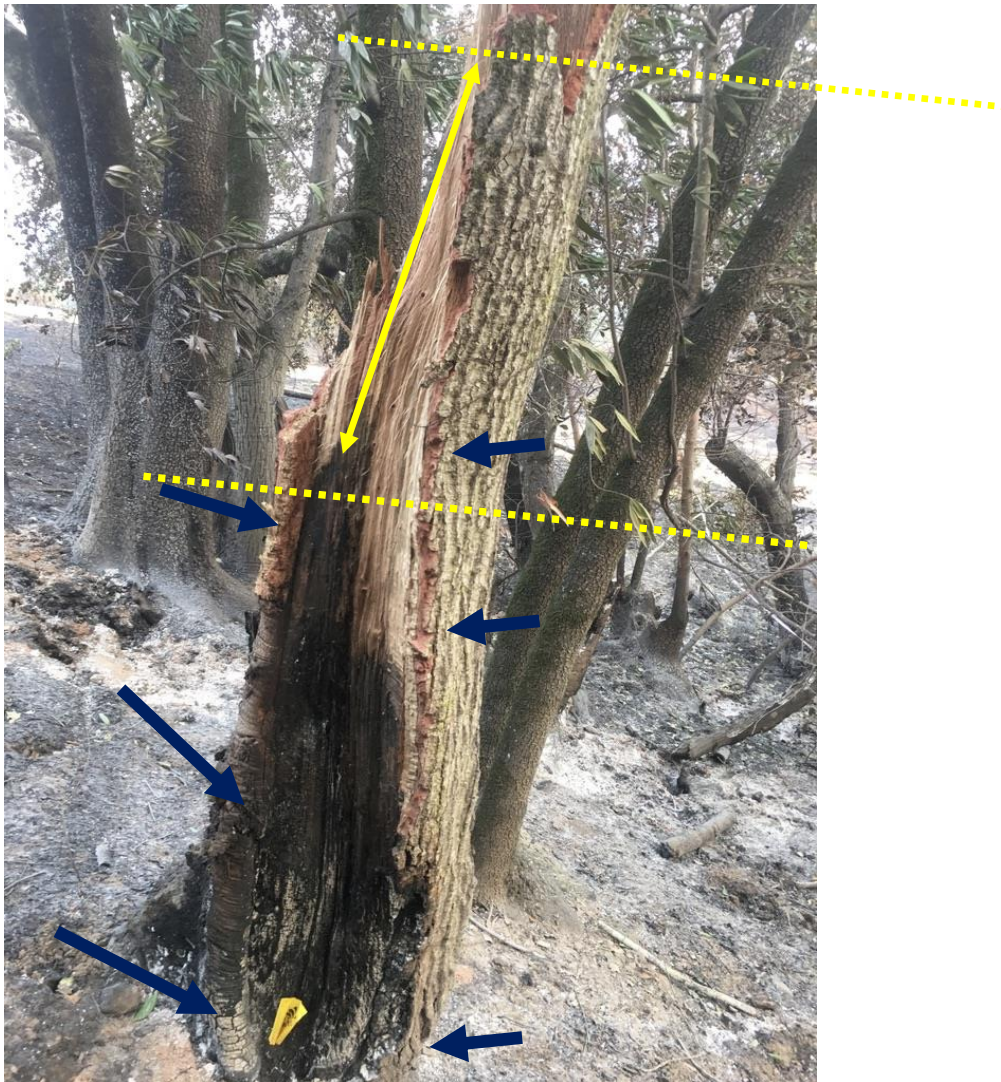
- Existing wound and margins of wound wood (blue arrows). The wood resisted fracture in this area.
- The oak tree was wounded several years ago. Note surrounding trees with superior wood quality remain un-fractured.
- The broken trunk lying next to the blue arrow is visible in Photos 1, 8, & 9 (top of the fractured trunk left standing).
- A significant point of weakness from bending stress. The wood fibers tore entirely to failure in this general area along the trunk (between yellow dotted line).
- See Photo 8 for broken trunk and canopy part and Photo 9 for the direction of fall.

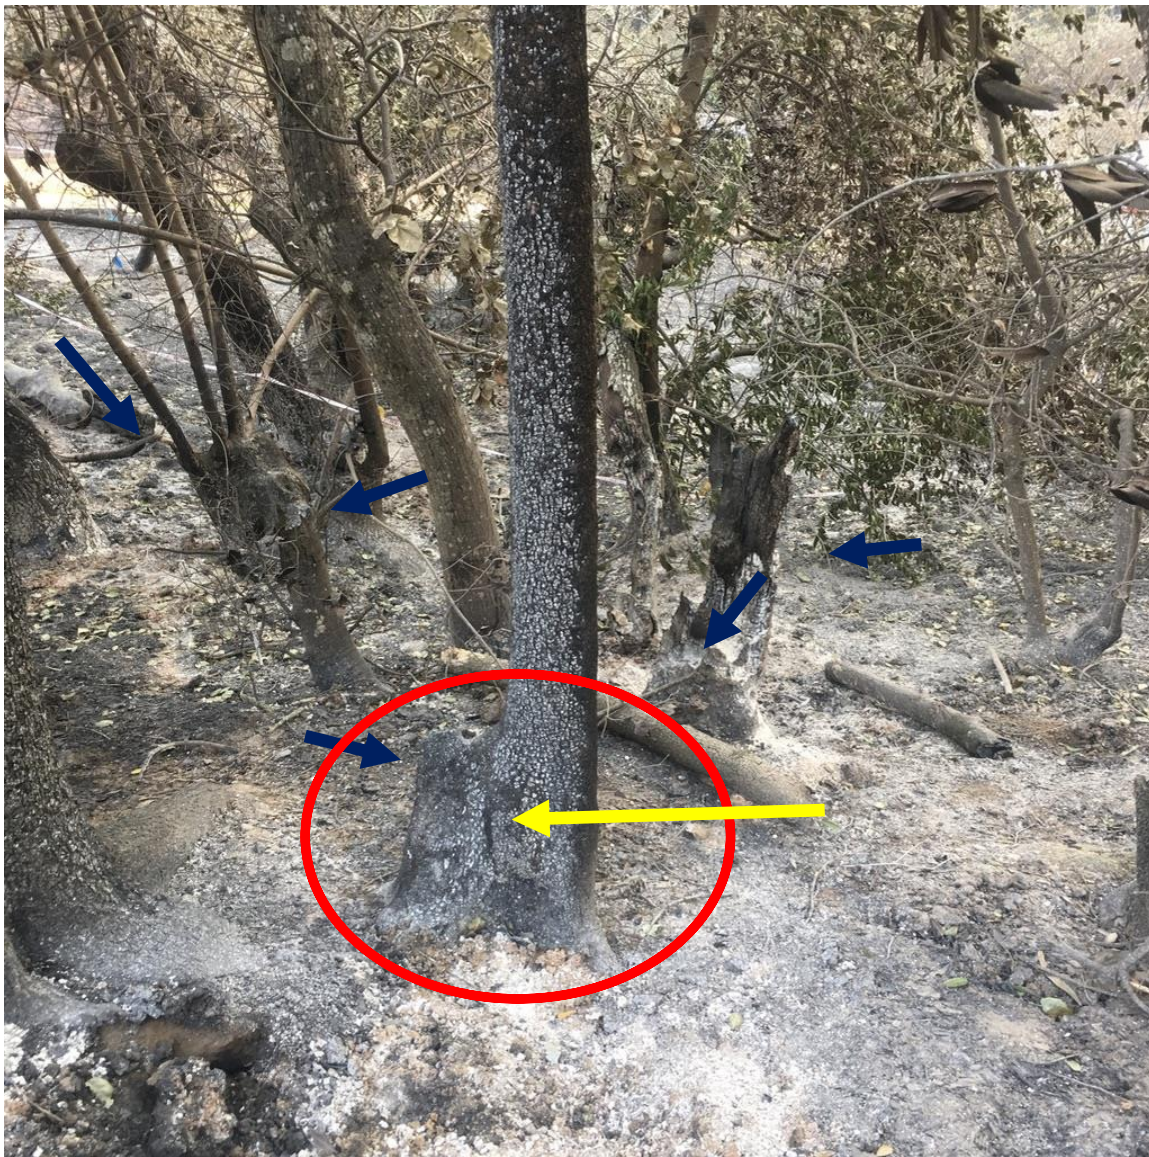
- The union between the two stems is defective and weak with a vertical bark inclusion (yellow arrow).
- The pre-existing decay (failed hollow stem on the left solid trunk).
- The decayed trunk was a greater factor of weakness during the failure event.

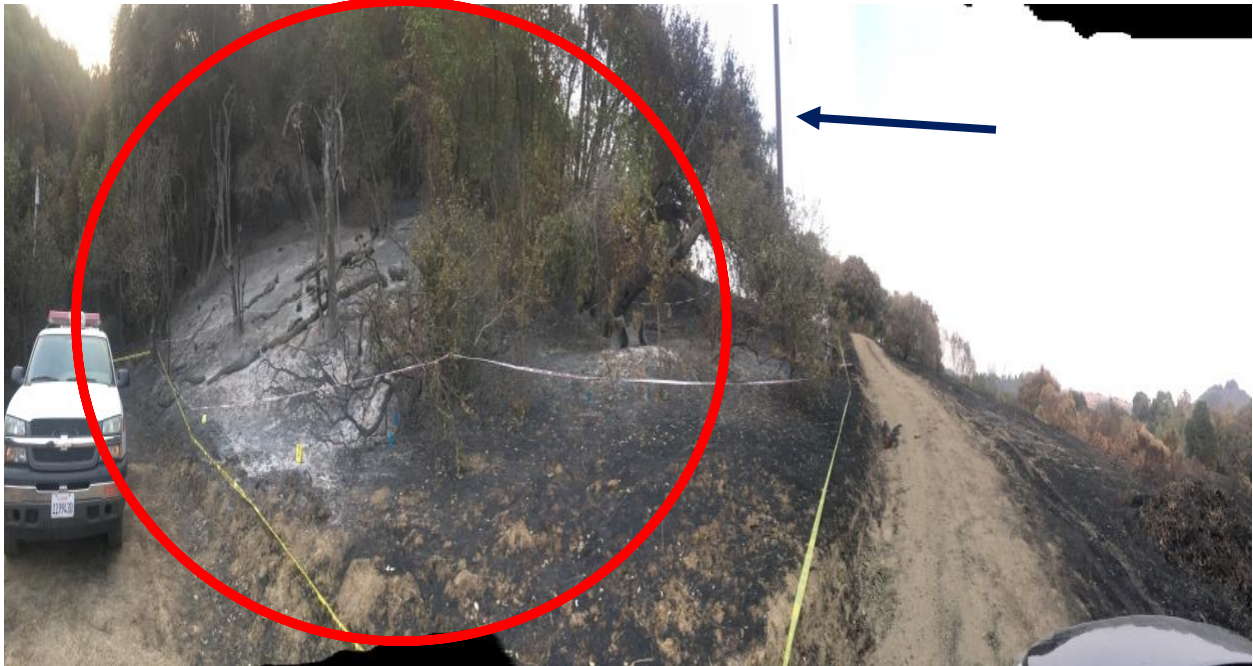
- Area of tree failure (red circle)
- Power pole (blue arrow)

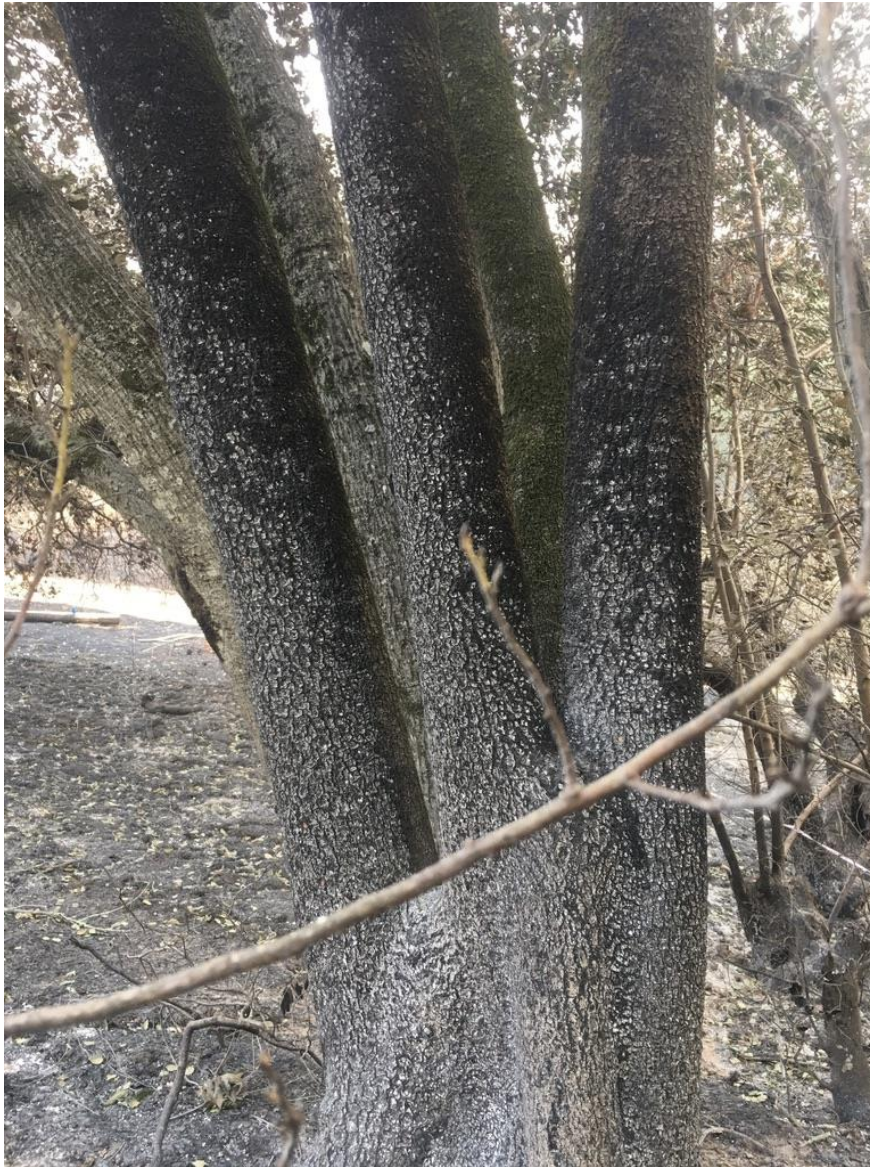
- Neighboring oak trees sound and solid with no visible decay and no evidence of failure.
- Even with the multiple leaders arising at one point.
- Comparing to surrounding trees with decay, the trees with sound wood withstood the wind load much better.
- Pre-existing conditions such as decay was a factor leading to failure at this site.

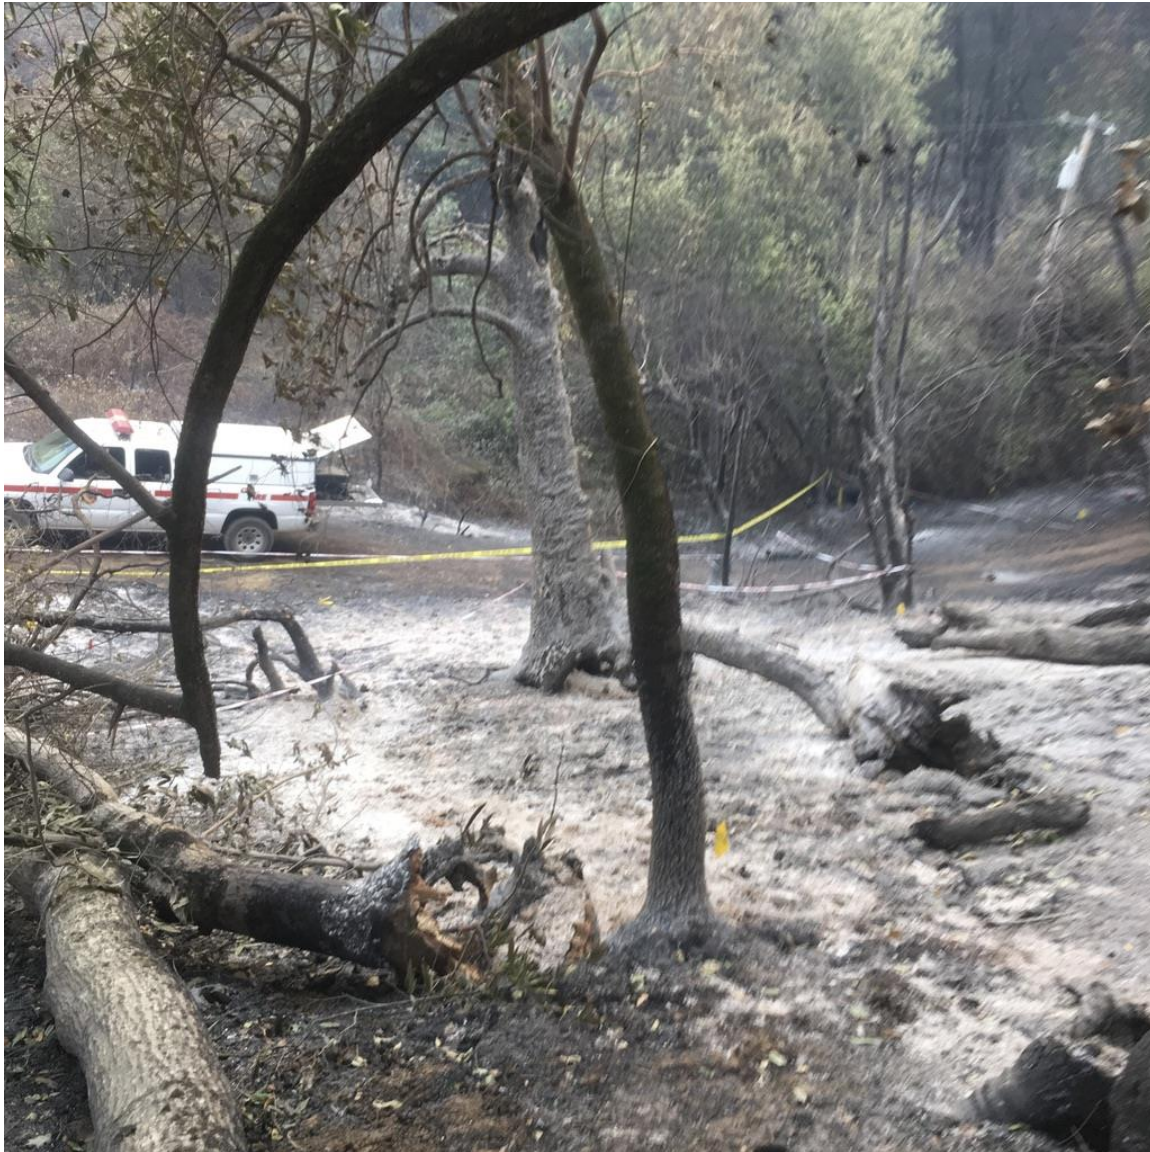
- Decay, defects, and tree failures

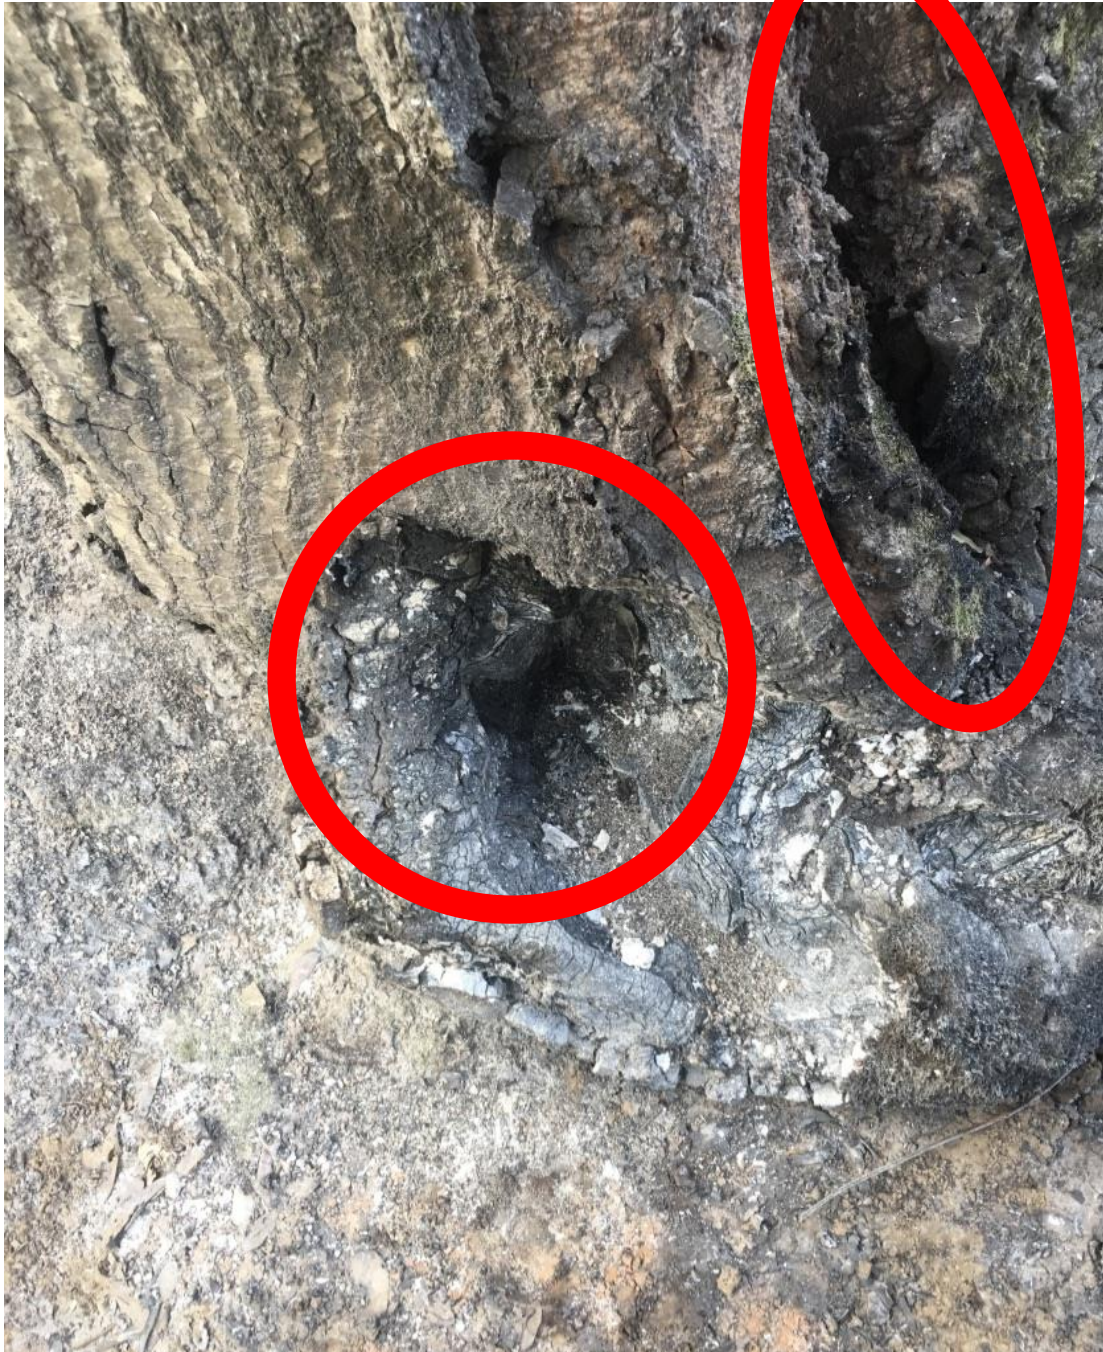
- Subject tree. Open cavities on north side of trunk

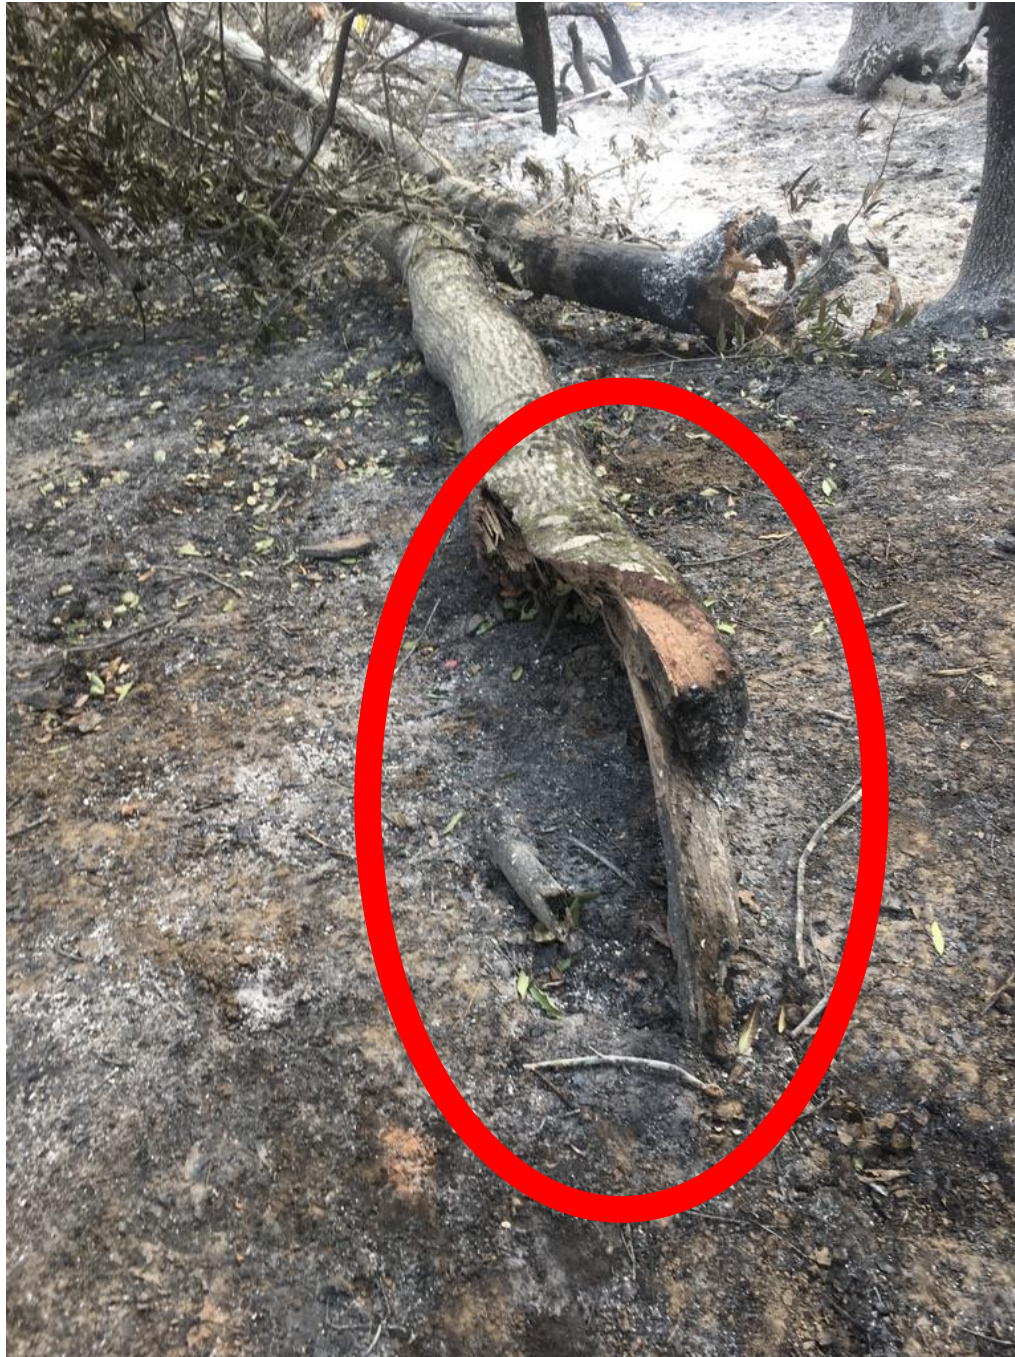
- Subject tree failure once connected to Photo 2

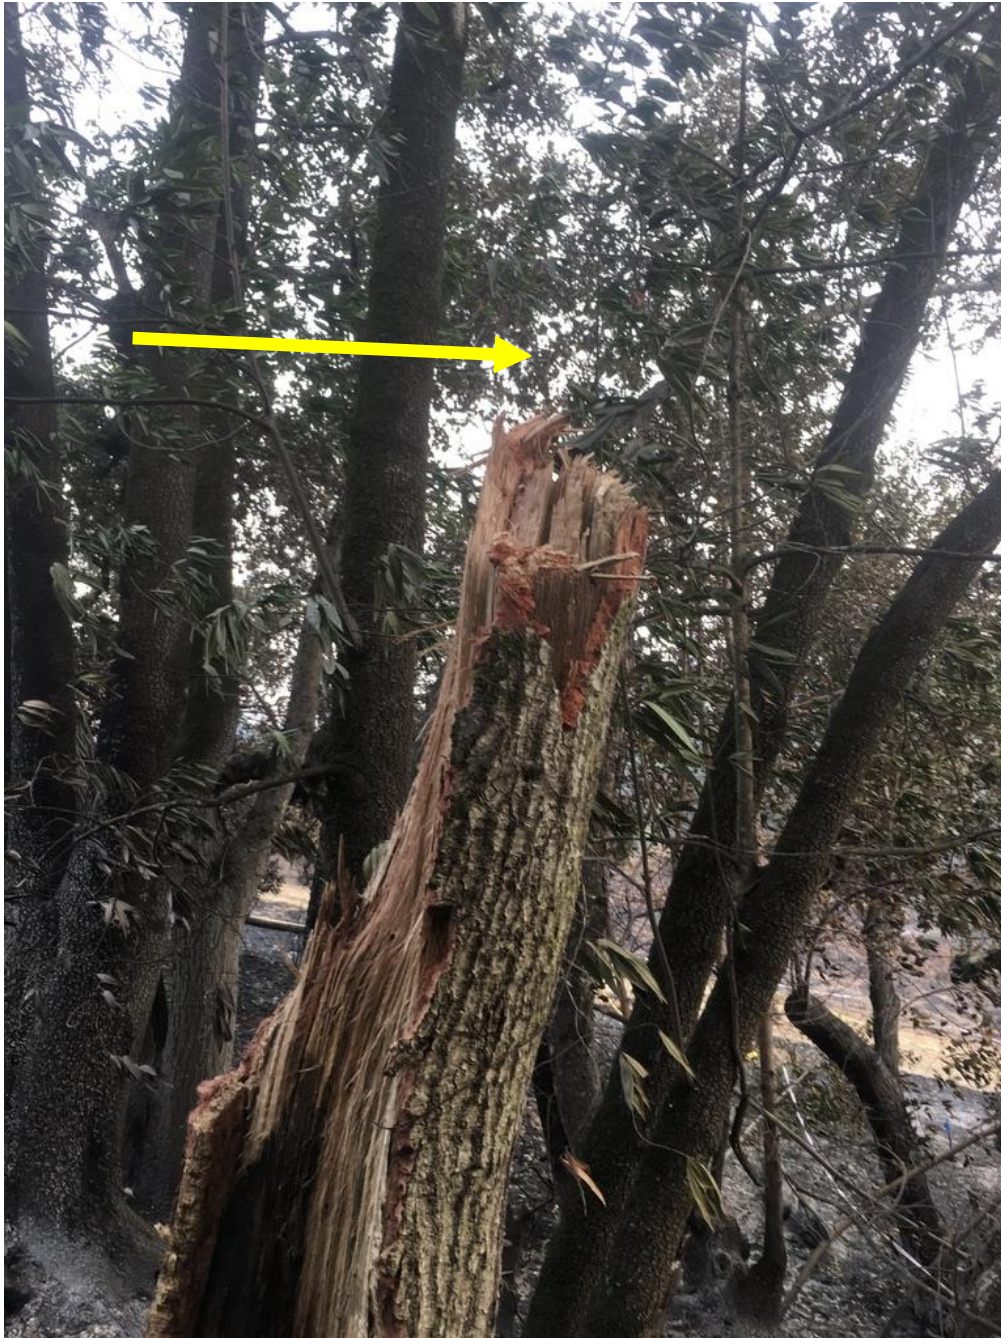
## Appendix IV Wood Decay Lab Results
