Docket: : R.11-02-019
Exhibit Number : DRA-13
Commissioner : Florio
ALJ : Bushey
Witness : Rondinone

**DIVISION OF RATEPAYER ADVOCATES
CALIFORNIA PUBLIC UTILITIES COMMISSION**

**DRA REBUTTAL TESTIMONY
ON THE
PIPELINE SAFETY ENHANCEMENT PLAN OF
PACIFIC GAS AND ELECTRIC COMPANY**

Treatment of Electric Welded (EW) Pipe

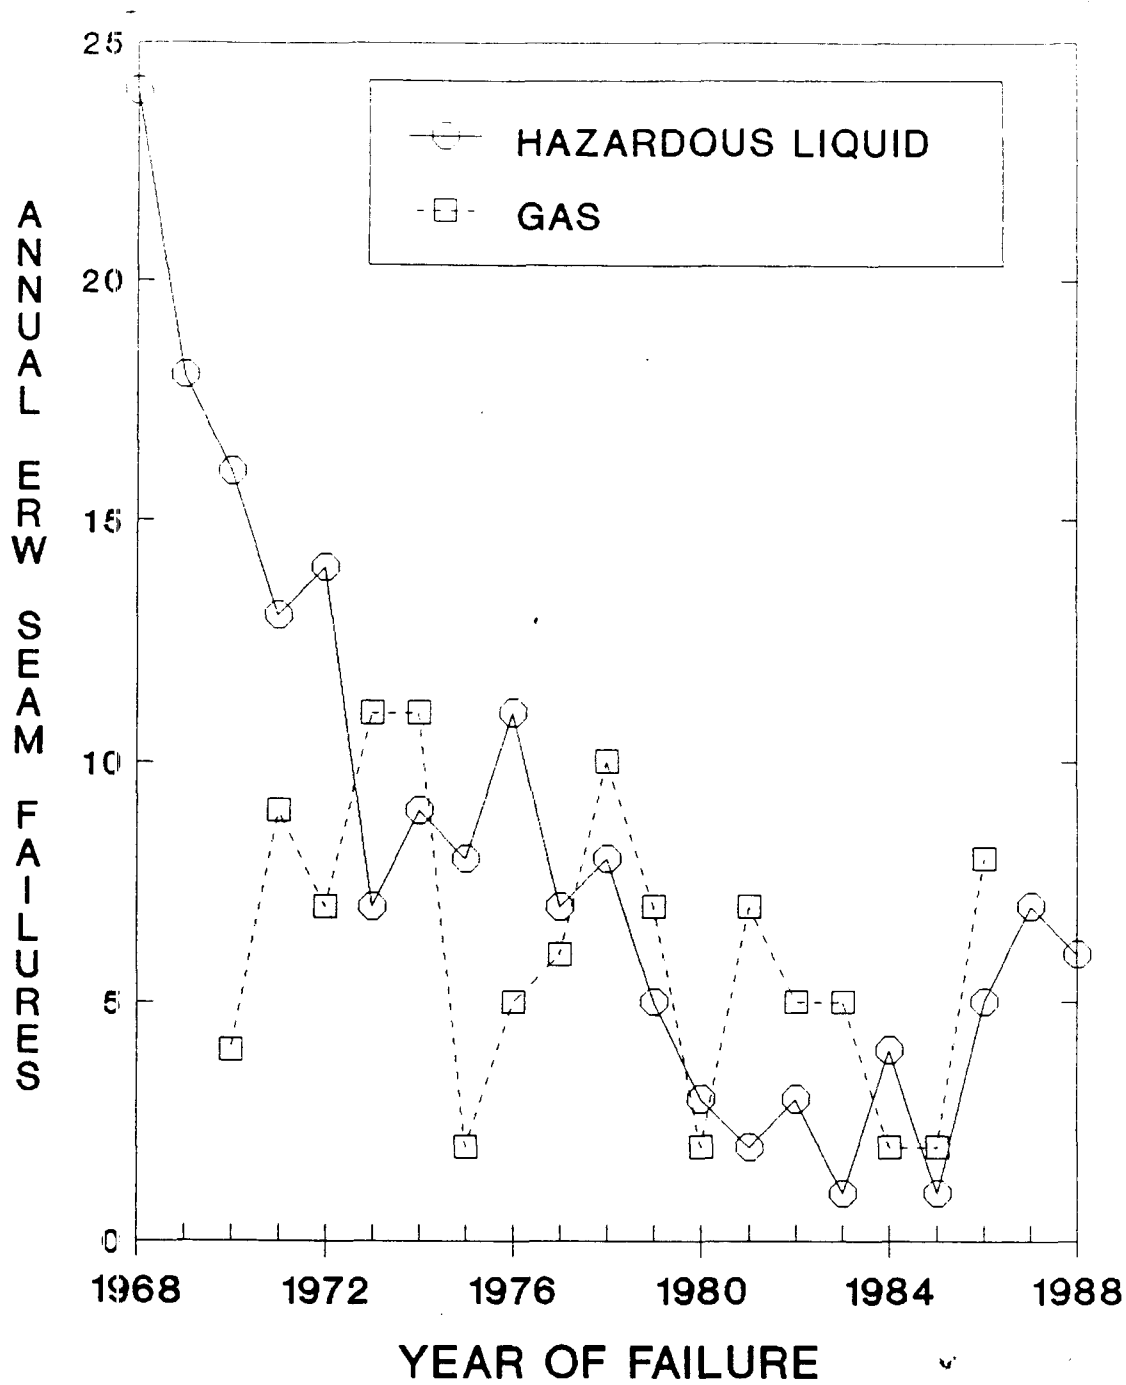
In both tables, a dramatic decrease can be seen in the number of failures/year for pipelines constructed after 1970. For HL, Table 4, only three of the 170 total failures (the construction decade is not known for two cases) occurred for pipelines constructed in the 1970s and 1980s; for NG, Table 5, the relative numbers are five of 94. It might be argued that these numbers reflect the fact that more miles of pipe were installed before 1970 than after that date. However, it was seen in Table 1, for interstate HL lines, that there are 46,217 miles of pre-1970 ERW pipe compared to 19,549 miles of more recent ERW pipe. Clearly the dramatic decrease in failures/year cannot be accounted for solely by the relative miles of pipe installed, and it must be concluded that ERW pipe manufactured before 1970 is significantly more susceptible to seam failures than ERW pipe produced after that date. This transition corresponds closely to the changes in manufacturing, inspection and testing procedures described in Section 2.0.

Figure 1. Annual Number of ERW Seam Failures in Hazardous Liquid Transmission Lines and Natural Gas Gathering and Transmission Lines During the Period 1968-1988 (15).

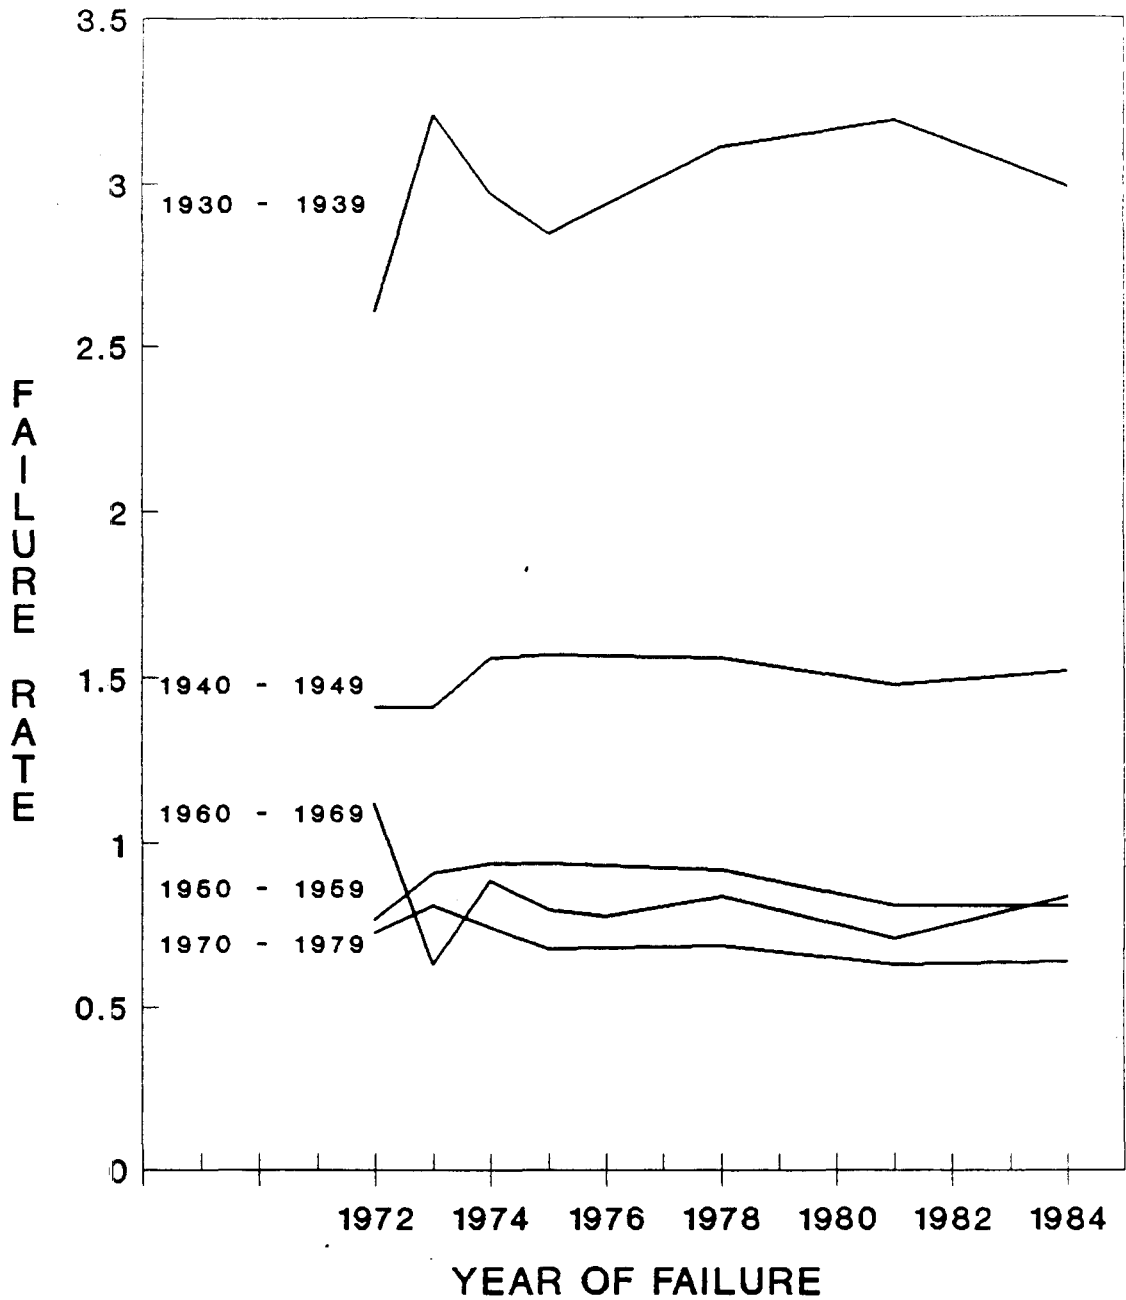
Given the occurrence of corrosion and fatigue, it might be expected that the number of failures per year would increase with the increasing age of the pipe. It is somewhat surprising therefore that no such significant effect is observed in Tables 4 and 5. This can be seen by examining each construction decade separately and noting the number of failures in each event year. Note that while the number of miles of pipe installed per decade is not known it is reasonable to assume that the mileage remains substantially unchanged after the end of a particular decade (neglecting replacement), at least for pipelines constructed after 1950. On this basis, the data suggest that the rate of failure does not increase significantly with time.

Figure 2. Annual Rates of Failure (number per year per 1000 miles of pipeline) in Natural Gas Gathering and Transmission Pipelines for the Period 1970-1984 Classified by Decade of Construction (16).

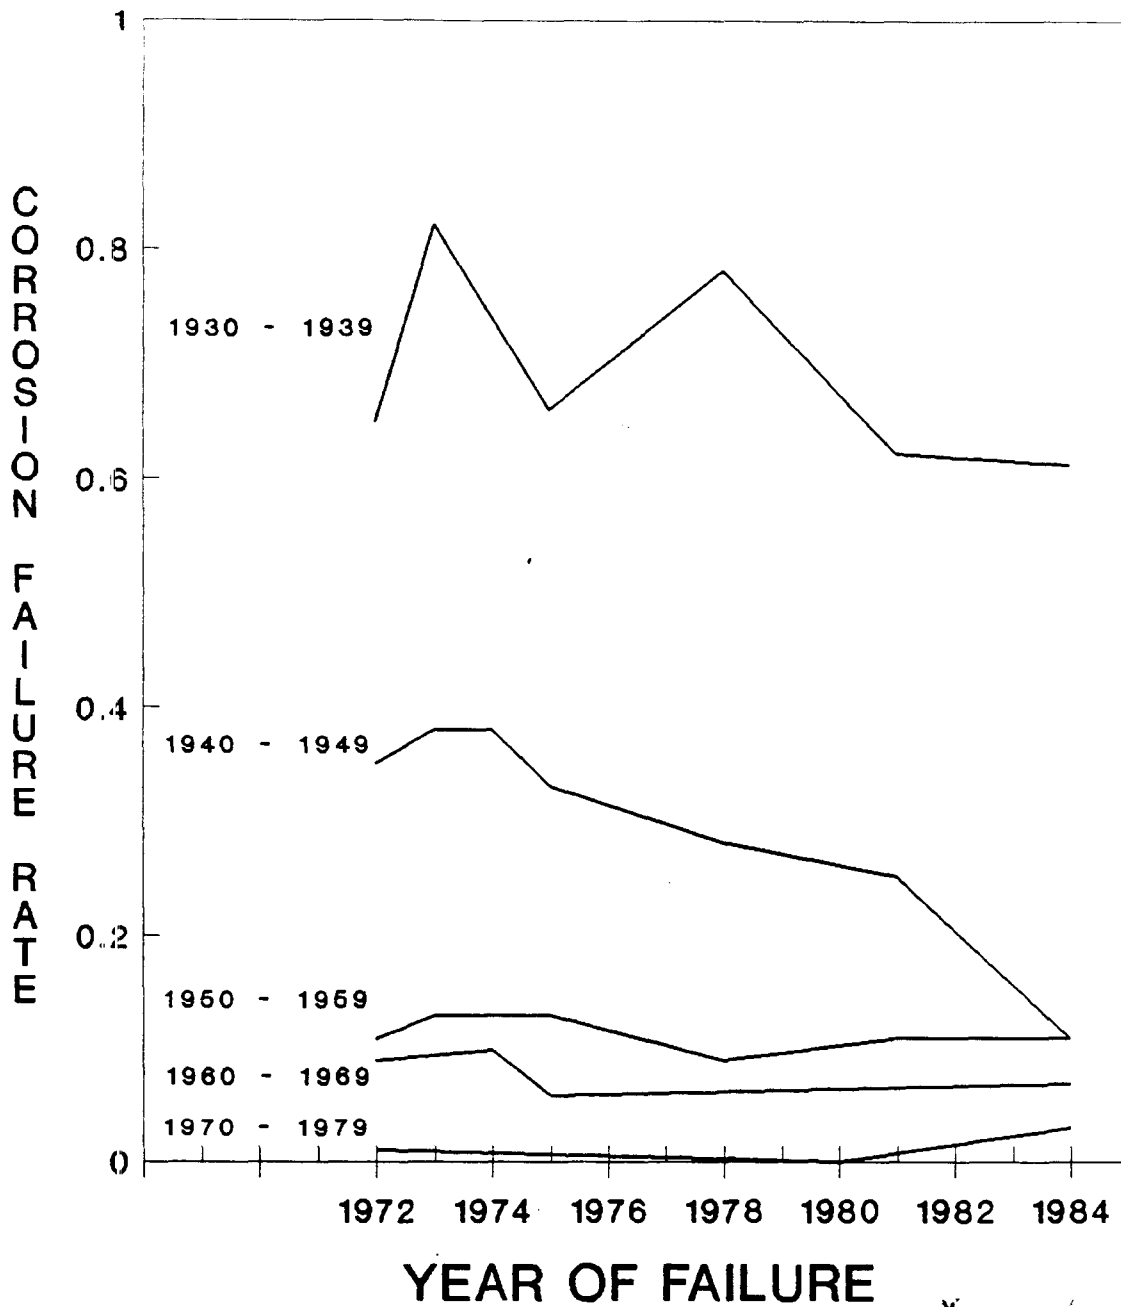
Figure 3. Annual Rates of Corrosion Failures (number per year per 1000 miles of pipeline) in Natural Gas Gathering and Transmission Lines for the Period 1970-1984 Classified by Decade of Construction (16).
