Order Instituting Rulemaking on the
Commission's Own Motion to Adopt New
Safety and Reliability Regulations for Natural
Gas Transmission and Distribution Pipelines
and Related Ratemaking Mechanisms

**DECLARATION OF SUMEET SINGH
SUPPLEMENTING THE VERIFIED STATEMENT OF
PACIFIC GAS AND ELECTRIC COMPANY'S VICE
PRESIDENT OF GAS TRANSMISSION MAINTENANCE
AND CONSTRUCTION IN RESPONSE TO RULING OF
ASSIGNED COMMISSIONER AND ASSIGNED
ADMINISTRATIVE LAW JUDGE.**

Report No. 5004.9268

**METALLURGICAL EVALUATION OF A SECTION FROM
L-147 MP 2.2 BRITTAN AVE. AND ROGERS AVE., SAN CARLOS**

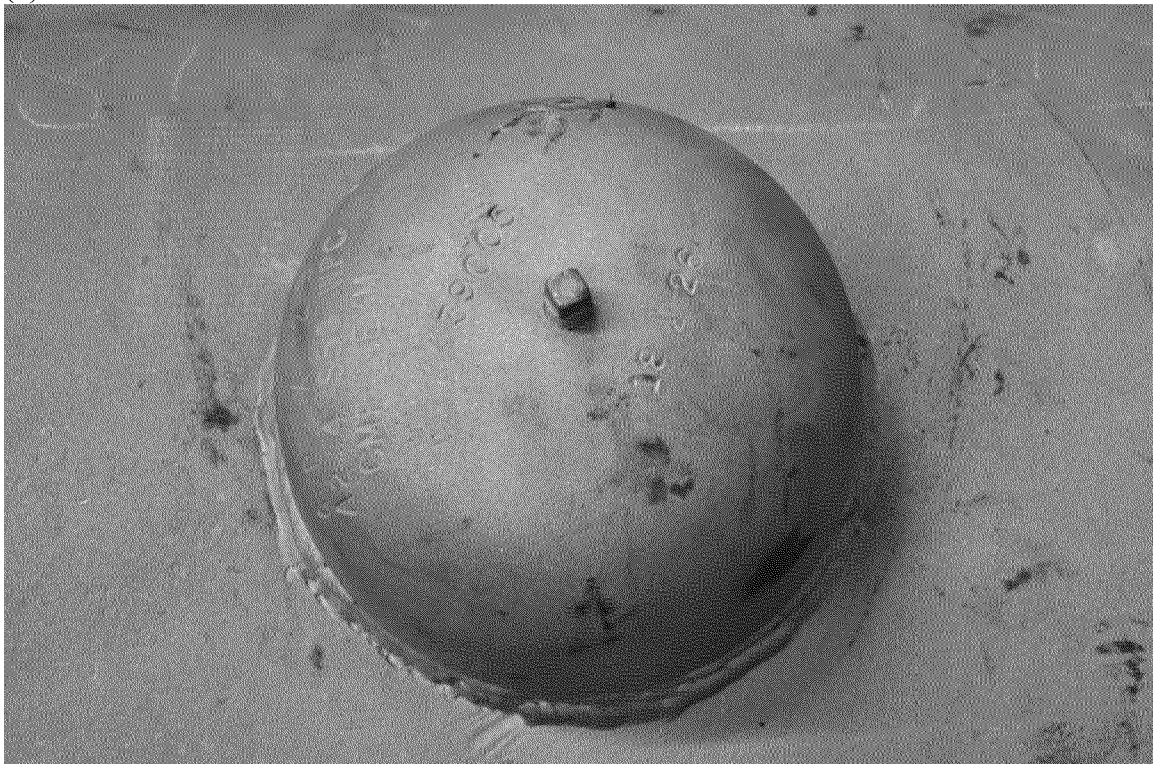
Figure 1 Photographs of the outside surface of sample half A as-received.

The subject sample of L-147 was received sectioned into two halves along the longitudinal axis, with the outside surface grit blasted, as shown in Figure 1 through Figure 5. The section half with the PLIDCO cap was arbitrarily labeled A and the other section was labeled B, in the laboratory. Based on the reported position of the cap, the longitudinal flame cuts were located at three o'clock and nine o'clock positions. Wall thickness measurements were made with a pointed anvil micrometer and the results are listed in Table 1. Small regions of weld metal and a few shallow hemispherical pits were present near the cap, as shown in Figure 2. Pits were also present just past the three o'clock position toward the cap, indicated in Figure 1. Pit depths were measured with a pit gage, and the results are listed in Table 2. No evidence of a leak location or repair was visible to the unaided eye on the inside surface of the pipe under the cap.

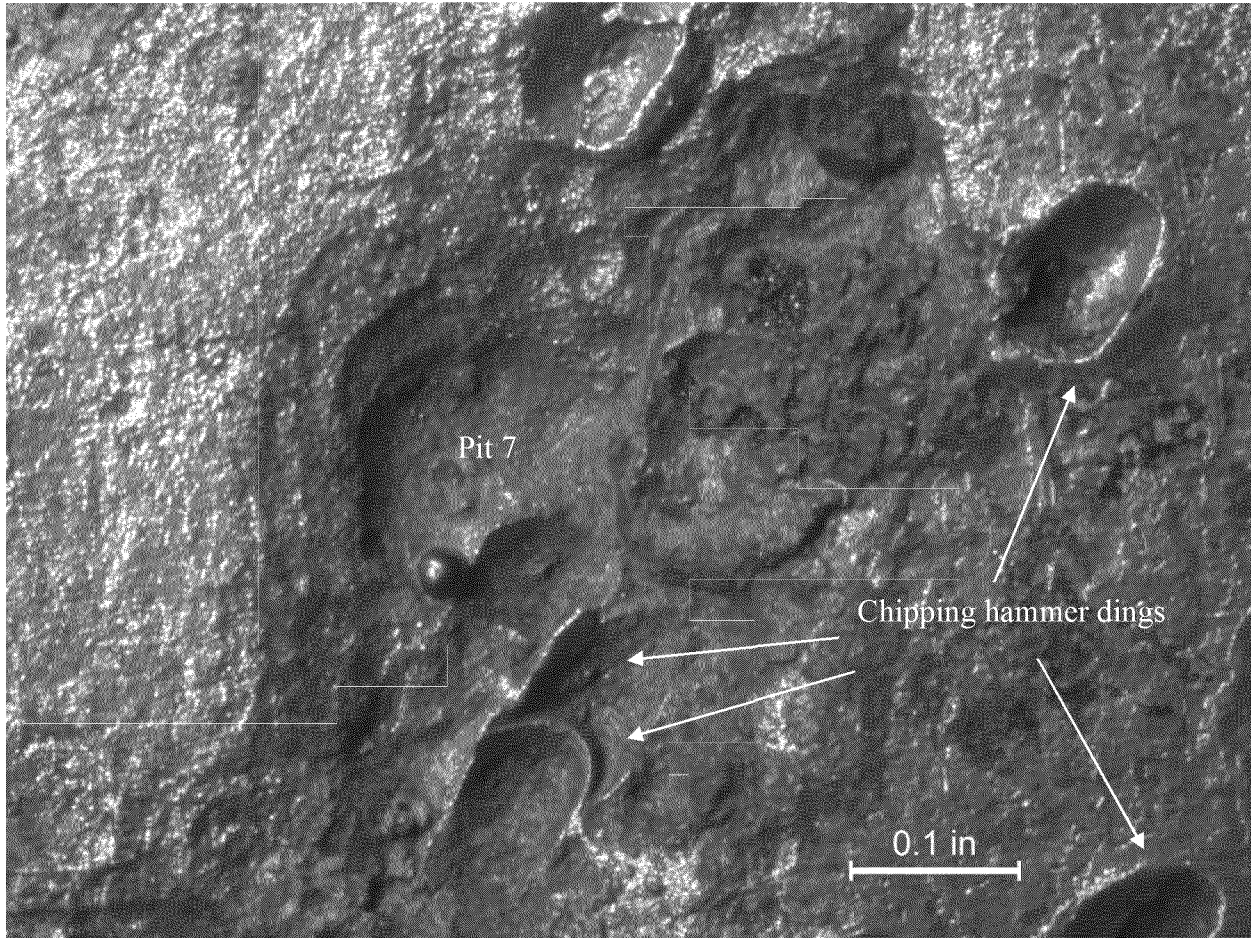
Figure 7 Macrograph of a pit under the PLIDCO cap, from the boxed area in Figure 6b.

The region containing the PLIDCO cap was sectioned from sample A and the cap was cut off to expose the outside surface of the pipe wall. The outside surface was covered with rust and had a slightly oily feel. Both surfaces were cleaned with dilute Oakite® 33 and a wire brush. The outside surface is shown before and after cleaning in Figure 6. Several regions of weld metal were visible on the outside surface. Examination using low-power optical microscopy revealed a pit consistent with corrosion on the outside surface, indicated in Figure 7. The inside surface is shown after cleaning in Figure 8. Indications of heat exposure were visible on the inside surface, corresponding to the weld metal on the outside surface. No evidence of weld burn through was detected, and fine grooves typical of wrought steel surfaces were continuous across the region, which indicated that repairs did not extend to the inside surface. Examination using low-power optical microscopy revealed a crack-like feature on the inside surface within the heat affected zone of a weld deposit, as shown in Figure 8b.

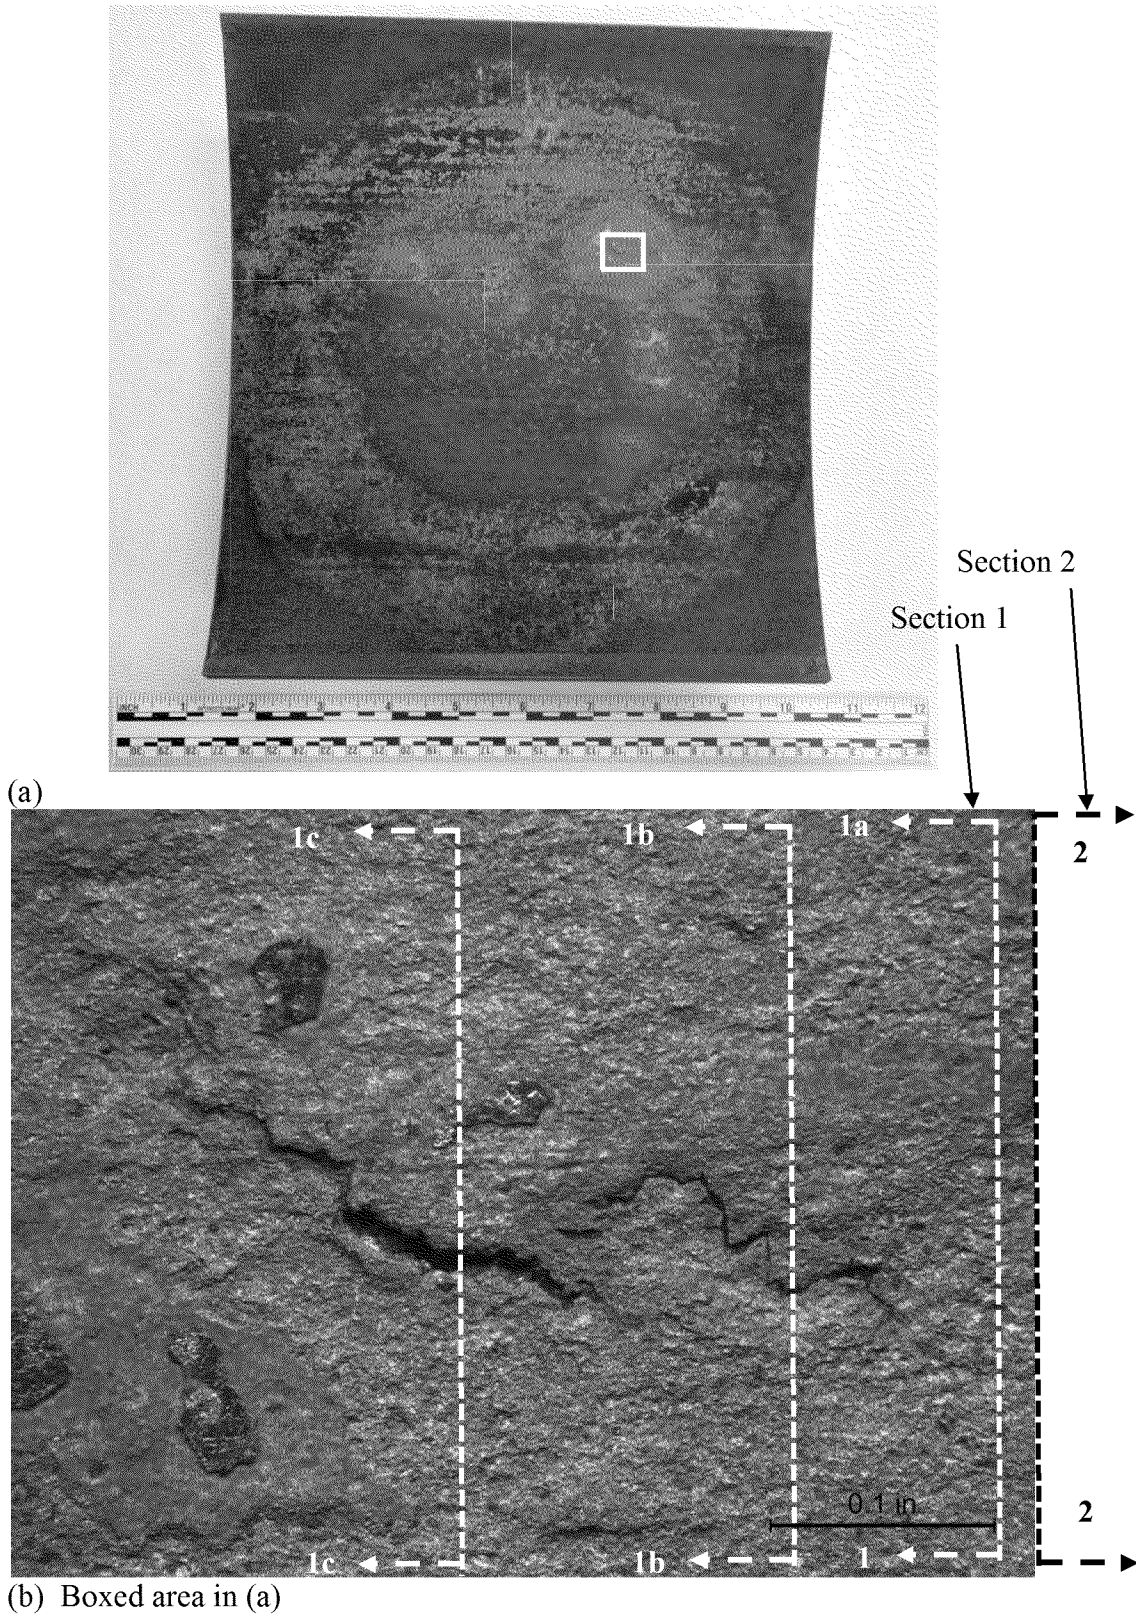
Figure 8 Photograph (a) and macrograph (b) of the inside surface of sample half A under the PLIDCO cap, after cleaning.

The sample shown in Figure 6 was returned to PG&E for radiography. A digital radiograph of the sample is shown in Appendix A along with a photograph of the sample. A crack indication was found that corresponded to the crack-like feature detected visually on the inside surface, shown in Figure 8b.

Specimens were prepared for metallography from section 1 and 2 indicated in Figure 8b. Weld crater cracks and heat affected zone liquation cracks were present in the sections. Serial grinding and polishing was performed on section 1, referred to as sections 1a, 1b, and 1c. As shown in Figure 10 through Figure 20, a weld crater crack extended from the outside surface into the weld heat affected zone in section 1a, but did not penetrate through the wall at this location. Shrinkage porosity was present near the outside surface, and intergranular cracks consistent with grain boundary liquation were present in the heat affected zone.

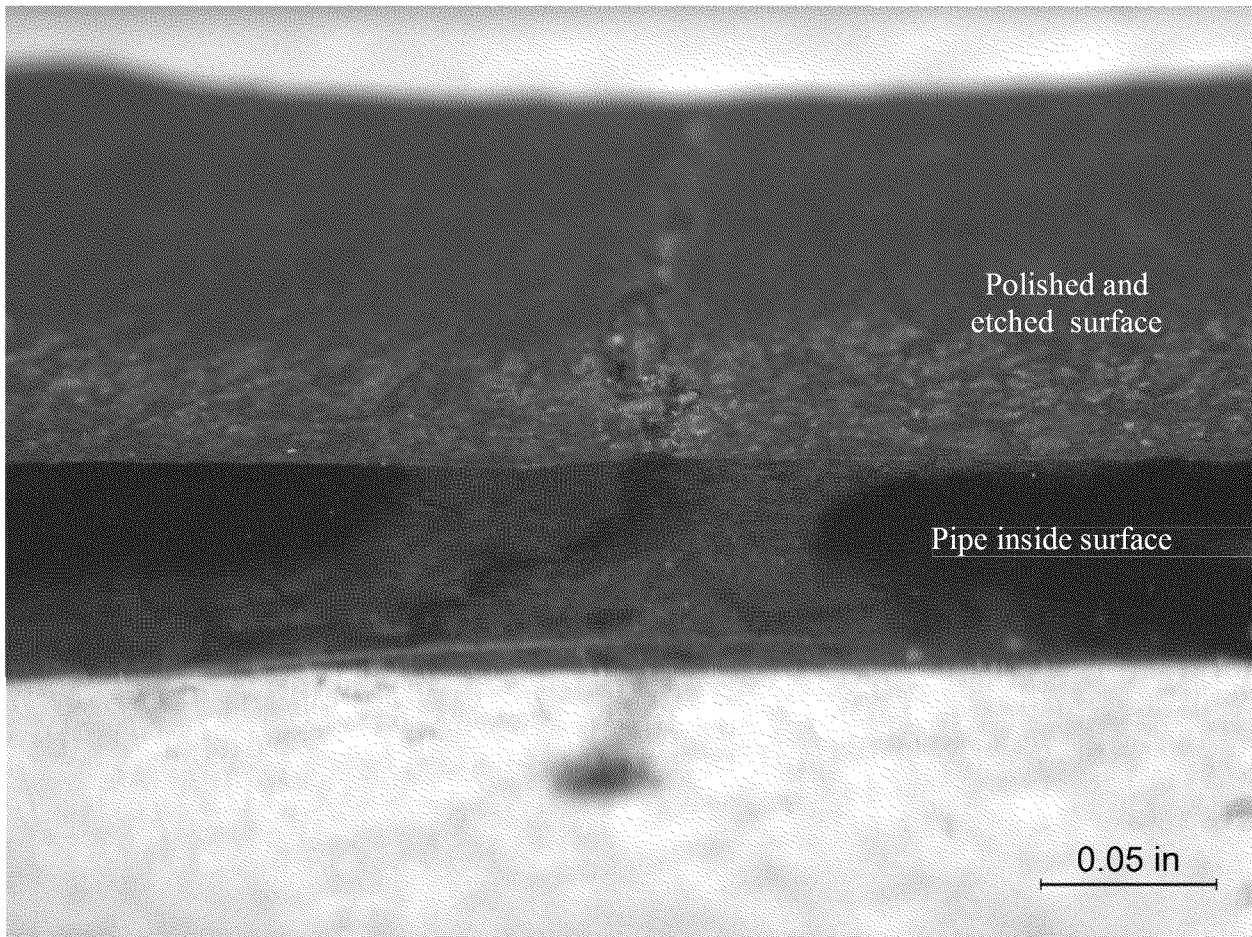
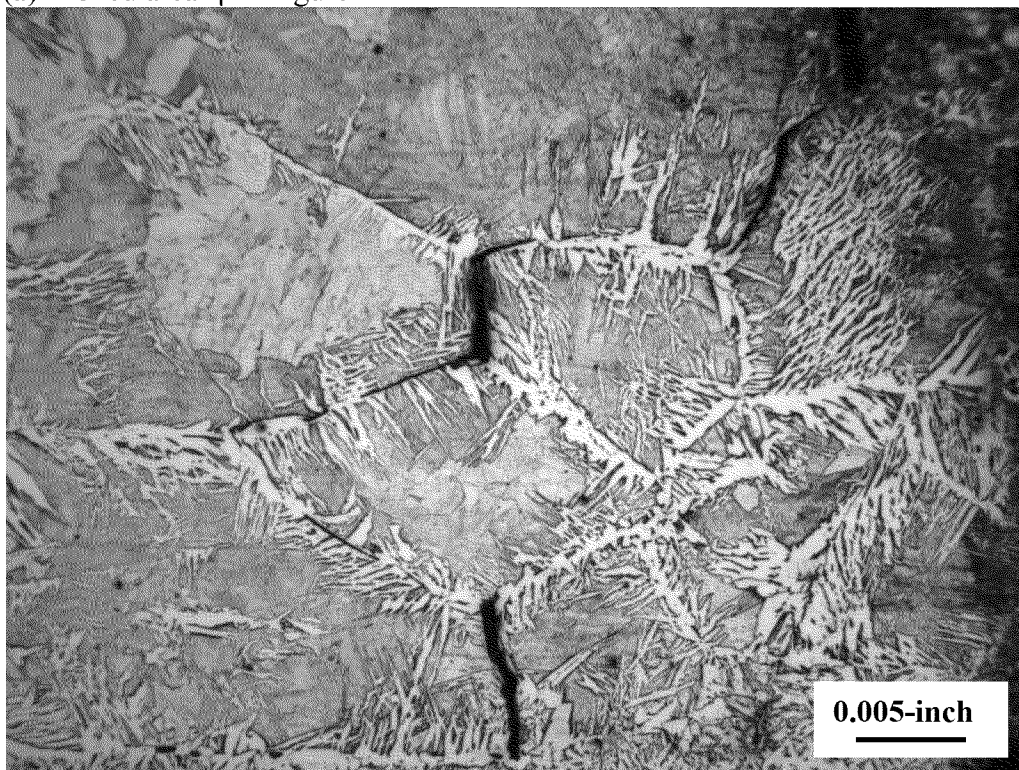
Figure 16 Images of the specimen prepared for metallography, section 1c. Etched with 2% nital.

In section 1c, shown in Figure 16 through Figure 18, one small ligament at the outside surface prevented demonstration of a through-wall leak path. Once again, the weld crack morphology was consistent with shrinkage and the heat affected zone crack morphology was consistent with grain boundary liquation. In all three sections of specimen 1, the weld fusion zone followed a smooth broad contour with no indications of external corrosion prior to welding.

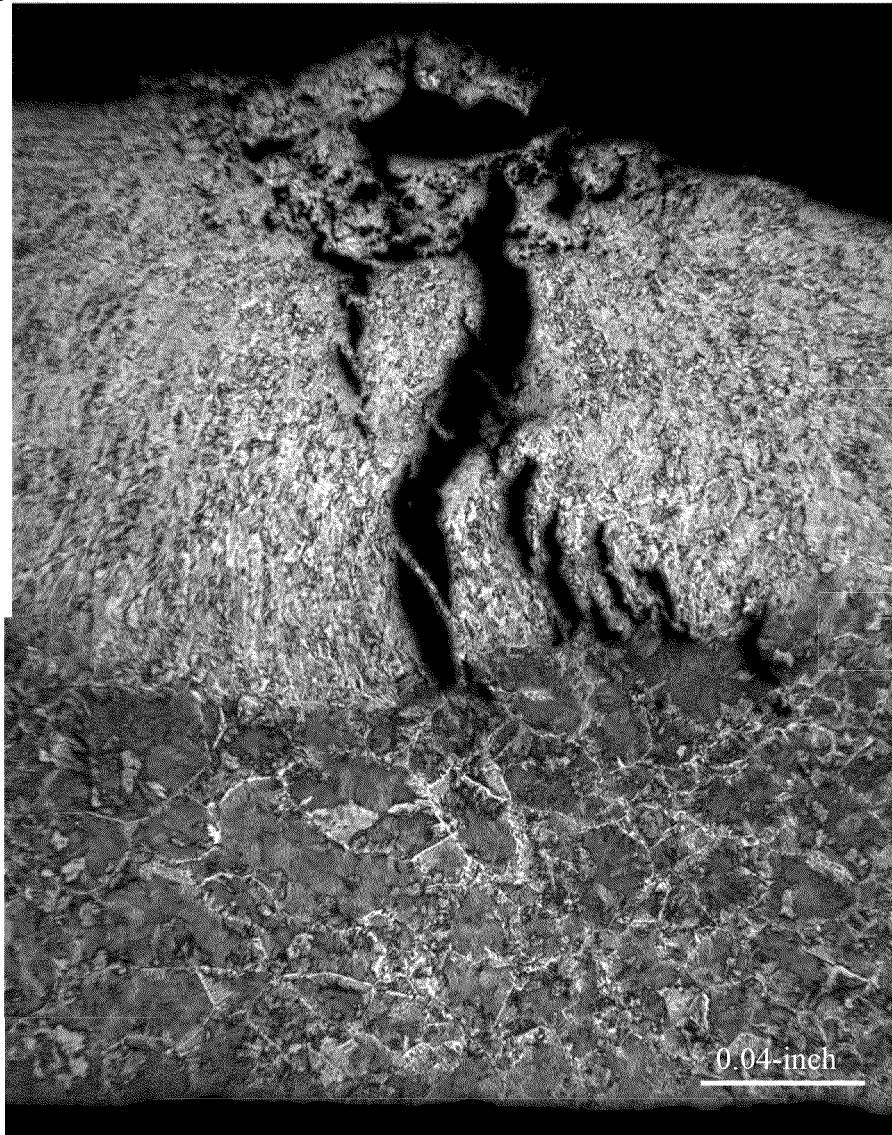
Figure 19 Photograph and composite micrograph of section 2. Etched with 2% nital.

Section 2 is shown in Figure 19. The fusion zone in this section had a profile that was more varied in depth than in sections 1a through 1c, which suggested the possibility that the weld metal was deposited to build-up locations where wall thickness had been reduced by external corrosion. Measurements of the minimum thickness of base metal beneath the weld metal are shown in Figure 10, Figure 13, Figure 16, and Figure 19.
