Order Instituting Rulemaking on the  
Commission's Own Motion to Adopt New  
Safety and Reliability Regulations for Natural  
Gas Transmission and Distribution Pipelines  
and Related Ratemaking Mechanisms

**DECLARATION OF SUMEET SINGH  
SUPPLEMENTING THE VERIFIED STATEMENT OF  
PACIFIC GAS AND ELECTRIC COMPANY'S VICE  
PRESIDENT OF GAS TRANSMISSION MAINTENANCE  
AND CONSTRUCTION IN RESPONSE TO RULING OF  
ASSIGNED COMMISSIONER AND ASSIGNED  
ADMINISTRATIVE LAW JUDGE.**

Report No. 5004.9268

**METALLURGICAL EVALUATION OF A SECTION FROM  
L-147 MP 2.2 BRITTAN AVE. AND ROGERS AVE., SAN CARLOS**

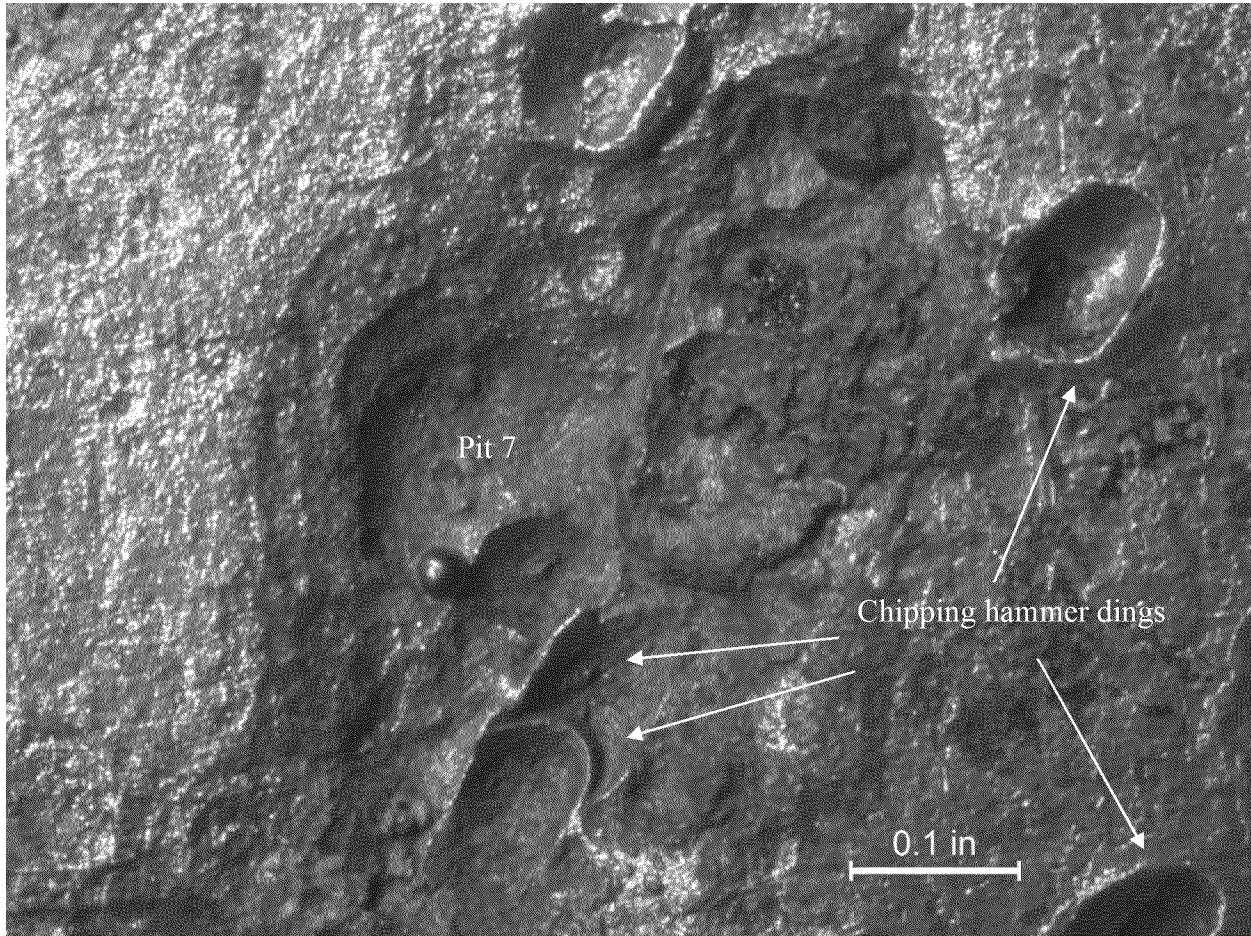
Figure 7 Macrograph of a pit under the PLIDCO cap, from the boxed area in Figure 6b.

The region containing the PLIDCO cap was sectioned from sample A and the cap was cut off to expose the outside surface of the pipe wall. The outside surface was covered with rust and had a slightly oily feel. Both surfaces were cleaned with dilute Oakite® 33 and a wire brush. The outside surface is shown before and after cleaning in Figure 6. Several regions of weld metal were visible on the outside surface. Examination using low-power optical microscopy revealed a pit consistent with corrosion on the outside surface, indicated in Figure 7. The inside surface is shown after cleaning in Figure 8. Indications of heat exposure were visible on the inside surface, corresponding to the weld metal on the outside surface. No evidence of weld burn through was detected, and fine grooves typical of wrought steel surfaces were continuous across the region, which indicated that repairs did not extend to the inside surface. Examination using low-power optical microscopy revealed a crack-like feature on the inside surface within the heat affected zone of a weld deposit, as shown in Figure 8b.

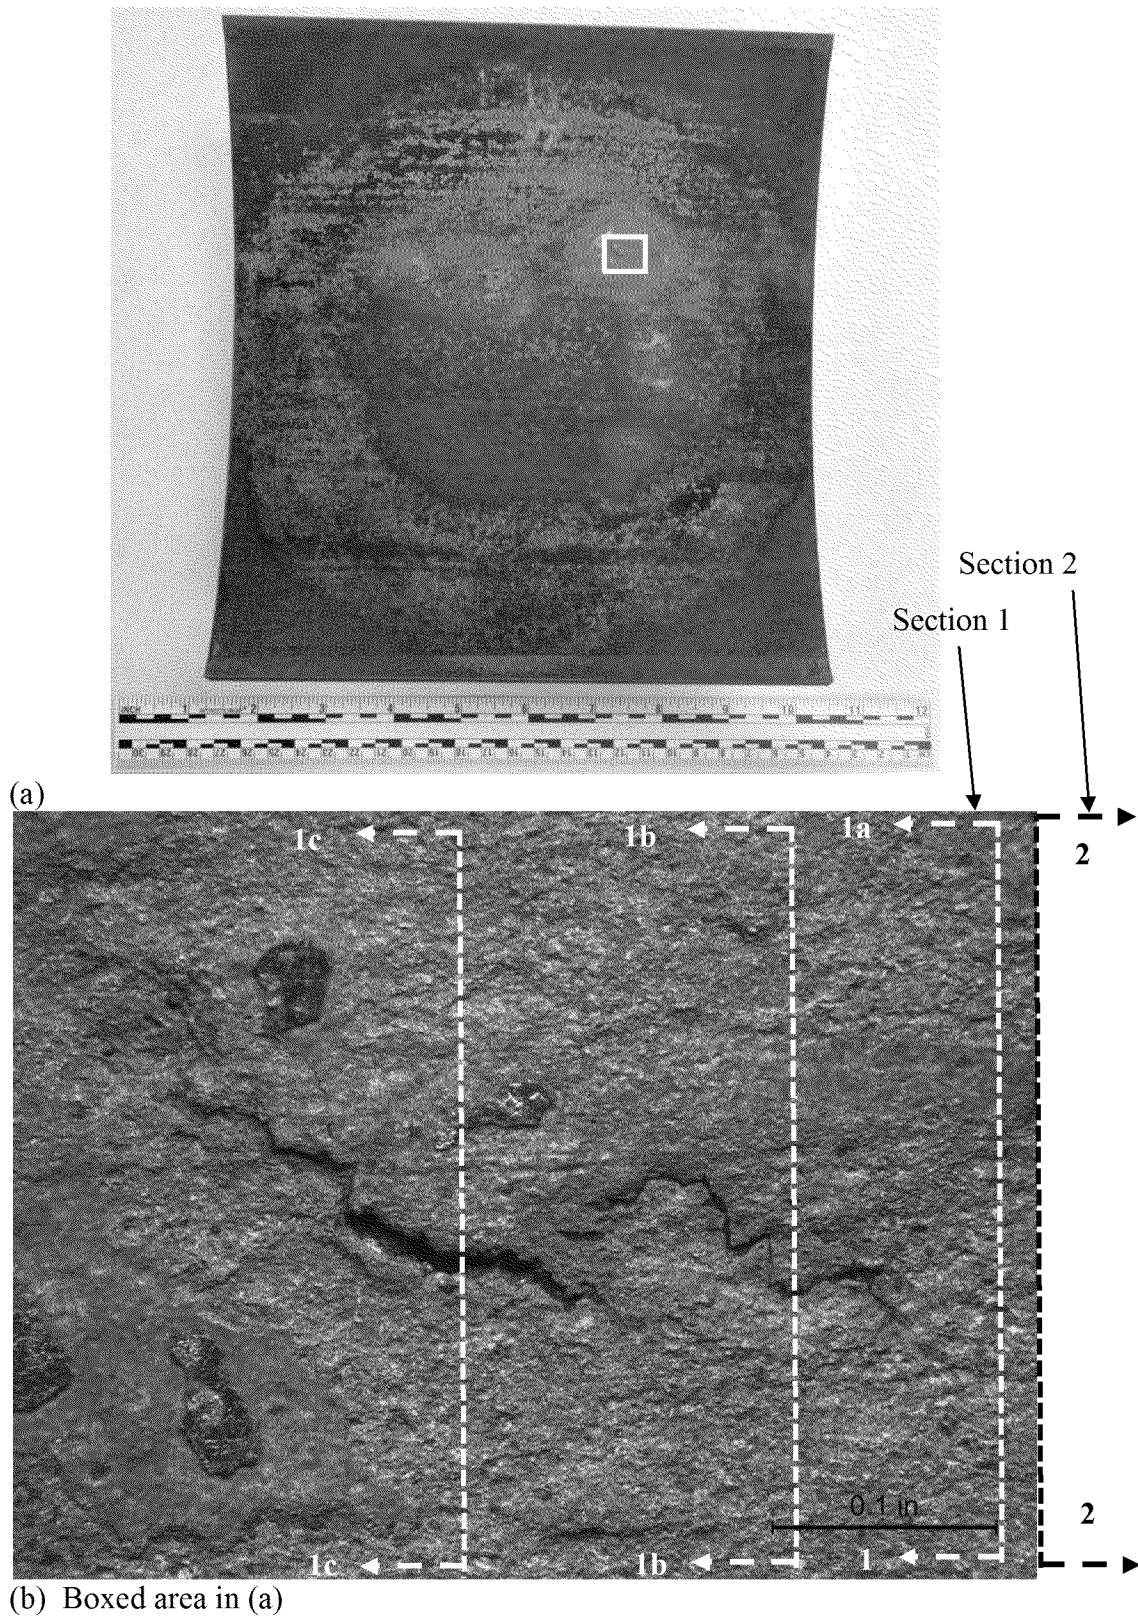
Figure 8 Photograph (a) and macrograph (b) of the inside surface of sample half A under the PLIDCO cap, after cleaning.

The sample shown in Figure 6 was returned to PG&E for radiography. A digital radiograph of the sample is shown in Appendix A along with a photograph of the sample. A crack indication was found that corresponded to the crack-like feature detected visually on the inside surface, shown in Figure 8b.

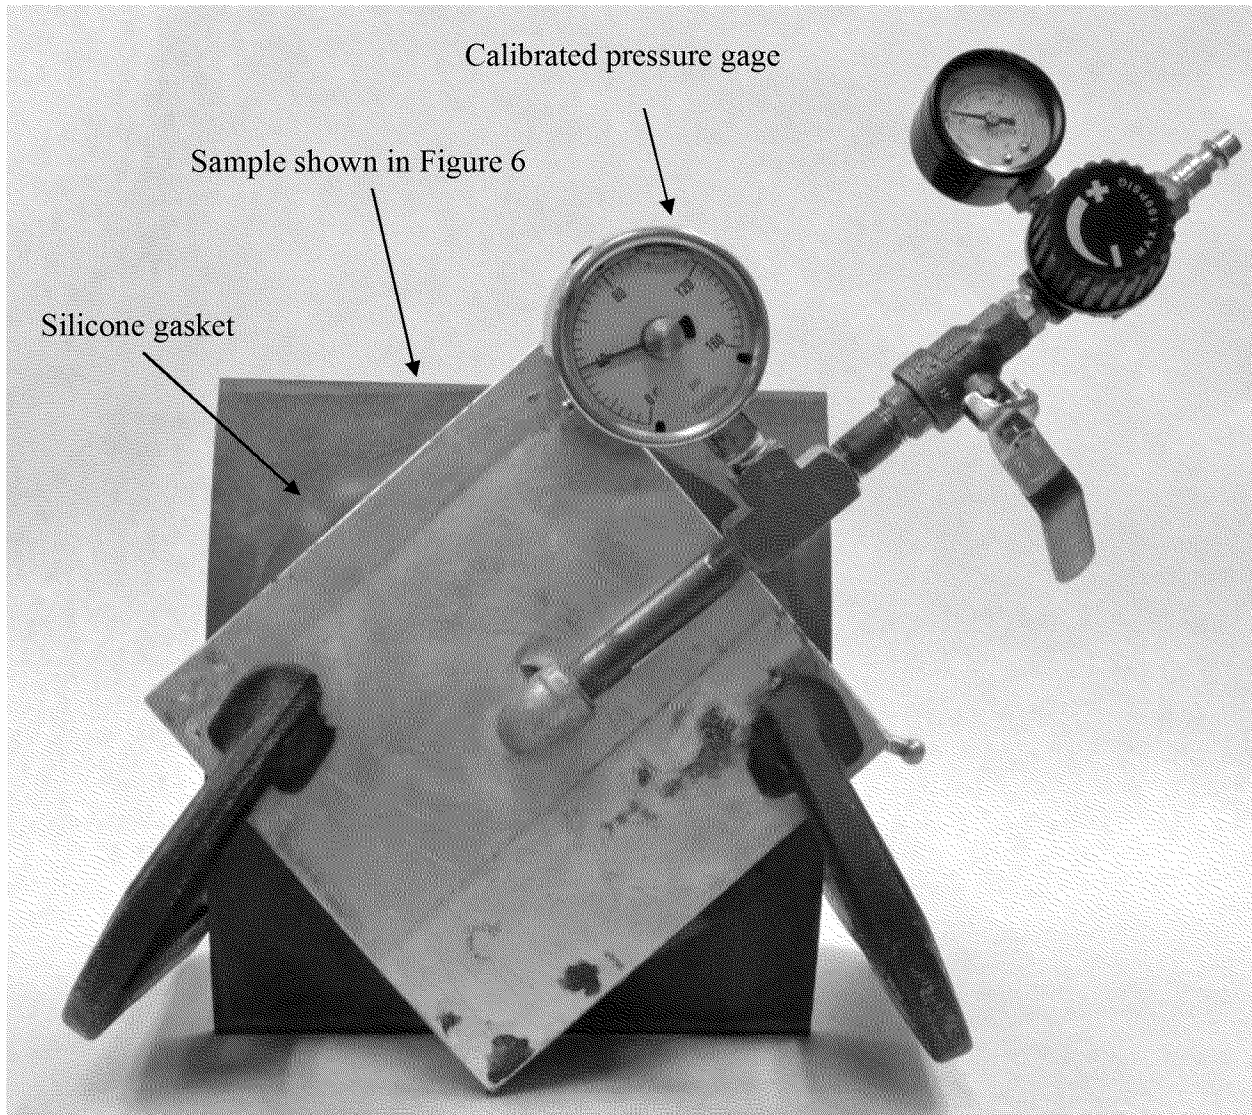
Figure 9 Pressure test setup.

A pressure test was performed by clamping a plate over the sectioned cap, sealed with a silicone gasket, and introducing 40-psig of compressed air. Snoop® liquid leak detector was applied to the inside surface. No leaks were detected. The compressed air was valved-off, and no pressure drop from 40-psig was detected after 45-minutes.

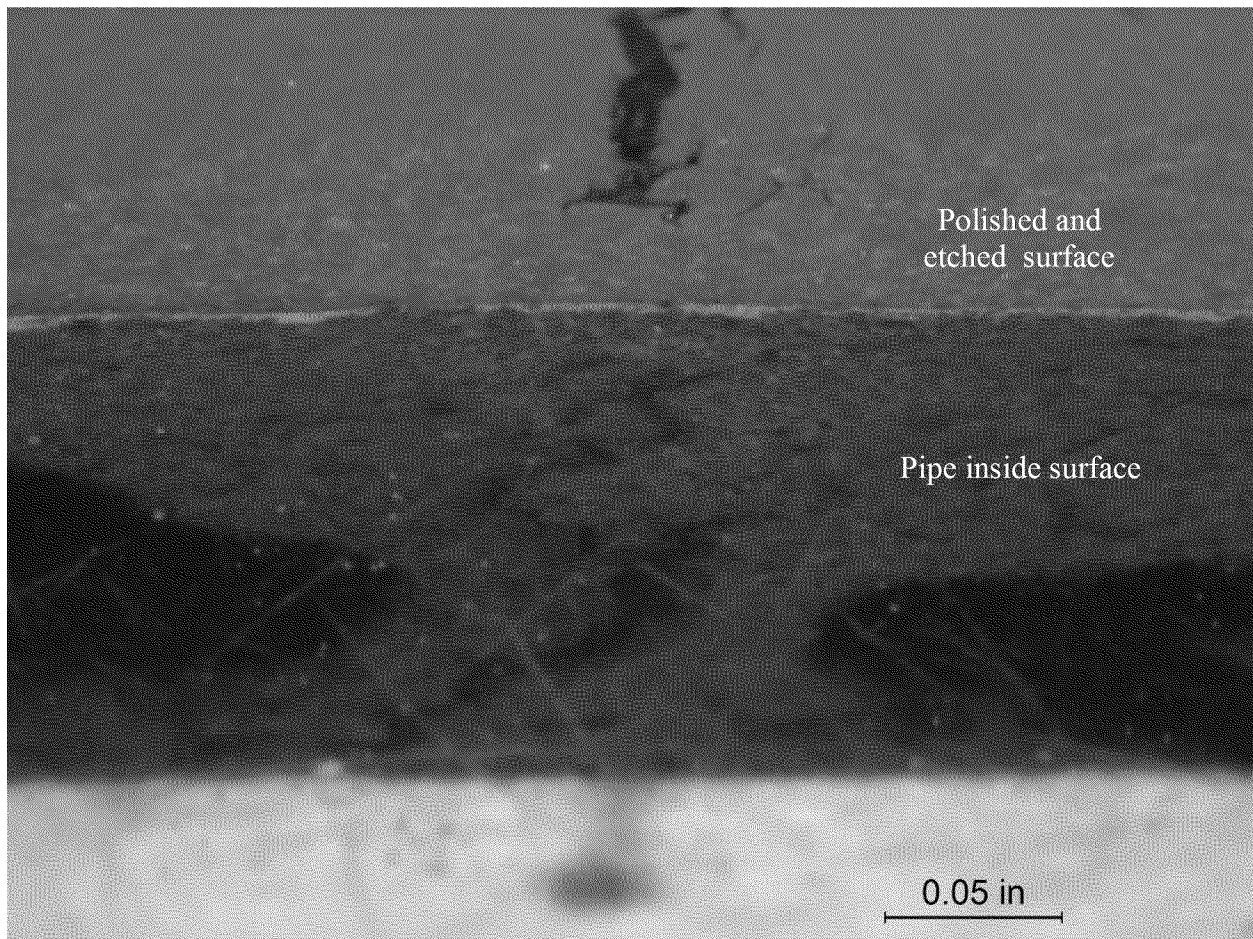
Figure 10 Images of the specimen prepared for metallography, section 1a. Etched with 2% nital.

Specimens were prepared for metallography from section 1 and 2 indicated in Figure 8b. Weld crater cracks and heat affected zone liquation cracks were present in the sections. Serial grinding and polishing was performed on section 1, referred to as sections 1a, 1b, and 1c. As shown in Figure 10 through Figure 20, a weld crater crack extended from the outside surface into the weld heat affected zone in section 1a, but did not penetrate through the wall at this location. Shrinkage porosity was present near the outside surface, and intergranular cracks consistent with grain boundary liquation were present in the heat affected zone.

Section 2 is shown in Figure 19. The fusion zone in this section had a profile that was more varied in depth than in sections 1a through 1c, which suggested the possibility that the weld metal was deposited to build-up locations where wall thickness had been reduced by external corrosion. Measurements of the minimum thickness of base metal beneath the weld metal are shown in Figure 10, Figure 13, Figure 16, and Figure 19.

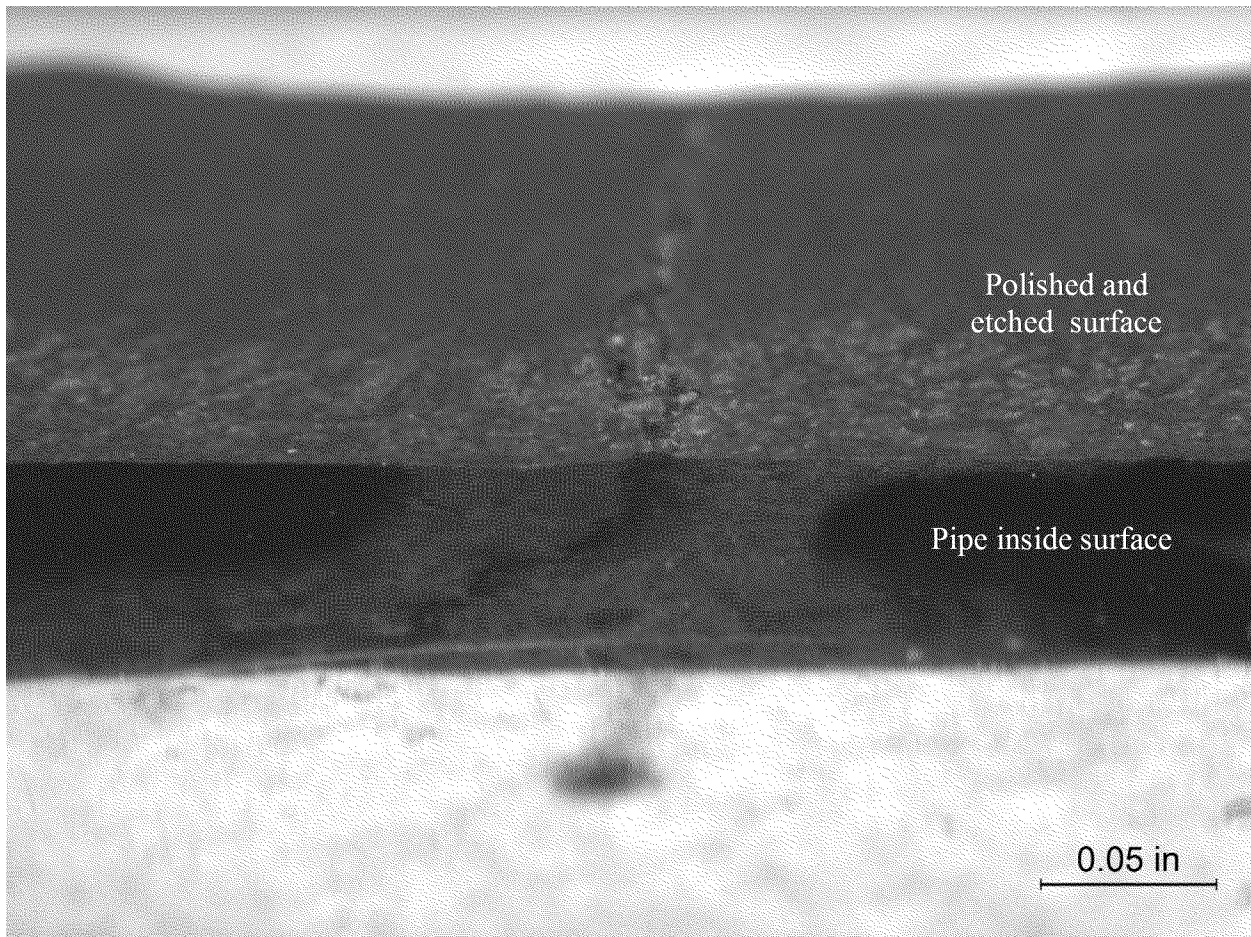
Figure 16 Images of the specimen prepared for metallography, section 1c. Etched with 2% nital.

In section 1c, shown in Figure 16 through Figure 18, one small ligament at the outside surface prevented demonstration of a through-wall leak path. Once again, the weld crack morphology was consistent with shrinkage and the heat affected zone crack morphology was consistent with grain boundary liquation. In all three sections of specimen 1, the weld fusion zone followed a smooth broad contour with no indications of external corrosion prior to welding.

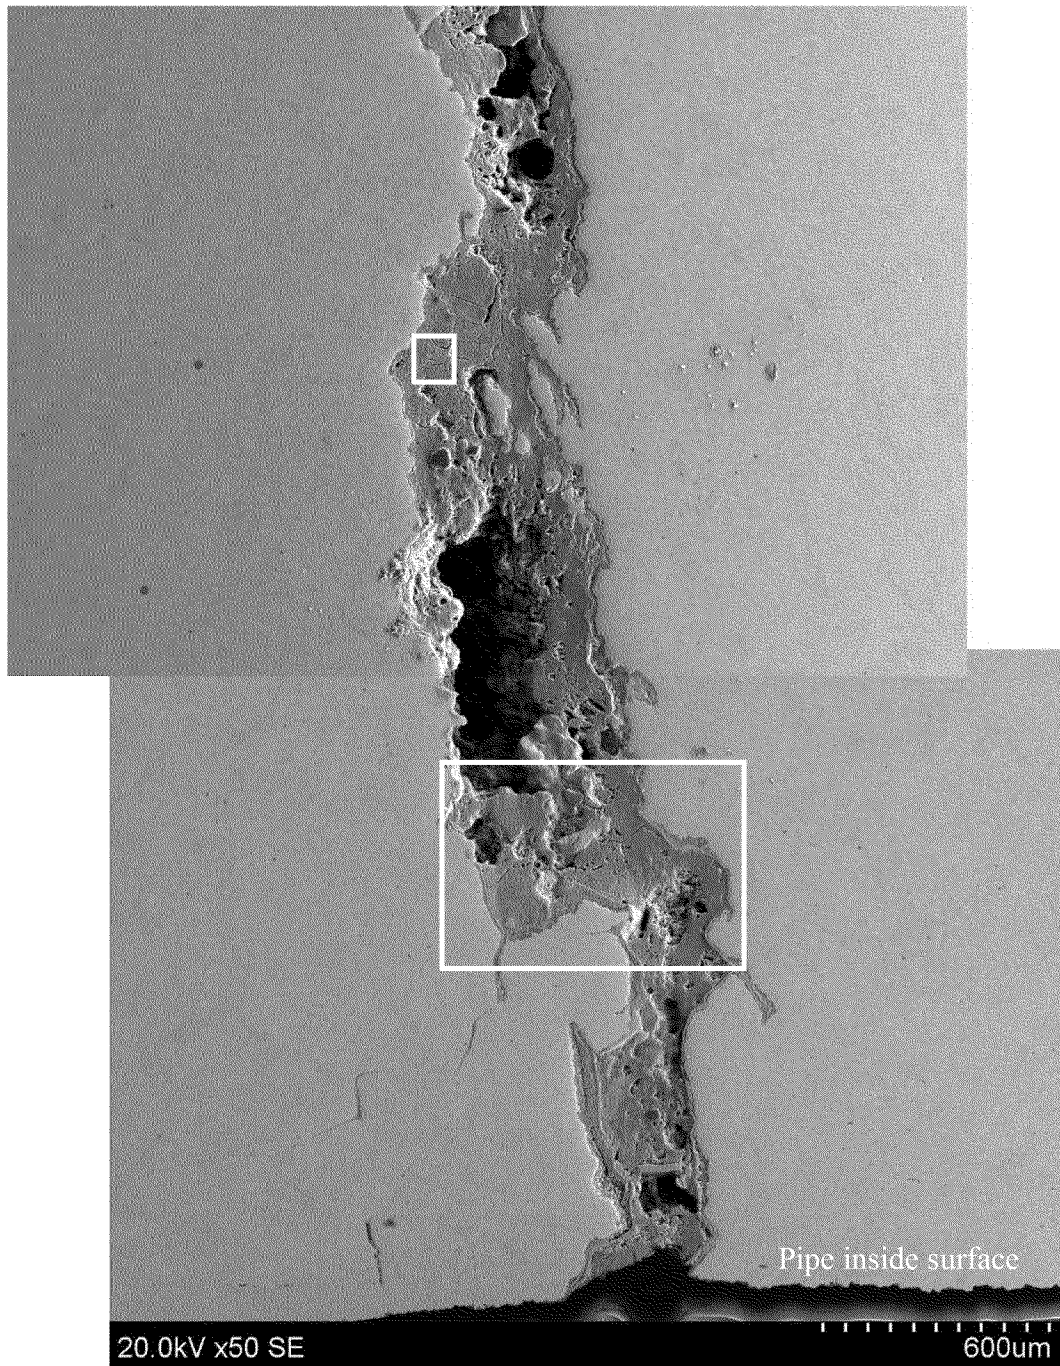
Figure 20 Composite SEM micrograph of the specimen prepared for metallography, section 1c.

Scanning electron microscopy (SEM) and energy dispersive X-ray spectroscopy<sup>2</sup> (EDS) was performed on the section 3 polished and etched surface. A composite SEM micrograph of the crack is shown in Figure 20. Much of the crack was filled with oxide, indicated by the morphology and chemical composition of primarily iron and oxygen, with sulfur present, likely from mercaptan in the gas stream.
