Surge Arrester Grounding

Briefing for SED

April 22, 2014

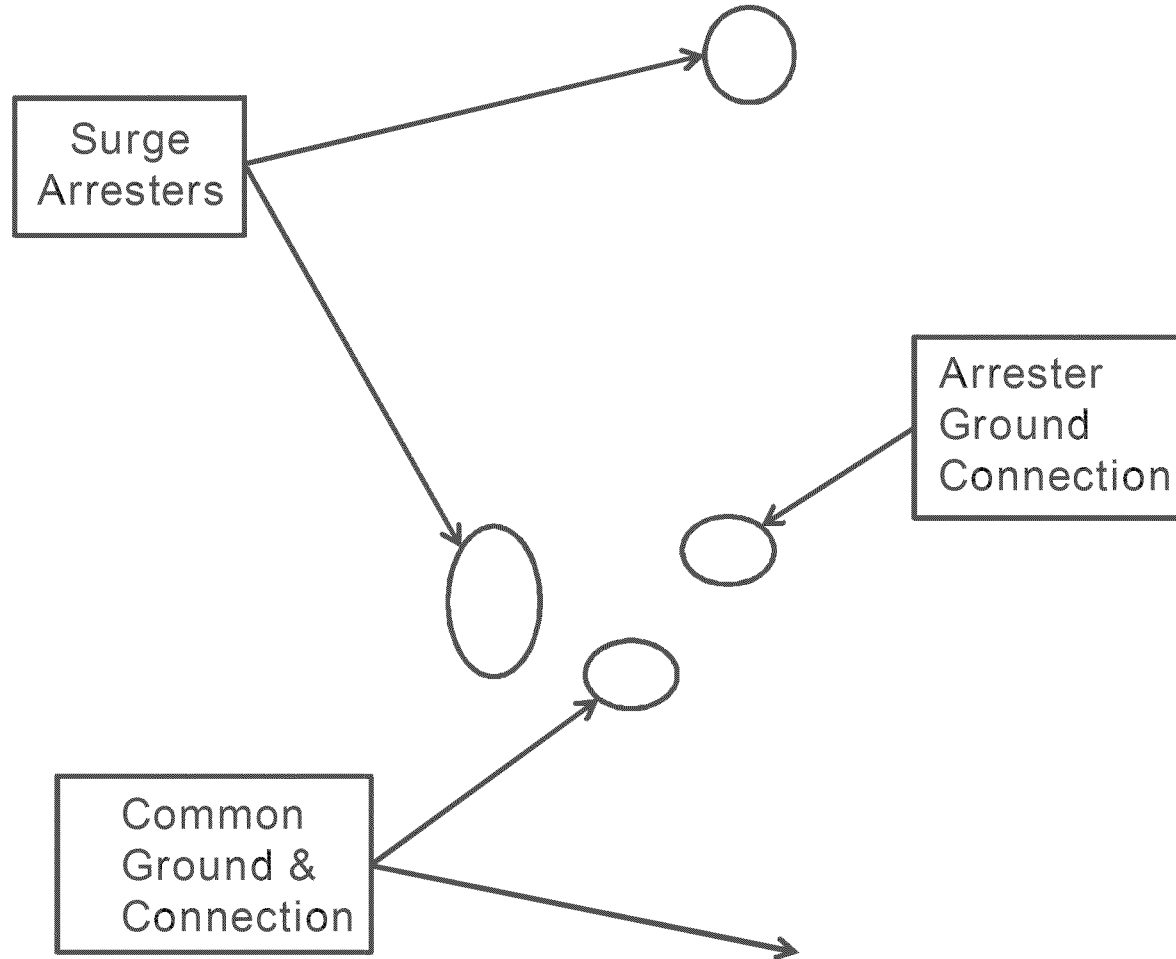
- 2007: PG&E contacted CPUC for clarification on the interpretation of Rule 33.3 of General Order 95. On October 12, 2007 the CPUC informed PG&E after reviewing Rule 33.3B that “Lightning arrester grounds may not be interconnected with secondary neutral grounds on single grounded secondary systems.”

Common Transformer Neutral Conductor and Surge Arresters Ground

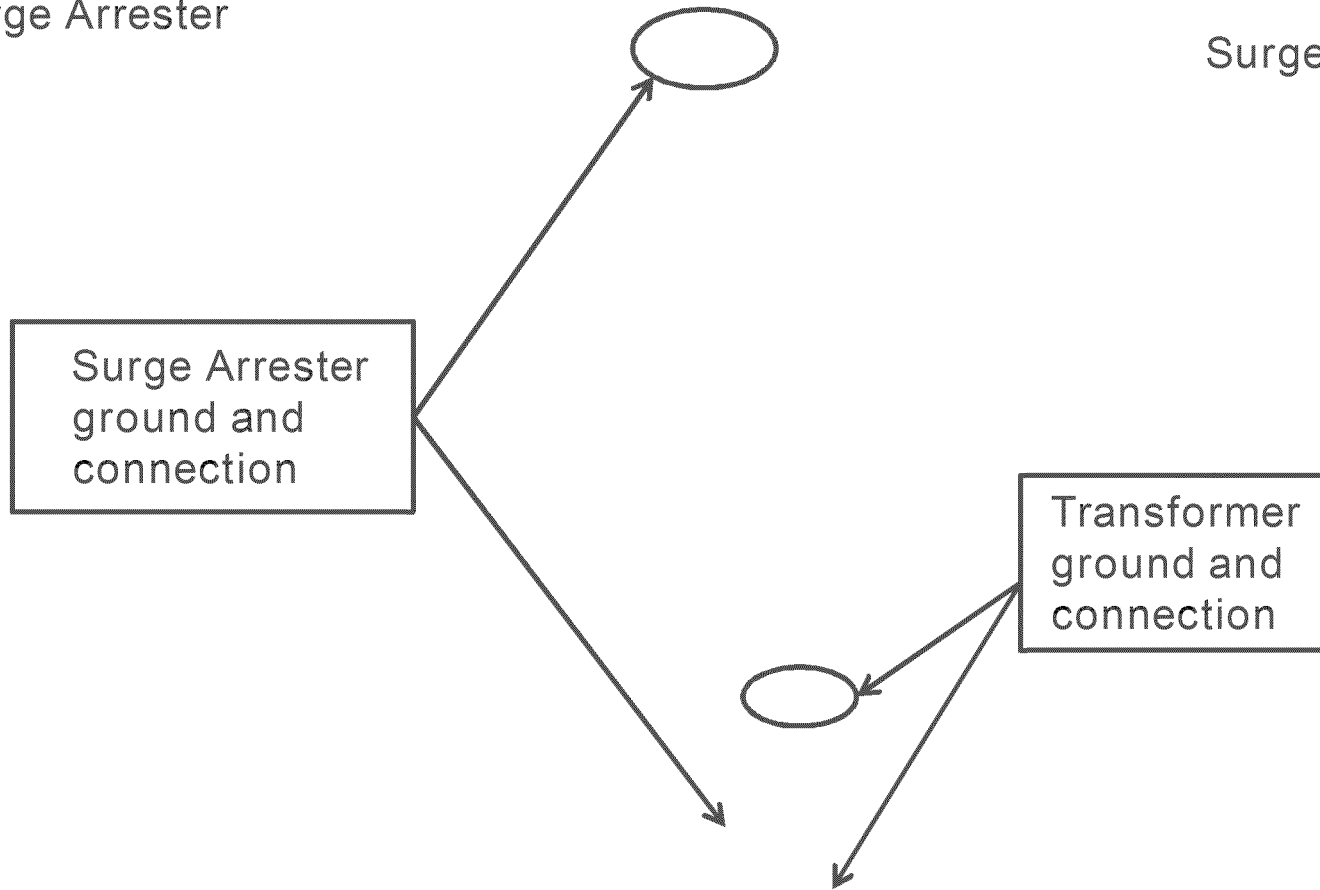
Separate Transformer Neutral Conductor and Surge Arresters Grounds

- 2008: PG&E took steps to address surge arrester grounding.
 - PG&E issued Bulletin 2008-15 addressing the grounding of surge arresters and transformers and revised Document 021904 Installation of Grounds on Wood Pole Transmission and Distribution Lines which requires a separate ground for surge arresters installed on distribution transformers.
