## PUBLIC UTILITIES COMMISSION

**CPUC File No.: E2009-08**

**SUBJECT:** General Order (GO) 165 Compliance Audit of Bear Valley Electric Service (BVES)

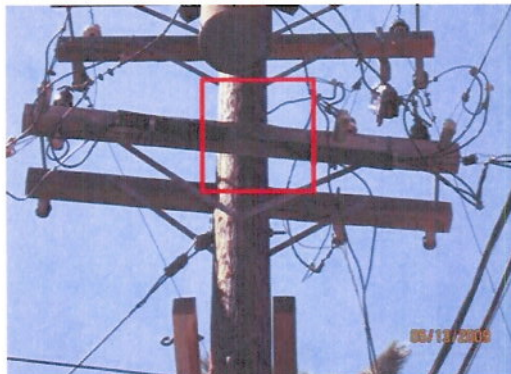
**Picture 1**

- a) Pole 4644BV had damaged weathering on secondary conductors.
- b) Pole 4922BV had a broken secondary rise moulding. (See **Picture 1**)

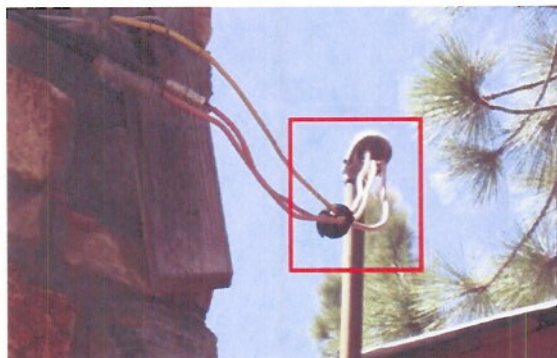
**Picture 2**

- c) Pole 31518CIT had exposed service drop conductors connected to 1162 Brookside Lane's weather head. (See **Picture 2**)

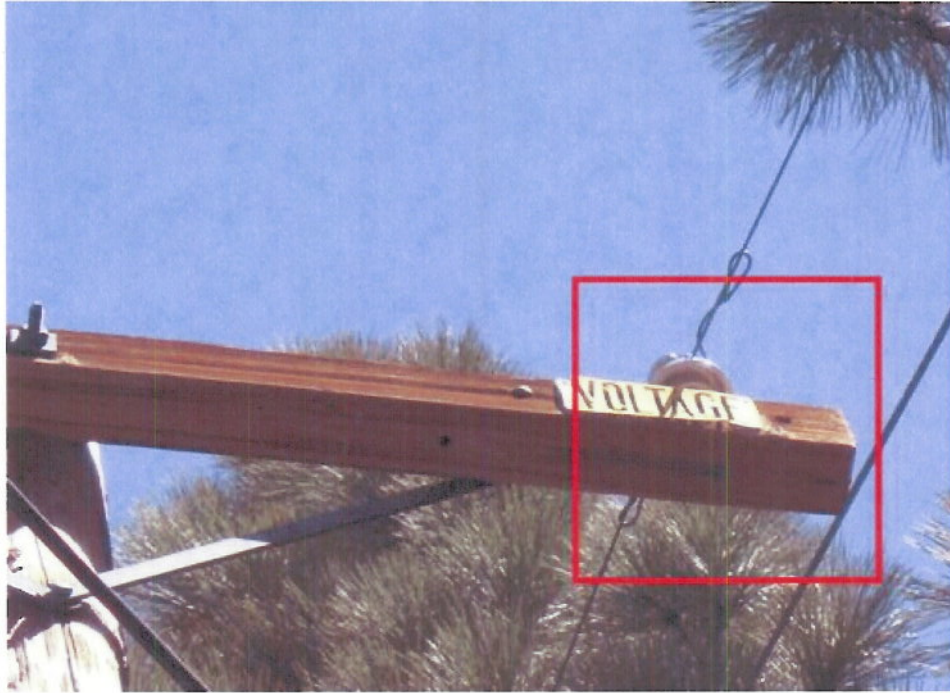
**Picture 3**

- d) Pole 8153BV had a missing washer on the throughbolt supporting a crossarm insulator. (See **Picture 3**)

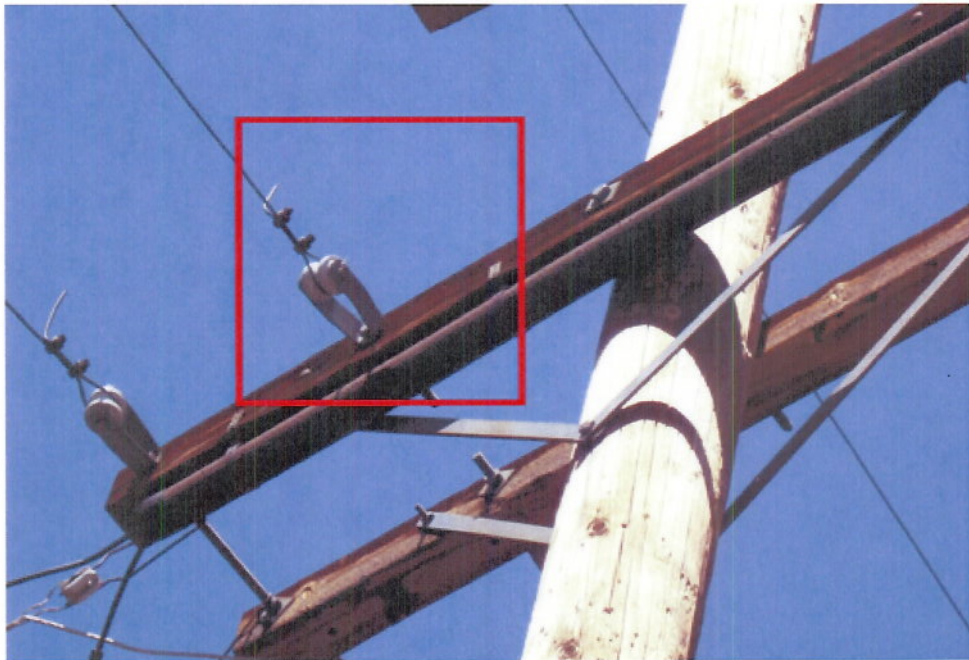
**Picture 4**

- e) Pole 8051BV had a loose crossarm insulator. (See **Picture 4**)

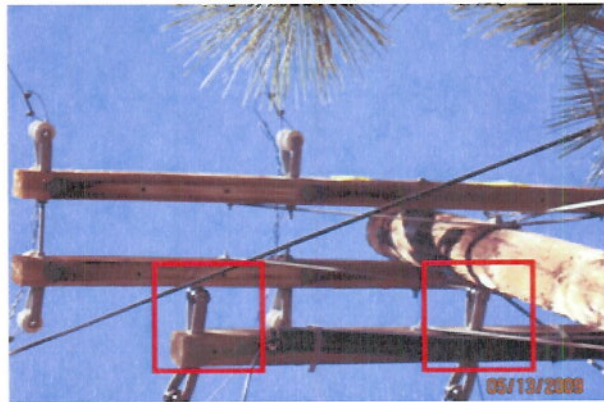
**Picture 5**

- a) 4644BV had two abandoned insulators. (See **Picture 5**)

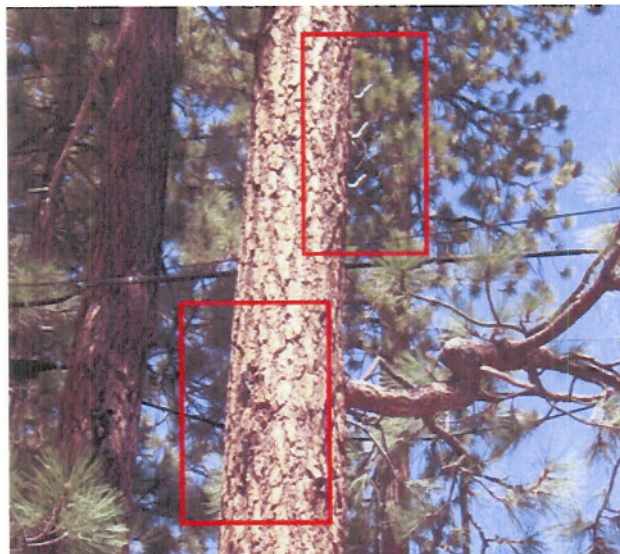
**Picture 6**

- b) 4922BV had two abandoned insulators.
- c) 9216BV had an abandoned insulator.
- d) There were 5 abandoned J-hooks (pictured below) on a tree adjacent to pole 31518CIT. (See **Picture 6**)

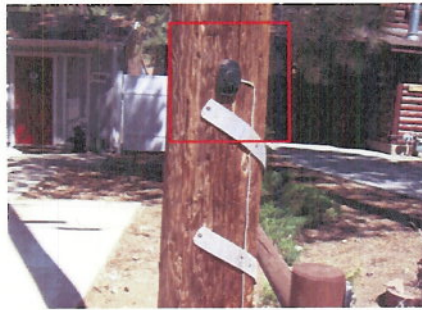
Picture 7

- a) 8065BV (pictured below) and 8063BV had similar attachments. (See Picture 7)

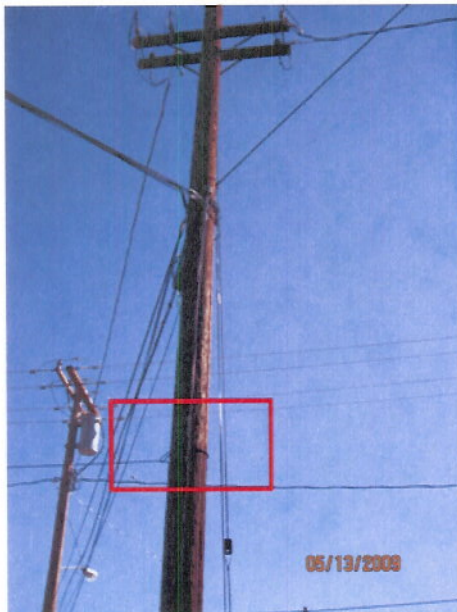
Picture 8

- b) BV7104 had an unidentified cable attached to the pole. (See Pictures 8 and 9)

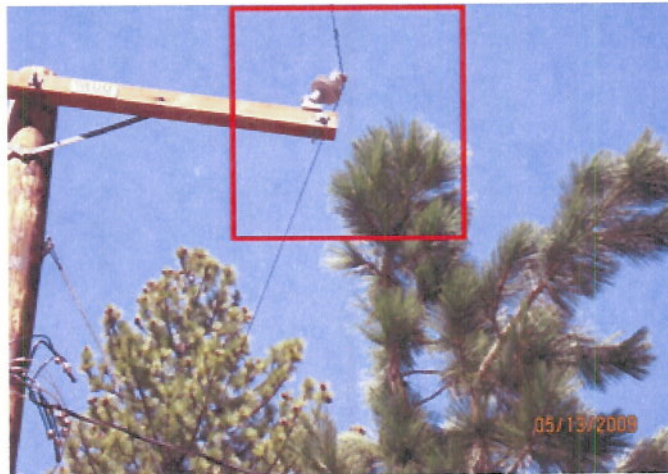
**Picture 10**

- a) Pole BV11689 had an encroaching tree branch at the primary conductor level.  
(See **Picture 10**)

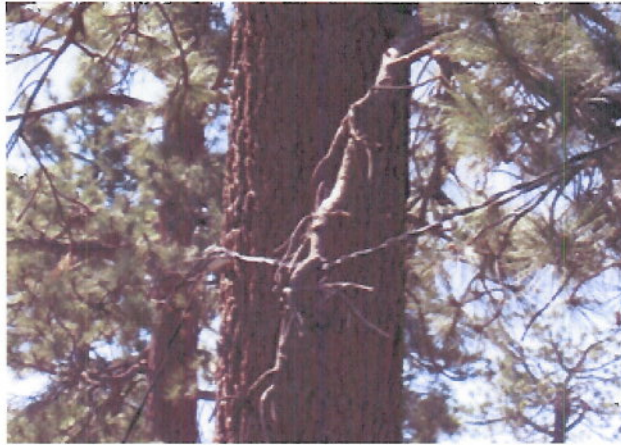
**Picture 11**

- b) Pole 8151BV had a secondary service drop showing strain from tree contact due to a misplaced tree guard.
- c) The following poles had secondary service drop(s) showing strain from tree contact:
- 4644BV
  - 31519CIT
  - BV11689 (See **Picture 11**)
  - 8153BV

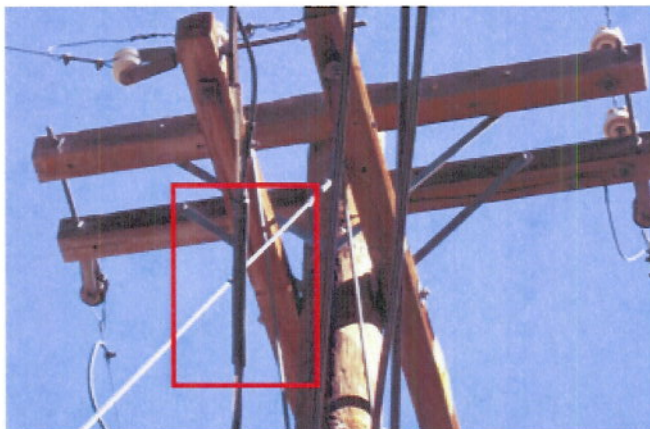
**Picture 12**

- a) Pole BV4642 had the down guy wire touching a communication cable.
- b) Pole BV4643 had the down guy wire touching a secondary service drop.  
(See Picture 12)

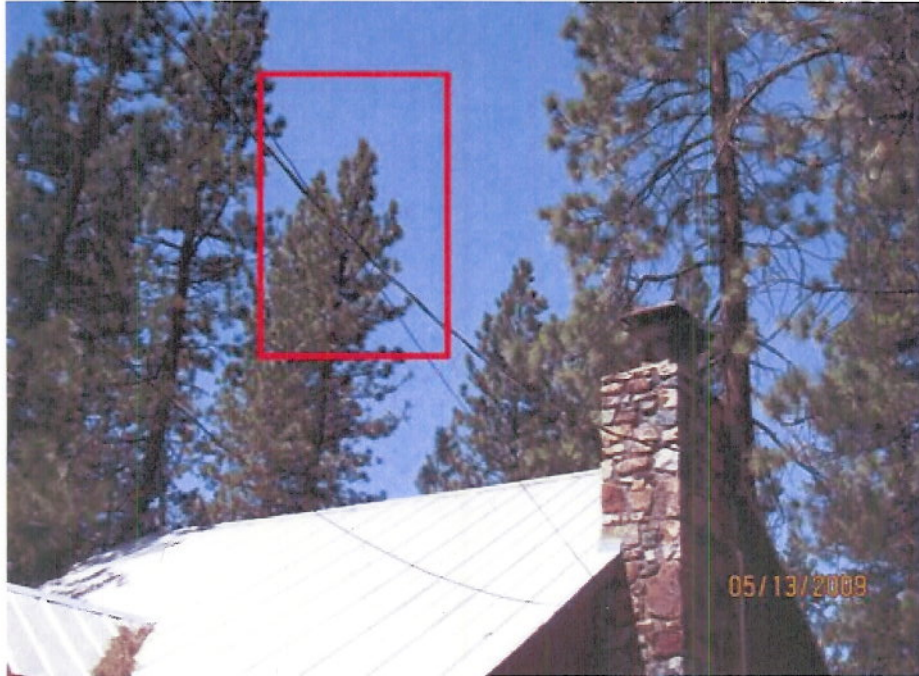
Picture 13

- c) Pole 31518CIT had the secondary service drop touching a communication cable.  
(See Picture 13)

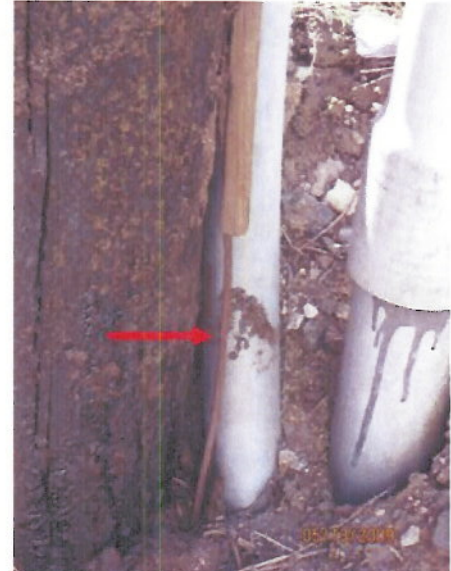
Picture 14

The following poles had damaged or missing ground mouldings:

- BV9531 (See Picture 14)
- BV9530
- CIT60513
- 4968BV
- 9214BV
- 7744BV
- 8132BV
- 8266BV
- 8151BV
- 8151BV
- 8064BV

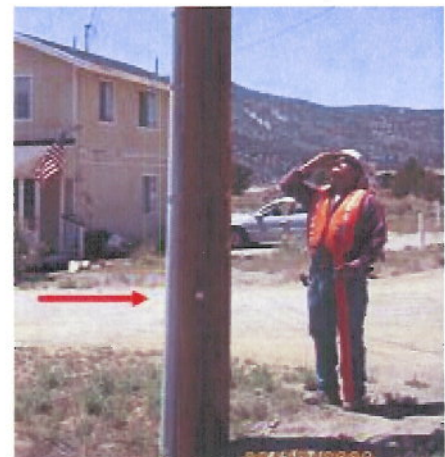
Picture 15

The following poles exceeded 36 inches between the attachment materials:

- BV10249
- 9214BV (See Picture 15)
- 8266BV

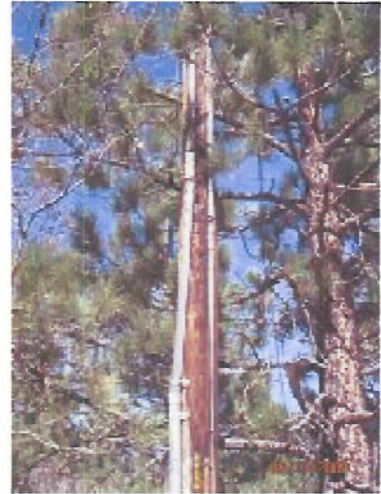
Picture 16

Pole 6922BV had climbing space obstructed by a tree.  
(See Picture 16)

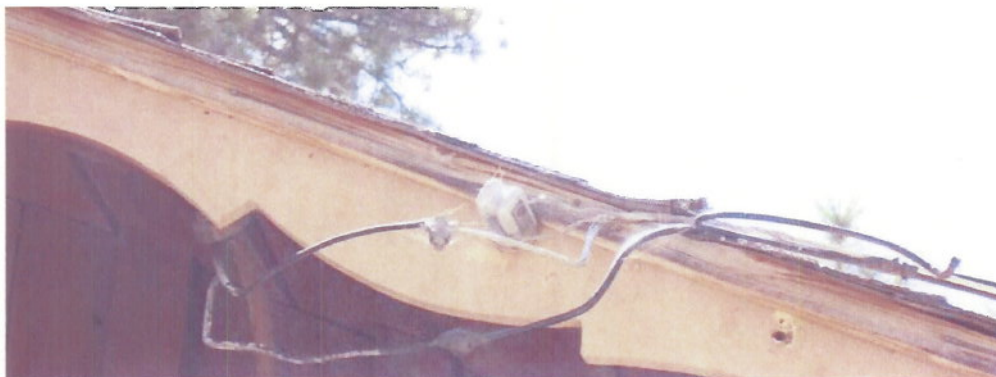
Picture 17

Pole 31518CIT had a secondary service drop deflected by 1161 Brookside Lane’s roof. (See Picture 17)

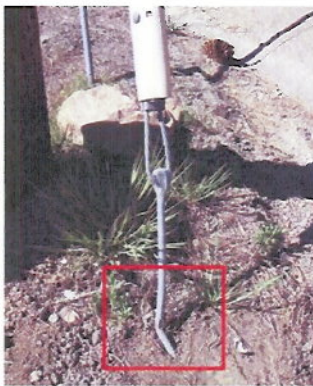
Picture 18

Pole BV4642 had a bent guy anchor, resulting in the guy to be slack.  
(See Picture 18)

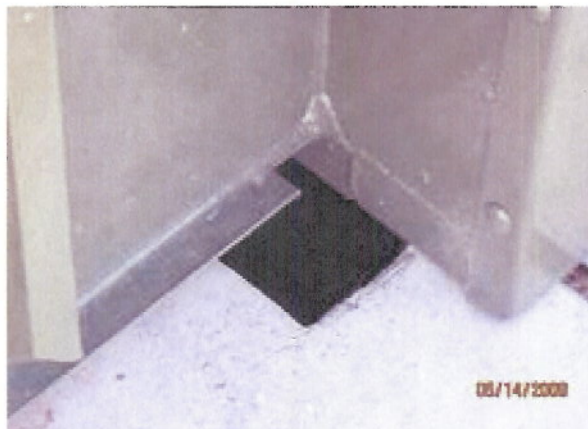
Picture 19

The following padmount transformer equipment has openings accessible to the public:

- a) 1217250402 (See Picture 19)

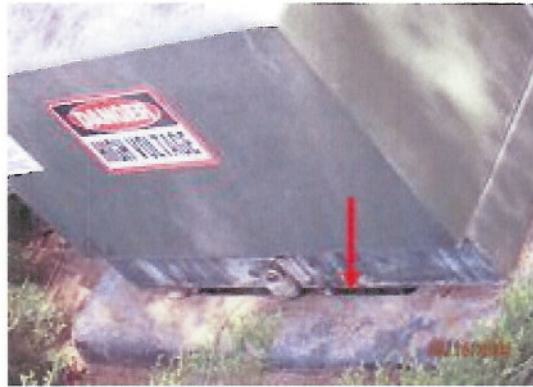
Picture 20

b) 911078518 (See Picture 20)

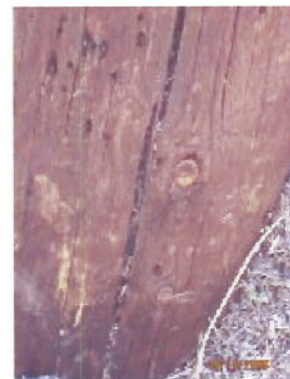
Picture 21

1. Pole CIT60513 may have an ant infestation at the base of the pole. The pole should undergo intrusive testing to determine the safety factor to ensure compliance with GO 95 Rule 44.2. (See Picture 21)

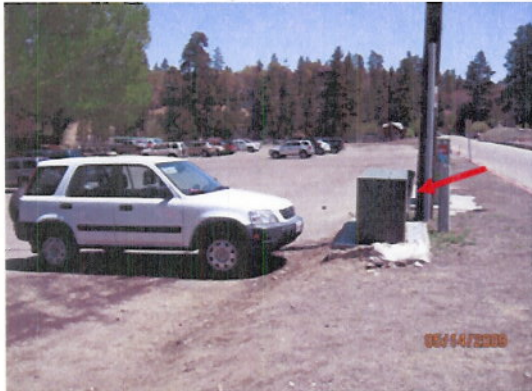
Picture 22

- Surface equipment adjacent to pole 10237BV, located in the parking lot of Bear Mountain Ski Resort, 43101 Goldmine Drive, Big Bear Lake, should be protected from accidental damage by vehicular traffic by installing barricades. (See Pictures 22 and 23)

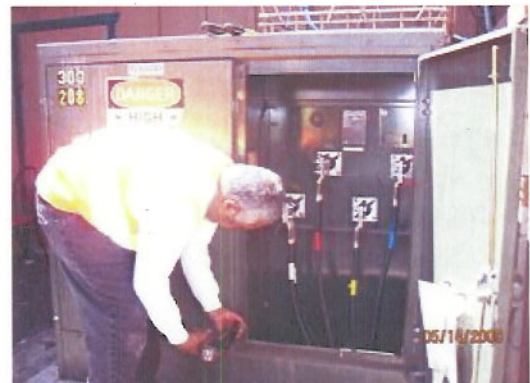
Picture 24

- While inspecting underground equipment with Dan Gutierrez, we found that he was not wearing personal protective equipment (PPE), such as a pair of gloves or a hard hat. When accessing any electrical equipment, workers should wear the appropriate PPE to guard against potential safety hazards. (See Picture 24)

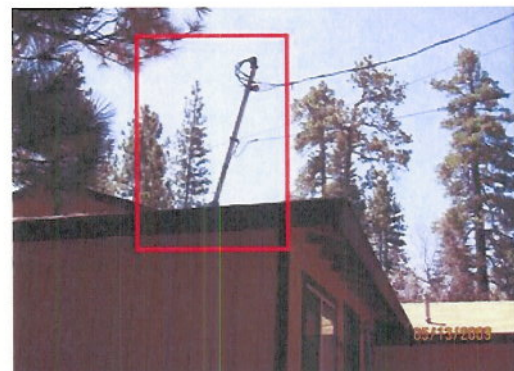
Picture 25

- Pole 4922BV had a secondary service drop connected to a bent weather head with a missing cap. (See Picture 25)
