# CALIFORNIA PUBLIC UTILITIES COMMISSION Safety and Enforcement Division Electric Safety and Reliability Branch

# **Incident Investigation Report**

Incident Number: E20141112-01

**Utility:** PG&E

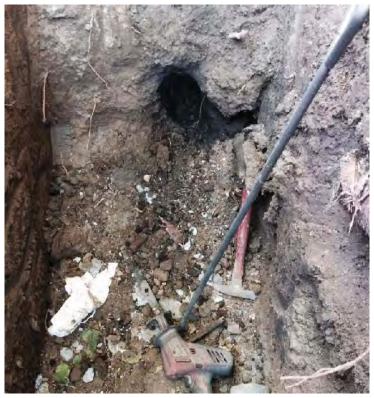
Figure 2. Saw and location of explosion.

The damaged conductor was installed by PG&E in 1990 via a bore-in method that does not require excavation. When installing the conductor, the proper clearance of six (6) inches (GO 128, Rule 33.4-A3a) when crossing another utility or foreign structure, was not obtained. The conduit and conductor were installed by boring through the ground and clay sewer pipe. The PG&E facilities were left interfering with the operation of the sewer pipe.

I believe Mr. did not excavate around the sewer pipe because he believed that the underground conductor was, in fact, a root because PG&E's markings did not indicate any underground PG&E's facilities at this location. Figure 2 (below), taken the day of the incident by PG&E, shows the charring of dirt from the explosion from within the pipe. Mr. inserted the saw into the pipe and proceeded to saw the conduit resulting in the injury.

My investigation found PG&E in violation of GO 128, Rule 17.7 for not marking its underground facilities properly, and Rule 33.4-A3a for not installing its conduit with at least 6 inches of separation from the residential sewer pipe.
