SCE VALLEY SOUTH SUBTRANSMISSION PROJECT

Date: August 8, 2019
To: Eric Chiang, Project Manager, CPUC
From: Vida Strong, Aspen Project Manager
Subject: Monitoring Report #8: July 21, 2019 to August 3, 2019

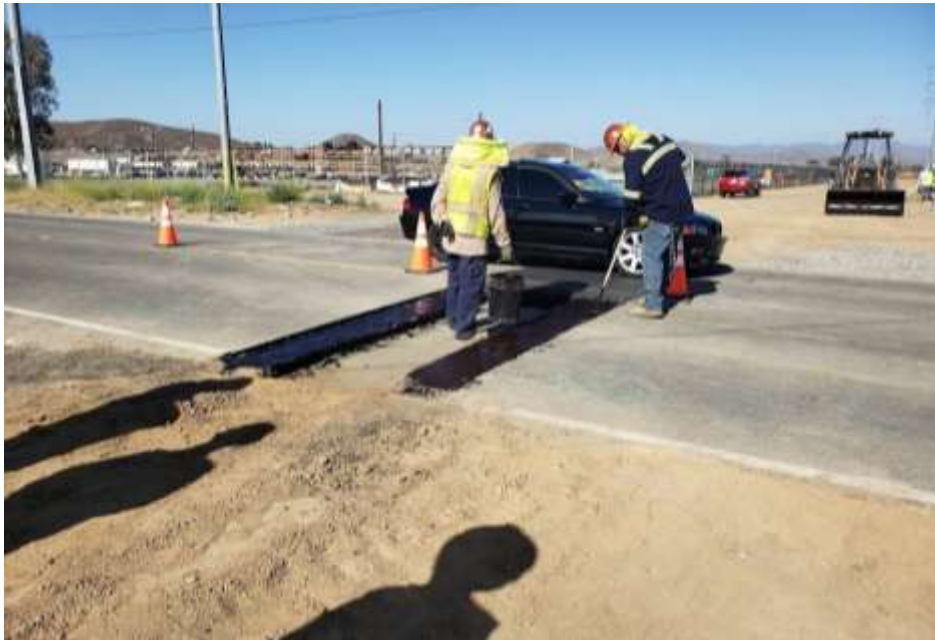
2. BMP inspections and maintenance occurred at TSP foundation locations in Segment 1.
3. Cattract pulled rope through the conduit on the northern underground and paved the trench across Menifee Road (see Photo 1). Cattract then mobilized to southern underground section on Leon Road (Construction Areas UNK207 through UNK222), marked, and cut pavement for the underground trench and vaults.

Photo 1 – Paving activities on Menifee Road for the northern underground section near Valley Substation (July 24, 2019).

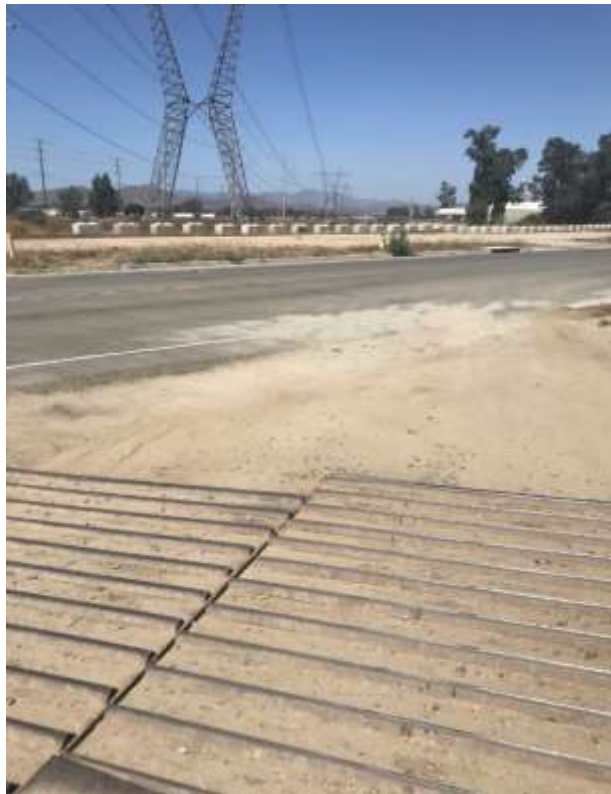
8. On July 24, the CPUC EMs observed the Valley Yard construction entrance off Matthews Road with track out; the entrance hadn't been improved in accordance with SWPPP TC-1 requirements (see Photo 2). The Wilson Environmental Manager and the SCE Environmental Manager were notified of

Photo 2 – Track-out at the construction entrance without proper SWPPP TC-1 required stabilization off Matthews Road to the Valley Yard (July 24, 2019).

the observation. During a conference call on July 25, SCE stated that a construction entrance in accordance with SWPPP TC-1 requirements will be installed at the location. During the CPUC EMs visit on July 31, it was noted that a stabilized entrance was installed (see Photo 3).

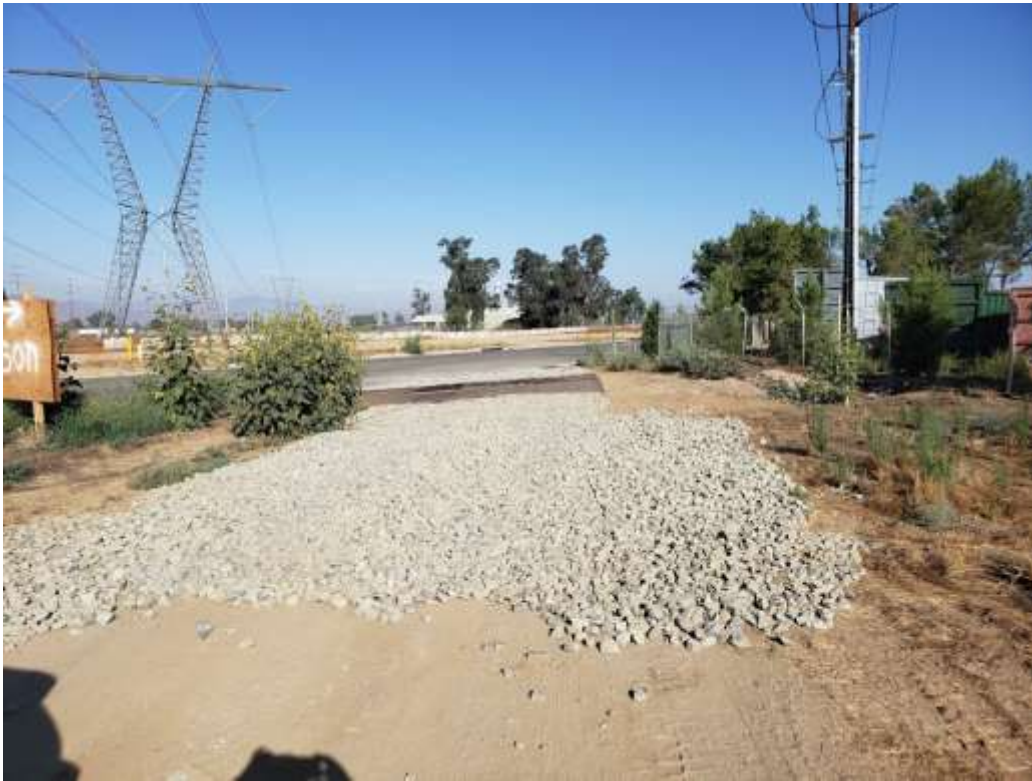
Photo 3 – Valley Yard construction entrance with SWPPP TC-1 required stabilization (July 31, 2019).
