**PROJECT MEMORANDUM
SCE TRANSMISSION PROJECTS, SEGMENTS 1 - 11**

To: John Boccio, Project Manager, CPUC
From: Vida Strong, Aspen Project Manager
Date: June 3, 2010
Subject: Weekly Reports 121-122 — May 9 to May 22, 2010

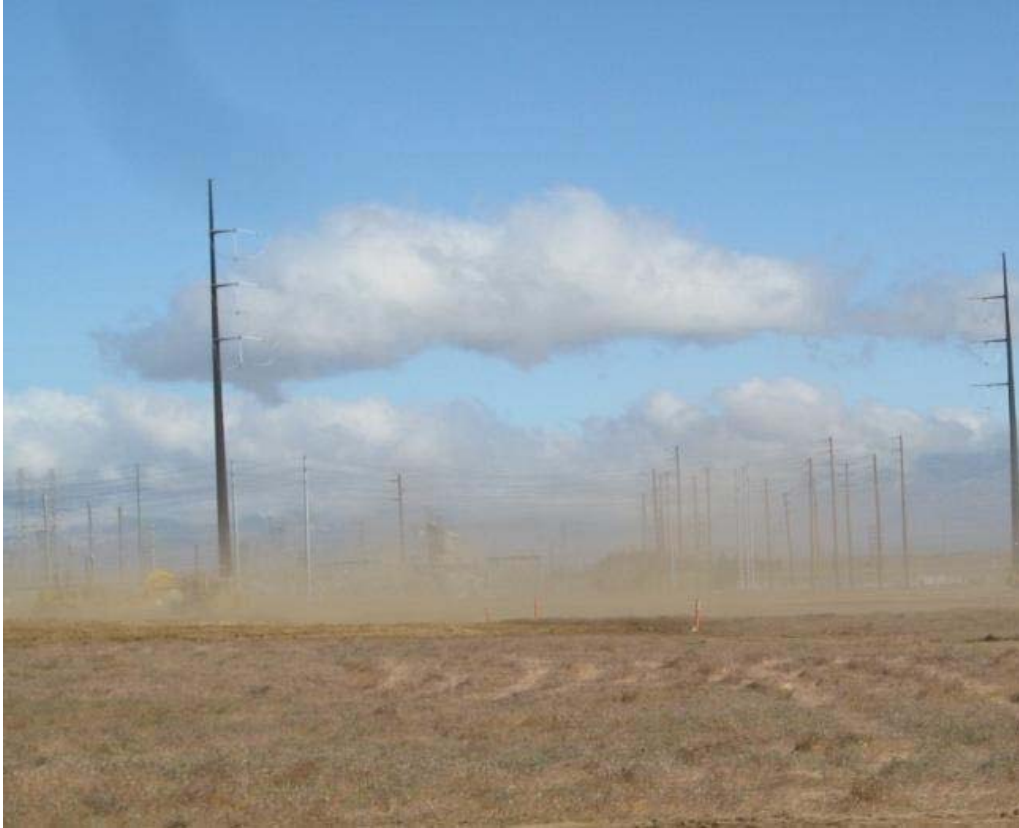
2. High winds caused dust problems at the Antelope expansion area. The problem was brought to the attention of the SCE Site Manager. Water trucks are present, but during high winds dust was still observed leaving the work site (see Figure 1).

Figure 1: Fugitive dust observed during grading activities at the Antelope substation expansion area.

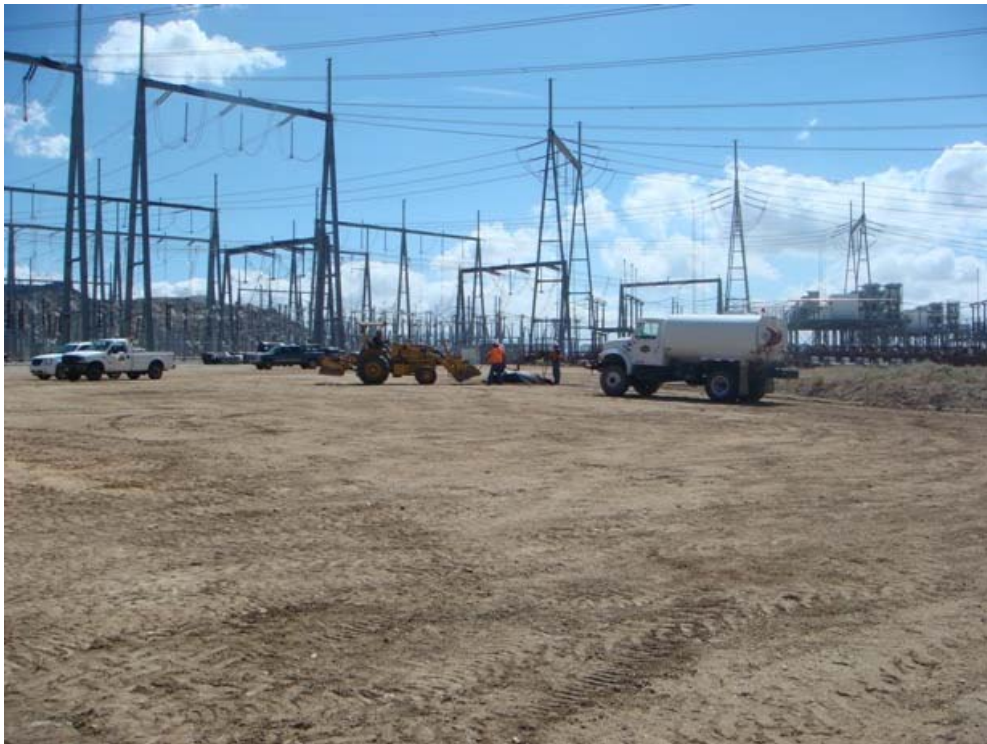
1. Activities continued under CPUC NTP #2 for the expansion of the Vincent Substation. Grading of the expansion area has yet to occur. Other activities included clearing an area for trailers to be relocated, foundation prep-work, and cable trenching, all within the existing substation area (see Figure 2). Topsoil salvage took place for a small, cleared area and is being stored onsite.

Figure 2: Construction at the Vincent Substation within the existing substation.
