**PROJECT MEMORANDUM
SCE TRANSMISSION PROJECTS, SEGMENTS 1 - 11**

To: John Boccio, Project Manager, CPUC
From: Vida Strong, Aspen Project Manager
Date: June 30, 2010
Subject: Weekly Reports 125-126 — June 6 to June 19, 2010

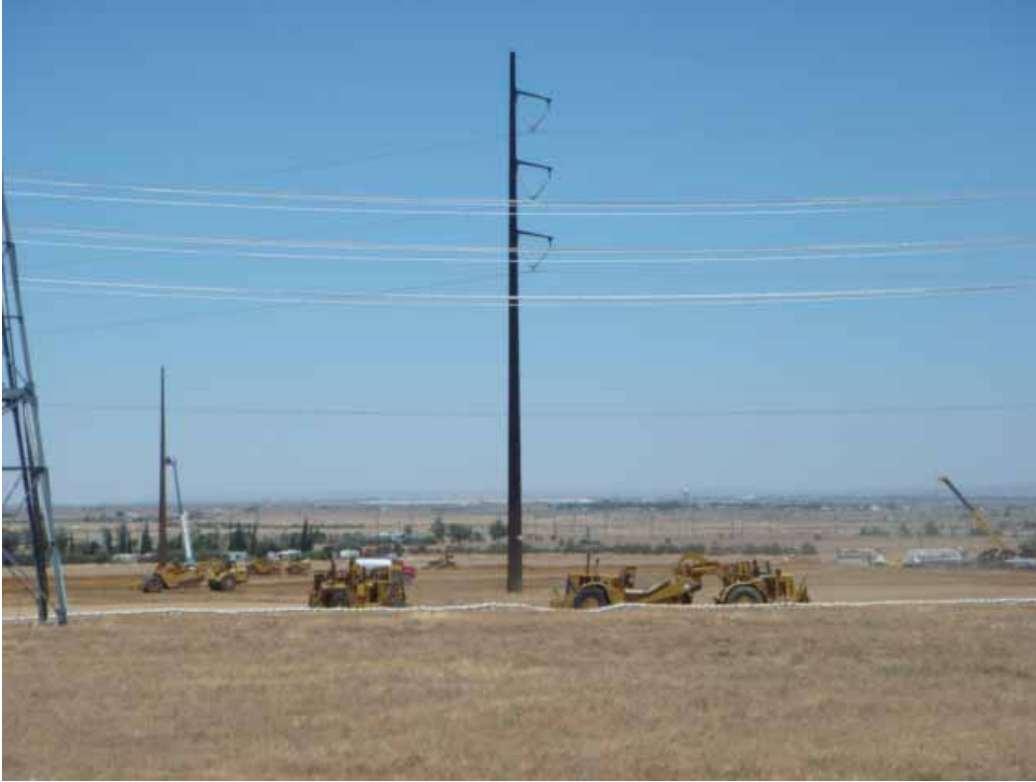
Figure 1: Grading continued at the Antelope Substation.

1. Grading of the Antelope Substation continued and additional soil was delivered from Windhub Substation (see Figure 1).
2. The Sagebrush 220 kV transmission line relocation continued with the installation of four new tubular steel poles.
3. The 66 kV crew pulled cable to vaults near Towers 171 and 172.
4. Erosion problems have been identified at several locations in Segment 1 including Towers 9 and 99. Repairs have been made at Tower 99, subject to SCE review, and have yet to be conducted at Tower 9.
5. Habitat restoration continued in Segment 1. ECORP and Nature's Image are conducting maintenance activities including weeding in areas previously seeded. Areas still requiring treatment in Segment 1 include Wire Stringing Site 3 and Tower 9.

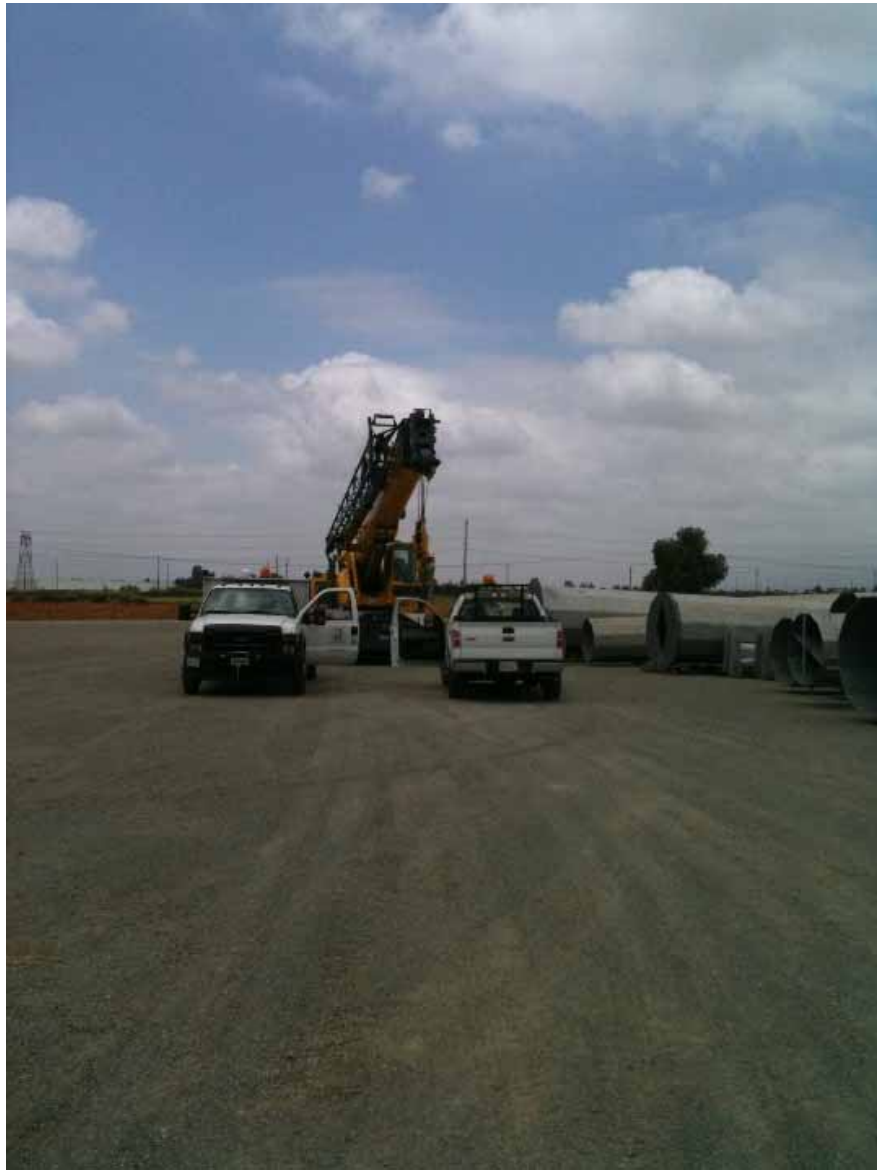
Figure 2: Material delivery to the Rancho Vista Yard. Exclusion fencing for the Delhi sands flower-loving fly area is seen in background.

2. The Rancho Vista Yard in Rancho Cucamonga began receiving materials on June 7, 2010. Materials were off-loaded in the northeast portion of the yard (see Figure 2). Orange fencing in the yard clearly demarcated the 50-foot buffer for Delhi sands flower-loving fly; no construction activity occurred within the sensitive area.

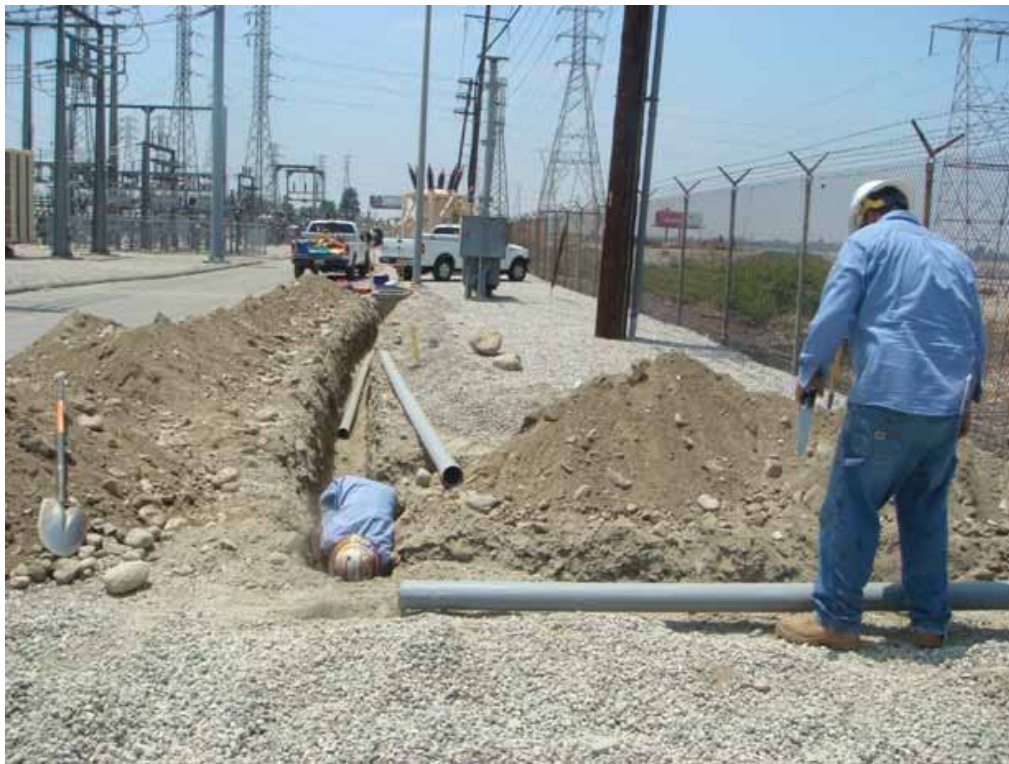
Figure 3: Trenching inside of the Rio Hondo Substation for the Segment 7 Telecom work.

4. Segment 7 Telecom work included underground trenching within the Rio Hondo Substation and installation of a wood pole. Segment 7 telecom work also included helicopter activities, including lifting equipments, tools, and workers to support fiber optic cable installation between towers and spanning Interstate 605 (see Figures 3 and 4).

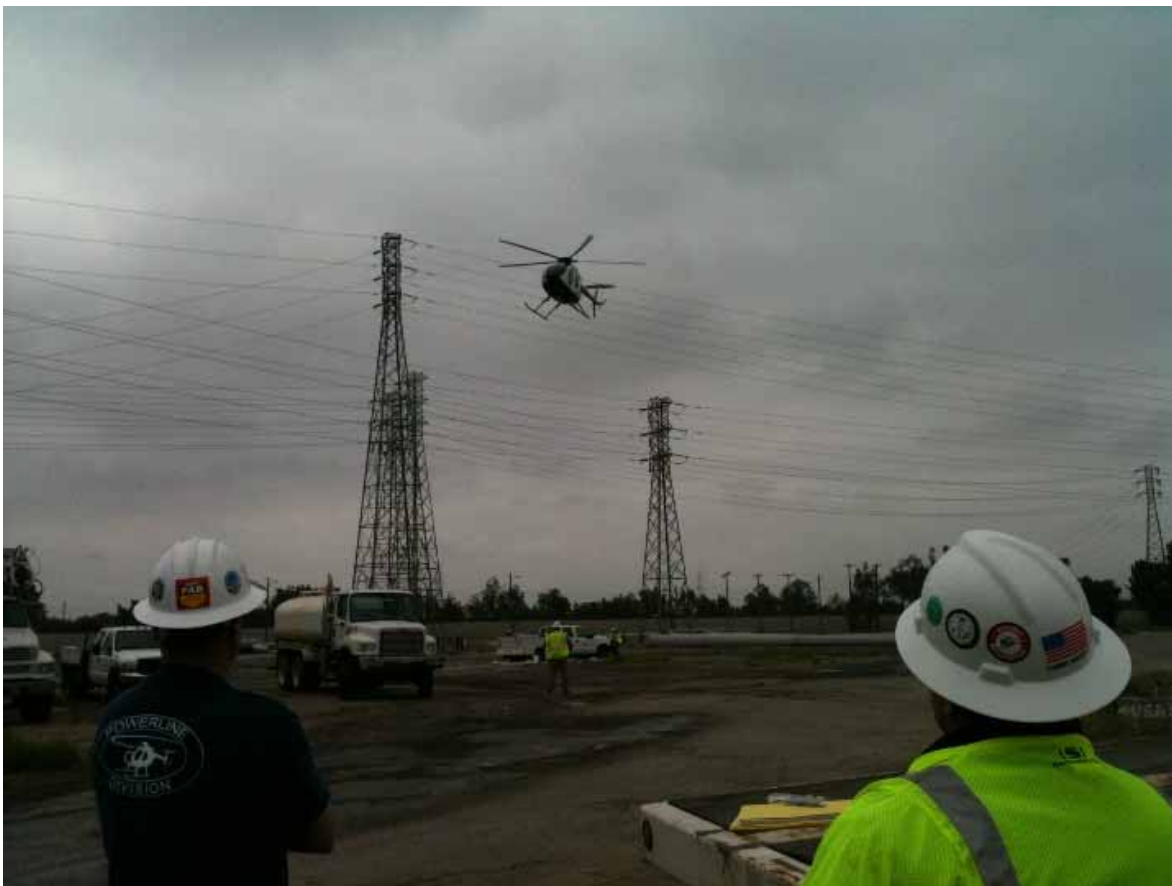
Figure 4: Helicopter installation of the Segment 7 Telecom line near the Rio Hondo Substation.
