**PROJECT MEMORANDUM  
SCE TRANSMISSION PROJECTS, SEGMENTS 1 - 11**

**To:** John Boccio, Project Manager, CPUC  
**From:** Vida Strong, Aspen Project Manager  
**Date:** October 15, 2010  
**Subject:** Weekly Report 140 – September 26 to October 2, 2010

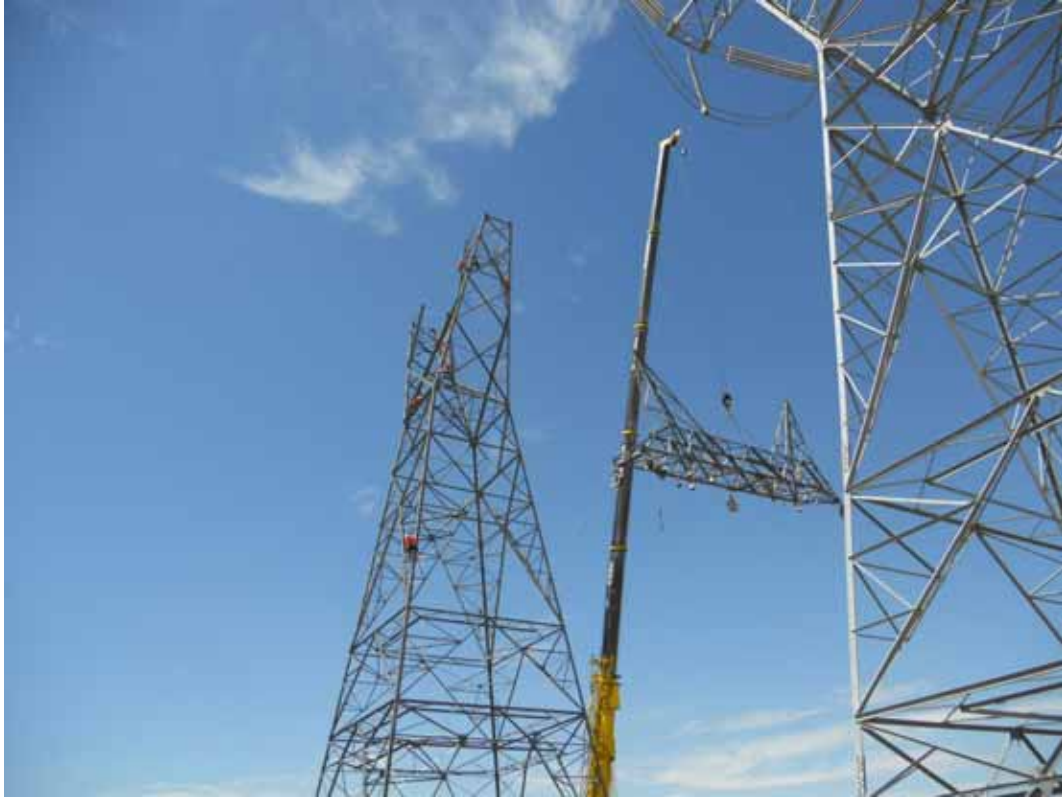
1. Electrical and 220 kV work continued within the Vincent Substation.
2. Work activities on Segment 4 at Towers 34 and 35 included tower erection, water truck, and heavy equipment use (Figure 1).
3. Activities at the Racetrack Yard included equipment maintenance, installation of green screen along the yard perimeter fence, and water line excavations. Material delivery and pulling wire into the trailers was conducted at Material Yard 28.
4. Work continued on Segment 5 at Towers 58A to 62. Activities included foundation drilling, equipment delivery, BMP installation, assembling forms for the pole foundations, and setting steel rebar cages in foundation holes (Figure 2).

**Figure 1:** Segment 4, Tower 34 bridge installation

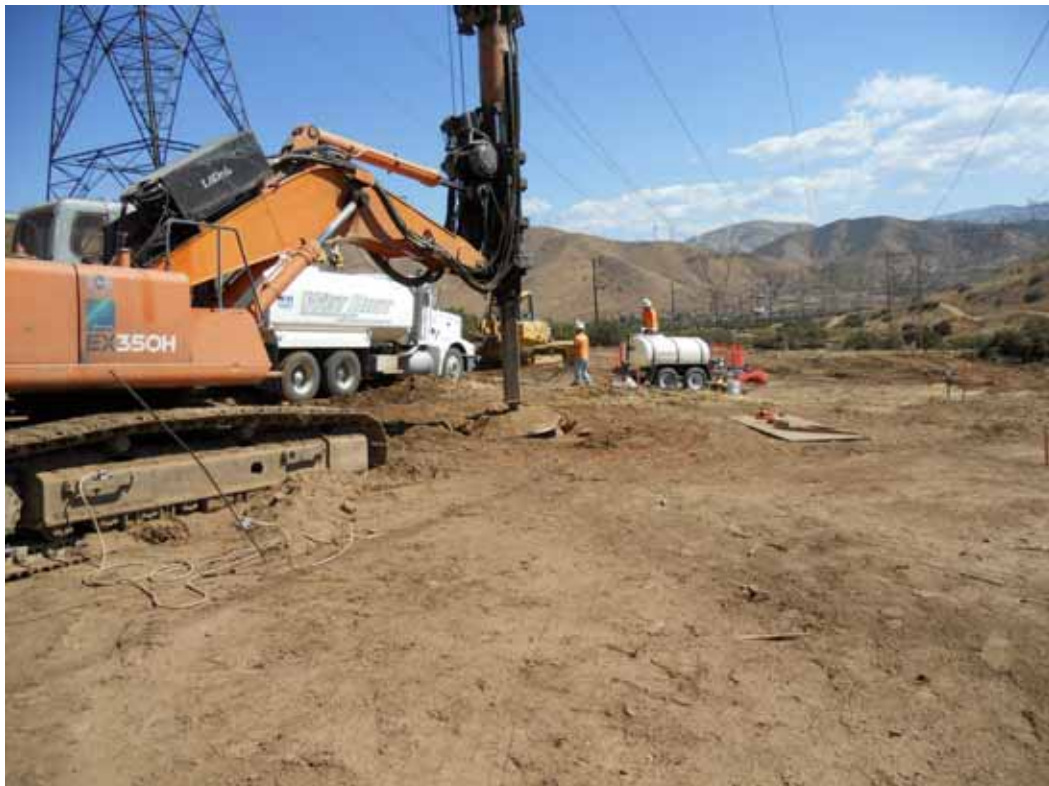
**Figure 2:** Segment 5, Tower 61 foundation drilling

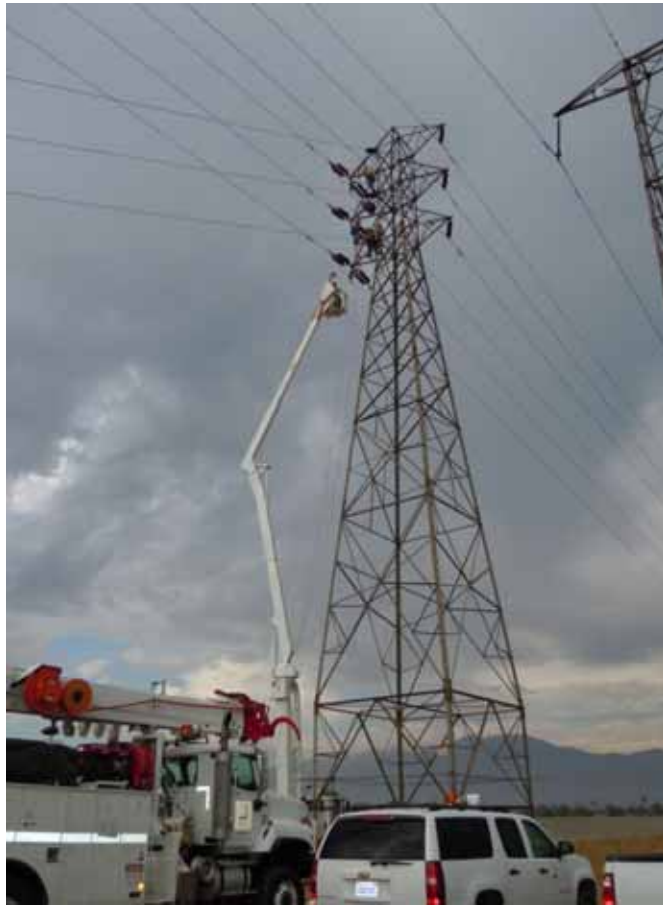
1. During the subject period, SCE crews continued work on the Rio Hondo–Amador-Jose-Mesa line. SCE crews performed work on a tower north of Ramona Boulevard (see Figure 3), where they rearranged line connections from a wooden power line to the tower. SCE crews also continued work on the Chino Substation 66 kV Relocation in the City of Chino. Work included the framing and setting of lightweight steel poles between Eucalyptus Avenue and Chino Hills Parkway.

**Figure 3:** On the Rio Hondo–Amador-Jose-Mesa 66 kV line, crews rearrange a line connection on a tower north of Ramona Boulevard.

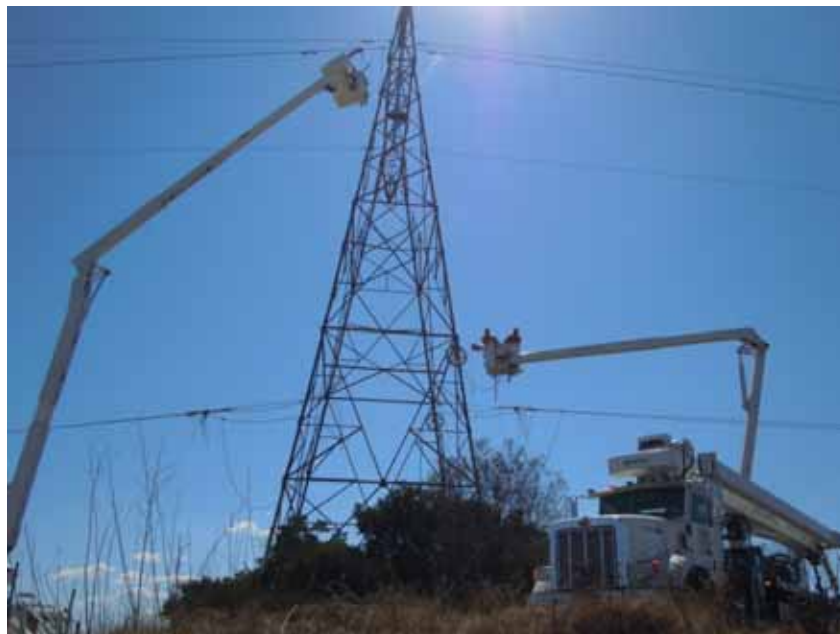
3. Demolition of the Chino-Mesa 220 kV towers continued in the City of Industry in Tonner Canyon, Segment 8, Phase I (see Figure 4). Crews removed hardware and wires from Towers M56-T4 east through M58-T3. Wire was removed between M57-T2 and M58-T3 using V-grooves and ropes to avoid letting the wire hit the vegetation or the ground. After the wire was removed between towers M57-T2 and M56-T4, the ropes were removed using a helicopter.

**Figure 4:** In Tonner Canyon, crews install travelers on old transmission lines prior to removal.

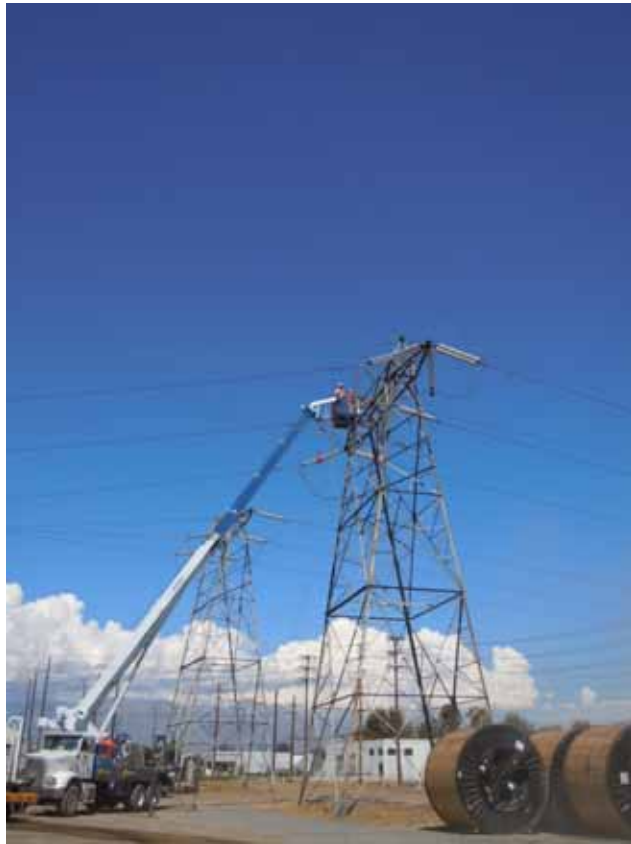
4. Construction in Segment 8, Phase 2 began with the wreck-out of the Chino-Mira Loma No. 1 structures in the cities of Chino and Ontario. Work included the removal of hardware and wire between Towers M0-T4 and M3-T4 (see Figure 5).

**Figure 5:** Segment 8 Phase 2, crews remove hardware at M0-T2 adjacent to Chino Substation.
