**PROJECT MEMORANDUM
SCE TRANSMISSION PROJECTS, SEGMENTS 1 - 11**

To: John Boccio, Project Manager, CPUC
From: Vida Strong, Aspen Project Manager
Date: November 04, 2010
Subject: Weekly Report 144 — October 24 to October 30, 2010

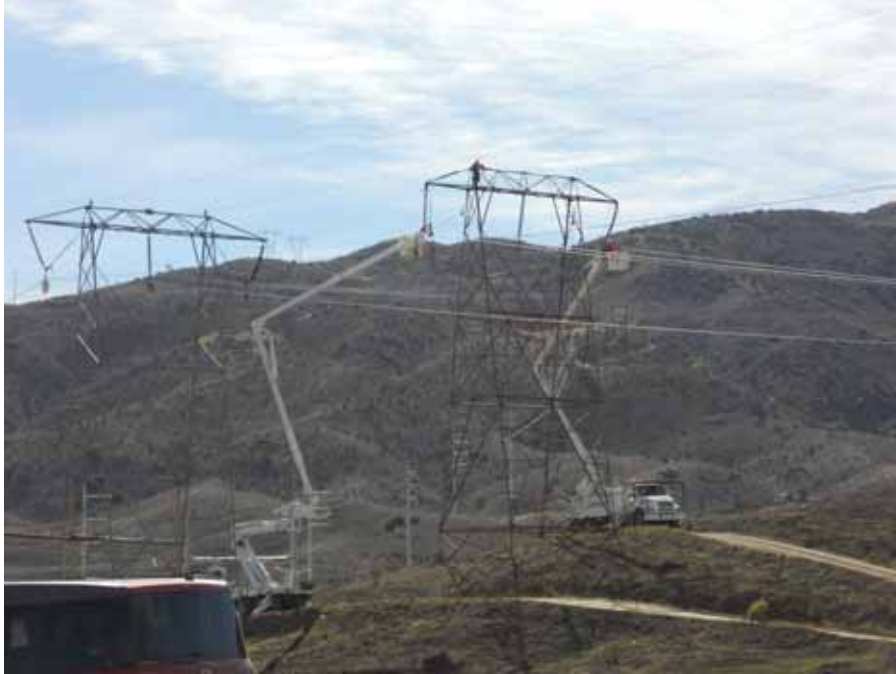
Figure 1: Segment 5: Wire removal from existing 220 kV lines during the Sagebrush Transmission Line outage near Tower 37.

5. Other work on Segment 5 took place between Towers 30 and 41. This included BMP installation (i.e. fiber rolls), foundation drilling for new towers, rebar cage placement, and wire removal from the existing 220 kV wreck-out lines between Towers 37 and 41 (see Figure 1).

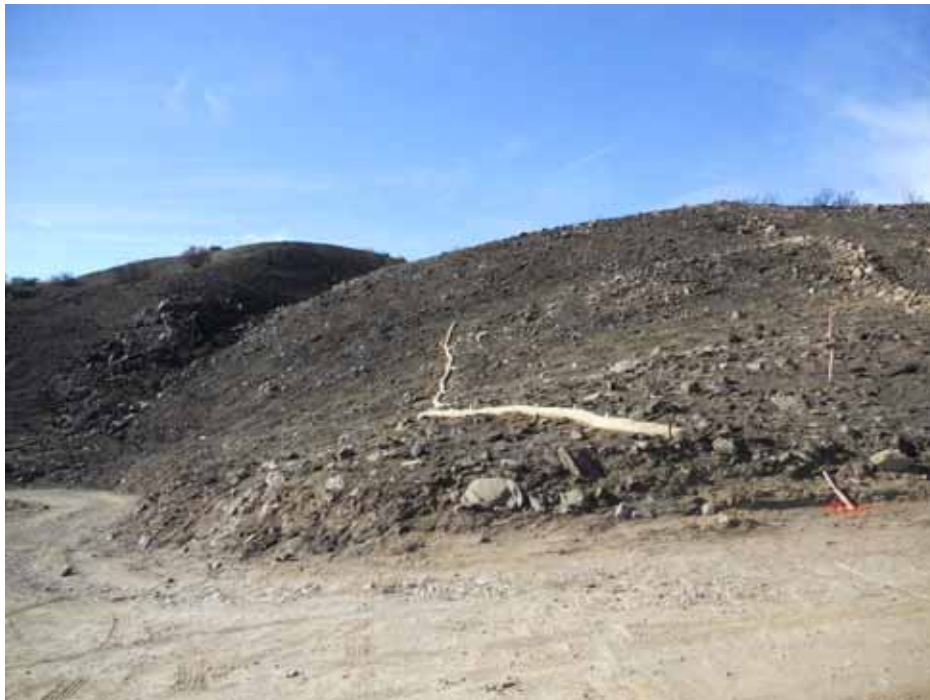
Figure 2: Segment 5: BMP (fiber roll) installation at Tower 31.

3. The CPUC EM and Burns & McDonnell Environmental Coordinator observed BMP installation outside of disturbance areas on Segment 5 at Towers 31 and 37 (see Figure 2). The installation of BMP's outside the disturbance limits was discussed with the SWPPP inspector for H&M, and was consistent with the approved SWPPP.

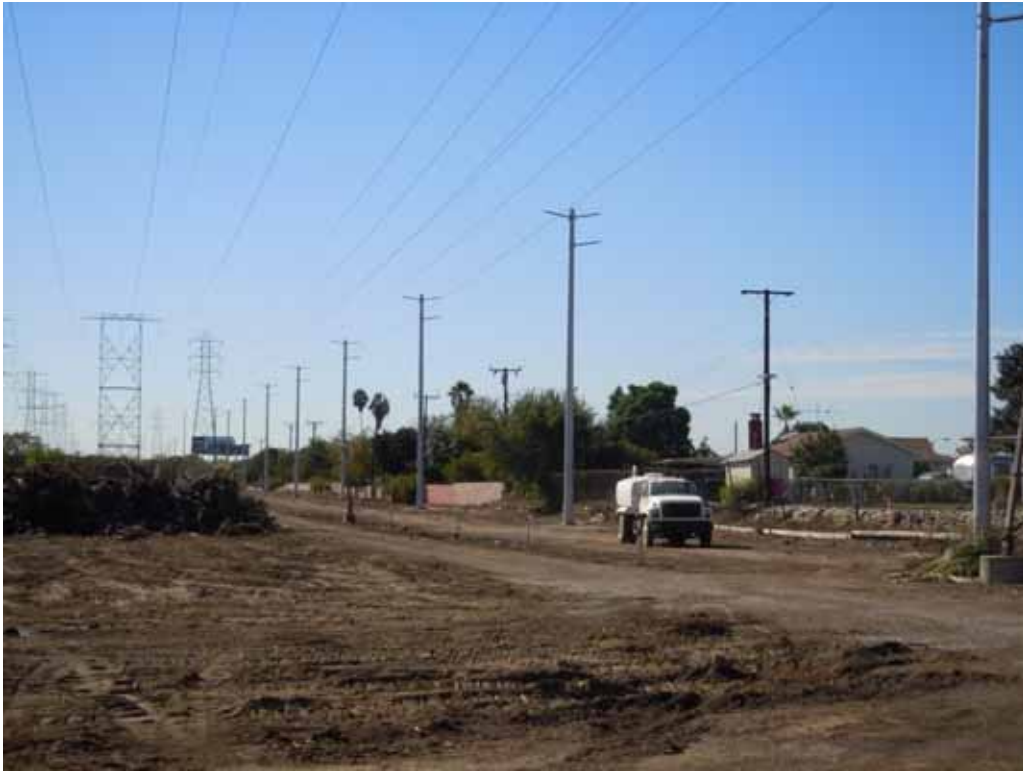
Figure 3: Newly installed Rio-Hondo-Amador-Jose-Mesa 66 kV poles within Gallos Nursery in the City of El Monte.

1. During the subject period, SCE crews continued work on the Rio Hondo–Amador-Jose-Mesa line continued in the City of El Monte within a nursery (see Figure 3).
2. Work on Segment 8 Telecom (final splicing) was completed.
3. Segment 8, Phase 1: Wilson crews removed towers M66-T2 through M65-T3 in the City of Chino (see Figure 4). Additionally, crews removed conductor and static wire from Towers M59-T2 to M56-T4 within Tonner Canyon in the City of Industry (see Figure 5).
4. Segment 8, Phase 2: Wilson construction crews completed the wreck-out of towers on the Chino–Mira Loma No. 1 structures in the Cities of Chino and Ontario during the subject period. DCX crews continued scrapping towers; materials were cut and then hauled off-site. Additionally, Tri-State drilled the foundation for Tower M0-T3 and began pouring the foundation on October 30th (see Figure 6).

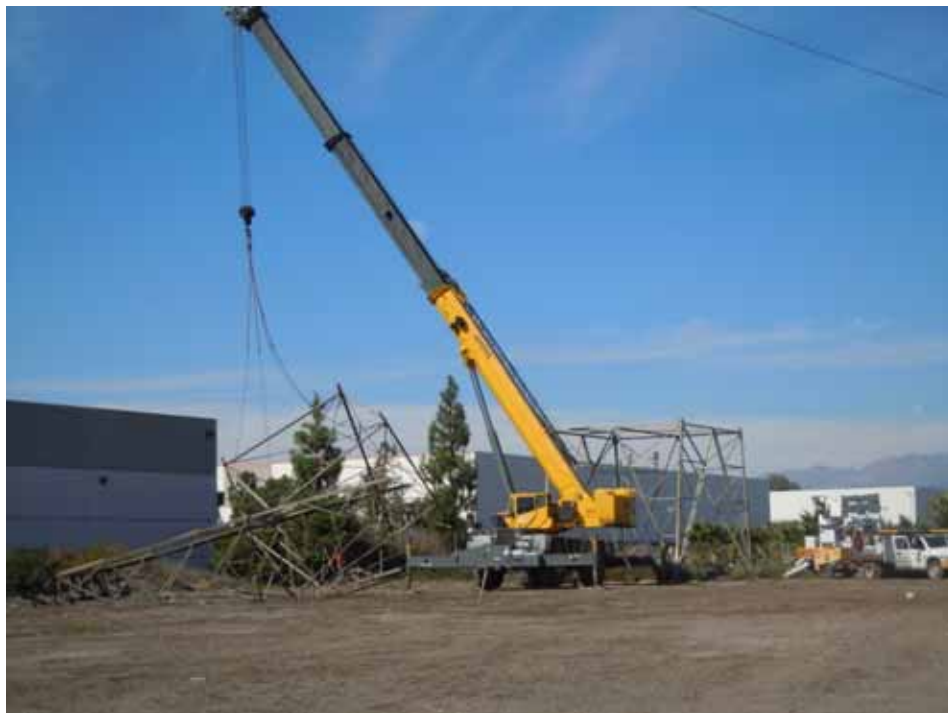
Figure 4: A Wilson crew works to remove Tower M66-T2 in the City of Chino, Segment 8, Phase 2.

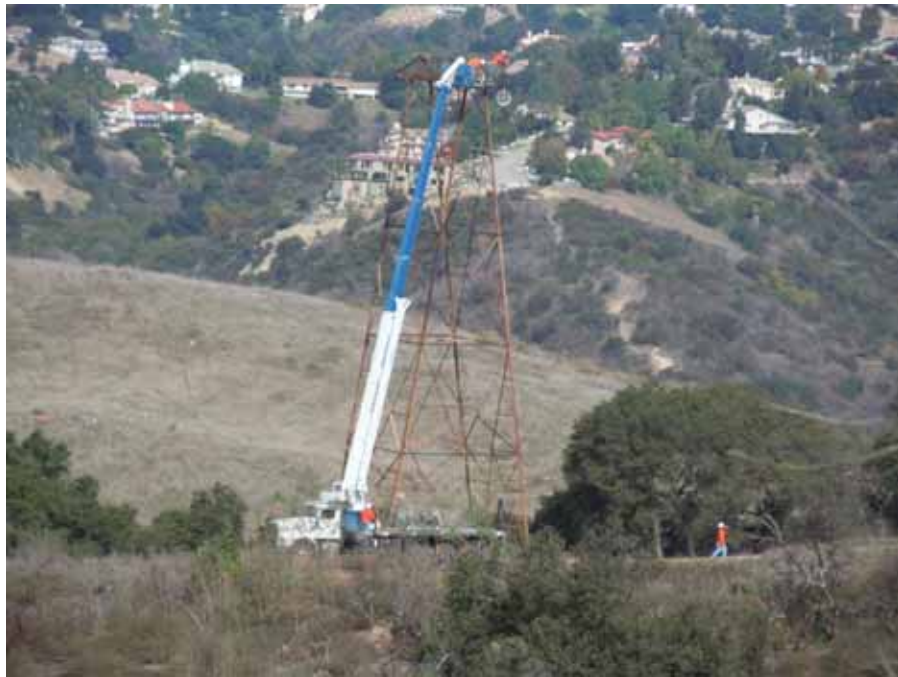
Figure 5: A Wilson lineman removes a traveler in preparation for tower wreck-out in Tonner Canyon, Segment 8, Phase 1.

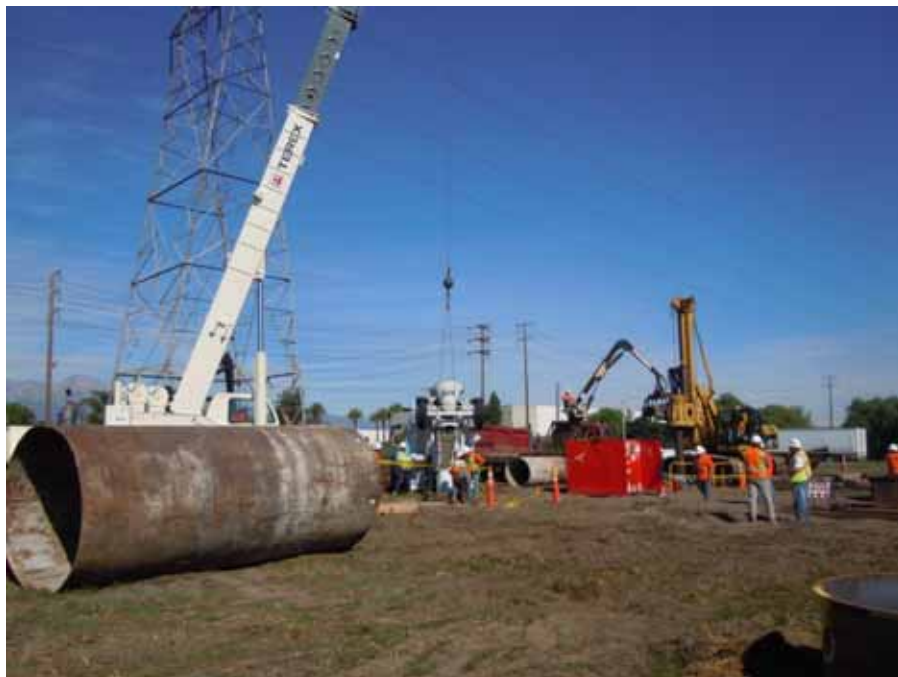
Figure 6: Segment 8 Phase 2, concrete pour for Tower M0-T3 foundations, outside of Chino Substation.
