**PROJECT MEMORANDUM
SCE TRANSMISSION PROJECTS, SEGMENTS 1 - 11**

To: John Boccio, Project Manager, CPUC
From: Vida Strong, Aspen Project Manager
Date: January 28, 2011
Subject: Weekly Report 156, January 16 to 22, 2011

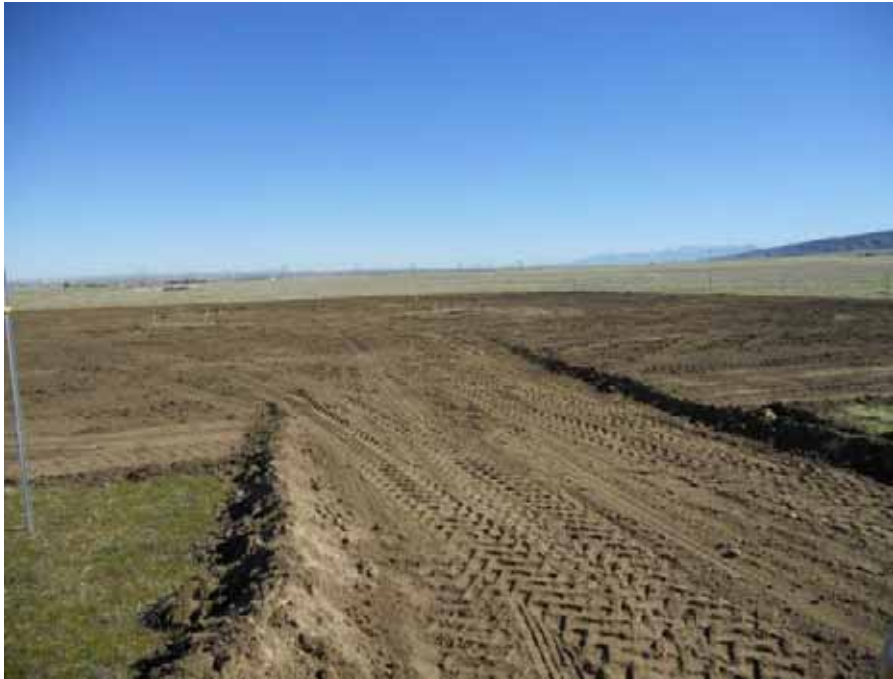
Figure 1: Site preparation for the construction of Tower 46, Segment 4.

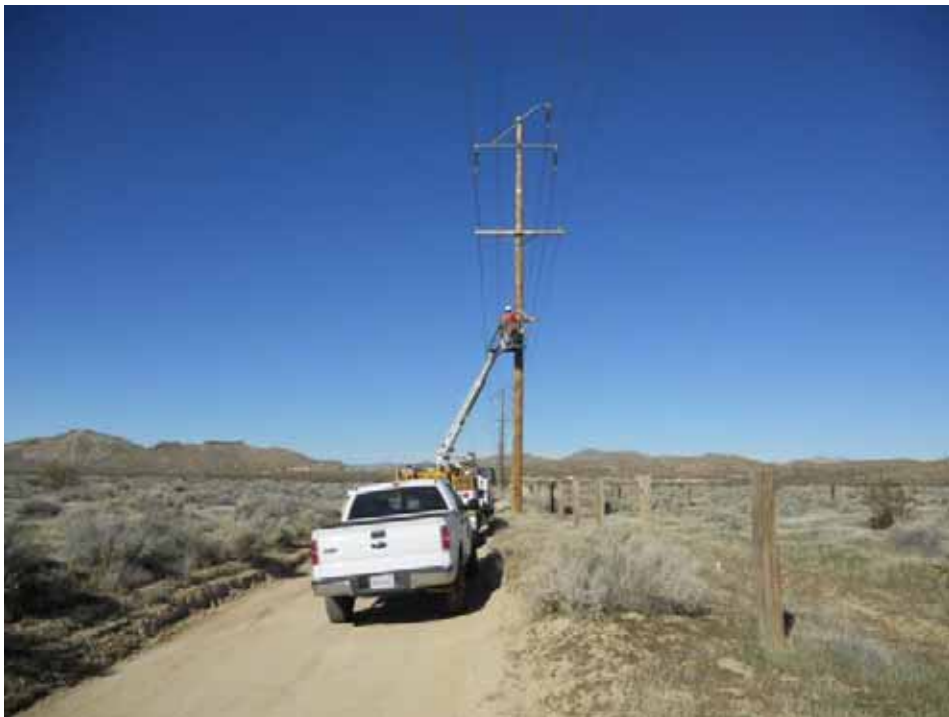
6. Segment 10 Telecom: Three H&M crews commenced work from the Rosamond Substation working north on 90th Street. One crew trenched from an existing wood pole along 90th into the Substation. Two crews worked from the road to install cable arms on the existing wood poles (see Figure 2). A

Figure 2: H&M crew installing cable arms on existing wood poles to support the telecom fiber optic cable (FOC) on 90th Street, Segment 10 Telecom.

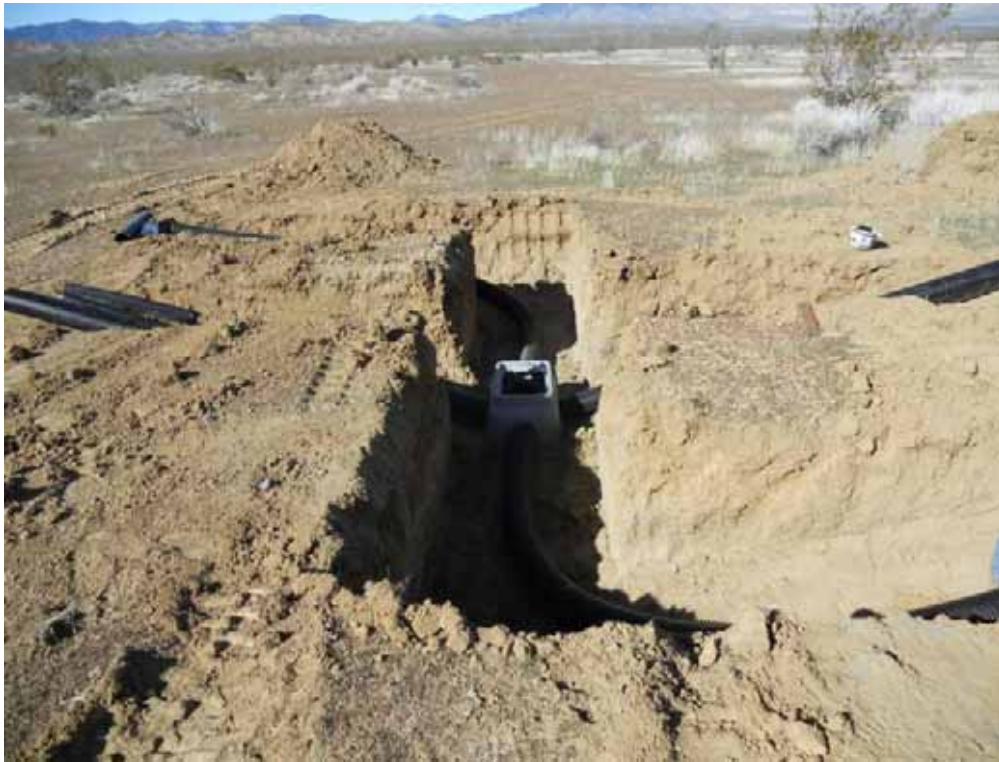
3. For the Whirlwind Substation construction, passive relocation activities took place for the burrowing owls and desert kit foxes within the substation boundary. The artificial burrowing owl and desert kit fox burrow construction commenced on Monday, January 17th outside of the Whirlwind Substation (see Figure 3). Three owl burrows were enhanced and another three artificial burrows were constructed. Two artificial kit fox dens were constructed. The original burrows will be collapsed after appropriate monitoring has been completed.

Figure 3: Artificial kit fox den near Whirlwind Substation, Segment 9.

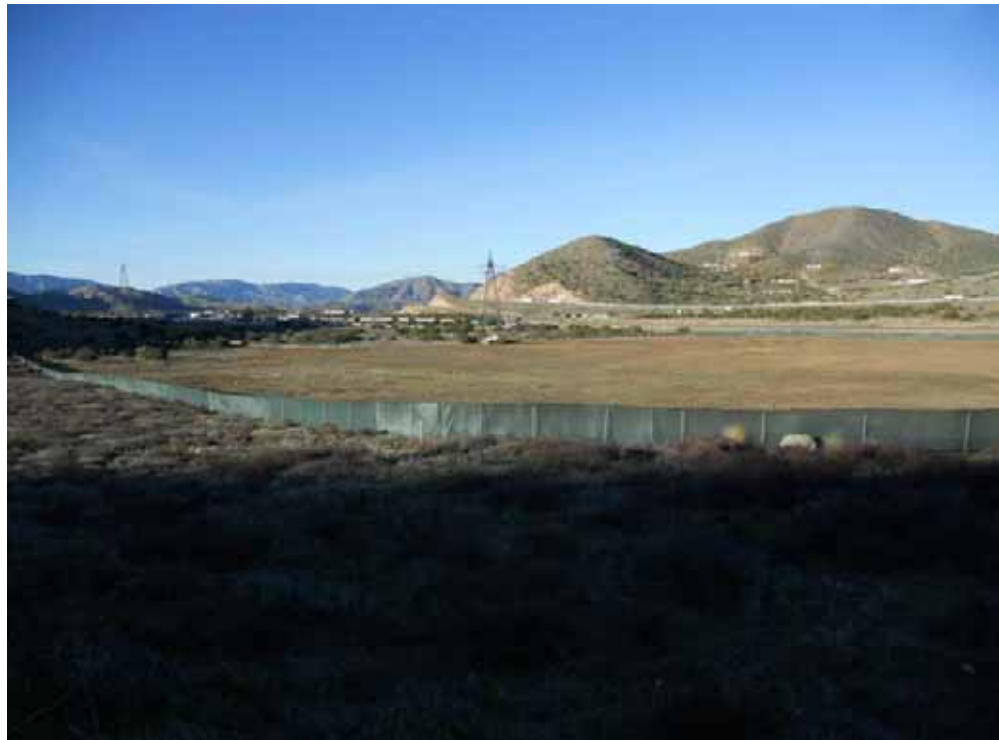
1. The Final EIS was released by the Angeles National Forest (ANF) on September 14, 2010. The ANF Record of Decision was issued on October 4, 2010, and the Special Use Permit is anticipated for release in early 2011. Construction is expected to begin in May 2011.
2. Vincent North and South Material Yards: During the subject period, fence installation continued, the Vincent South Yard was bladed, and BMP's were installed (see Figure 4).

Figure 4: View of fenced Vincent South Material Yard, Segments 6 & 11.

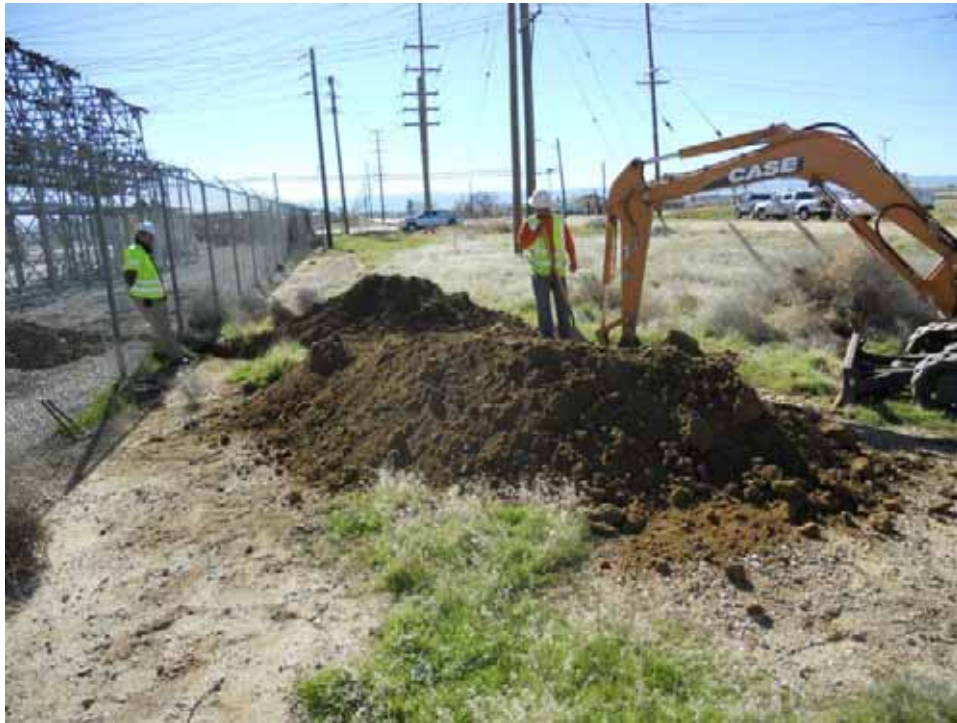
Figure 5: H&M crew trenching for underground FOC placement outside the Rosamond Substation, Segment 10 Telecom.

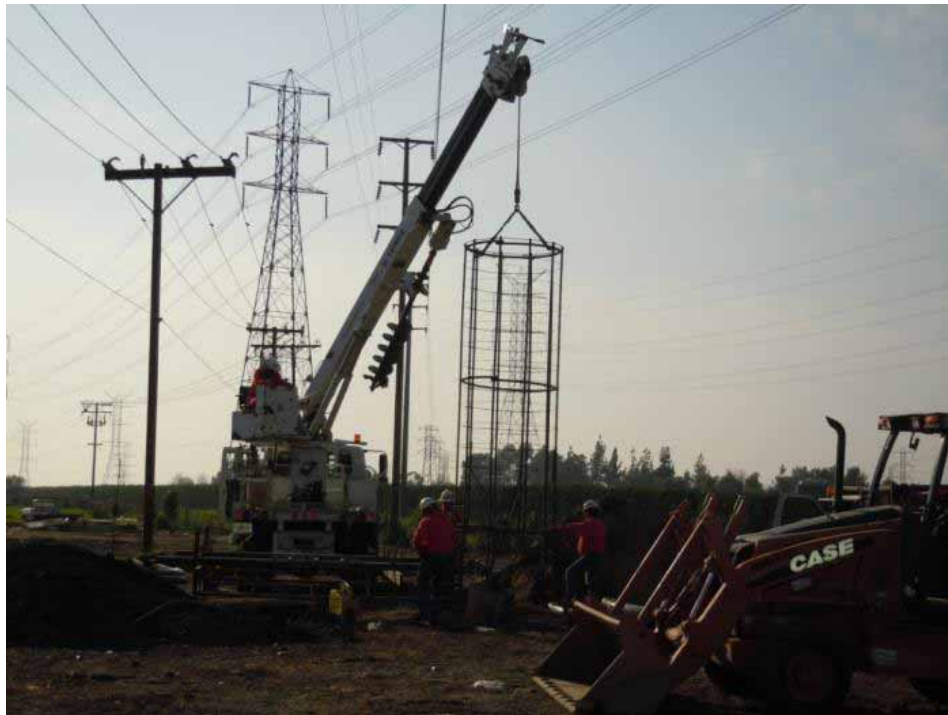
Figure 6: Crews installing foundation cage for a 66 kV riser pole, Segment 8.

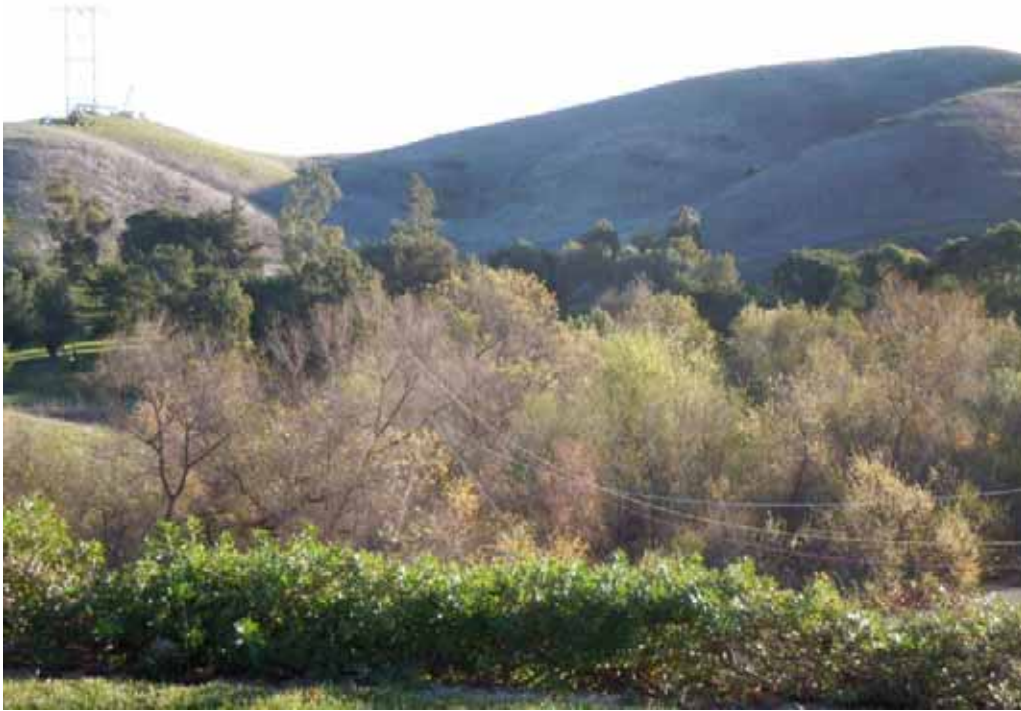
3. Segment 8, Phase 1: Wilson, DCX and Tri-State crews continued to work within Tonner Canyon in the City of Industry. Crews worked on assembly at Tower M23-T2a and began wire stringing at the M57-T3 shoofly. Additionally, crews began work within the City of Chino Hills, removing conductor at Towers M59-T2 through M64-T5, which included a crossing at the 71 freeway and over listed riparian bird habitat (see Figure 7). Tri-State continued drilling at Tower M58-T1.

Figure 7: Crews remove conductor using a sockline at Tower M60-2, Segment 8 Phase 1, near Chino Hills.

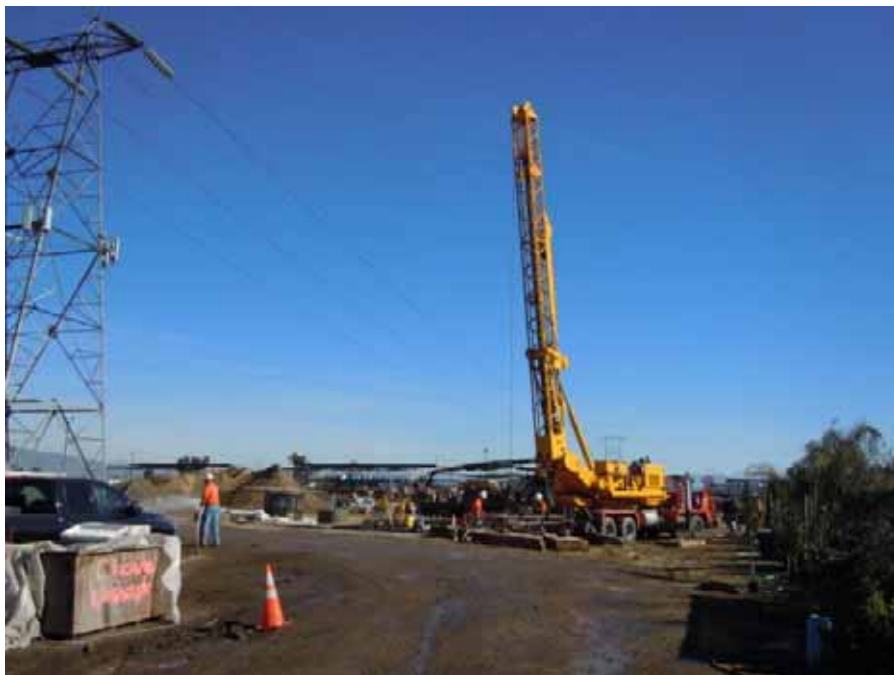
4. Segment 8, Phase 2: Wilson crews continued erection work at Towers M0-T4, Tri-State drilled foundations at Tower M1-T3, M1-T4 and M3-T1 (see Figure 8). DCX finished the foundations at Tower M3-T3 and began drilling foundations M3-T4 and M4-T3. Additionally, material was removed from the right-of-way from Towers M6-T9 through M6-T5 due to security concerns.

Figure 8: A Tri-State crew drills the foundation for Tower M1-T3, Segment 8, Phase 2, near Chino.
