**PROJECT MEMORANDUM
SCE TRANSMISSION PROJECTS, SEGMENTS 1 - 11**

To: John Boccio, Project Manager, CPUC
From: Vida Strong, Aspen Project Manager
Date: March 18, 2011
Subject: Weekly Report 162, February 27 to March 5, 2011

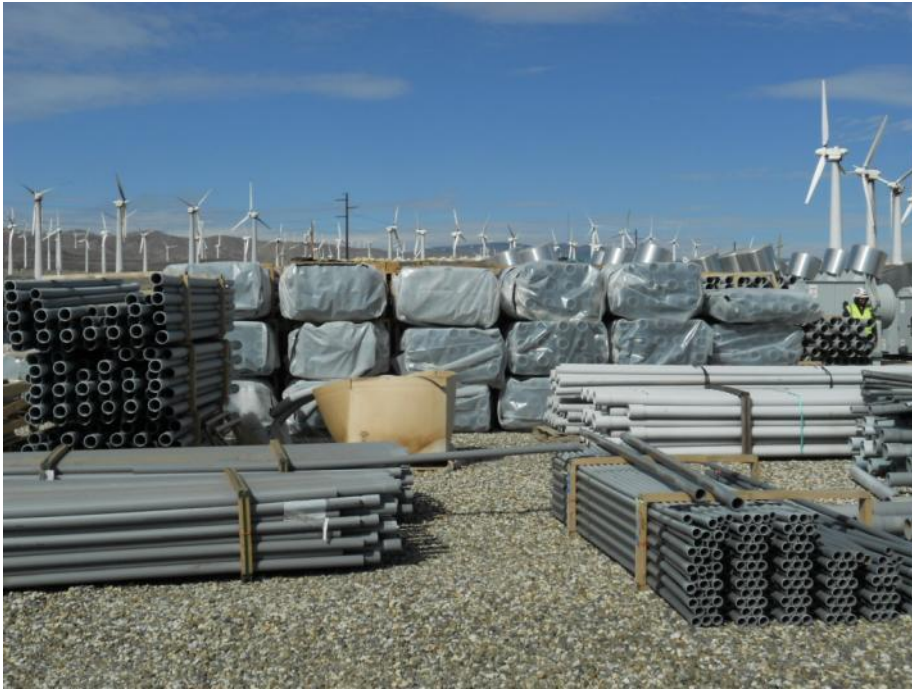
Figure 1: Plastic covering materials in Windhub Substation as bird deterrent, Segments 1-3.

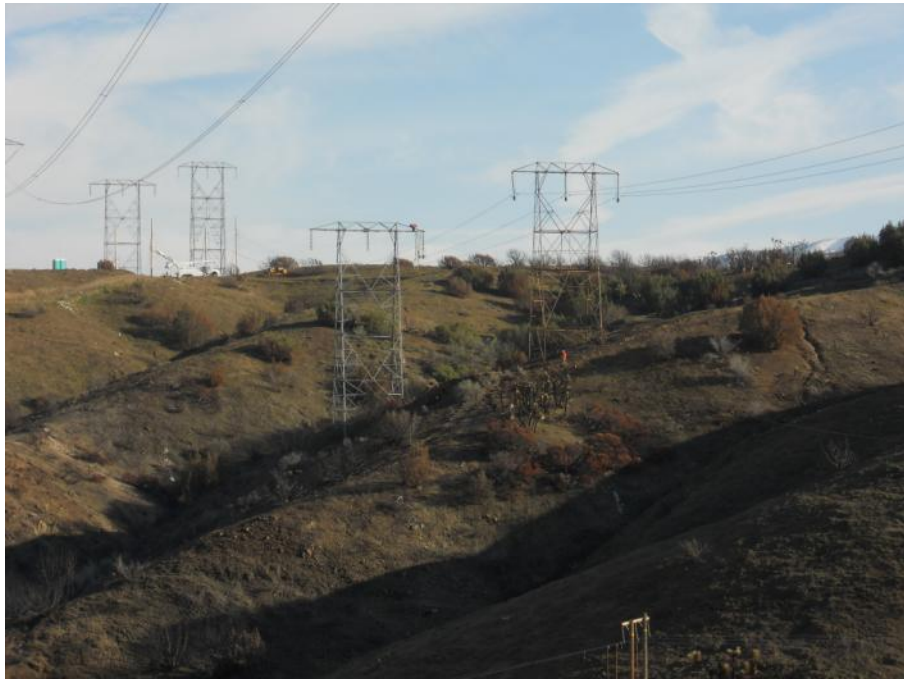
Figure 2: H&M removing wire across Godde Hill Road, Segment 5.

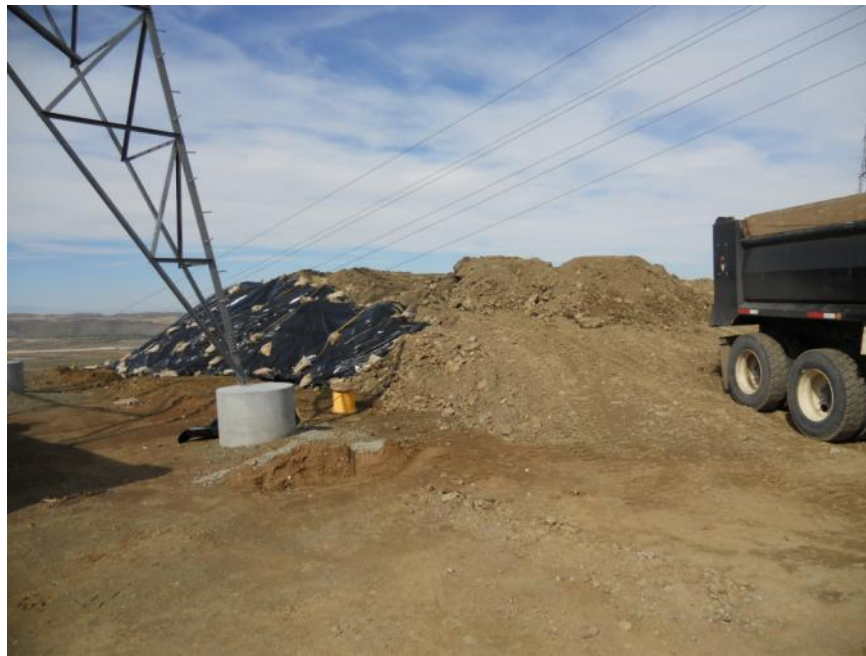
Figure 3: Soil from new access road grading at Tower 42 being stockpiled at Tower 41, Segment 5.

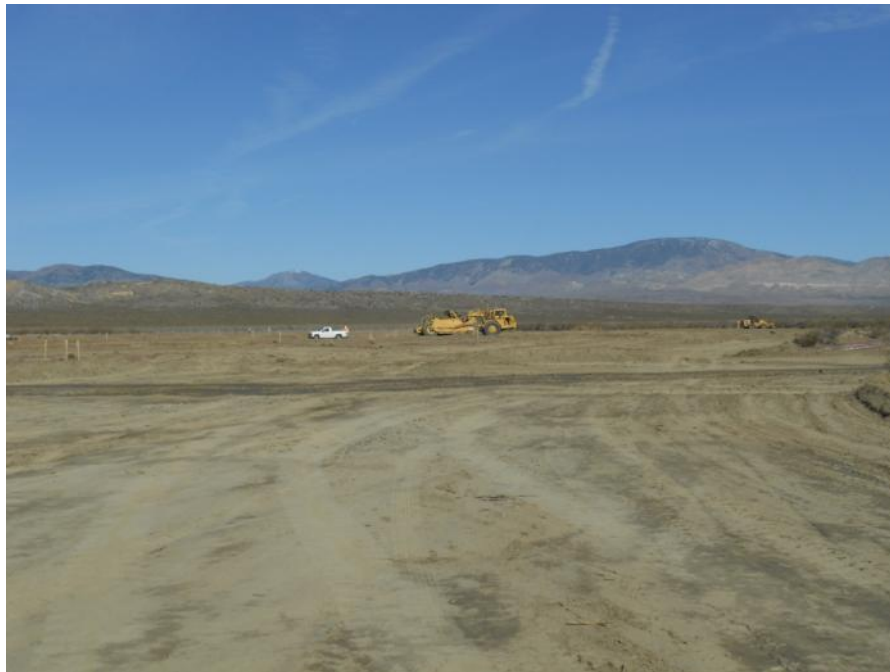
6. Whirlwind Substation: Moore Fence Company continued trenching for the tortoise and chain link fence installation along the fence limits on the west side of 170th Street. The concrete slab over the LADWP underground aqueduct was completed. Grubbing and grading operations began on Wednesday, March 2nd (see Figure 4).

Figure 4: Grubbing and grading at Whirlwind Substation, Segment 9.

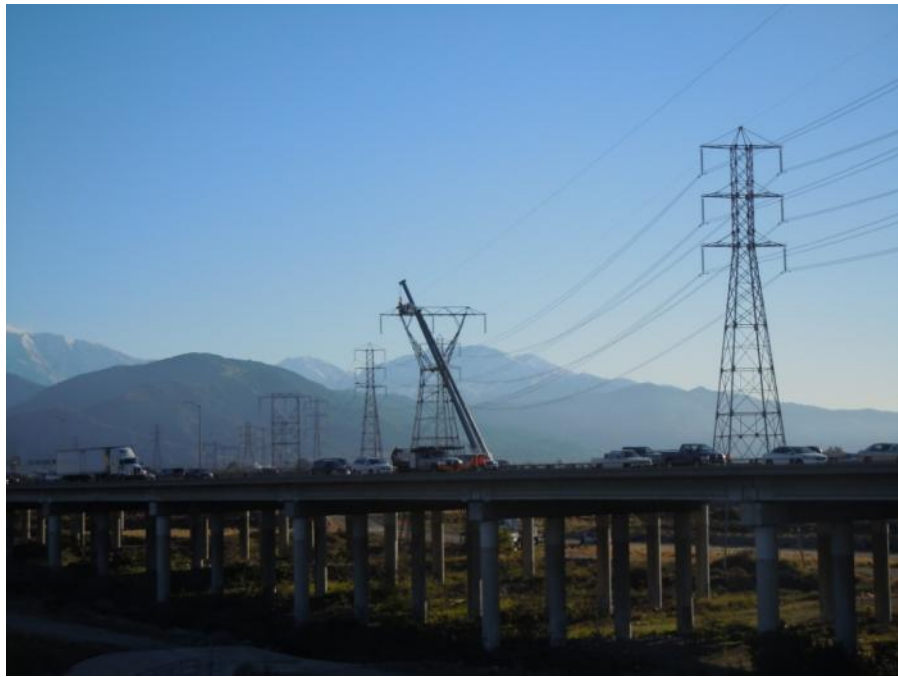
2. Segment 7: Tri-State continued drilling two foundations in the City of Duarte. Wilson removed conductor across Interstate 605, wrecked out three towers and continued assembly at Tower M54-T3a (see Figure 5). Additionally, DCX crews continued foundation demolition and tower shearing at five towers.

Figure 5: Crews preparing to remove conductor across Interstate 605, Segment 7.

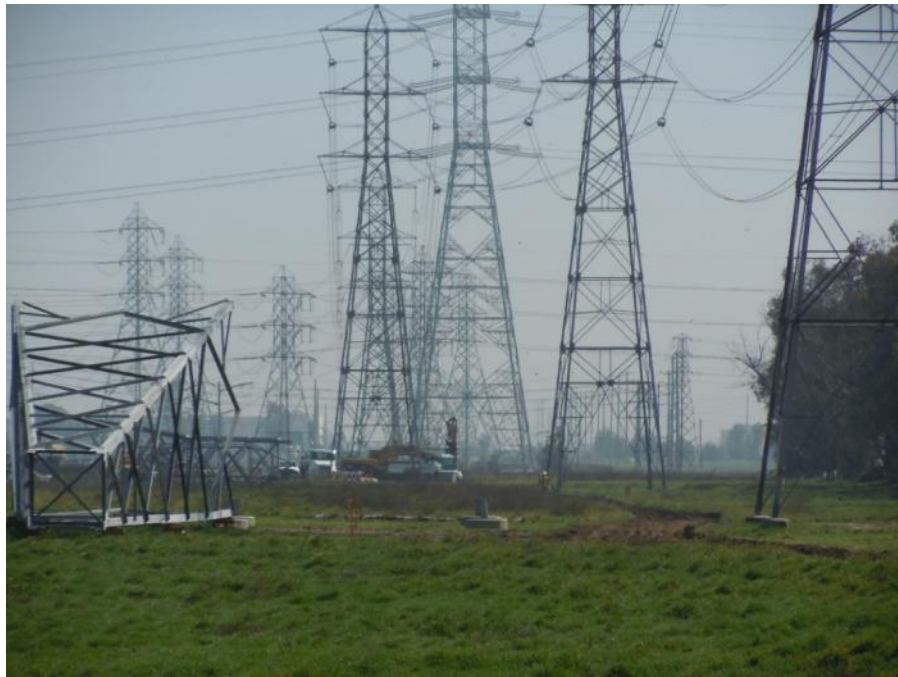
4. Segment 8, Phase 2: Wilson crews continued assembly work at four towers on the Chino–Mira Loma No. 1 line. Tri-State and DCX crews drilled foundations at five tower locations (see Figure 6). Additionally, DCX crews continued to mow within disturbance areas around towers and wire setup sites.

Figure 6: Crews drill a foundation for new 220 kV tower, Segment 8, Phase 2.

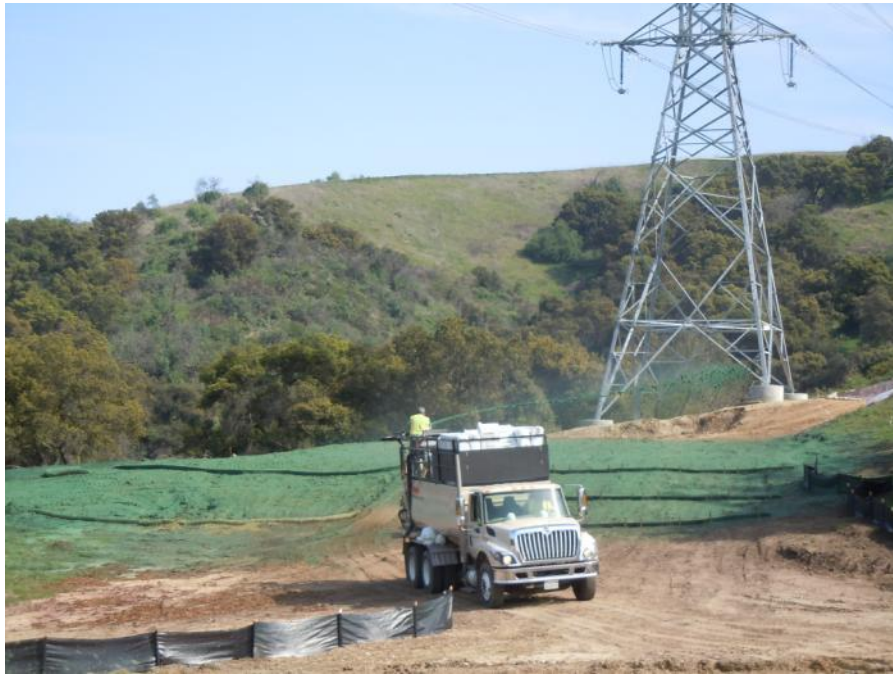
4. Wilson sprayed a soil binder at tower sites M57-T3 and M57-T4 (see Figure 7) for erosion control. The CPUC EM requested the Materials Safety Data Sheet (MSDS) for the soil binder from the contractor. The review of the soil binder determined that it was not non-toxic, as required by MM AQ-1a.

Figure 7: Crews spraying a soil binder for erosion control, Segment 8, Tonner Canyon.
