**PROJECT MEMORANDUM
SCE TRANSMISSION PROJECTS, SEGMENTS 1 - 11**

To: John Boccio, Project Manager, CPUC
From: Vida Strong, Aspen Project Manager
Date: April 6, 2011
Subject: Weekly Report 165, March 20 to March 26, 2011

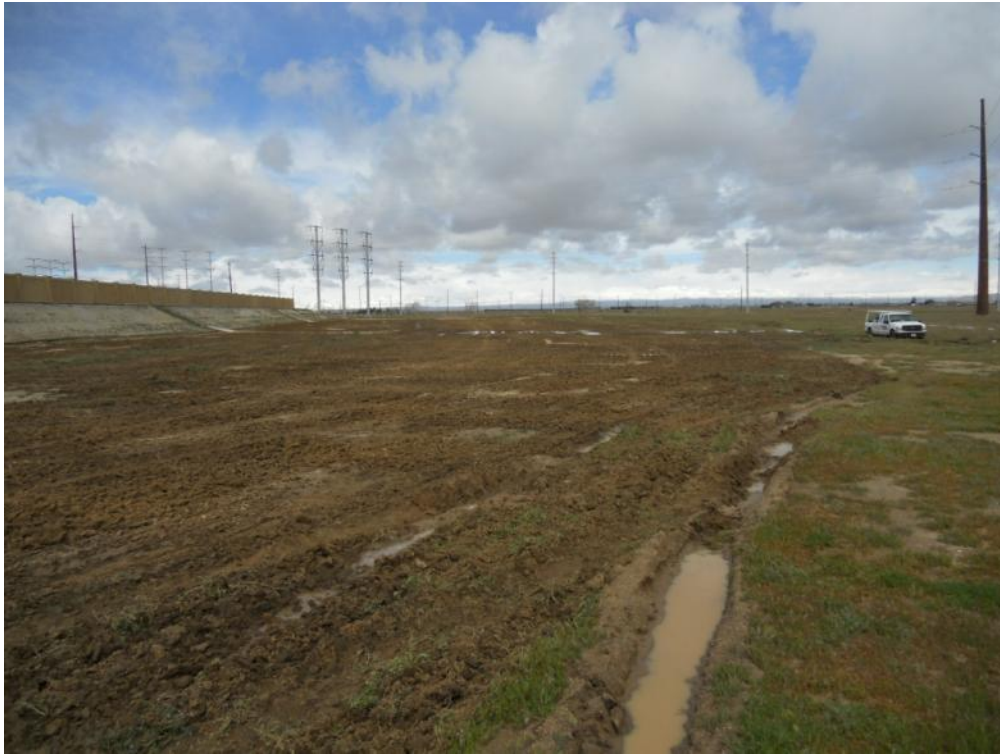
Figure 1: View of the east side of the Antelope Substation expansion that was recently prepped for seeding.

2. SCE received CDFG concurrence on March 24th to remove a partially built house finch nest from a boom truck within the Antelope Substation.
3. The CPUC EM met with the Burns & McDonnell biologist to look at the restoration work that occurred on the east and south side of the Antelope Substation expansion (see Figure 1).

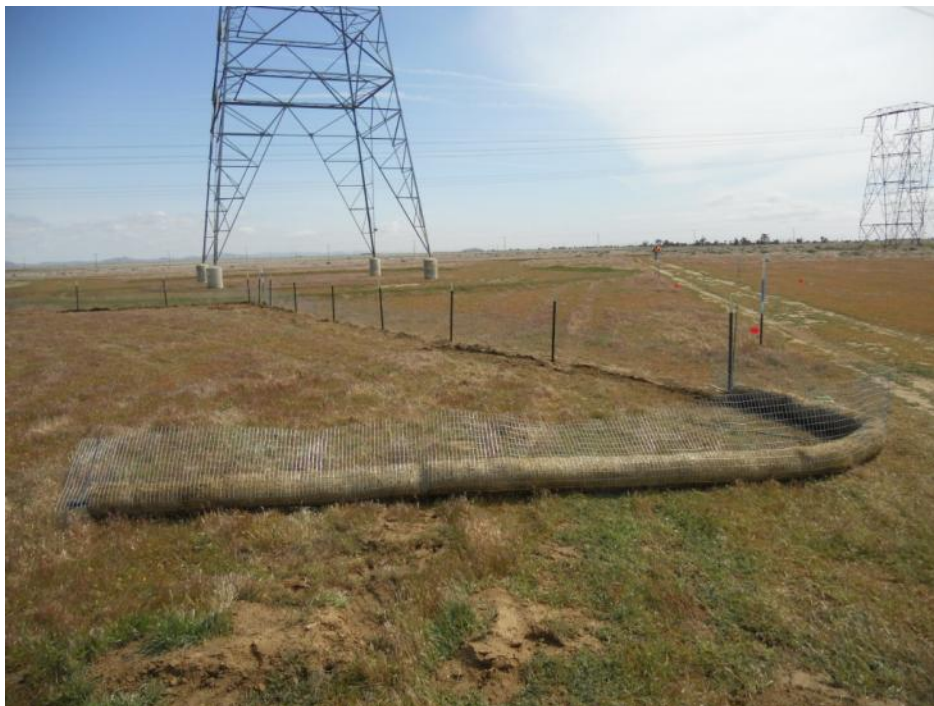
Figure 2: Tortoise fence installed around Tower 20 disturbance area, Segment 4.

2. Segment 4: KV Structures (drilling contractor) continued drilling, setting rebar cages using a spider jig for stub angle placement, and concrete pouring at Towers 20-23 and 46. H&M steel crews continued tower assembly work at Towers 30-32, 48, 51, and 52. Access roads to new towers were bladed from Tower 5 to 10. BMP's (i.e. fiber rolls) were installed from Tower 19 to 22. Tortoise fence installation continued at Interset Tower M74-T1B (just outside of the Whirlwind Substation) and Tower 20 (see Figure 2).

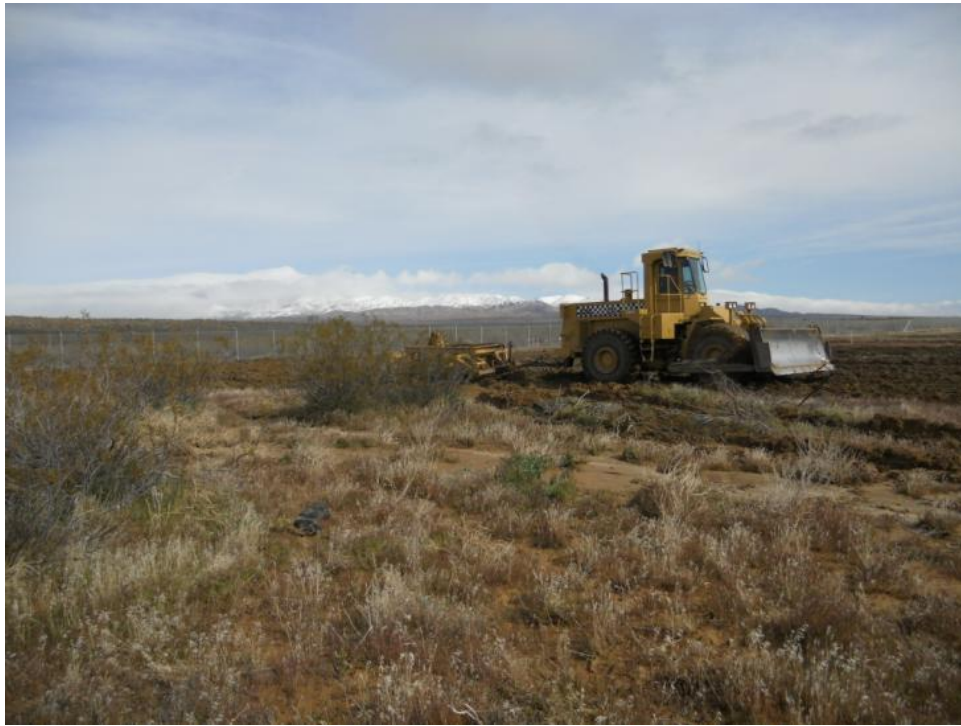
Figure 3: Grubbing of jurisdictional drainage in Whirlwind Substation, Segment 9.

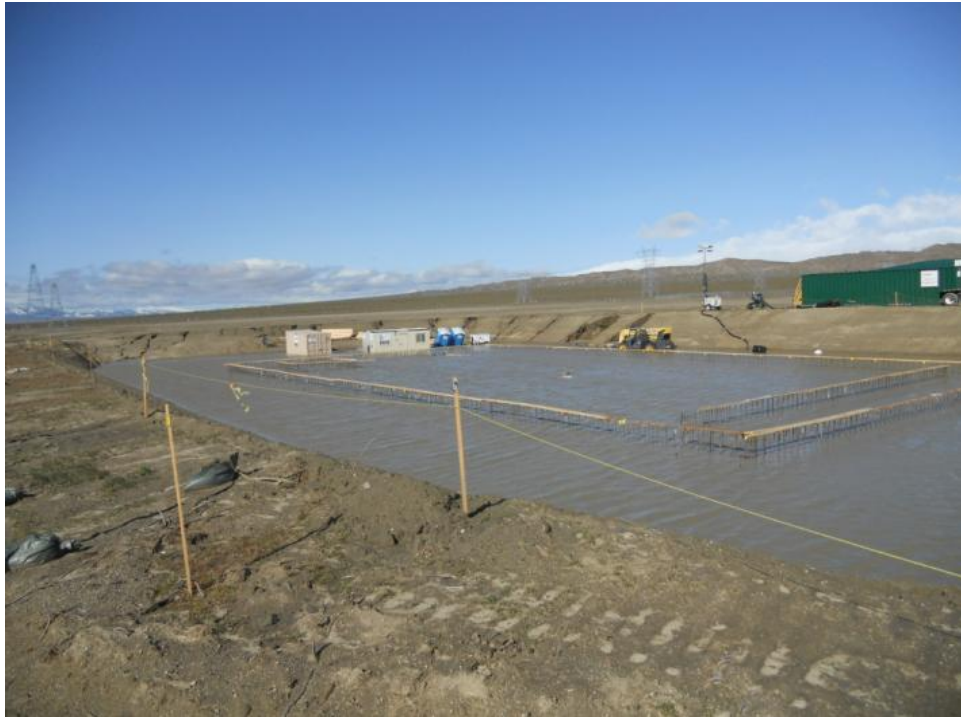
Figure 4: MEER excavation with 3-feet of stormwater in Whirlwind Substation, Segment 9.

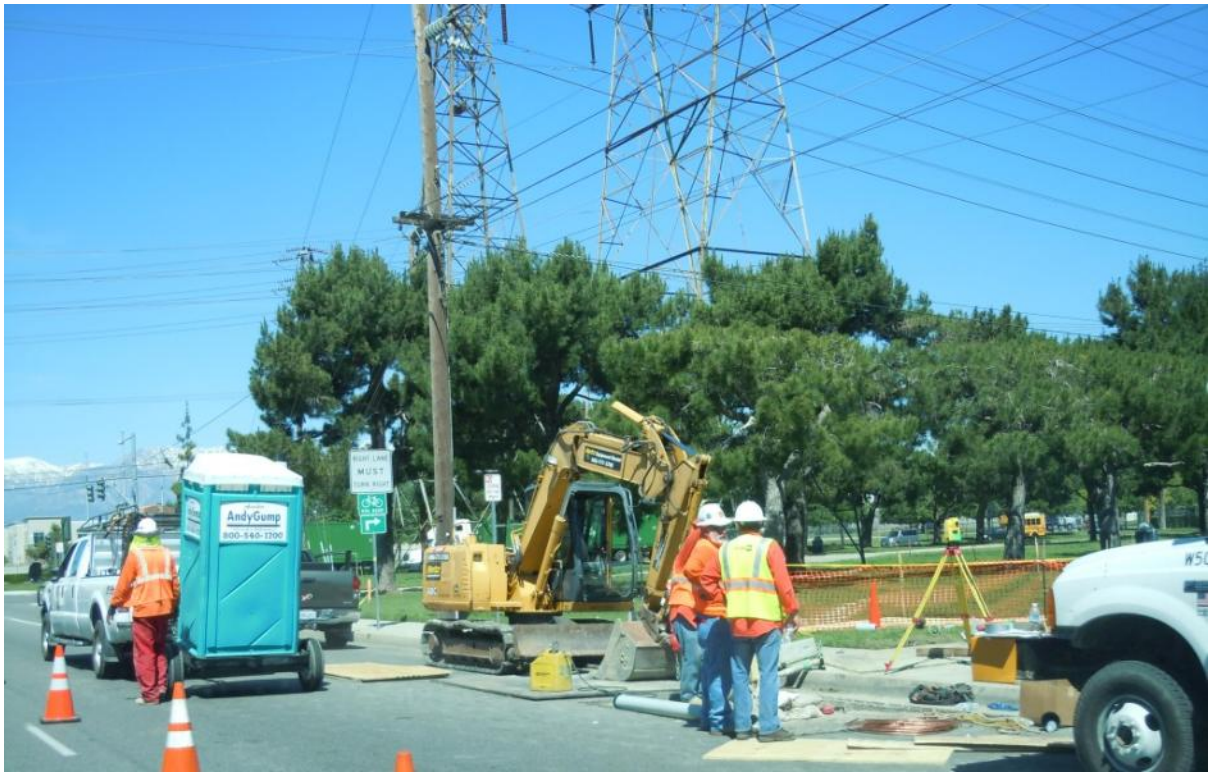
Figure 5: Crews work on a riser foundation, Segment 8 66 kV in the City of Chino.

1. Segments 7 & 8, 66 kV: During the subject period, Wilson crews continued work on the foundations for riser and non-riser poles for the Chino 66 kV Relocation, though work was delayed by rain (see Figure 5). Crews drilled holes and placed cages. Thirty-one of fifty-four foundations are now complete. SCE crews worked on the overhead portion of the Walnut-Hilgen-Industry-Mesa-Reno line and within the Duck Farm, pulling conduit.

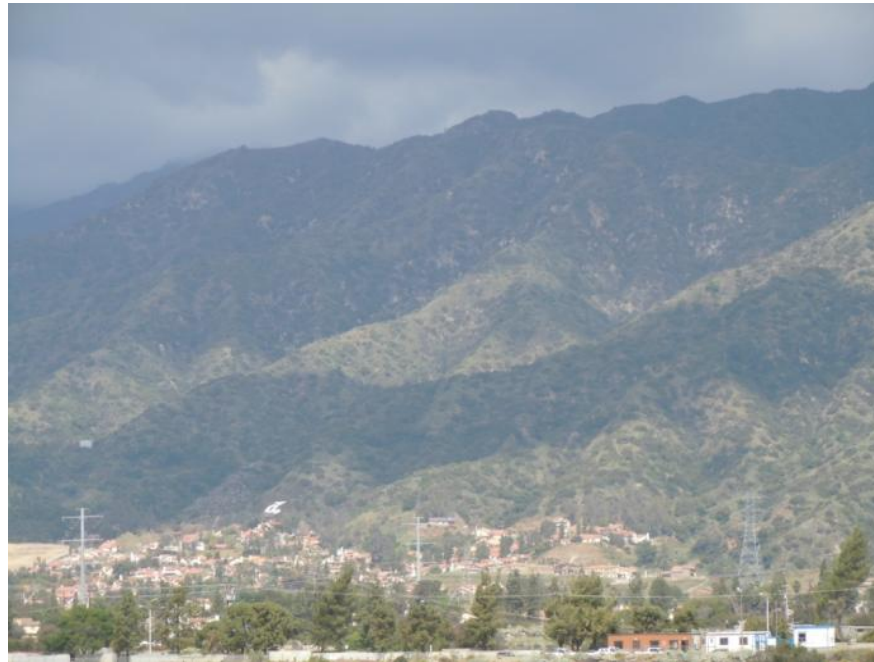
Figure 6: New tubular steel poles and lattice tower in the City of Duarte, Segment 7.

2. Segment 7: Tri-State began preparation to drill a foundation within the Duck Farm in the City of South El Monte. Wilson crews assembled and erected M28-P2 (see Figure 6) and removed wire from M34-T4 through M35-T2 across the Interstate 10 freeway. DCX crews continued grading at Van Tassel Mountainway.

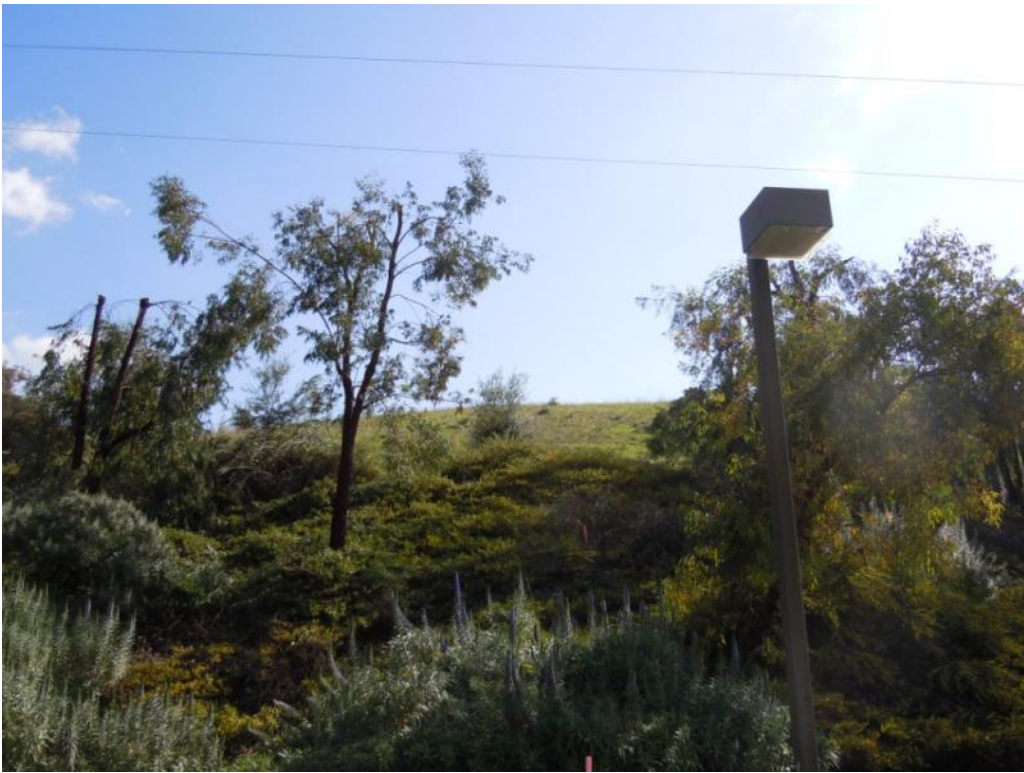
Figure 7: Recently topped trees, Segment 8, Phase 4, within Pathfinder Park.

5. The CPUC EMs received six preconstruction surveys and sweeps for construction on both Segments 7 and 8 during the subject period. The CPUC EMs observed recently topped trees underneath power lines in Pathfinder Park while conducting the field verification for Tower M29-T1B. The trees had been cut by an SCE right-of-way clearance crew (see Figure 7) two days before TRTP crews mobilized to this area.
