**PROJECT MEMORANDUM
SCE TRANSMISSION PROJECTS, SEGMENTS 1 - 11**

To: John Boccio, Project Manager, CPUC
From: Vida Strong, Aspen Project Manager
Date: August 11, 2011
Subject: Weekly Report 183, July 24 to July 30, 2011

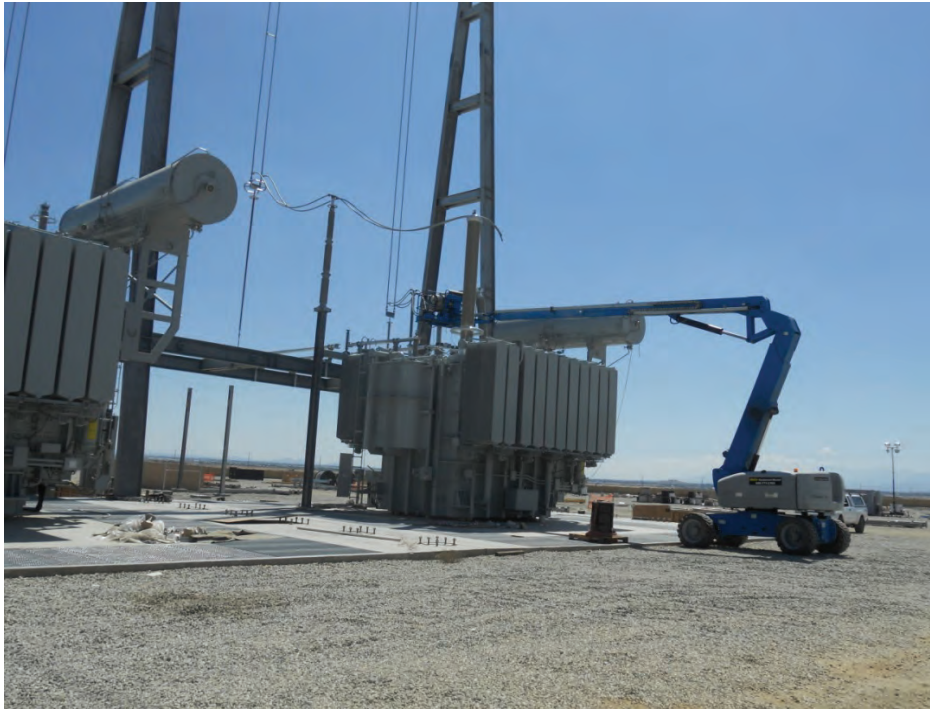
Figure 1: Conductor pulling into the transformers inside the Antelope Substation, Segments 1-3.

2. Construction activities at the Antelope Substation included conductoring and shunt capacitor assembly. Testing of transformers (AA banks) is complete and crews are bringing conductor into the transformers (see Figure 1).

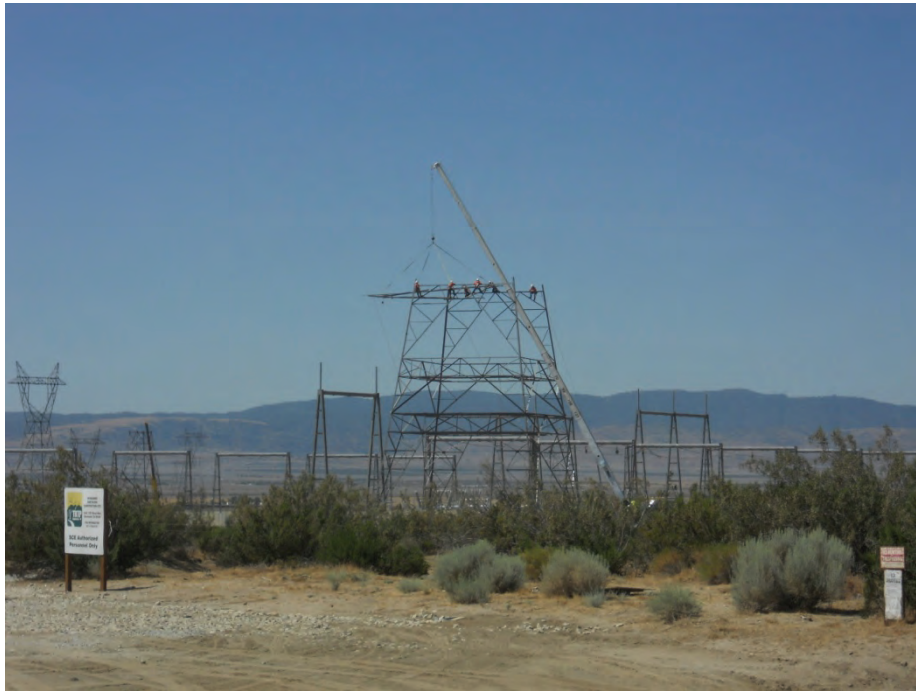
Figure 2: H&M steel crew erecting Tower 91 (just outside Whirlwind Substation), Segment 10.

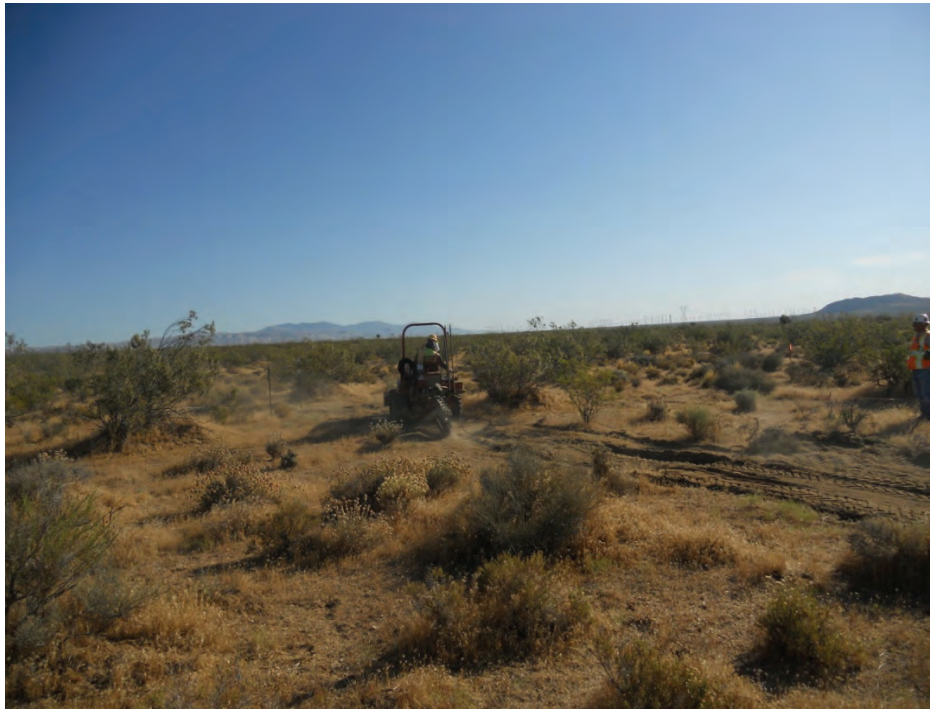
Figure 3: Moore Fence crew using a ditch witch to install tortoise fence at Tower 42, Segment 10.

heading northeast from Tower 52. The permanent fence installation crew continued work in the tower disturbance sites (see Figure 3). BMP's were installed along spur roads and tower disturbance sites. H&H Grading continued grubbing of disturbance sites and road improvement work along General Petroleum Road between Towers 57 and 52. Cut vegetation from General Petroleum Road is being removed from the road.

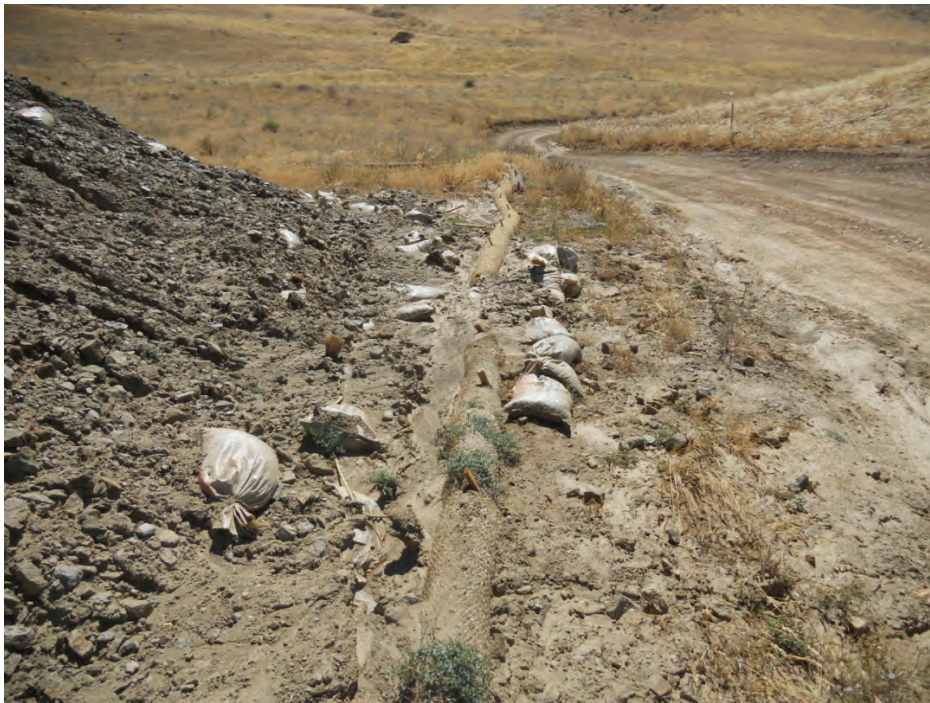
2. The CPUC EM's observed BMP's in disrepair around the soil stockpile near Tower 41 on Segment 5 (see Figure 4). SCE and Burns & McDonnell were informed of this issue.

Figure 4: BMP's in disrepair around soil stockpile near Tower 41, Segment 5.

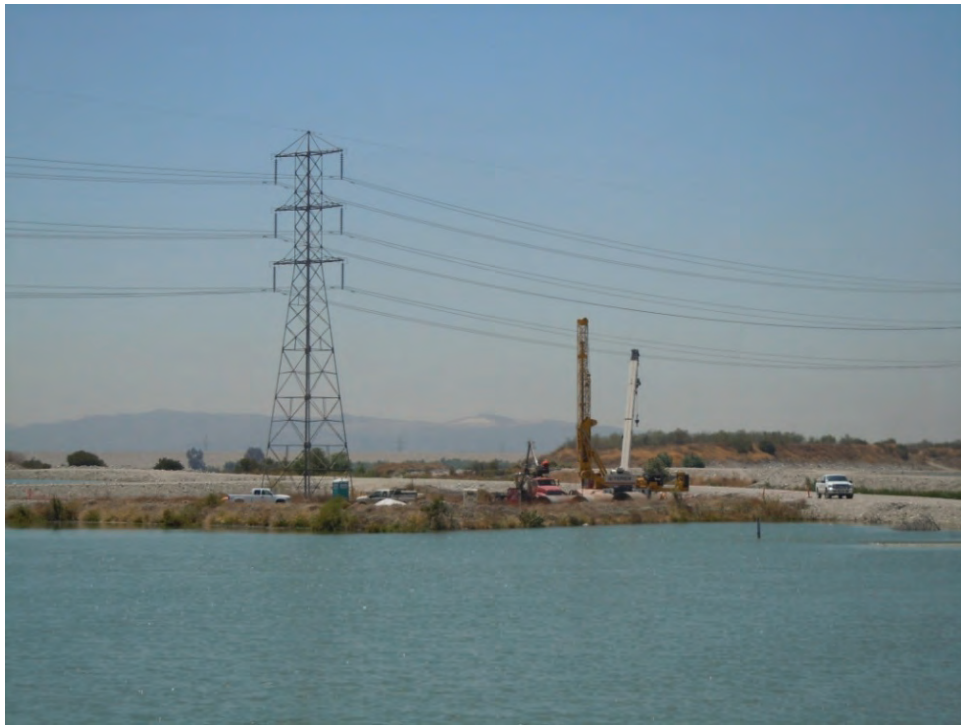
Figure 5: A Tri-State crew drills a foundation within USACE land, Segment 7.

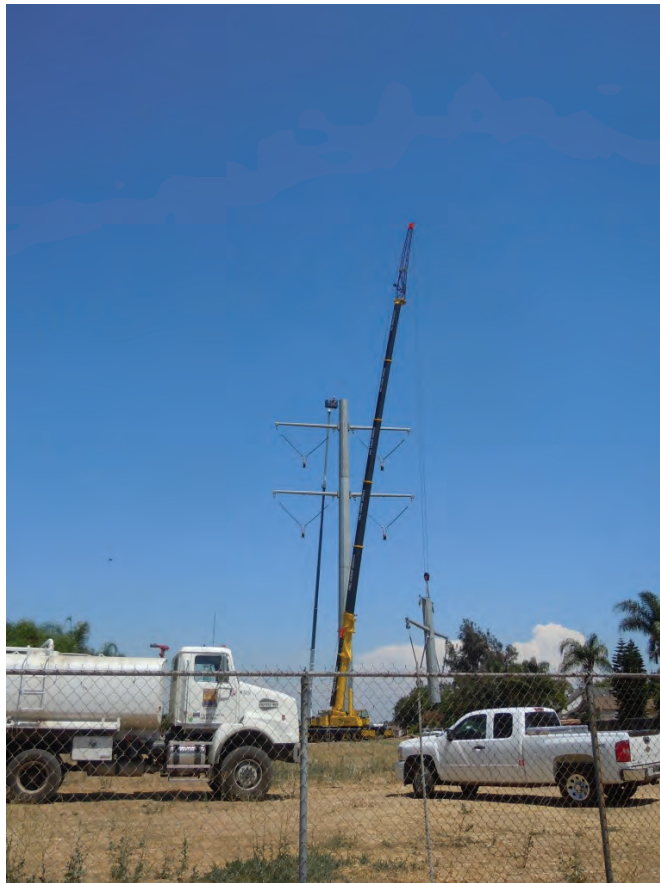
Figure 6: A crew sets a TSP within Chino Hills, Segment 8 Phase 1.

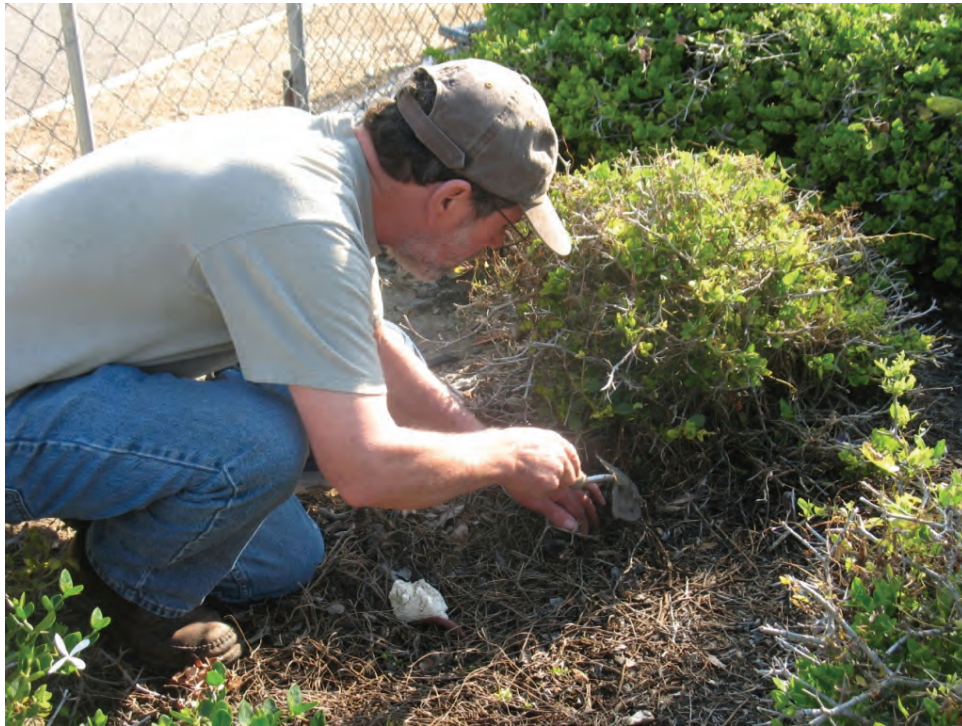
2. A specimen of a probable rare plant was discovered within the Segments 7 and 8 66 kV right-of-way. An SCE contractor from the Rancho Santa Ana Botanic Garden (RSABG) took rhizome and stem cuttings of the plant on July 25th (see Figure 7). The cuttings will be grown at the RSABG nursery; a location for future outplanting of the cuttings has not been determined. SCE is avoiding the plant via directional drill for the 66 kV underground installation.

Figure 7: A RSABG employee salvages a rhizome, Segment 8 66 kV.

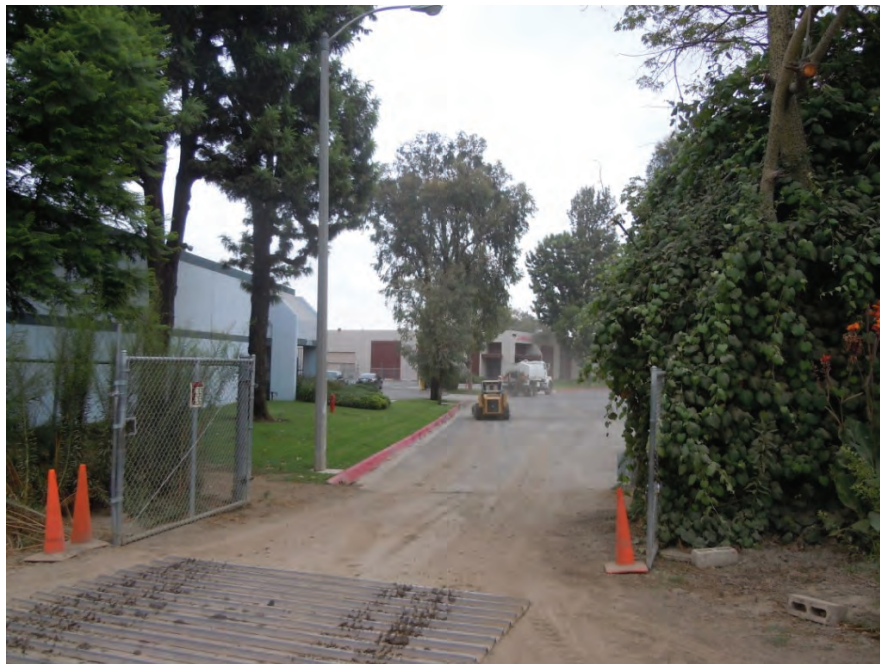
4. The CPUC EM observed trackout longer than 25 feet extending from the I-605 Shoofly onto Pellisier Place. This trackout was confirmed to be non-TRTP related, and is attributed to a separate construc-

Figure 8: A Wilson employee sweeps Pellisier Place to remove trackout, Segment 8 Phase 4

tion project using the same access point from Pellisier Place. Wilson continues to sweep Pellisier Place at the beginning and end of each day (see Figure 8).

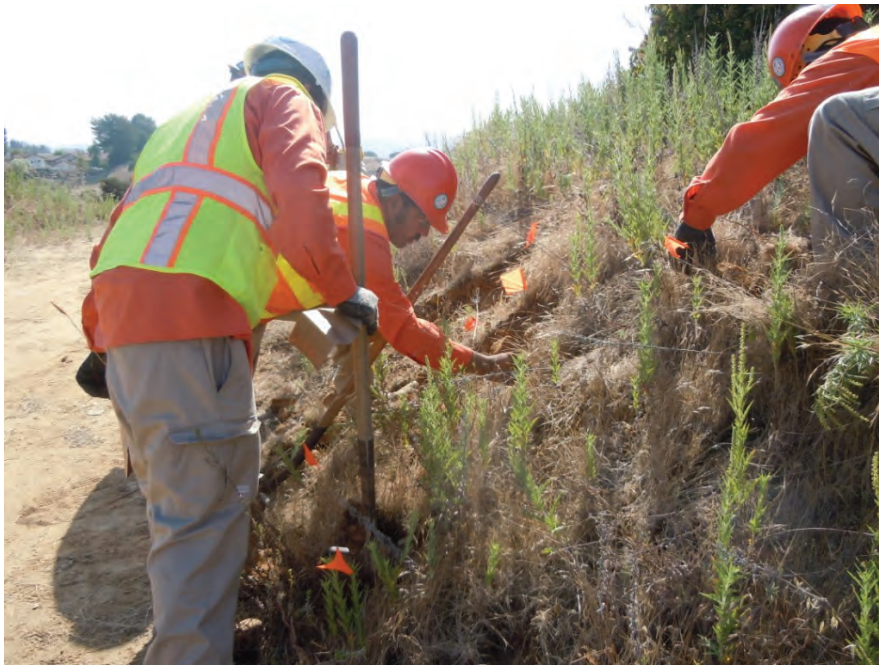
7. SCE provided a Special-Status *Calochortus* Species Mitigation Assessment Report on July 21st and conducted a follow-up phone call with the CPUC on July 22nd to discuss salvage of *Calochortus* bulbs within Tonner Canyon. Salvage was conducted at one tower site on July 28th. A total of 38 bulbs were salvaged from beneath the tower slated for removal (see Figure 9). Additional bulbs, also within tower disturbance areas, but in areas that could be avoided, were not salvaged. These bulbs were flagged/staked for avoidance.

Figure 9: A crew salvages mariposa lily bulbs, Segment 8 Phase 1.
