**PROJECT MEMORANDUM
SCE TRANSMISSION PROJECTS, SEGMENTS 1 - 11**

To: John Boccio, Project Manager, CPUC
From: Vida Strong, Aspen Project Manager
Date: August 18, 2011
Subject: Weekly Report 184, July 31 to August 06, 2011

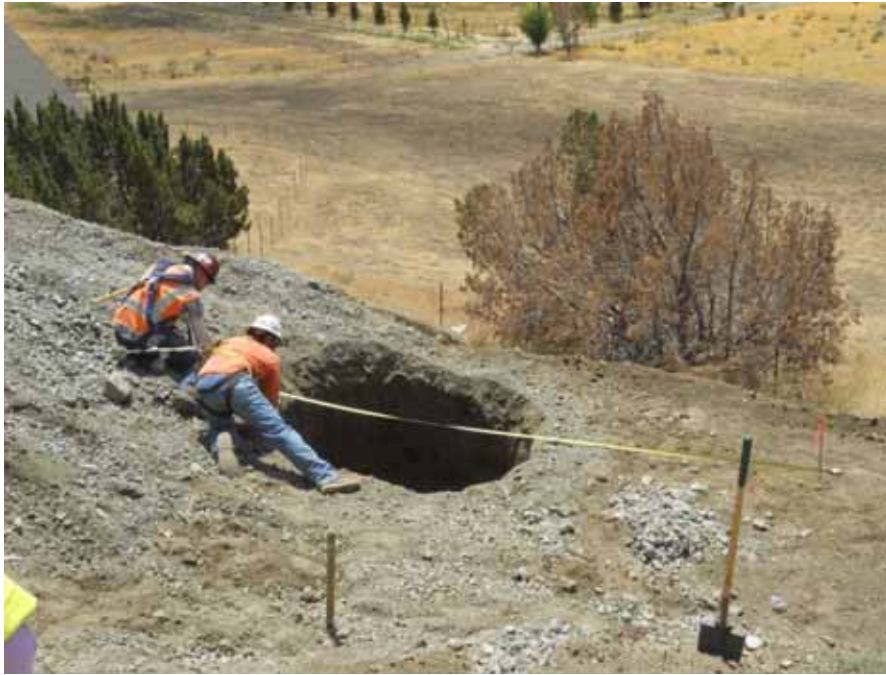
Figure 1: Woodward driller and Burns & McDonnell Inspector measuring foundation hole at Tower 28A, Segment 5.

3. Segment 5: Woodward Brothers (drilling contractor) continued drilling, setting rebar cages, and concrete pouring at Tower 28A, 29, and 31 (see Figure 1). H&M steel crews continued tower assembly and erection at Towers 18, 20, 31, 33, 34, 52, and 53. H&H Grading conducted removal of old steel and existing foundations from the 220 kV towers (see Figure 2). H&H also graded new access roads and crane pad sites in various locations. Maintenance access road grading also occurred throughout the segment. BMP maintenance occurred at several locations throughout the segment.

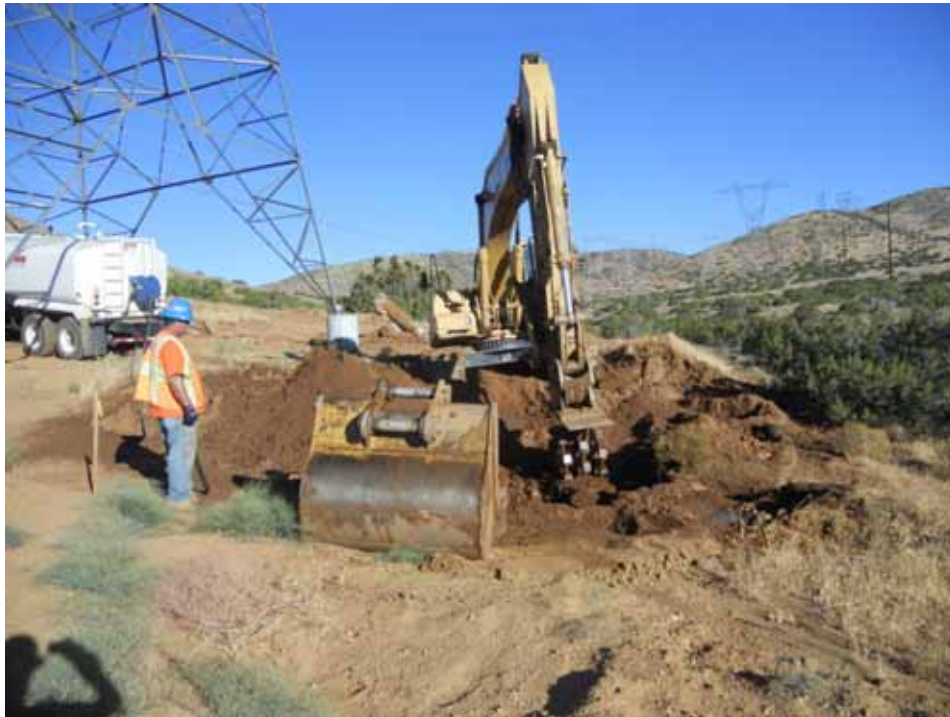
Figure 2: H&H Grading backfilling 220 kV foundation removal area near Tower 58, Segment 5.

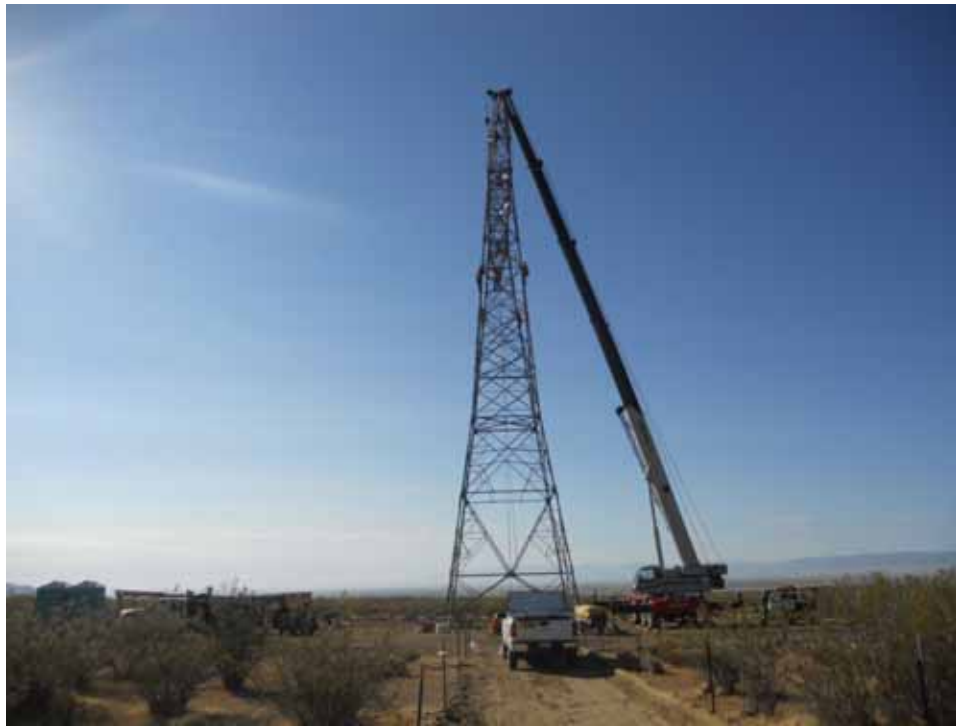
Figure 3: H&M steel crew erecting Tower 71, Segment 10.

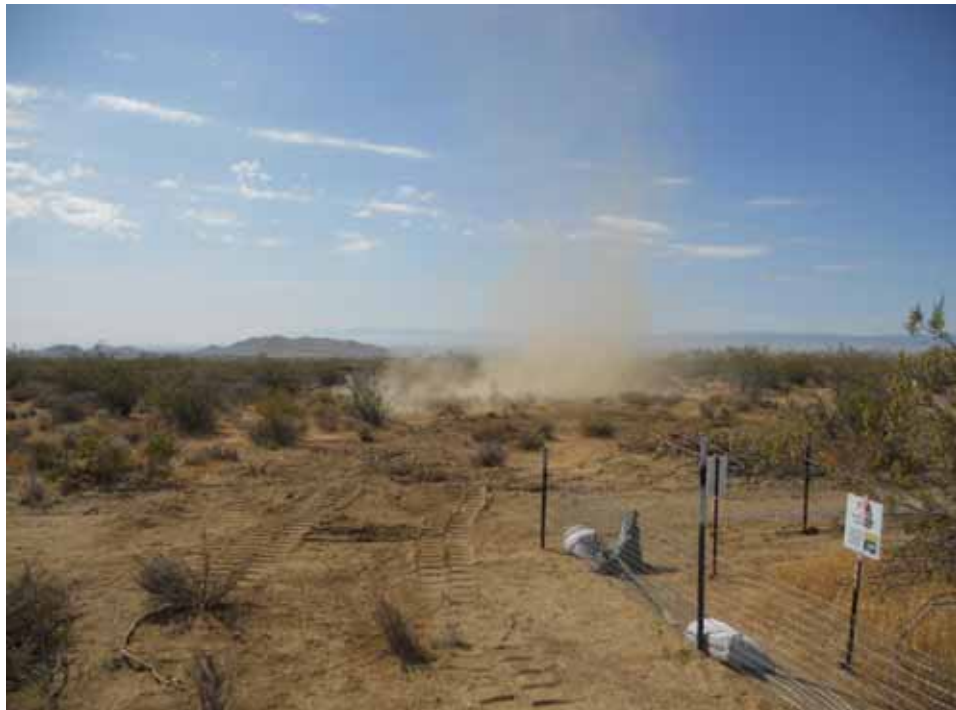
6. The CPUC EM observed fugitive dust from chipping activity at Construct 50 on Segment 10 (see Figure 3). The Burns & McDonnell Environmental Coordinator (EC) was informed of the observation and informed the grading contractor to obtain a water truck onsite. The CPUC EM stayed onsite until the water truck arrived and observed the watering activity (see Figure 4).

Figure 4: Fugitive dust from chipping activity at Tower 50 (no prior watering of site), Segment 10.

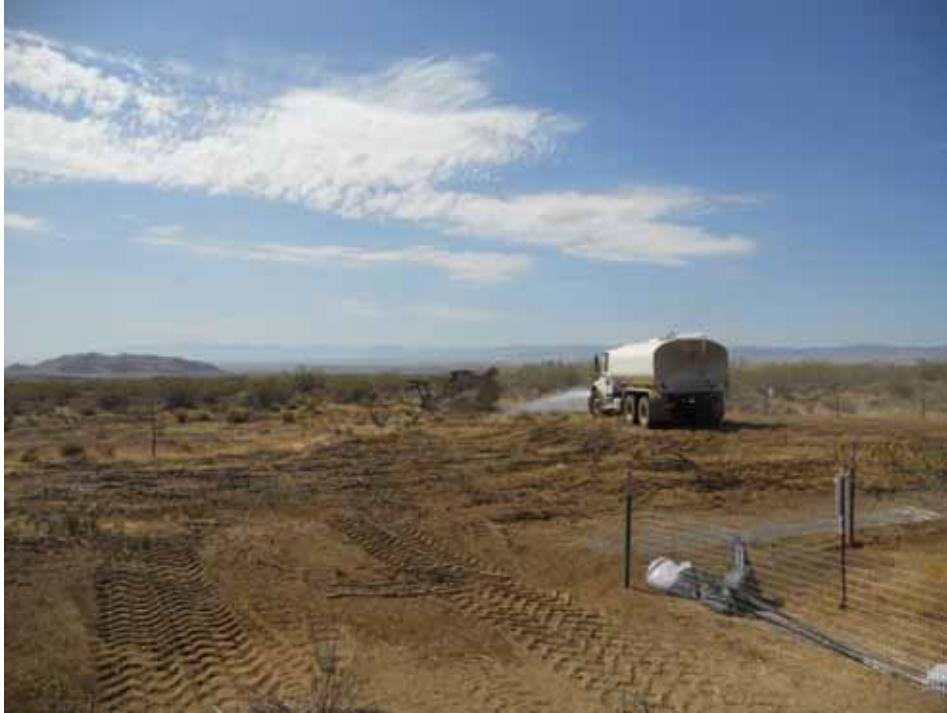
Figure 5: Water truck spraying behind the chipper at Tower 50 (after chipping had commenced), Segment 10.

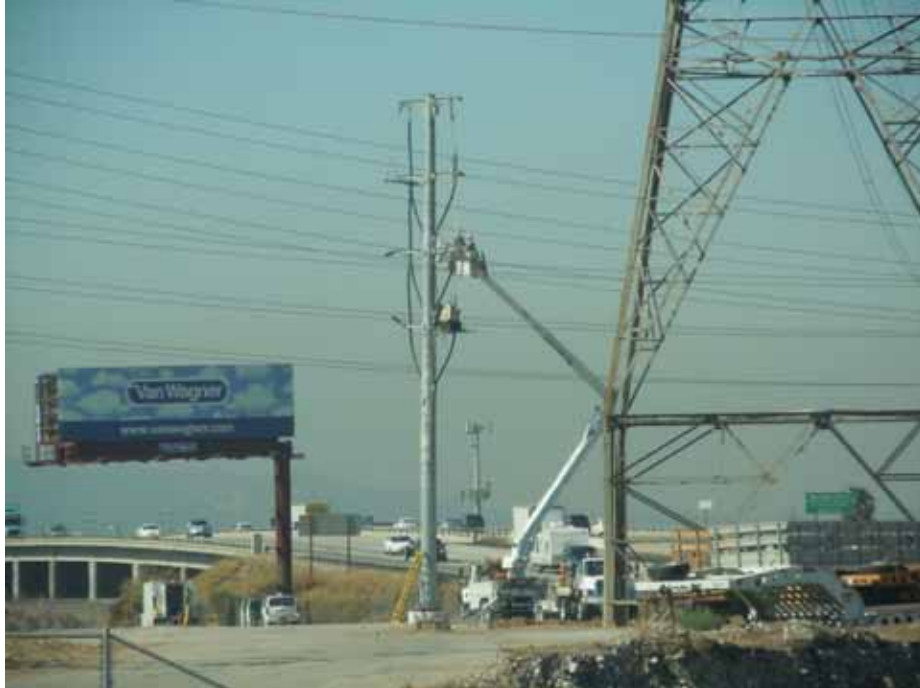
Figure 6: A 66 kV crew works on a riser pole on the Rio Hondo–Amador line, Segment 7.

1. Segments 7 & 8, 66 kV: During the subject period, Wilson crews continued worked on the overhead portion of the Rio Hondo–Bradbury line. Crews continued transferring 66 kV wire to poles along Arrow Highway and pulled conductor across the Interstate 605 (I-605). SCE crews continued pulling conduit on the Rio Hondo–Anita No. 2/Rio Hondo–Amador lines west and east of I-605. Additionally, SCE crews continued setting tubular steel poles (TSPs) and stringing wire on various 66 kV lines behind Mesa Substation. SCE crews also continued work on the Rio Hondo–Amador/Rio Hondo–Anita No. 2 line adjacent to Rio Hondo Substation. Crews pulled conduit through transition poles which transition conductor position between underground to overhead (see Figure 6).

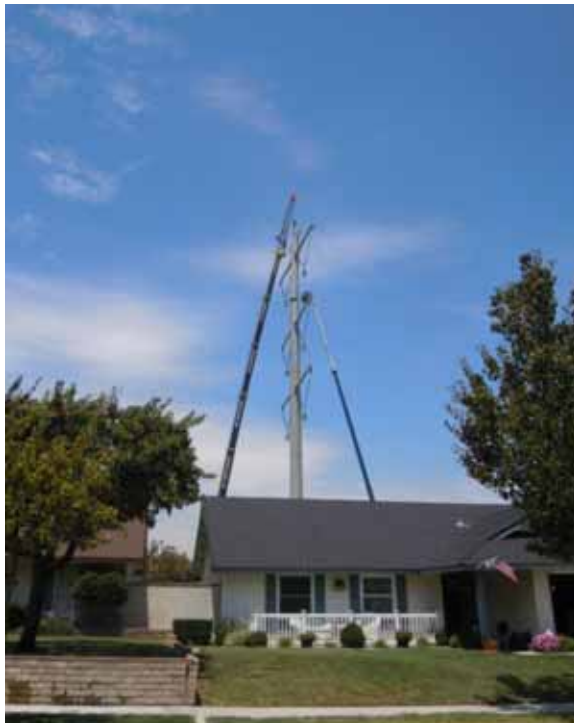
Figure 7: A Wilson crew sets the top segment of a TSP in Chino Hills, Segment 8 Phase 1.

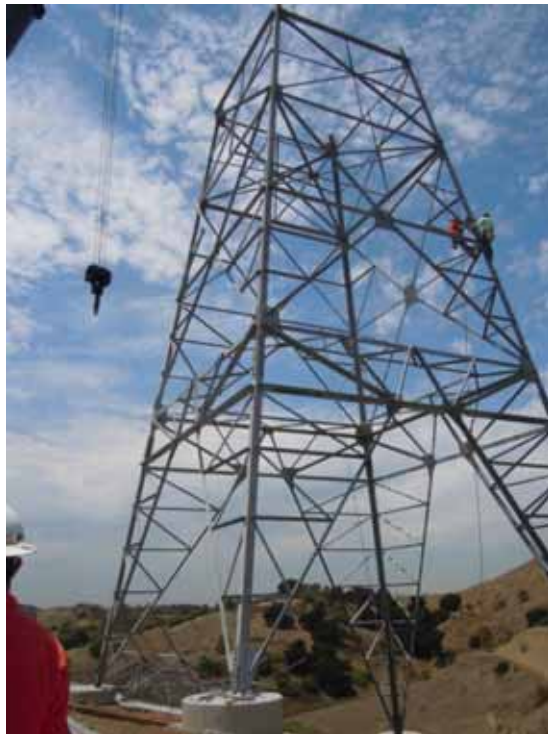
Figure 8: A crew assembles a TSP within Chino Hills, Segment 8 Phase 1.

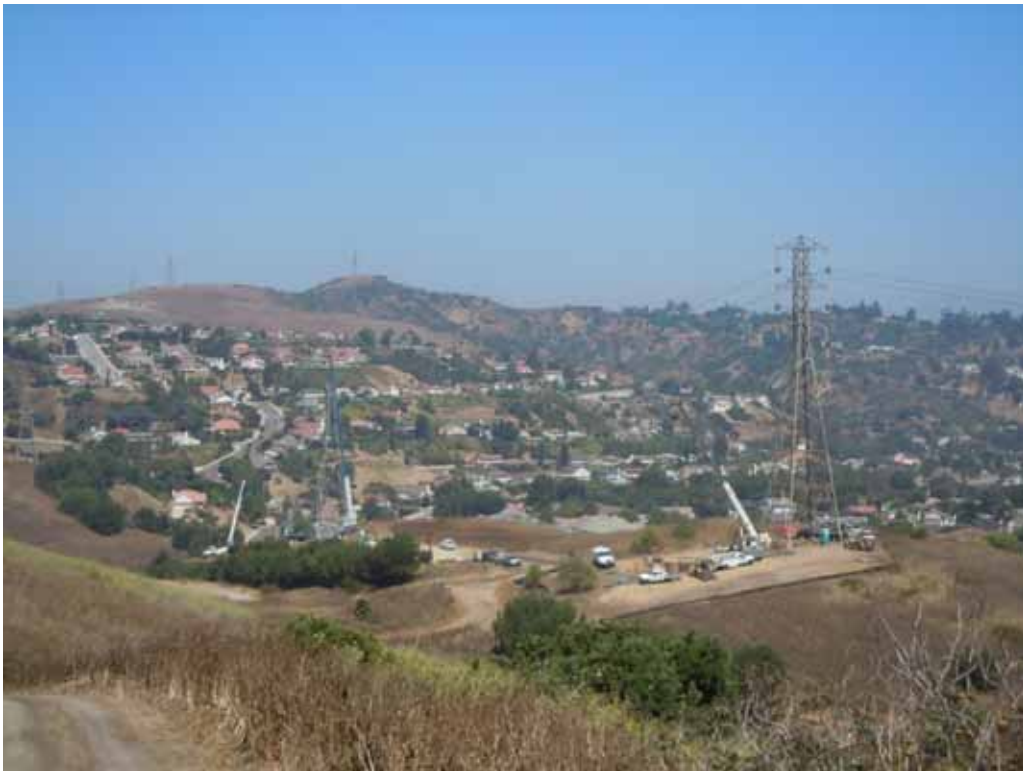
Figure 9: A DCX crew drills a 500 kV foundation (foreground) as a Wilson crew assembles a 220 kV interset tower (background), Segment 8 Phase 4.

5. Segment 8, Phase 3: No work occurred during the subject period.
6. Segment 8, Phase 4: DCX began drilling at one tower location and finished the foundation at another. Additionally, Wilson crews began assembly at Tower M3-T3A (see Figure 9). To date, 74% of the conductor and 61% of the structures on the existing 220 kV Chino-Mesa line have been removed. In total, one structure on the new double circuit 500 kV Mira Loma–Vincent line has been erected, and three structures on the 220 kV Chino-Mesa line have been erected.

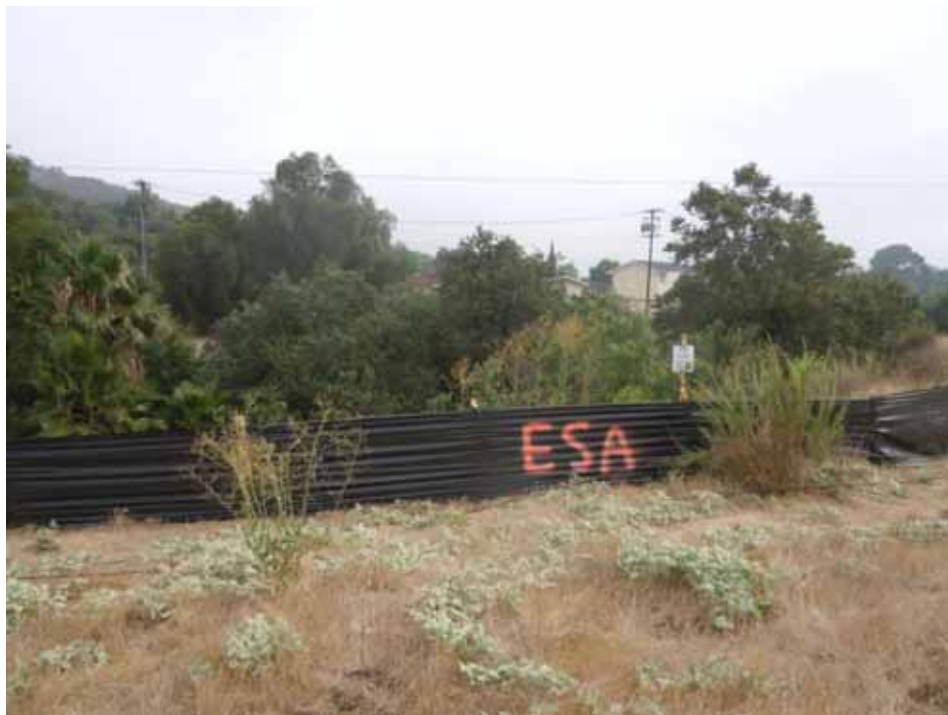
Figure 9: Southwestern pond turtle exclusion fencing surrounding Brea Creek.

5. Also in anticipation of removing conductor across the I-57 freeway, silt fencing was installed at WSS 8-4.22 adjacent to Brea Creek to exclude southwestern pond turtle from the work area (see Figure 10).
