**PROJECT MEMORANDUM  
SCE TRANSMISSION PROJECTS, SEGMENTS 1 - 11**

**To:** John Boccio, Project Manager, CPUC  
**From:** Vida Strong, Aspen Project Manager  
**Date:** August 26, 2011  
**Subject:** Weekly Report 185, August 07 to August 13, 2011

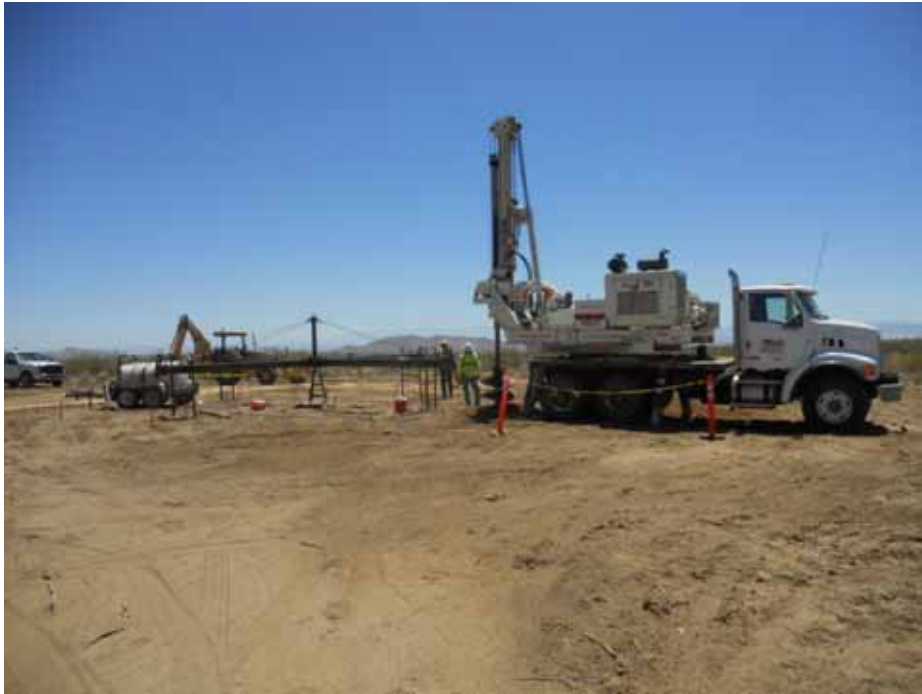
**Figure 1:** KV Structures drilling Tower 47, Segment 10.

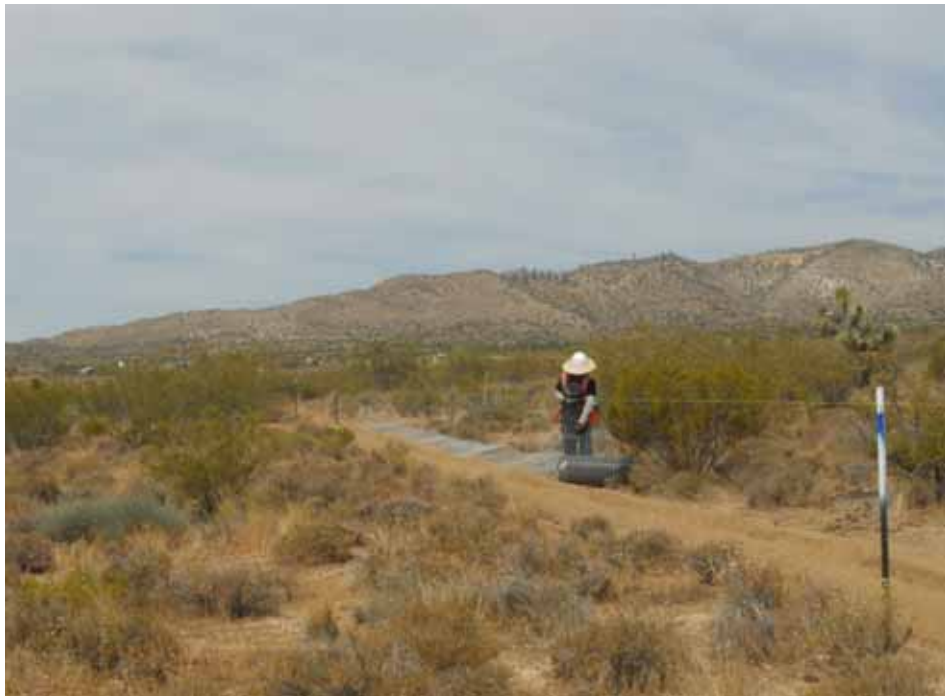
porary tortoise fence installation along General Petroleum Road. The permanent fence installation crew continued work in the tower disturbance sites (see Figure 2). BMP's were installed along spur roads and tower disturbance sites. H&H Grading continued grubbing of disturbance sites and road improvement work along General Petroleum Road. Joshua trees are being saved where feasible (see Figure 3).

**Figure 2:** Moore Fence crew member rolling out the tortoise fence along the wire setup site at Tower 29, Segment 10.

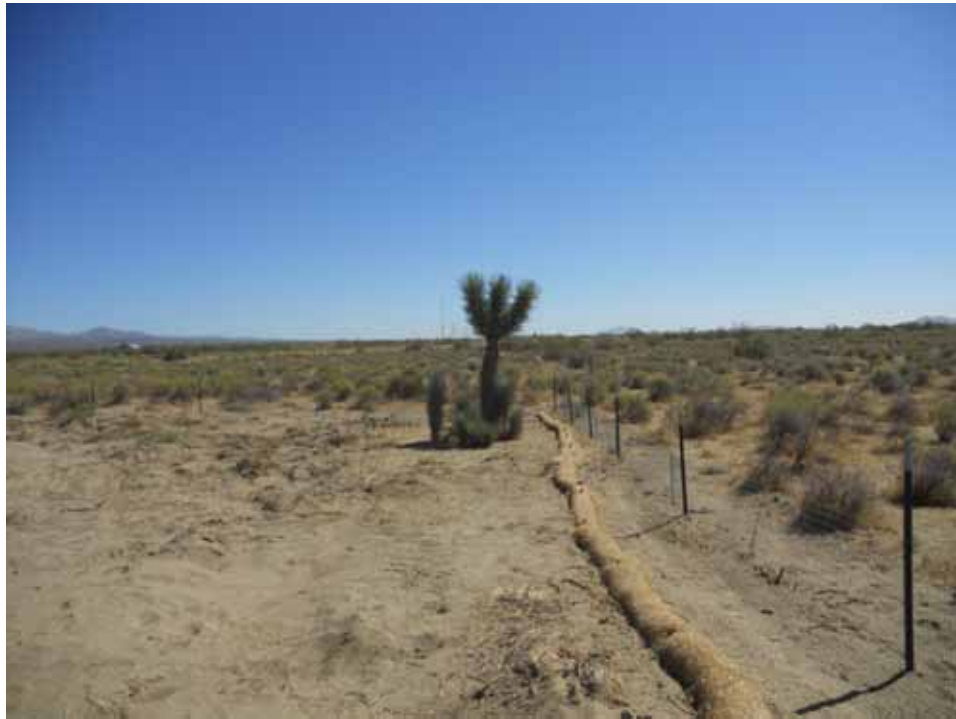
**Figure 3:** A saved Joshua tree in Tower 90 disturbance area, Segment 10.

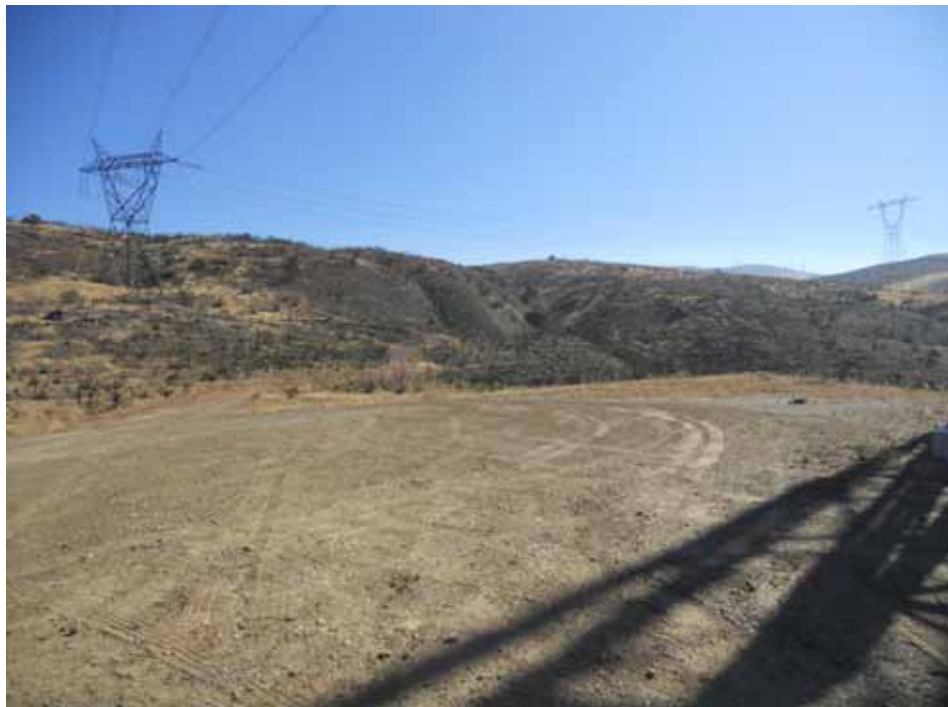
3. A TEWS was approved for use of a disturbed area adjacent to Tower 30 on Segment 5. This area will be utilized for parking and staging of equipment associated with the soil stabilization work (see Figure 4).

**Figure 4:** An approved TEWS area adjacent to Tower 30, Segment 5.

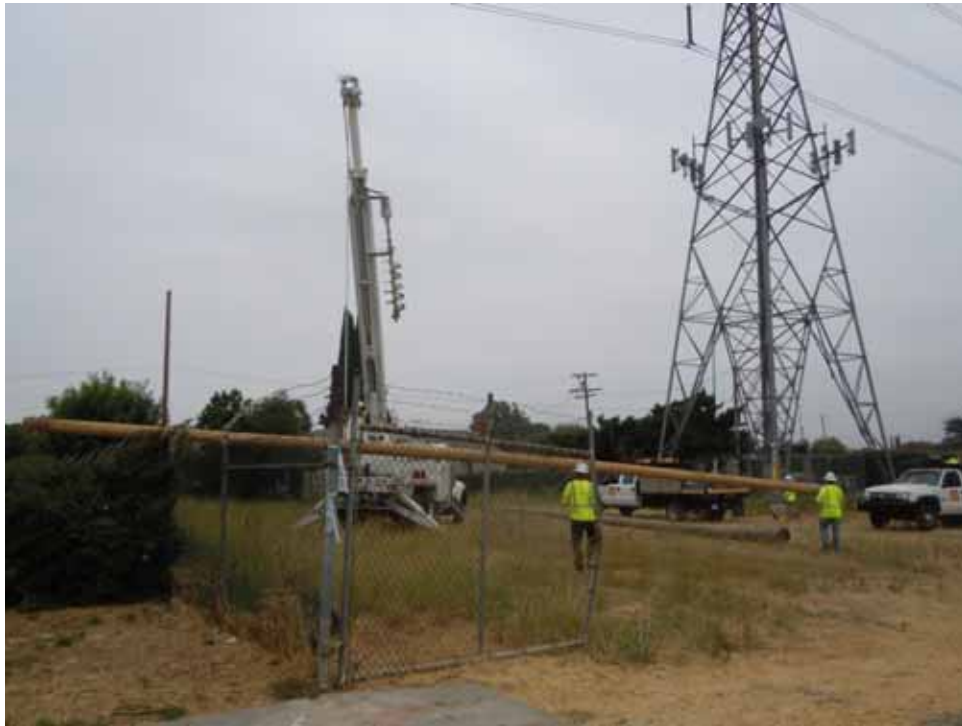
**Figure 5:** Crews prepare to install a guard pole site, Segment 11A.

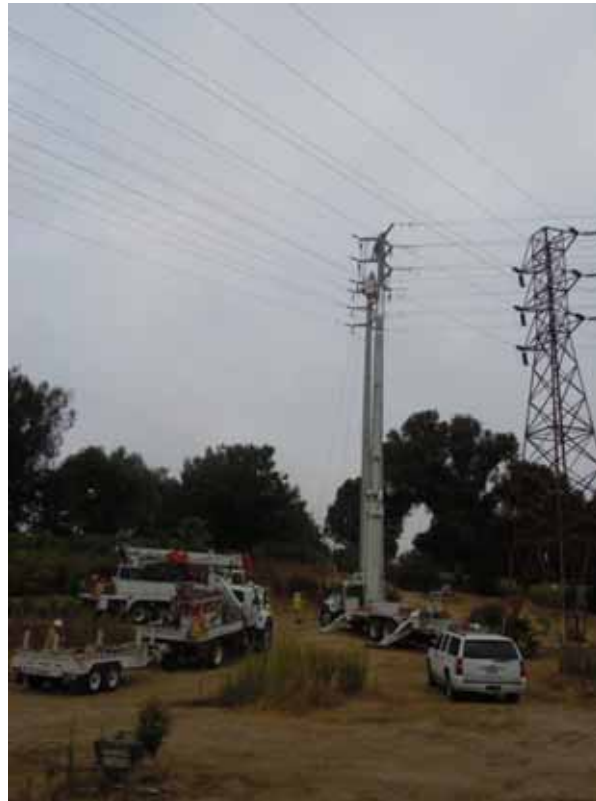
ferring 66 kV wire to poles along Arrow Highway and completed the installation of tubular steel poles (TSPs) on Ramona Boulevard, installing ground wires and hardware on poles. SCE crews continued pulling conduit on the Rio Hondo–Anita No. 2/Rio Hondo–Amador lines west and east of Interstate 605 (I-605). Additionally, SCE crews continued setting TSPs and stringing wire on various 66 kV lines behind Mesa Substation (see Figure 6).

**Figure 6:** SCE crews string wire on various 66 kV circuits, Segment 7.

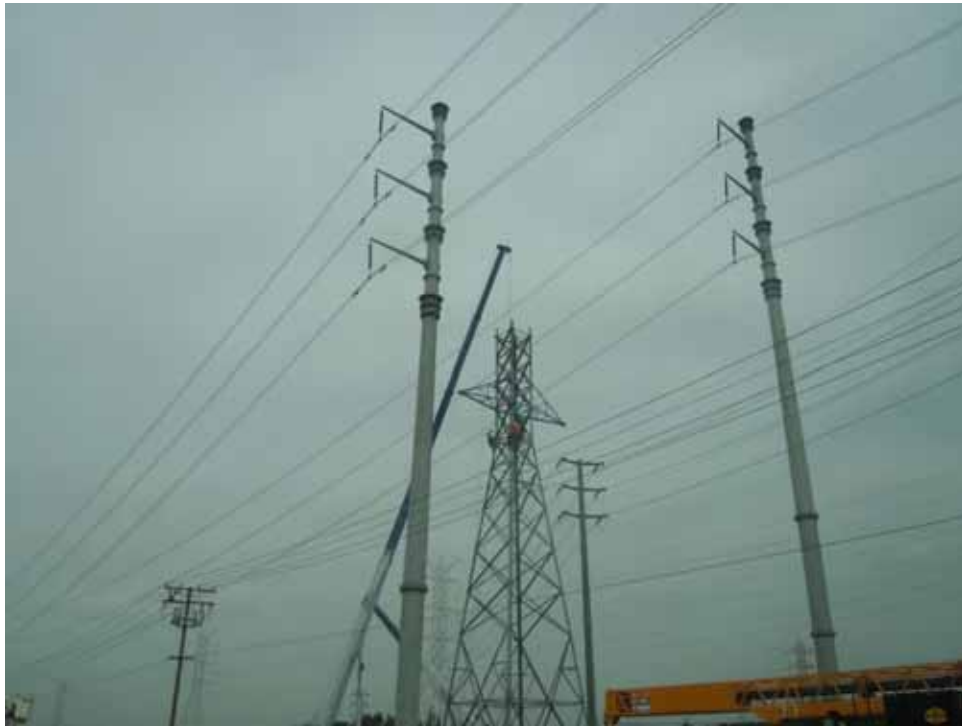
**Figure 7:** Crews assemble a tower at the I-605 Shoofly, Segment 8 Phase 4

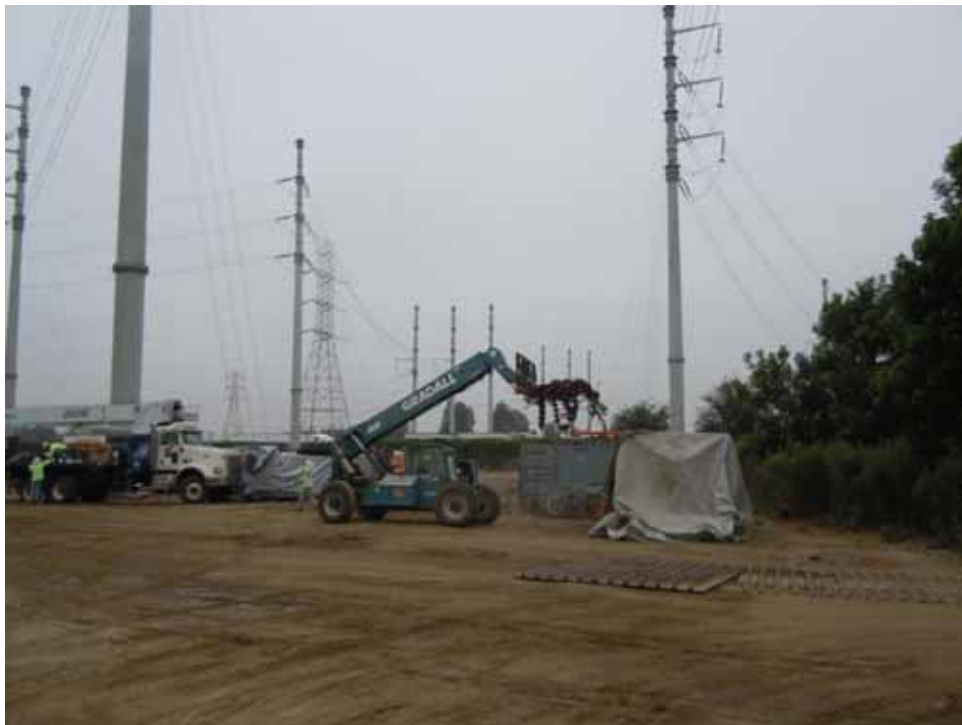
2. The CPUC EM spoke with SCE about the disturbance area on the east side of the I-605 Shoofly. Crews are currently using the area as a show-up site and are using the area for storage and construction waste disposal (see Figure 8). SCE replied that they are considering making the area a yard.

**Figure 8:** Crews dispose of construction waste at the I-605 Shoofly disturbance area, Segment 8 Phase 4

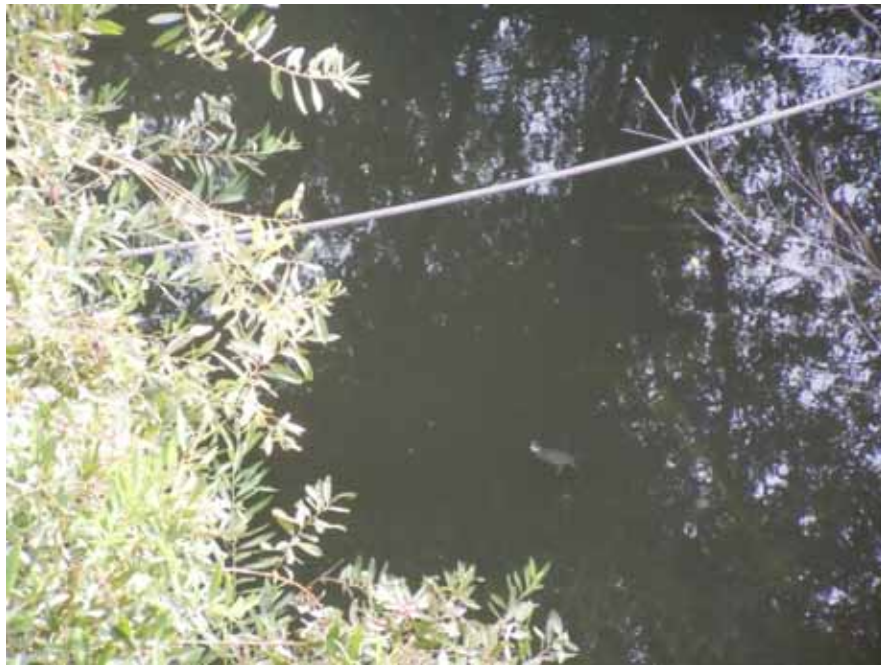
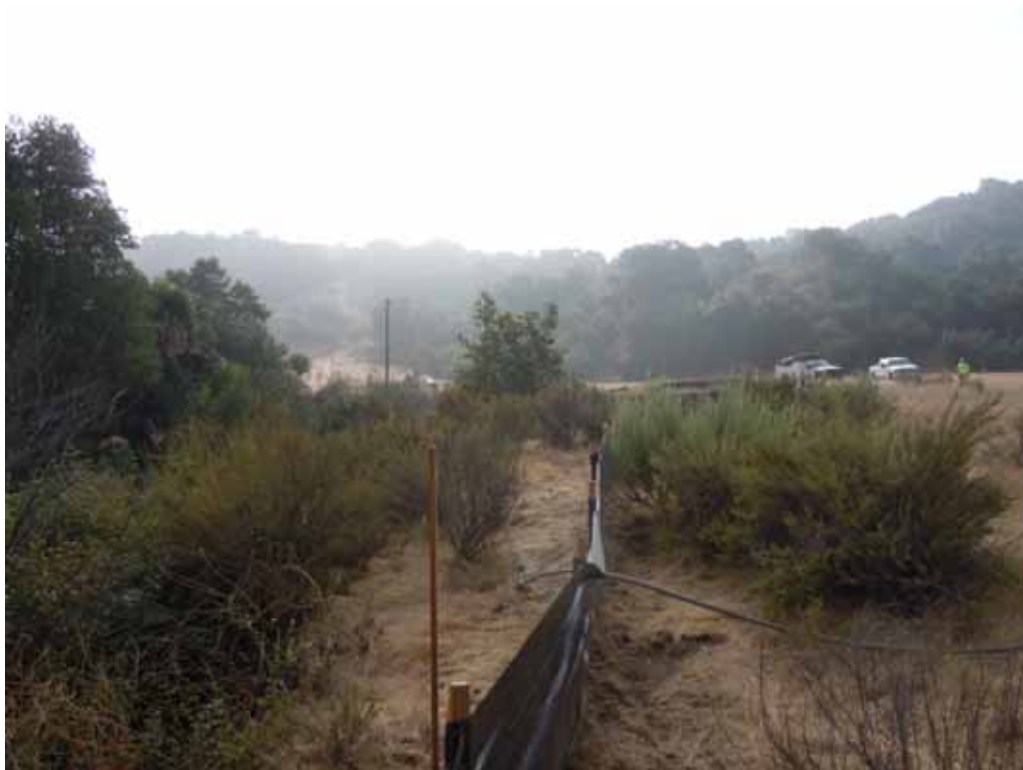
4. While removing conductor across the I-57 freeway, the silt fencing installed at Wire Setup Site 8-4.22 adjacent to Brea Creek to exclude southwestern pond turtle from the work area was damaged while the conductor was being lowered to the ground. The conductor was laid on top of the banks of the creek, though the CPUC EM could not observe whether it hit the bottom of the creek. No visible impacts to vegetation occurred (see Figures 9 and 10).

**Figure 9:** A southwestern pond turtle in Brea Creek with the removed conductor above it, Segment 8, Phase 1.

**Figure 10:** Conductor removed across the I-57 freeway sits atop the bank of Brea Creek, Segment 8 Phase 1.

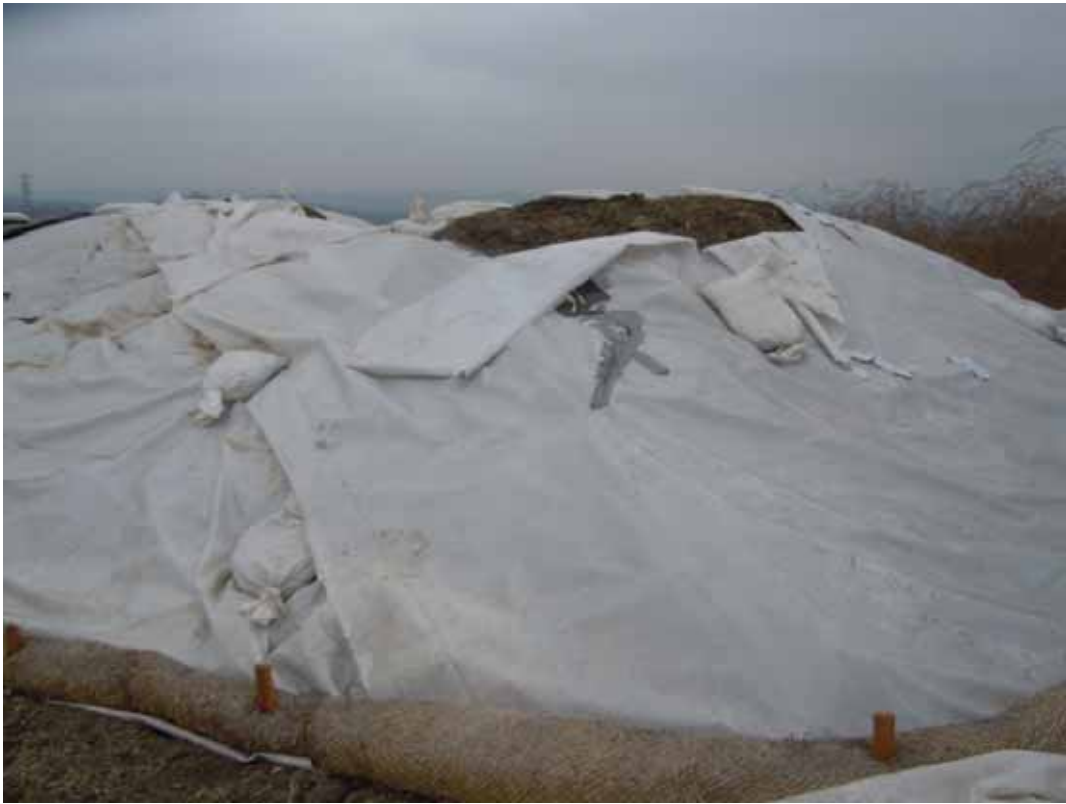
6. The CPUC EM observed a torn plastic covering at a soil pile at Tower M5-T1A. The CPUC EM notified Wilson and they replied that the covering would be fixed (see Figure 11).

**Figure 11:** Torn plastic atop a soil pile, Segment 8 Phase 4.
