**PROJECT MEMORANDUM  
SCE TRANSMISSION PROJECTS, SEGMENTS 1 - 11**

**To:** John Boccio, Project Manager, CPUC  
**From:** Vida Strong, Aspen Project Manager  
**Date:** September 06, 2011  
**Subject:** Weekly Report 186, August 14 to August 20, 2011

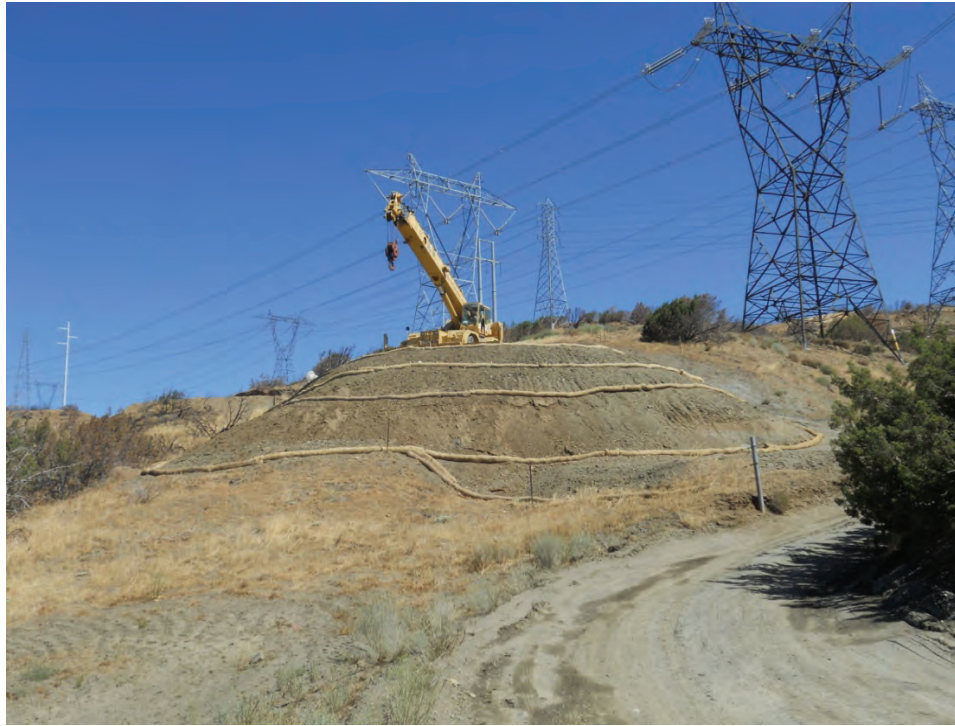
**Figure 1:** Crane pad site for Tower 28A with fiber roll BMP's, Segment 5.

3. Segment 5: Woodward Brothers (drilling contractor) continued drilling, setting rebar cages, and concrete pouring at Towers 28A, 28B, and 49 (see Figure 1). Woodward commenced foundation work on the Midway to Vincent tower upgrades starting with Towers M96-T4X, M96-T5X, M97-T1XXX, and M97-T4AX. H&M steel crews continued tower assembly and erection at Towers 16, 18, 23, 31, 37, 45, 62, and 67. H&H Grading conducted removal of old steel and existing foundations from the 220 kV towers. Demolition of the 220 kV towers is 95% complete. H&H graded new access roads in various locations (see Figure 2). The soil stabilization work at Tower 30 is on hold due to an engineering issue. BMP maintenance occurred at several locations throughout the segment. Wire stringing activities are scheduled to begin on August 29th.

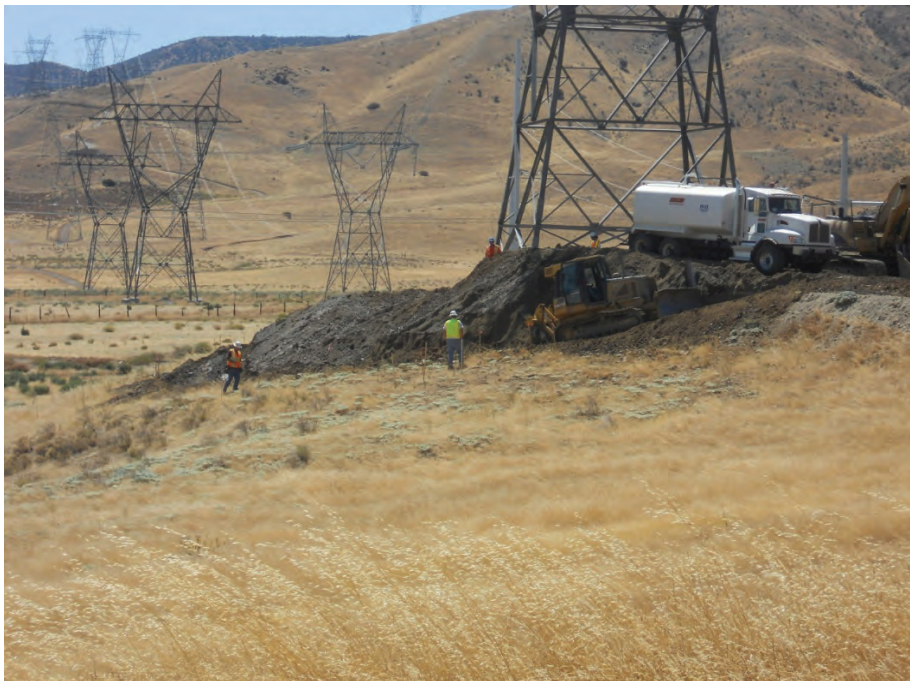
**Figure 2:** H&H grading the new access road at Tower 37, Segment 5.

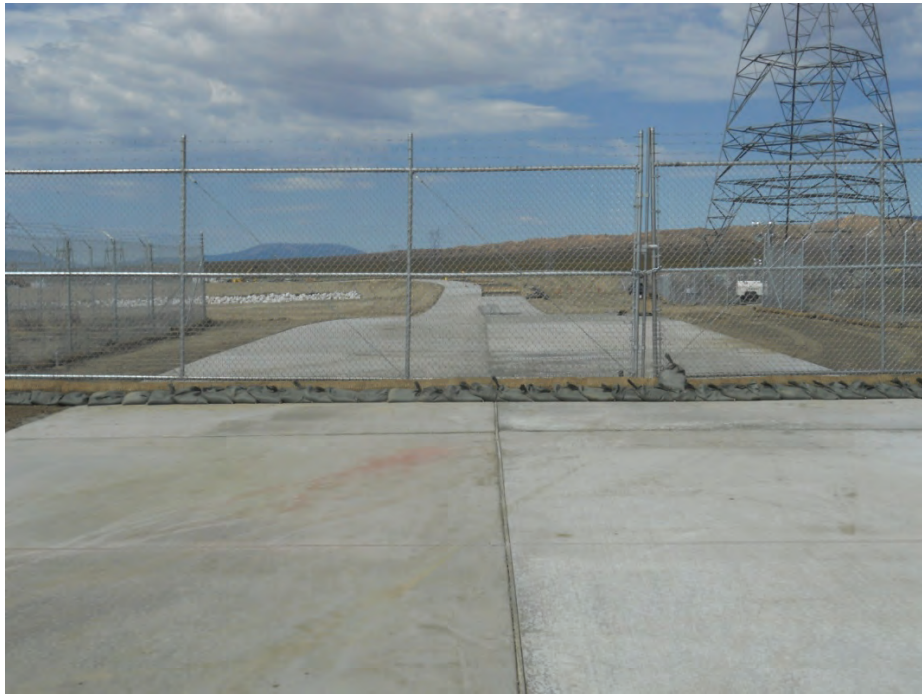
**Figure 3:** Concrete driveway at main gate to Whirlwind Substation, Segment 9.

6. Whirlwind Substation: Below-grade construction, civil foundations and conduits are 100% complete. Work completed in the 500 kV area includes switchrack, foundation work, setting of transformers, circuit breakers, buses, deadends, and grounding. The 220 kV switchrack, reactors, and cable trenching is 100% complete. Ongoing work in the 220 kV area includes bus deadends, conductor installation, disconnect switches, and grounding. Foundation pouring at the main entrance gate also occurred (see Figure 3). Watering for fugitive dust continued.

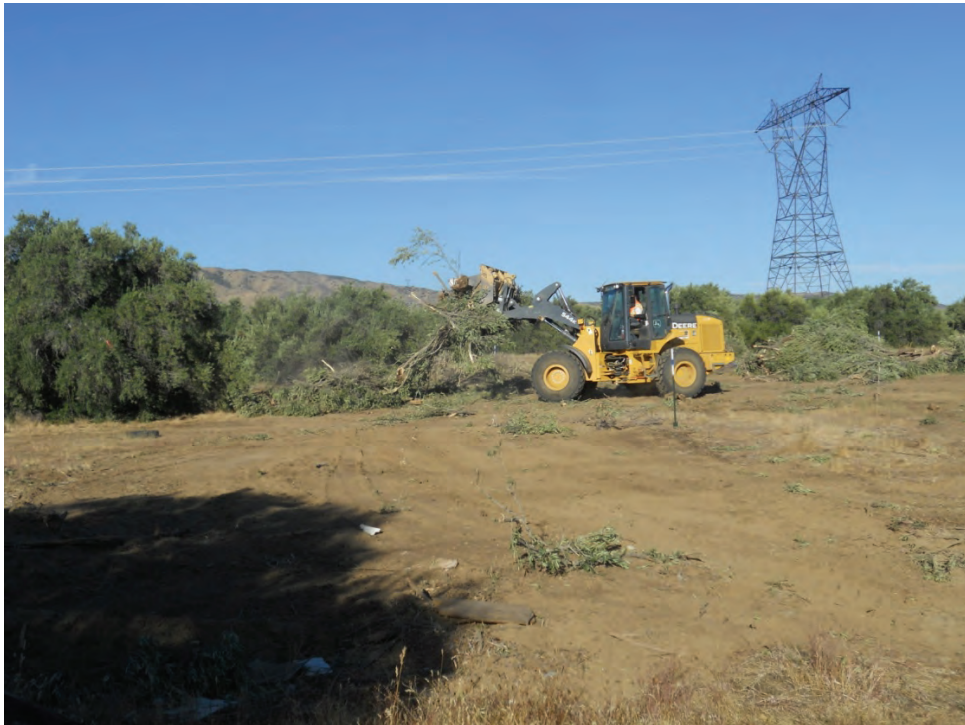
**Figure 4:** Olive tree removal near Towers 8 and M90-T1X, Segment 5.

8. Olive trees were removed from the disturbance areas at Towers 8 and M90-T1X on Segment 5 in preparation for foundation work (see Figure 4).
9. The CPUC EM verified disturbance staking for additional wire setup sites (WSS), guard pole site, and road improvement on Segments 4, 5, and 10. These additional areas were approved under Variances #76, 77, 79, and 80.

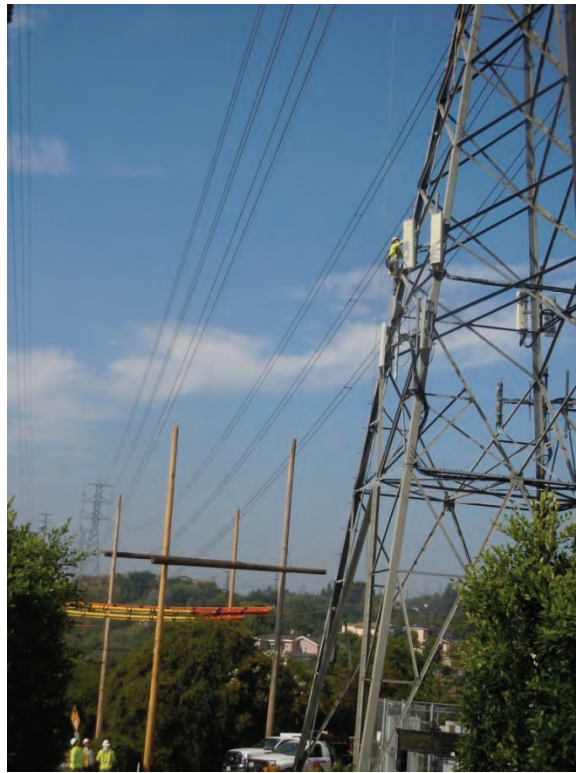
**Figure 5:** A PAR lineman climbs a tower to remove a traveler after conductor installation, Segment 11A.

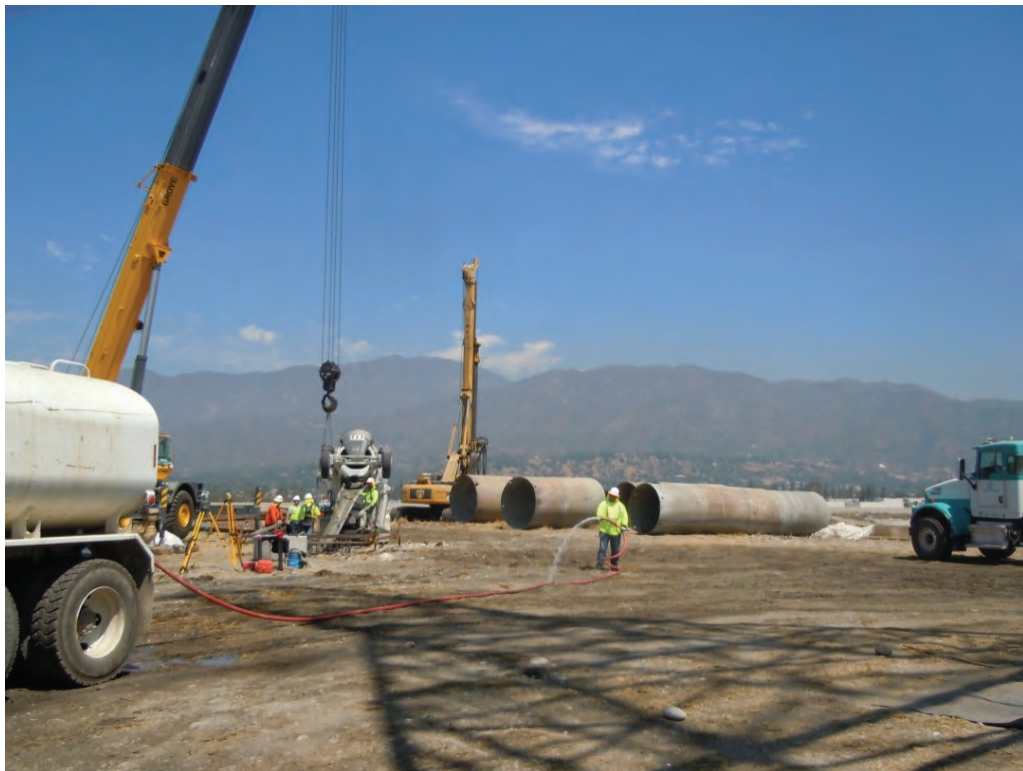
**Figure 6:** A Tri-State crew pours a foundation while watering for dust control, Segment 7.

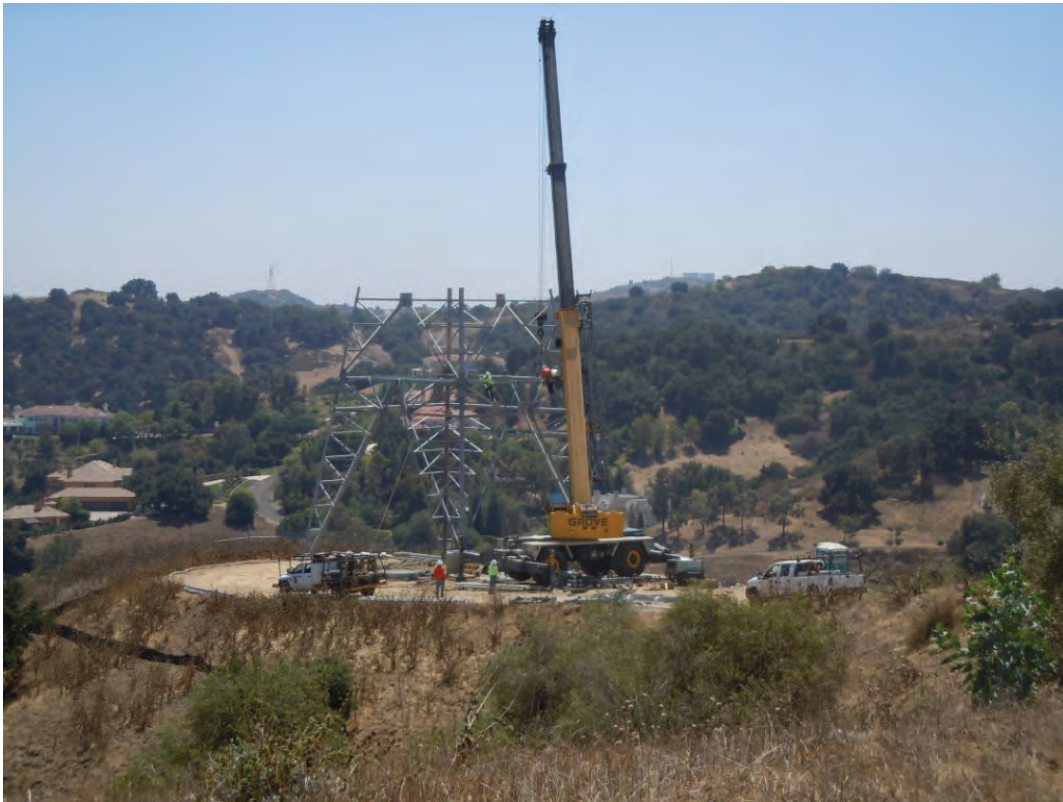
**Figure 7:** A Wilson crews assembles a tower, Segment 8 Phase 1.

3. Segment 8, Phase 1: Wilson crews mowed vegetation and installed BMPs at tower sites and wire setup sites to keep environmental surveys active (see Figure 7). Wilson continued assembly at one tower. Tri-State continued drilling at one tower location and three pole locations (see Figure 8). To date, 100% of the conductor and structures have been removed of the existing 220 kV Chino-Mesa and Mira Loma–Walnut and Mira Loma–Olinda lines. Of a total 43 new structures on the double circuit 500 kV Mira Loma–Vincent line, a total 83% of the foundations are complete (including 100% of the tubular steel pole foundations in the City of Chino Hills) and 30% of the towers are complete.

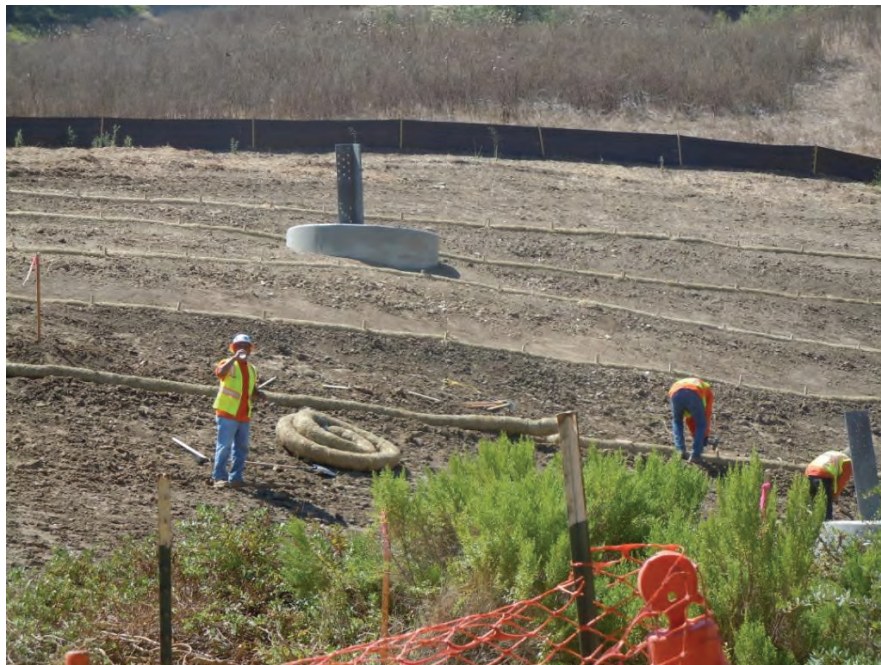
**Figure 8:** DCX crews install erosion control BMPs, Segment 8 Phase 1.

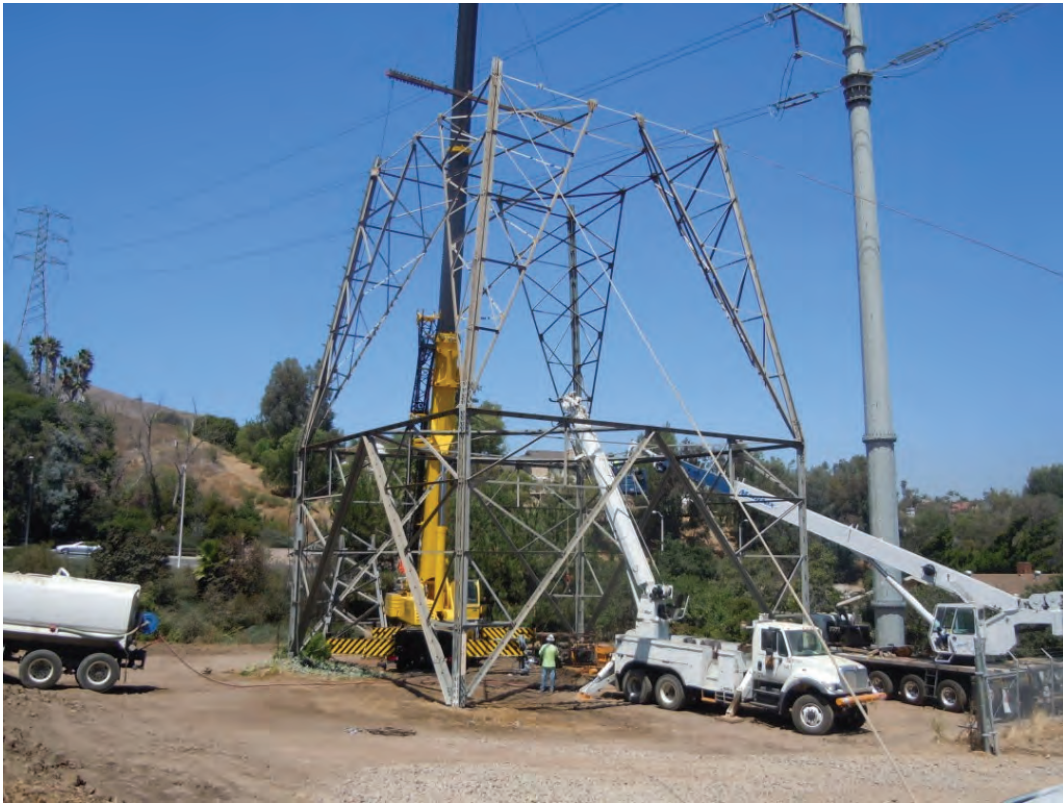
**Figure 9:** A Wilson crew removes a tower within Fullerton Yard, Segment 8, Phase 4.

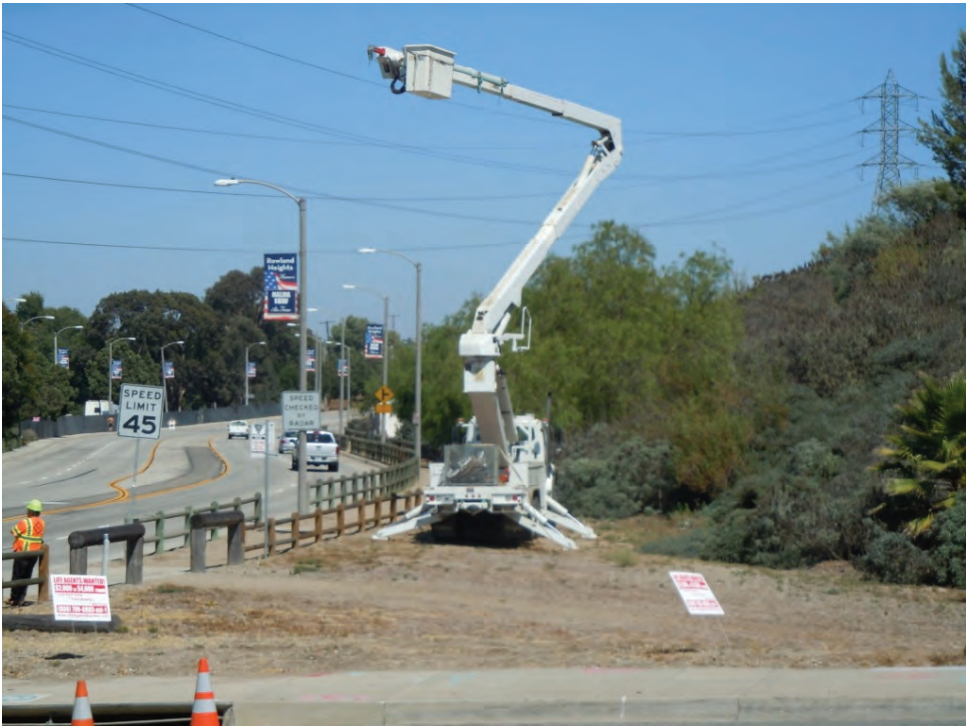
7. The CPUC EM observed that a boom truck being used as guard structure was parked in an unpaved area at the corner of Pathfinder Road and Fullerton Road in the City of Rowland Heights (see Figure 10). A TEWS request was received and approved on August 12<sup>th</sup> for an additional guard pole site at the locations, but the TEWS request had been conditioned for parking on a paved surface only. The CPUC EM spoke with SCE about the accuracy of future TEWS requests.

**Figure 10:** A boom truck parked outside of the area approved as a TEWS request, Segment 8 Phase 4.
