PROJECT MEMORANDUM
SCE TRANSMISSION PROJECTS, SEGMENTS 1 – 11

To: John Boccio, Project Manager, CPUC
From: Vida Strong, Aspen Project Manager
Date: September 15, 2011
Subject: Weekly Report 187, August 21 to August 27, 2011

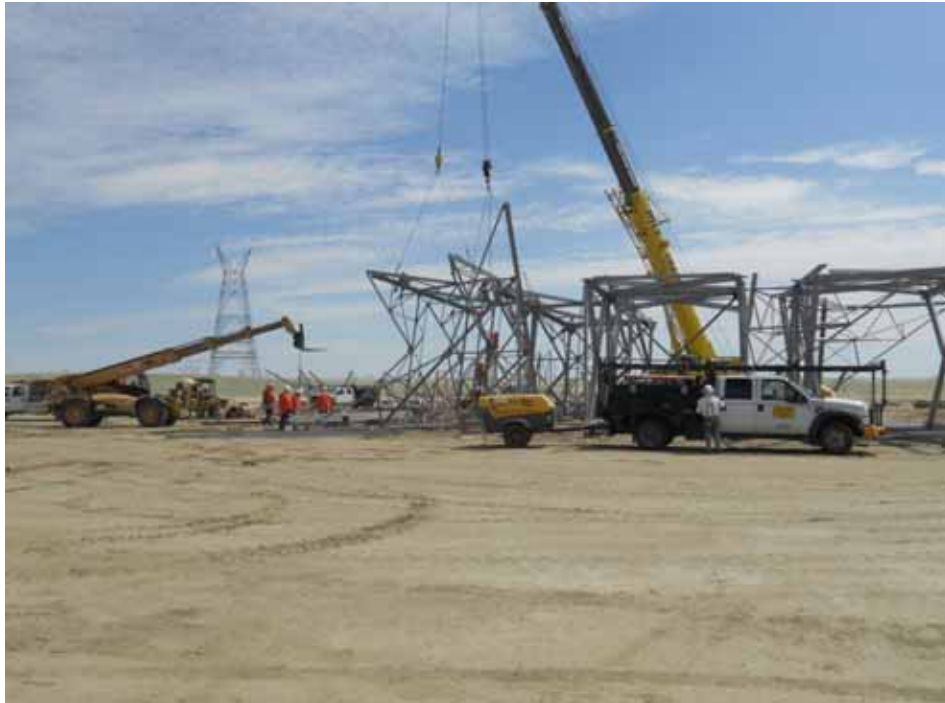
Figure 1: H&M steel crew assembling Tower 92 inside Whirlwind Substation, Segment 10.

4. Segment 10: KV Structures (drilling contractor) continued drilling, setting rebar cages using a spider jig for stub angle placement, and concrete pouring at Towers 26, 28, 32, 53, 63, and 73. Tower 89 has not been drilled due to an active bird nest. H&M steel crews continued tower assembly and erection at Towers 48 thru 50, 52, 54, 57, 60, 86, and 90 thru 92 (see Figure 1). Moore Fence Company con-

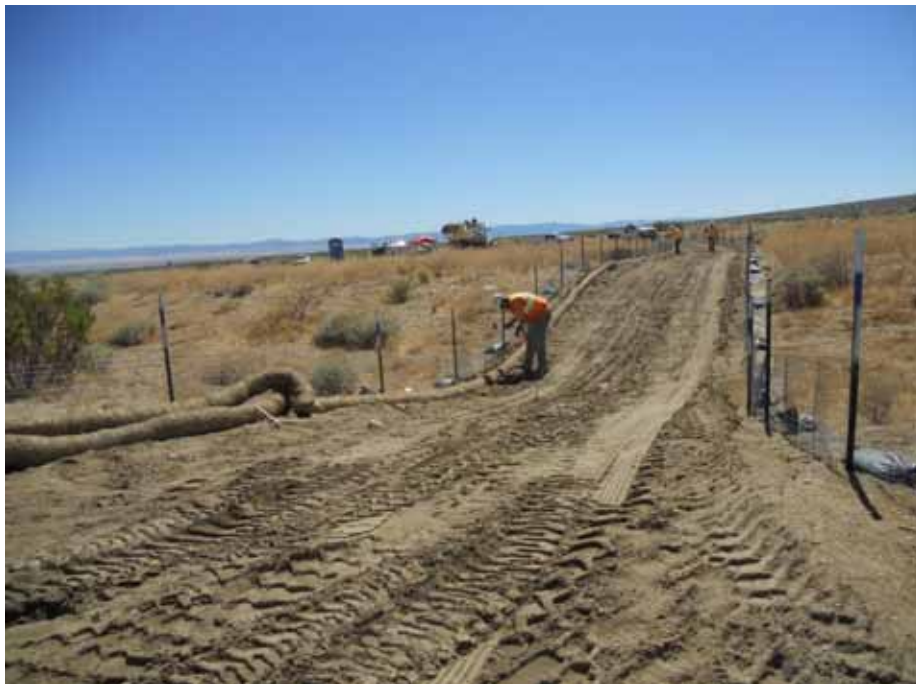
Figure 2: H&H Grading installing fiber rolls along the spur road to Tower 24 on the south side of Tehachapi Willow Springs Road, Segment 10.

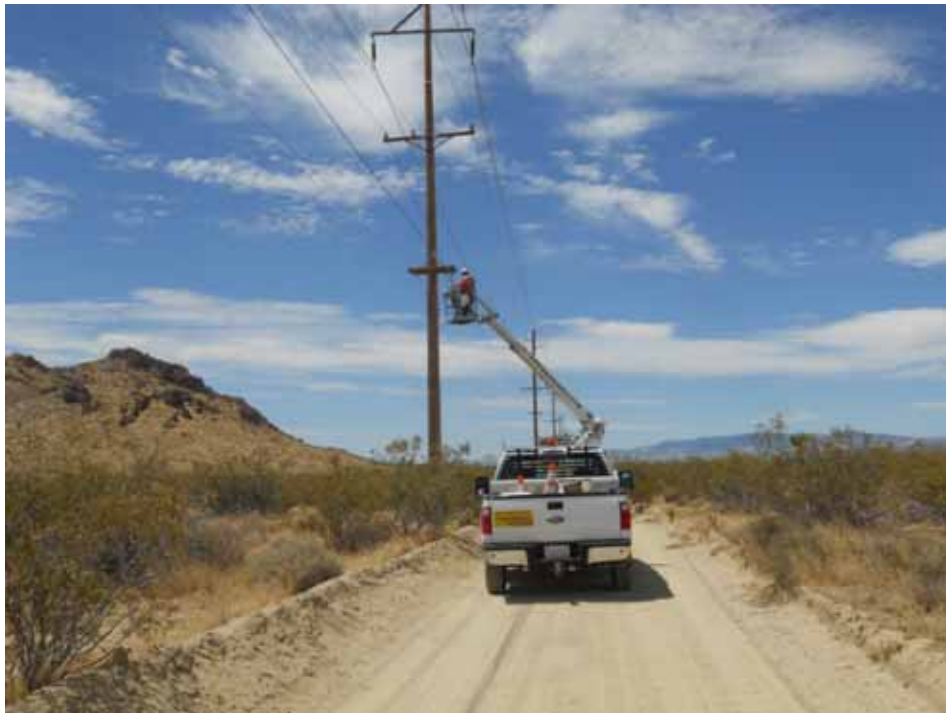
Figure 3: H&M crew adjusting the cable arms on wood poles on Favorito Road, Segment 10 Telecom.

5. Segment 10 Telecom: Work resumed on the Windhub to Rosamond portion of the segment. There were 22 poles that required cable arm adjustments and creating slack in the cable (see Figure 3).
6. Whirlwind Substation: Ongoing work included interior of the MEER building, construction of the SPCC retention basin, 500 kV and 220 kV areas, and grounding for chain link fencing. Foundation pouring at the main entrance gate also occurred. Watering for fugitive dust continued.

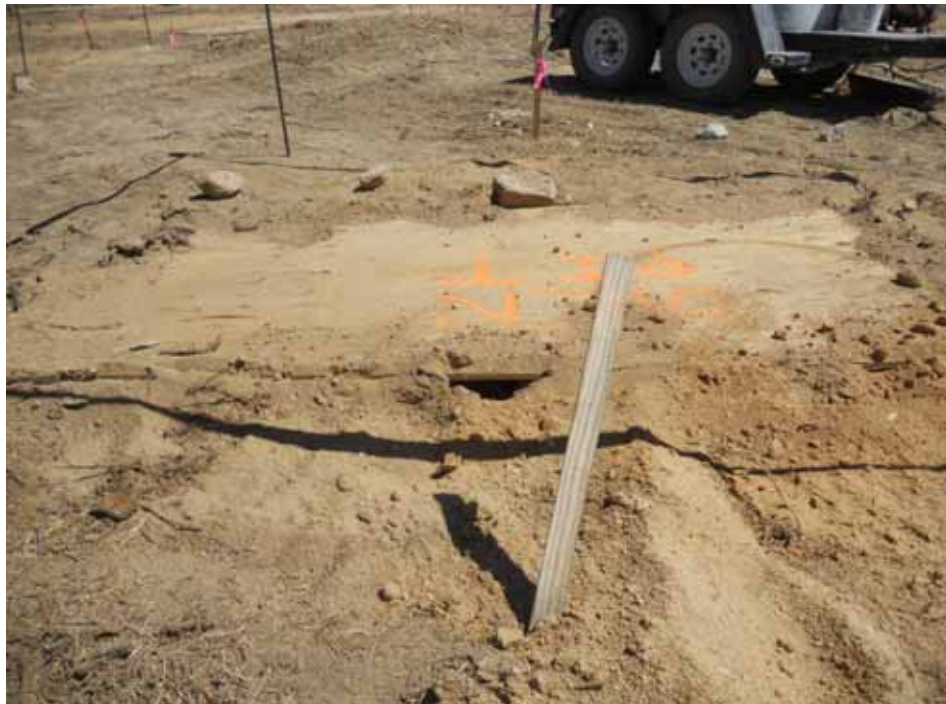
3. The CPUC EM denied a TEWS request for an area north of Elizabeth Lake Road on Segment 5 due to the proximity to a cultural site.
4. The CPUC EM observed a gap in the foundation hole covering at Tower 31 on Segment 10. The SCE Lead Biological Monitor and Burns & McDonnell Environmental Coordinator (EC) were notified of the observation. The information was passed on to the contractor so that the hole could be filled before leaving for the day (see Figure 4).

Figure 4: Gap in foundation hole cover at Tower 31, Segment 10.

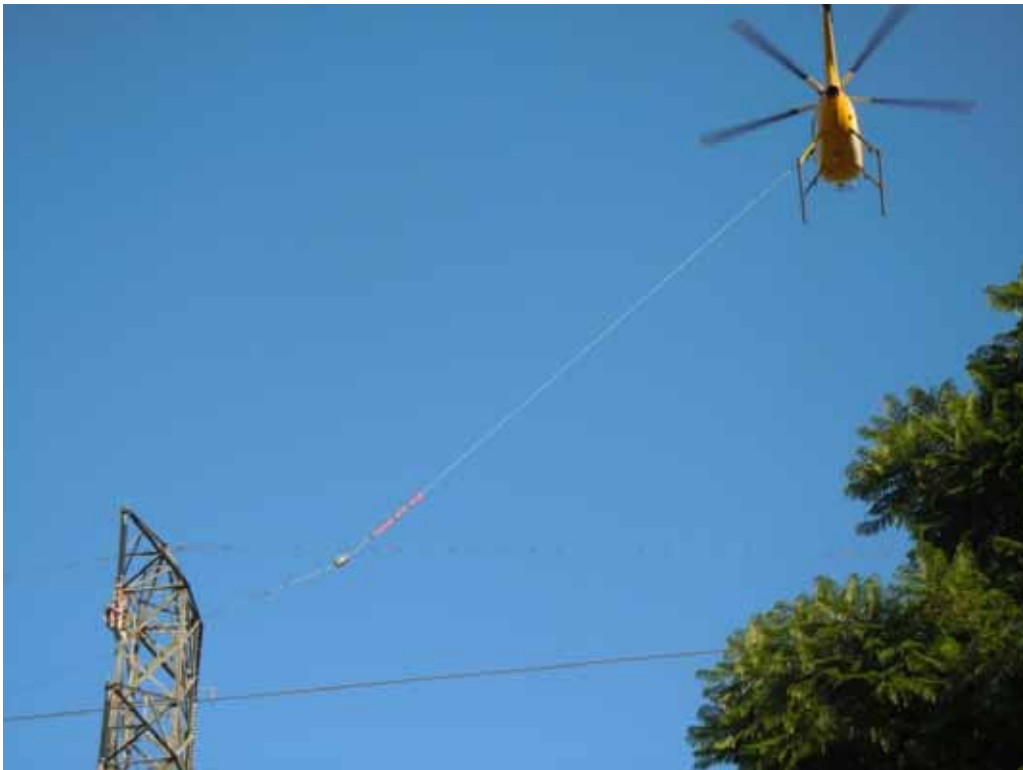
Figure 6: A helicopter pulls sockline through a traveler, Segment 11A.

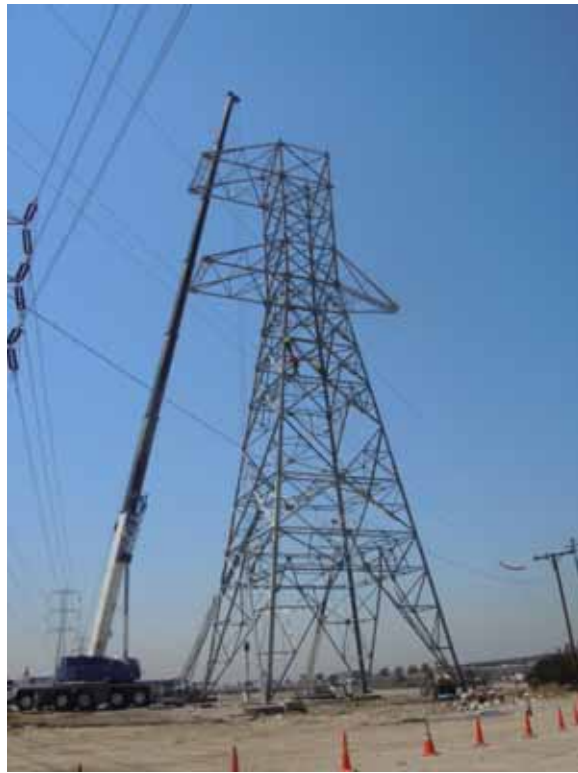
Figure 7: A Wilson crew assembles a tower, Segment 7.

2. Segment 7: Wilson crews mowed and installed BMPs at tower sites and wire setup sites to keep environmental surveys active. Wilson continued assembly of one tower within USACE land adjacent to Interstate 210 (see Figure 7). Tri-State continued drilling three tower foundations. To date, 72% of the conductor of the existing 220 kV Antelope-Mesa line has been removed, and 56% of the structures have been removed. Of the 78 new double circuit 500 kV structures on the Mira Loma–Vincent line, a total of 26% of the foundations are complete.

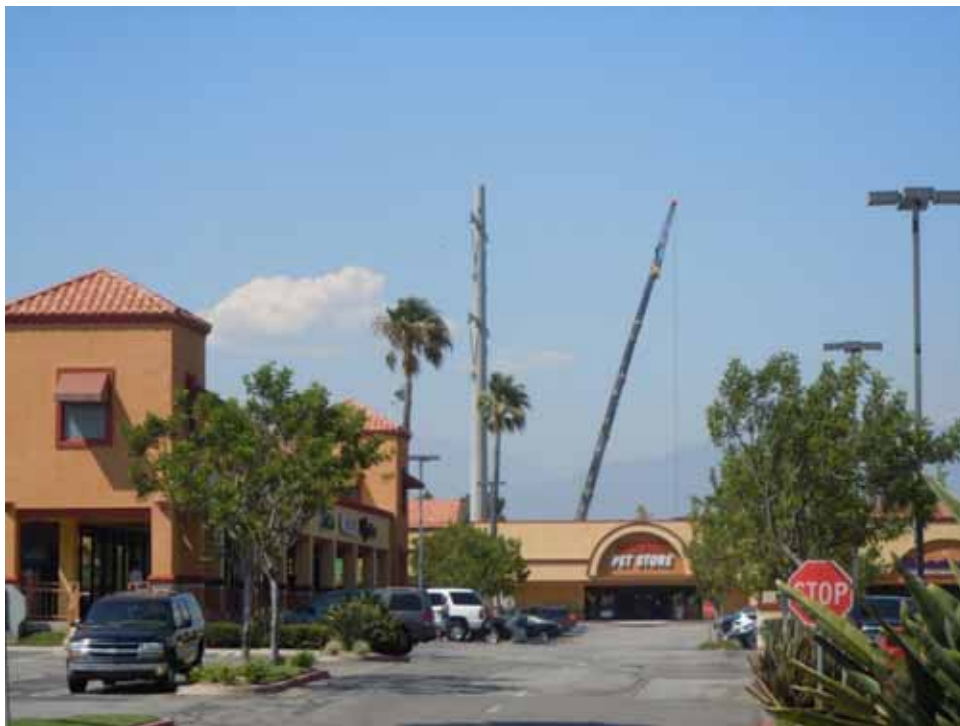
Figure 8: Erection of a TSP as seen from an adjacent mall, Segment 8 Phase 1.

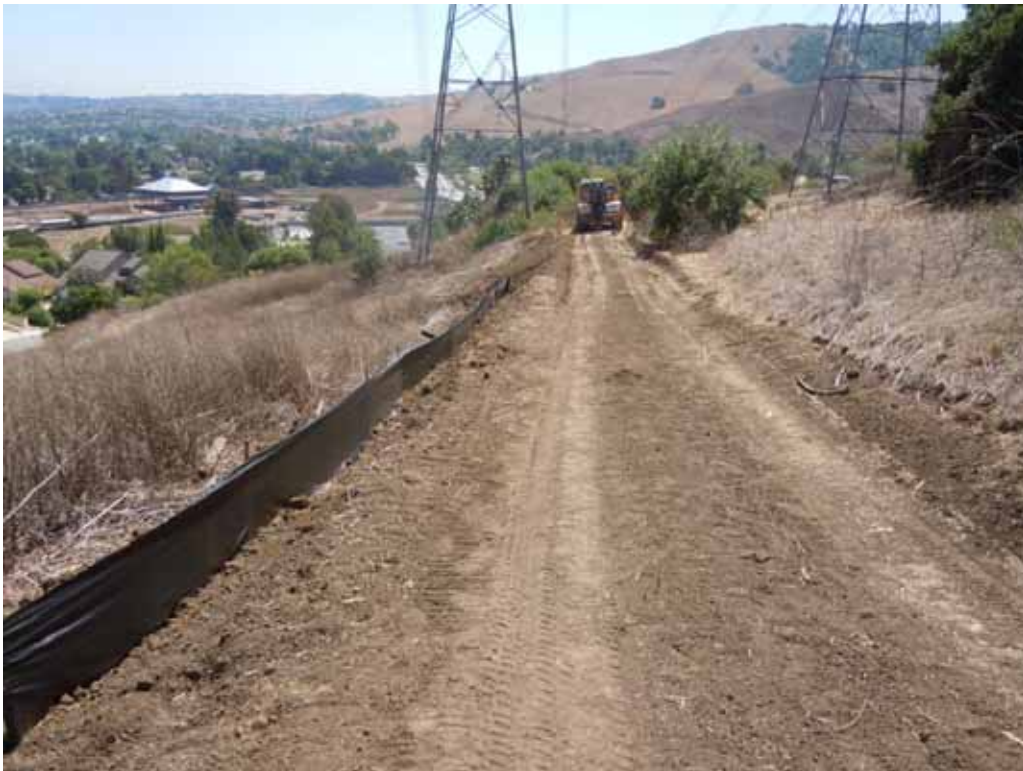
Figure 9: Access road that was unable to support the weight of a crane, Segment 8, Phase 4.

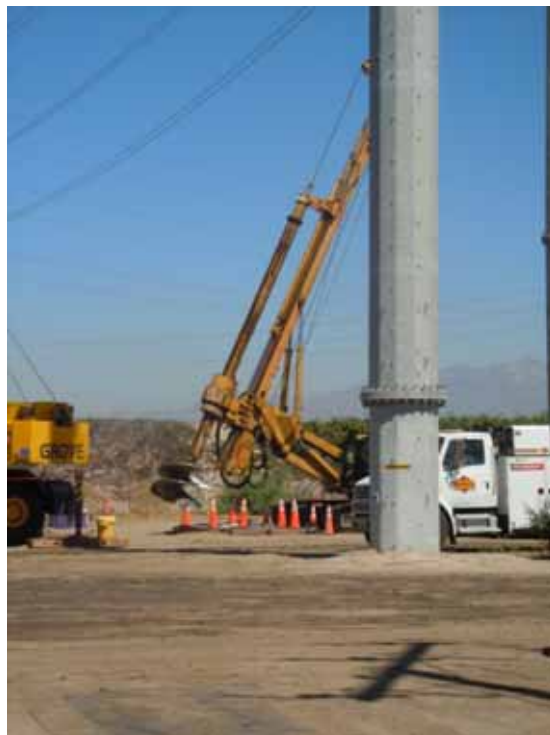
8. There was a 1.5 gallon hydraulic oil spill from a hose on a drill rig at Tower M7-T6 at the I-605 shoofly on August 24th. Approximately a half yard of affected soil was cleaned from the area and the SCE EIH was contacted following the spill (see Figure 10).

Figure 10: Drill rig after a hydraulic oil spill, Segment 8, Phase 4.
