**PROJECT MEMORANDUM
SCE TRANSMISSION PROJECTS, SEGMENTS 1 - 11**

To: John Boccio, Project Manager, CPUC
From: Vida Strong, Aspen Project Manager
Date: November 2, 2011
Subject: Weekly Reports 194 and 195, October 9 to October 22, 2011

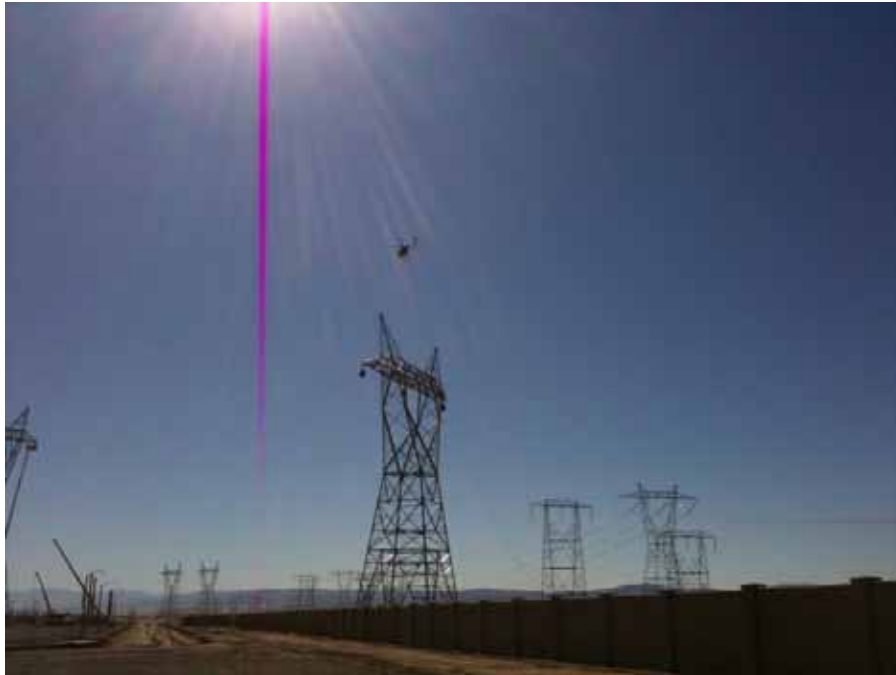
Figure 1: Helicopter being used for wire stringing preparation on Tower M73-T3B, Segment 4.

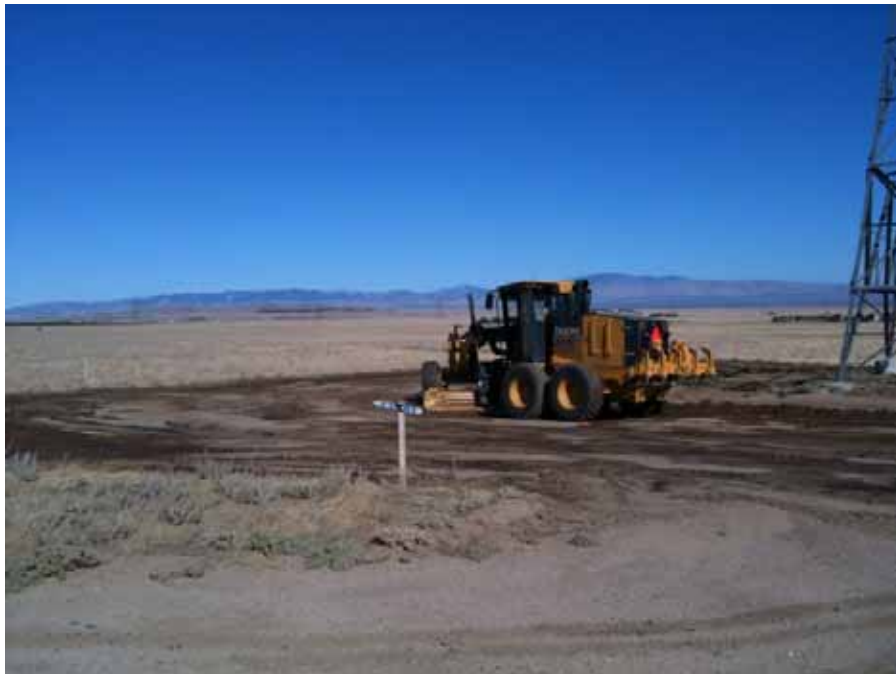
Figure 2: H&H Grading re-contoured Tower 52 disturbance site, Segment 4.

2. Segment 4: KV Structures (drilling contractor) commenced drilling, setting rebar cages using a spider jig for stub angle placement, and concrete pouring on the Midway-Vincent upgrade Towers M87-T2X and M87-T3X. Tower erection is approximately 89% complete. Wire preparation activity which included installing travelers on Towers M73-T3B and M73-T3C (see Figure 1) continued around Whirlwind Substation for the Midway-Vincent No. 3 outage which begins on October 24th. Wire stringing was conducted from Towers 20 to 34. Wire was also pulled from Towers 1 and M74-T1X into the Whirlwind Substation racks. H&H Grading began re-contouring tower disturbance sites at Tower 52 and are working north (see Figure 2).

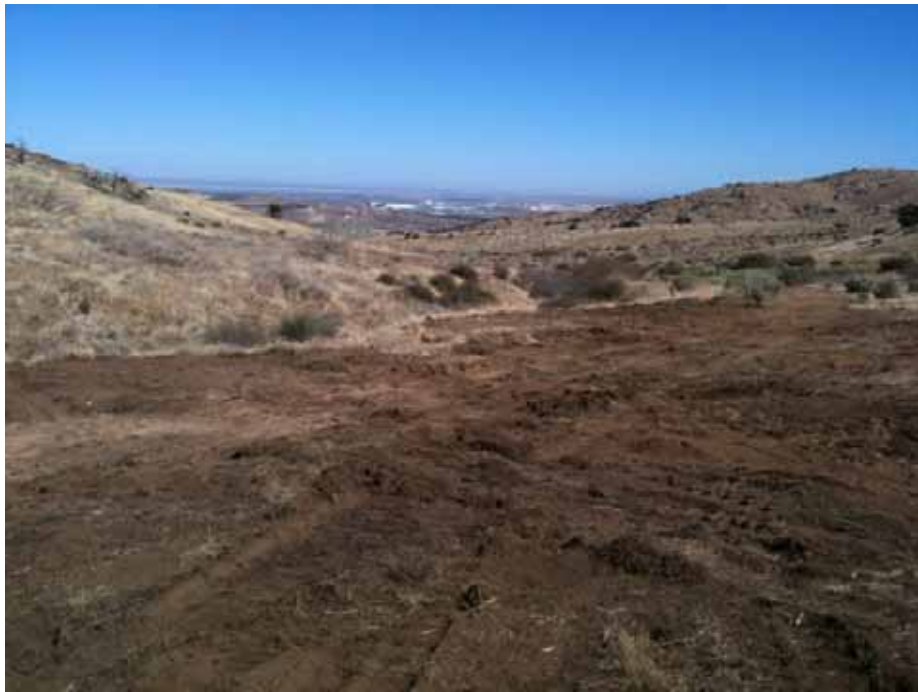
Figure 3: H&H Grading cleared and grubbed the wire set-up site south of Tower 51A, Segment 5.

2. The CPUC EM verified disturbance staking for Tower 55A on Segment 5 that was approved under Variance # 93. No issues were noted.
3. During clearing and grubbing of a wire set-up site (WSS) south of Tower 51A on Segment 5, the CPUC EM observed that a drainage crosses the WSS, but the Environmentally Sensitive Area (ESA) signs were installed east of the WSS. The SCE Lead Biologist was notified and asked to clarify the mapping of this jurisdictional drainage in relation to the WSS. The EM was informed that the drainage was not mapped as jurisdictional through the WSS, but ESA signs were added as extra precaution. The grading contractor was able to avoid disturbance to the drainage altogether.

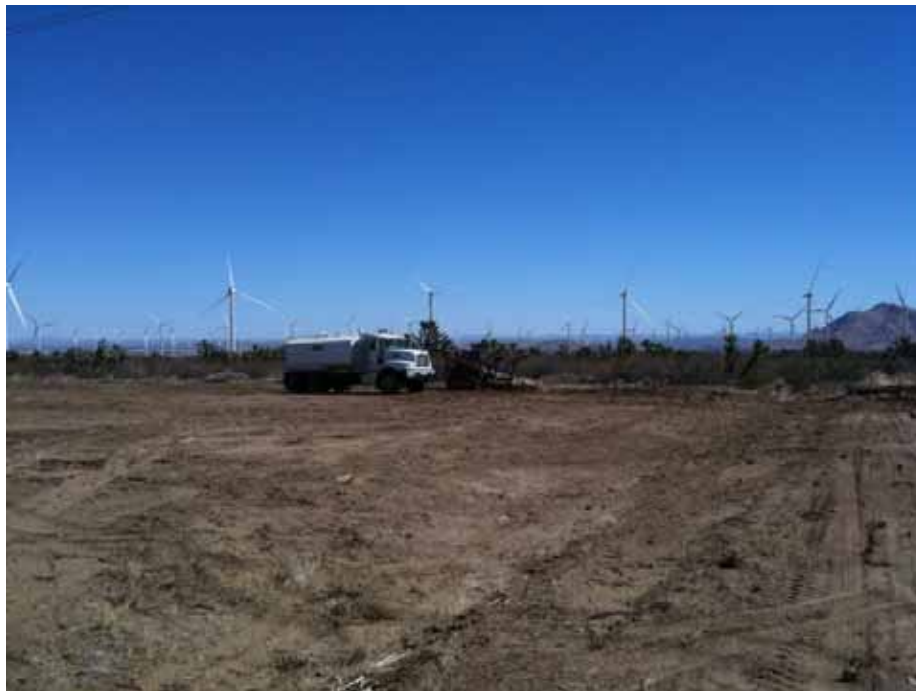
Figure 4: H&H Grading mulched Joshua trees in the wire set-up site at Tower 1, Segment 10

4. Segment 10: KV Structures (drilling contractor) continued drilling, setting rebar cages using a spider jig for stub angle placement, concrete pouring, and clean-up at Towers 1, 3, 12, 29, 37, 40, and 41. H&M steel crews continued tower assembly and erection at Towers 8 thru 11, 14, 16, 17, 21, 36, 43, 73, 89, and 91. Moore Fence Company installed tortoise fence at the wire sleeve sites between Towers 76 and 77 and between Towers 67 and 68. They continued removing the temporary fence from access roads. They also conducted permanent fence maintenance and sand bag replacement. H&H Grading continued clearing, grubbing, and grading of wire pull sites. Joshua trees are being chipped and mulched in the wire pull sites (see Figure 4).

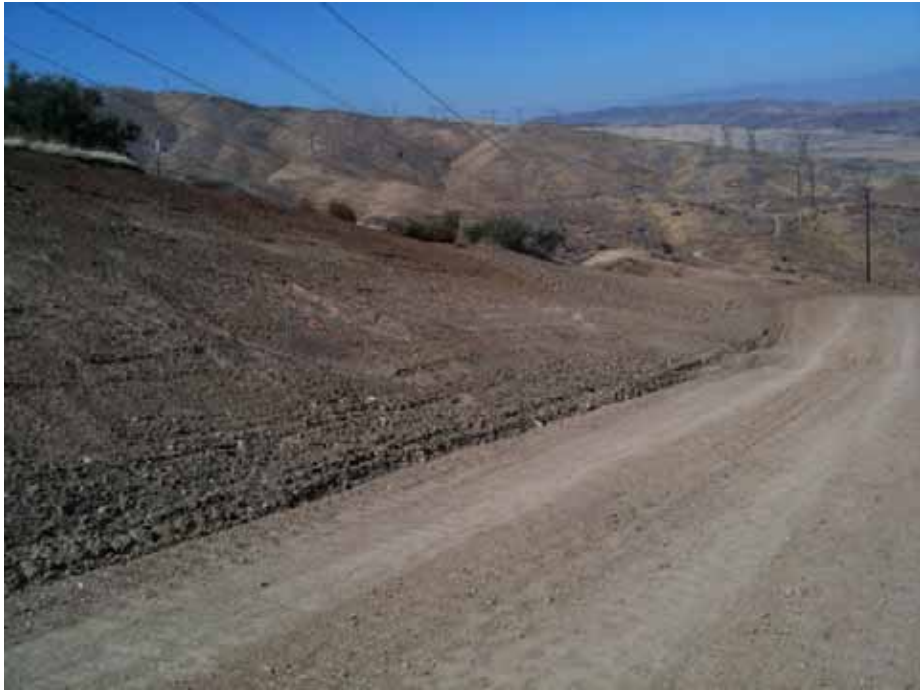
8. The CPUC EM provided the SCE Environmental Coordinator with photo documentation concerning potential erosion of disturbance areas that are adjacent to access roads which would cause sedimentation to leave the site. These sites were observed on Segment 5 and currently do not have BMP's installed (see Figure 5).

Figure 5: Disturbance area near Tower 49 that lacks BMP's (i.e. fiber rolls), Segment 5.

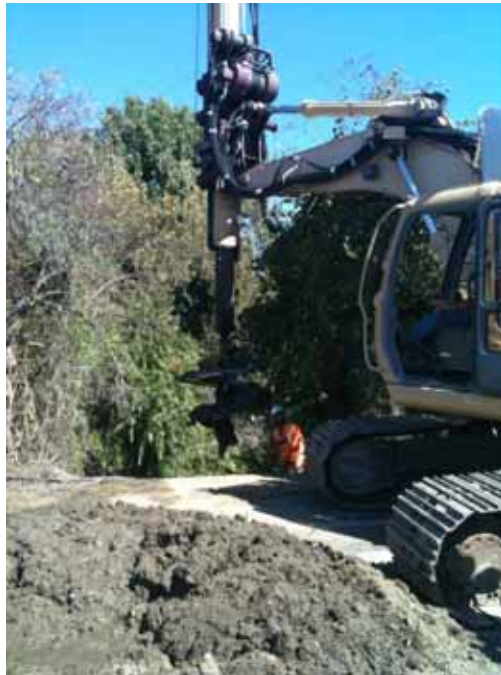
Figure 6: Foundation drilling along San Gabriel Boulevard with spill pile, Segment 8.

3. On October 11th, during drilling for 66 kV foundation 4704312E along San Gabriel Boulevard, hydrogen sulfide gas was detected by the hand-held gas monitor. Per the requirements of the contractor Health and Safety Plan, the contractor stopped work at the location and contacted SCE. In coordination with SCE, readings using two additional meters were taken at 15 feet and 6 feet from the excavation, at the surface of the excavation and 16 feet down hole and there was no gas detection from both meters. SCE directed crews to continue work.

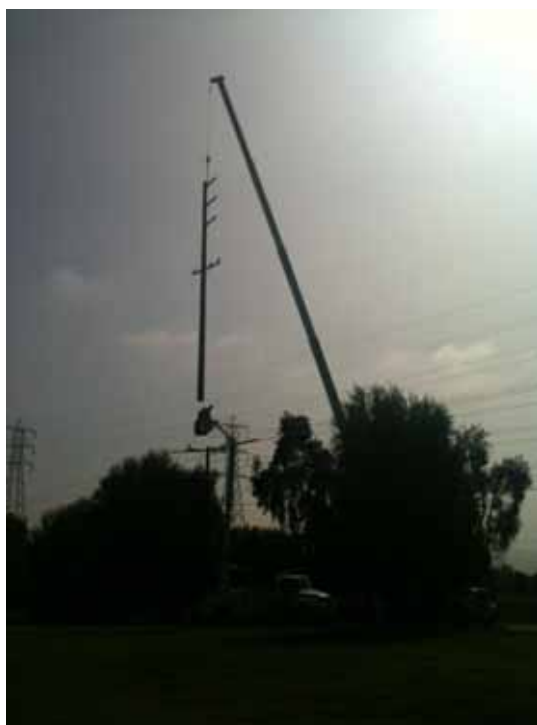
Figure 7: Crews set a lightweight steel pole, Segment 7 66 kV.

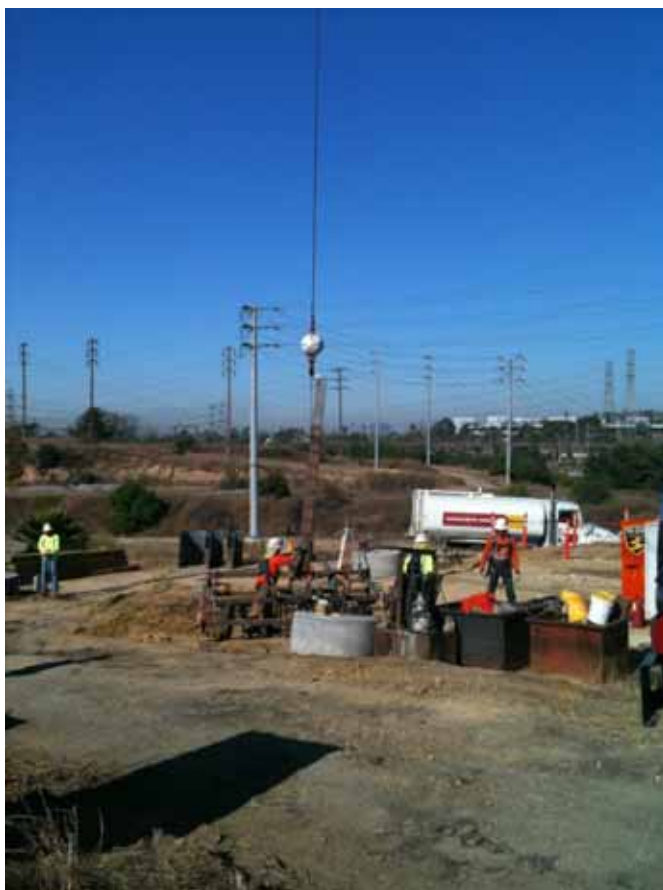
Figure 8: Crews lower a stub angle into a foundation, Segment 7.

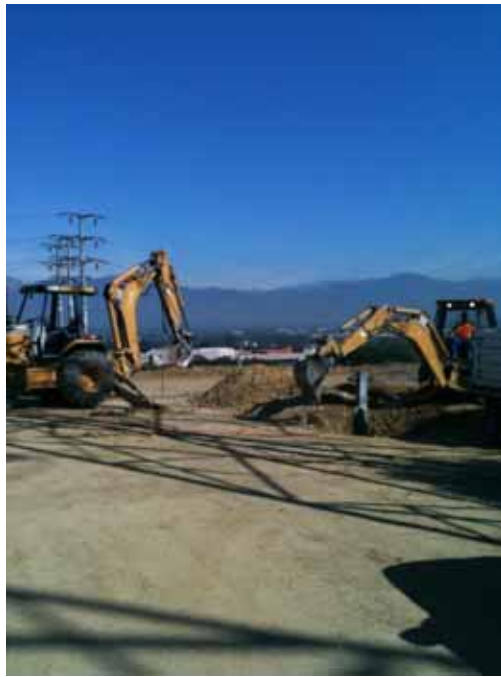
Figure 9: Foundation demolition within Montebello Hills, Segment 7.

2. On October 10th the CPUC EM observed DCX crews excavating foundations and shearing material with a torch within Montebello Hills without a gas monitor on-site. Per Mitigation Measure E-3b and the contractor's Health and Safety Plan, all ground disturbance within 500 feet of a known oil well must have gas monitoring. The CPUC EM notified SCE and the contractor sent a gas monitor to the site. An SCE Level 1 non-compliance was issued for the incident.

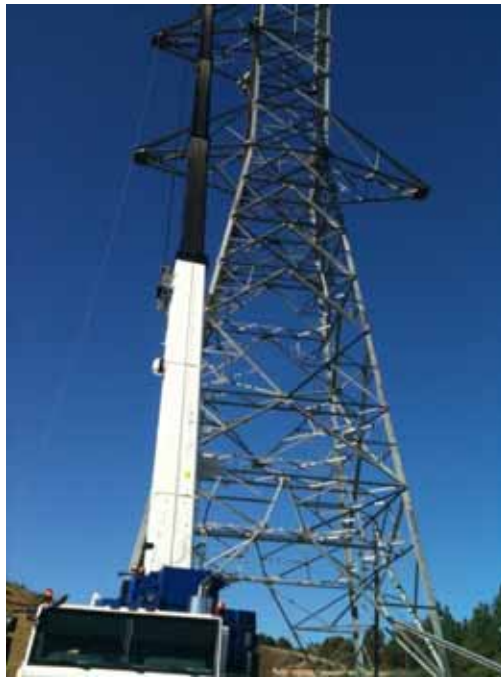
Figure 10: Crews assemble a tower within Chino Hills, Segment 8 Phase 1.

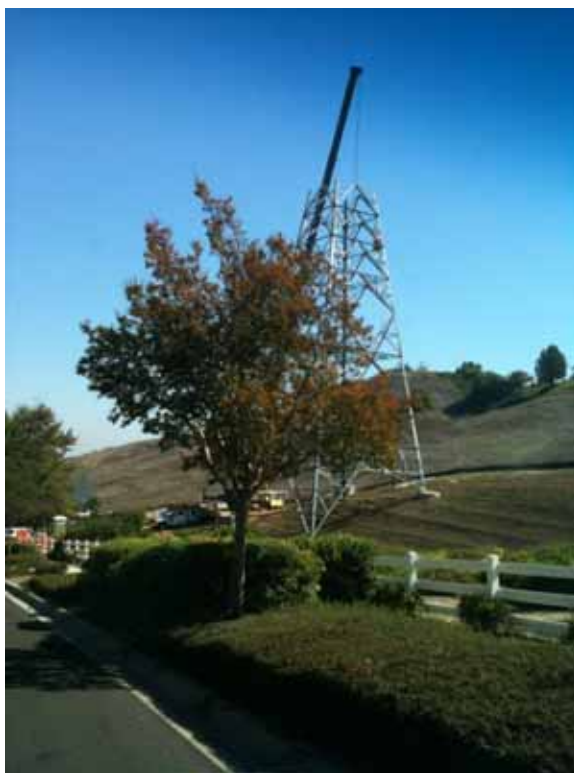
Figure 11: Crews assemble a tower within Chino Hills, Segment 8 Phase 1.

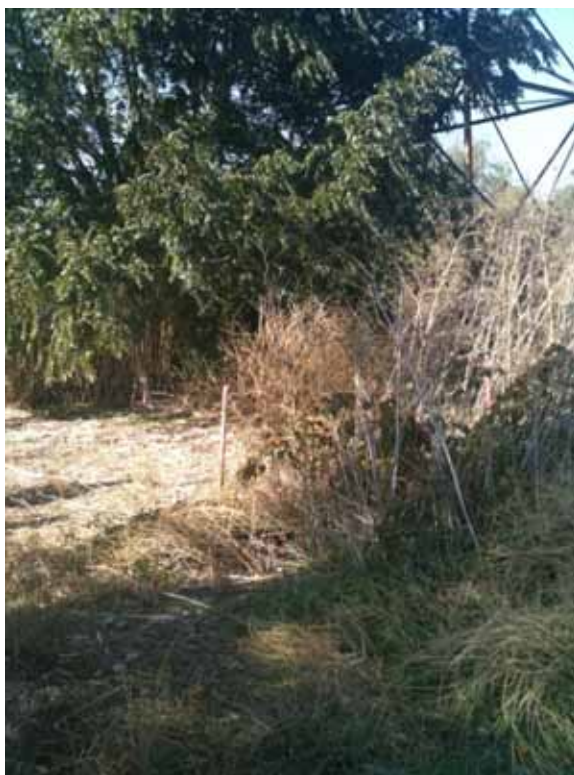
Figure 12: A cleared 66 kV disturbance area within Whittier Narrows, Segment 8.

6. A kick-off meeting was held on October 18th for overhead 66 kV work on both the Rio Hondo–Amador-Jose-Mesa and Walnut-Hilgen-Industry-Mesa-Reno. Topics discussed included disturbance areas for work sites, environmental compliance issues and access roads to sites, which are covered under the CDFG Incidental Take Permit (see Figure 12).
