PROJECT MEMORANDUM

ANTELOPE TRANSMISSION PROJECT, SEGMENTS 1, 2 AND 3A

To: John Boccio, Project Manager, CPUC
Justin Seastrand, Project Manager, ANF
From: Vida Strong, Aspen Project Manager
Date: May 6, 2009
Subject: Weekly Reports 66 and 67: April 12–25, 2009.

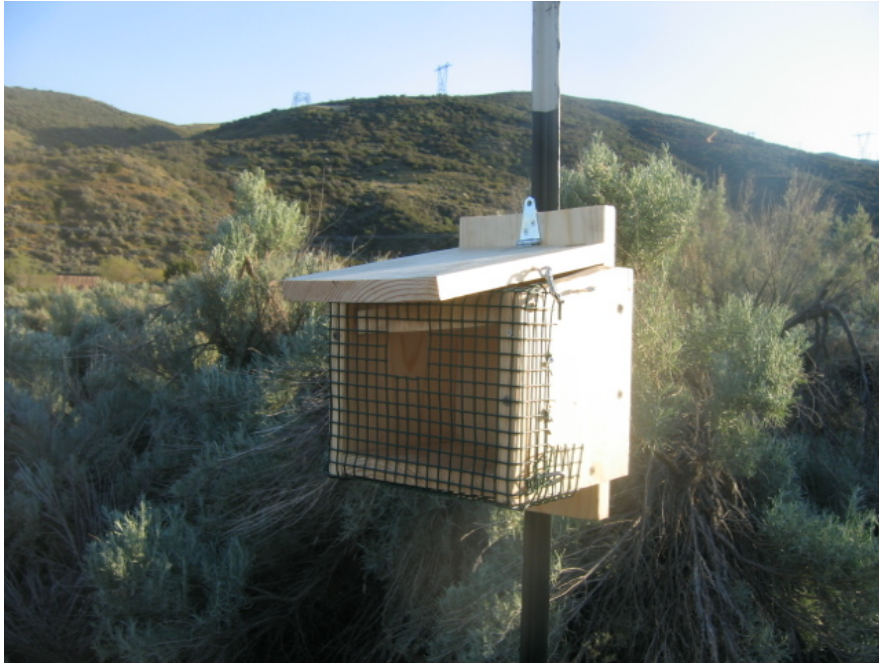
Figure 1: Nest boxed used to relocate house finch nests containing eggs on Segment 2. Note: relocated nest failed.

1. On April 21st, the CPUC EM learned that SCE had contacted USFWS and CDFG for approval to remove three active house finch nests from equipment in Segment 2 and at the Avenue J Yard. The CPUC EM reminded Burns and McDonnell environmental staff that the CPUC requires documentation of approvals granted by resource agencies prior to this activity occurring. Artificial nesting boxes were used to relocate the nests into, but the adult birds did not follow and incubate the eggs in all three cases (see Figure 1).

2. On April 25th, another house finch nest containing one egg was moved into a nest box at the Hydrant Yard by Burns and McDonnell environmental staff. In this case, prior approval from CDFG and USFWS was not granted before this nest removal took place. This nest was also abandoned by the adult birds. SCE was reminded again that the documentation for active nest removals must be provided to the CPUC prior to moving the nests.

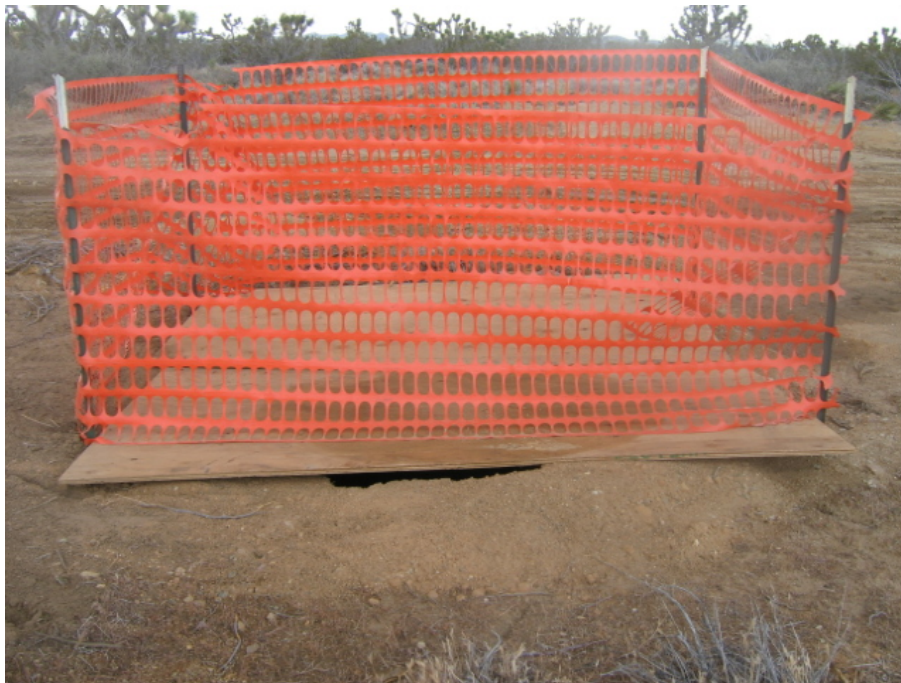
Figure 2: Gaps between the ground surface and plywood covers in desert tortoise areas of Segment 3A.

- f. If a tortoise is observed in project areas, it can not be moved to facilitate construction
2. On April 22nd, Aspen Biologists, Chris Huntley and Jennifer Lancaster, met with CPUC EM, Jenny Slaughter, to tour areas of Segment 3A to ensure that tortoise protection measures were being implemented. During the tour of the area, several project access roads were observed with little or no flagging to indicate which roads could or could not be used. Open foundation holes (drilled) were found to be covered with plywood and surrounded with orange construction fencing (see Figure 2). At these locations, gaps were evident between the plywood and the ground surface, and the fencing was ripped or down in some locations. Some foundation holes partially dug were left uncovered during the day. Also observed were trucks traveling over 15 miles per hour and equipment moving without checking underneath for tortoises. These observations were all related to SCE at the end of the field tour.

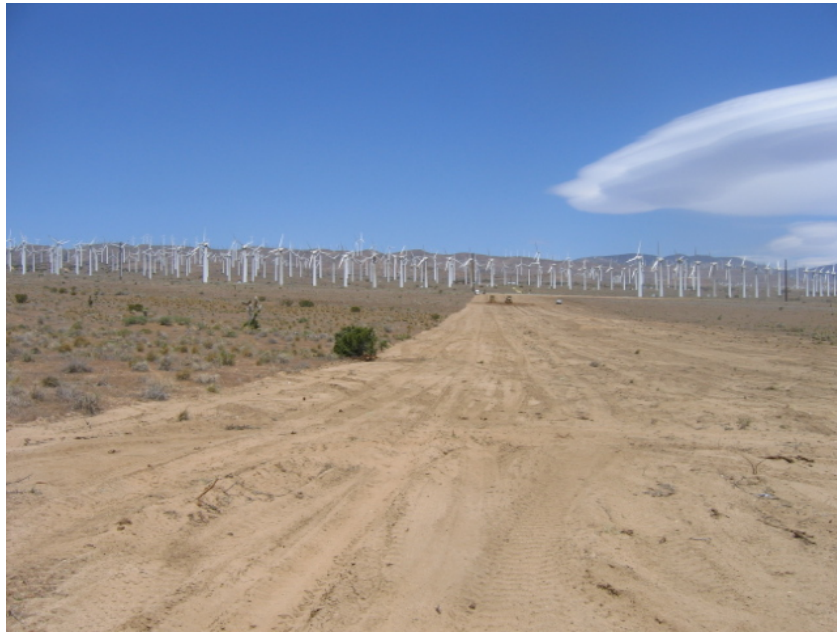
Figure 3: Grading and brush clearing of the new Windhub Substation.

5. Vegetation clearing at the Windhub Substation site began on April 21st (see Figure 3). Biological, archaeological, and Native American monitors were present during this activity. Windhub grading contractors plan to work Monday-Thursday each week.

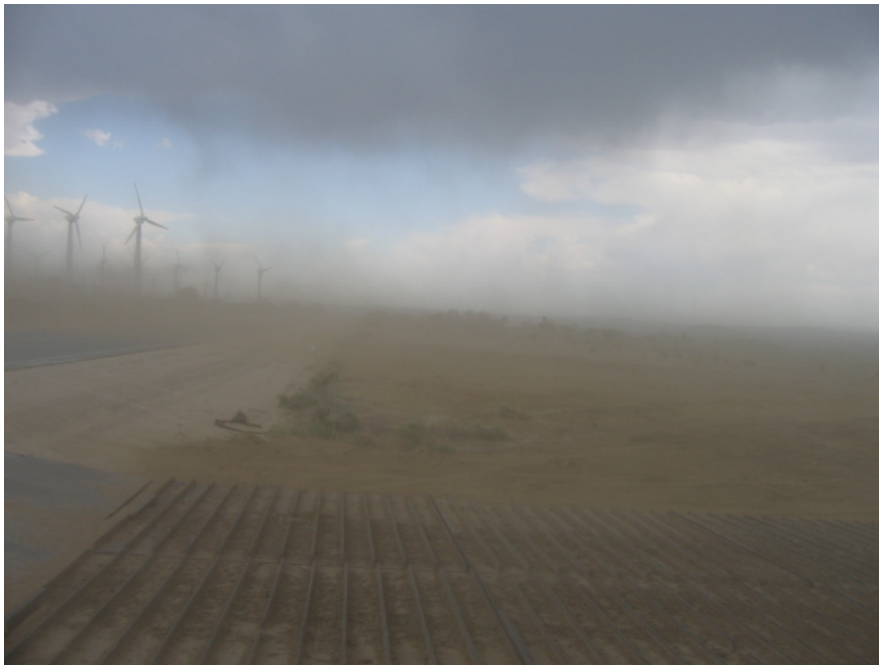
Figure 4: Dust from the Windhub Substation site blowing across Oak Creek Road.

4. At the Windhub Substation construction site, the CPUC EM observed large clouds of fugitive dust blowing across Oak Creek Road on April 22nd (see Figure 4). SCE was reminded that they were responsible to control dust at construction sites at all times (grading crews are only working Monday–Thursday).
