PROJECT MEMORANDUM
SCE BANDUCCI SUBSTATION PROJECT

To: Jensen Uchida, Project Manager, CPUC
From: Vida Strong, Aspen Project Manager
Date: November 27, 2017
Subject: Monitoring Report #5: October 29 to November 17, 2017

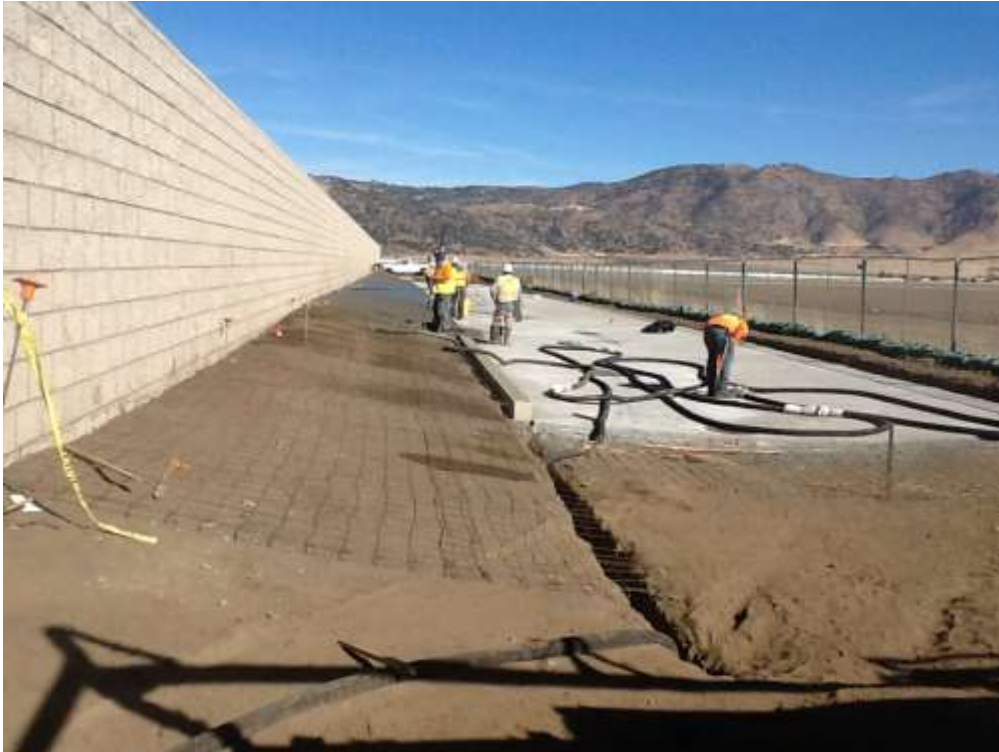
Figure 1 – Professional Construction crews graded and poured the concrete v-ditch surrounding the Banducci Substation site.

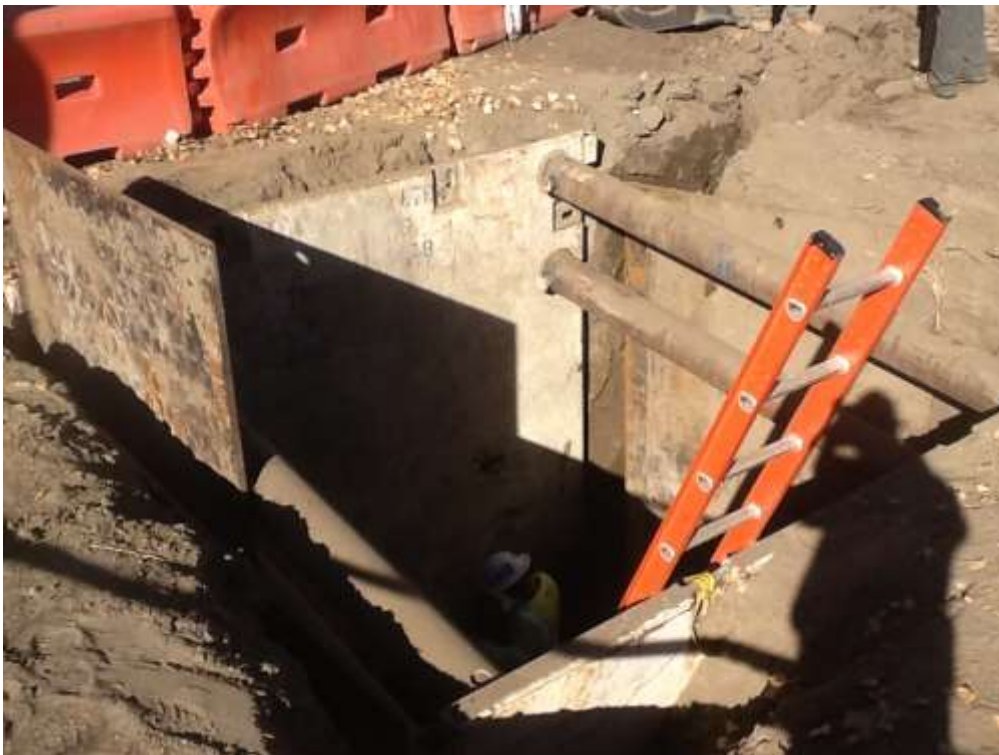
7. H&M crews conducted trenching, conduit installation, and backfilling activities along Pellisier and Highline Roads (see Figure 2).

Figure 2 Trenching and vault tie in occurred along Pellisier Road.

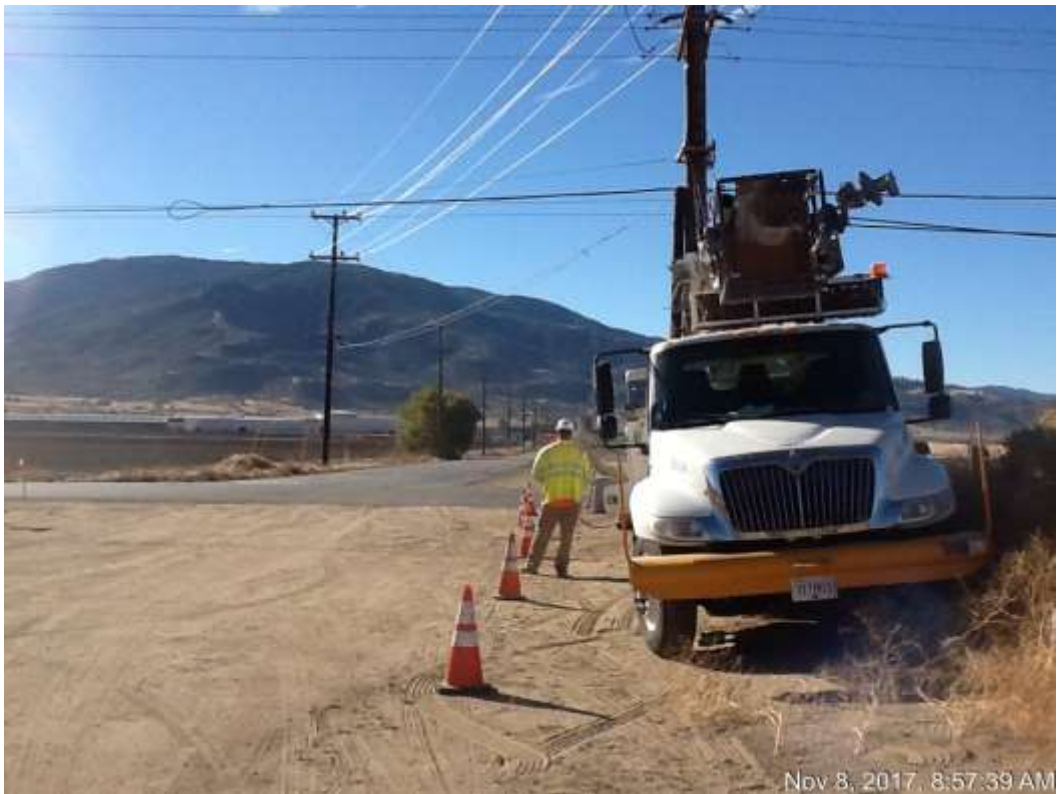
9. H&M crews began work on Routes 1 and 2 of the Telecommunication work on September 27.
10. Two crews conducted telecom cable installation, one on each route. Overhead cable was installed between the Cummings Substation and the California Correctional Facility on Route 1, and on Route 2 from Cherry Lane to Woodford Tehachapi Road at the interface of Highway 202 (see Figure 3). Telecom installation along the Caltrans right-of-way is pending the issuance of encroachment permits.

Figure 3 – Telecom crews installed fiber on Route 2 near the Banducci Substation.

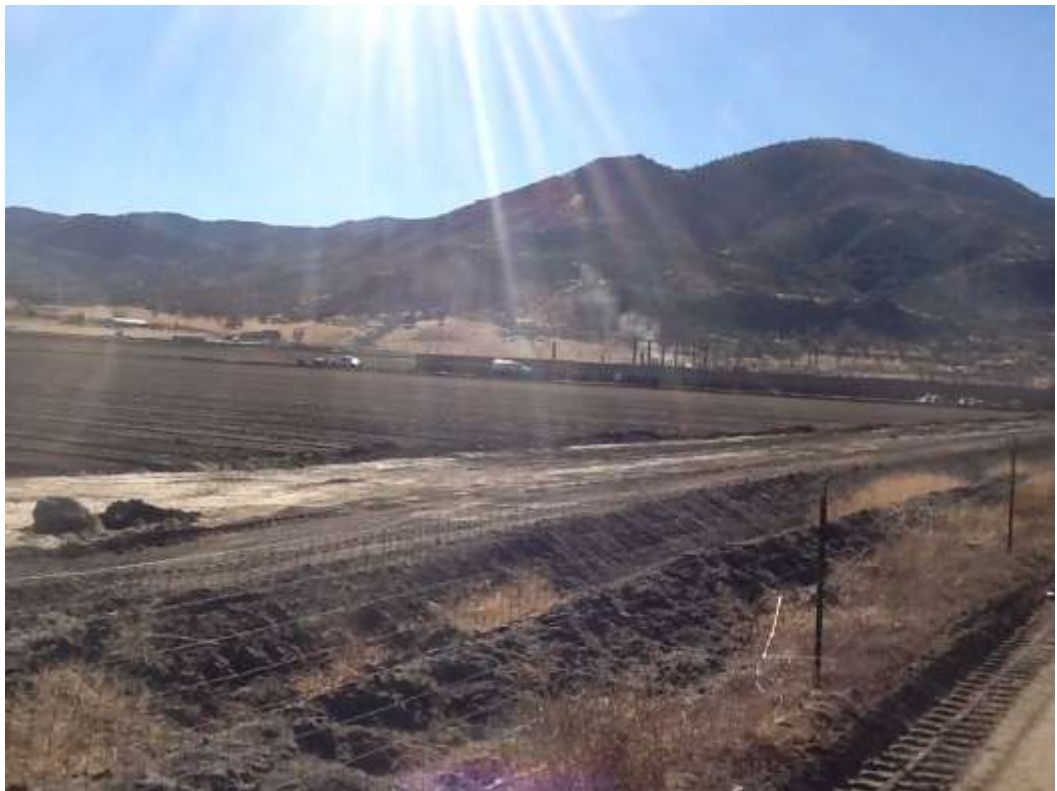
2. The CPUC EM observed smoke coming from the substation site on November 8. Upon closer inspection, a cement pump trailer in use for the v-ditch pour was observed to be malfunctioning (see Figure 4). The crews halted work and another pump trailer was brought to the site.

Figure 4 – Smoke coming from the Banducci Substation due to a malfunctioning cement pump.

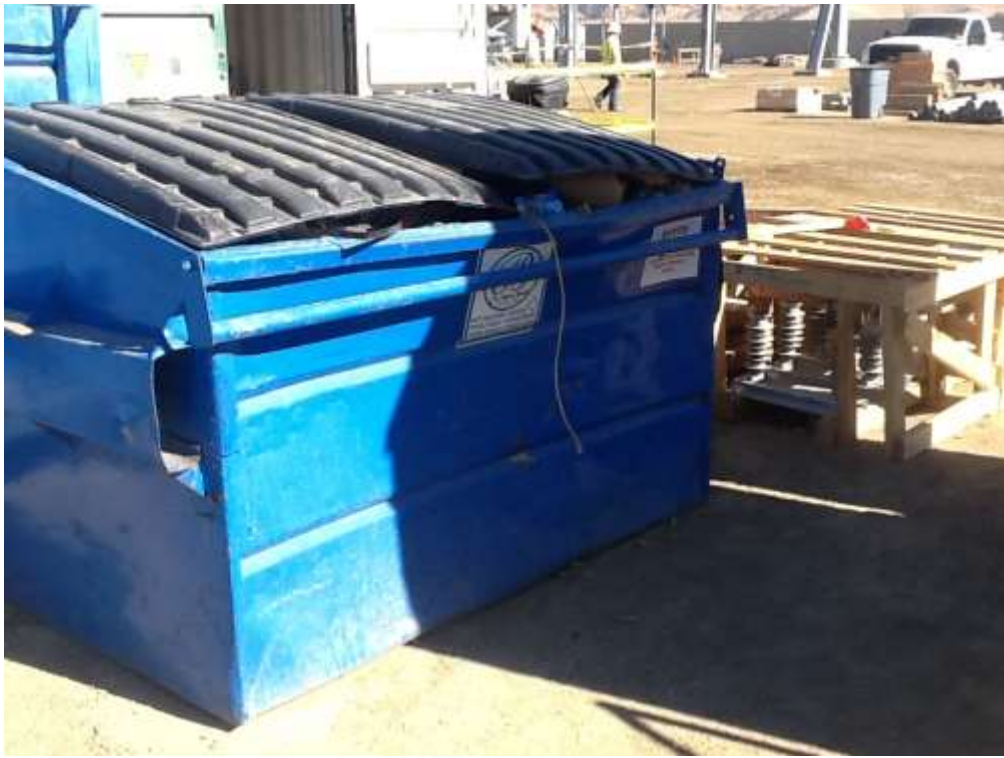
7. No non-compliances were reported by SCE and none were observed by the CPUC EM.
8. Weekly SWPPP inspections are taking place at both the substation and telecom work sites. Minor concerns noted were trash dumpsters that were full and maintenance to a concrete wash out (see Figure 5).

Figure 5 – Trash dumpster needing service at the Banducci Substation.
