**PROJECT MEMORANDUM
DELTA DPA CAPACITY INCREASE SUBSTATION PROJECT**

To: Junaid Rahman, CPUC
From: Vida Strong, Aspen Project Manager
Date: March 7, 2008
Subject: Weekly Report #19: February 24, 2008 – March 1, 2008

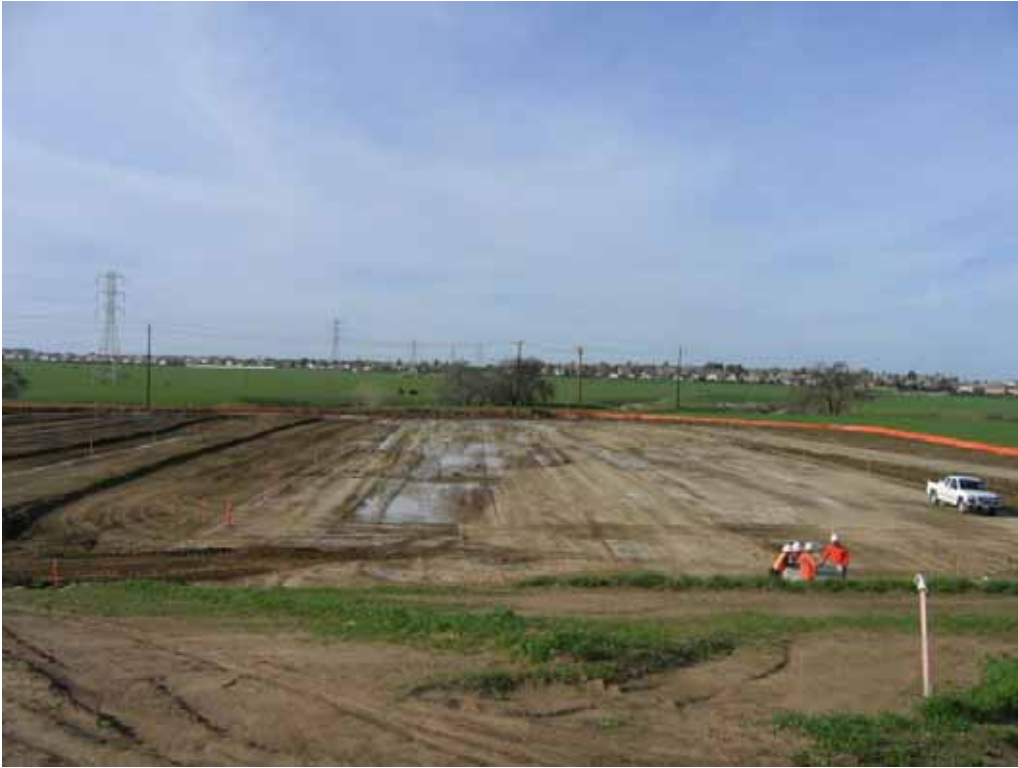
Figure 1 – PG&E Delta Substation site, February 26, 2008.

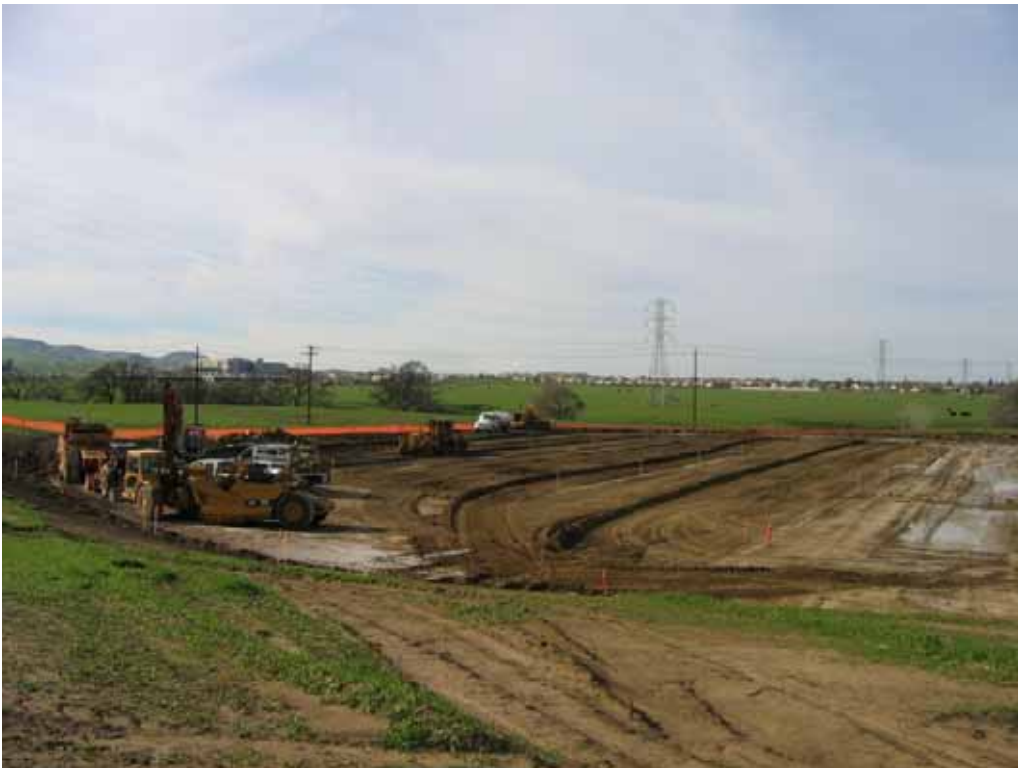
On Monday, construction crews excavated a trench and installed a drainage culvert along the hillside on the south side of the substation site. On Tuesday, crews set the final grade on the stakes within the substation site and dewatered the western half of the substation by pushing water around to evaporate it and then blading the area (see Figures 1 & 2). On Wednesday, crews graded the substation and set a catch basin at the south end of the site. On Thursday, crews continued to work on setting the final grade at the substation site. On Friday, the final grade at the substation site was completed.

Figure 2 – Crews blading the western side of the substation site to dry it out, February 26, 2008.

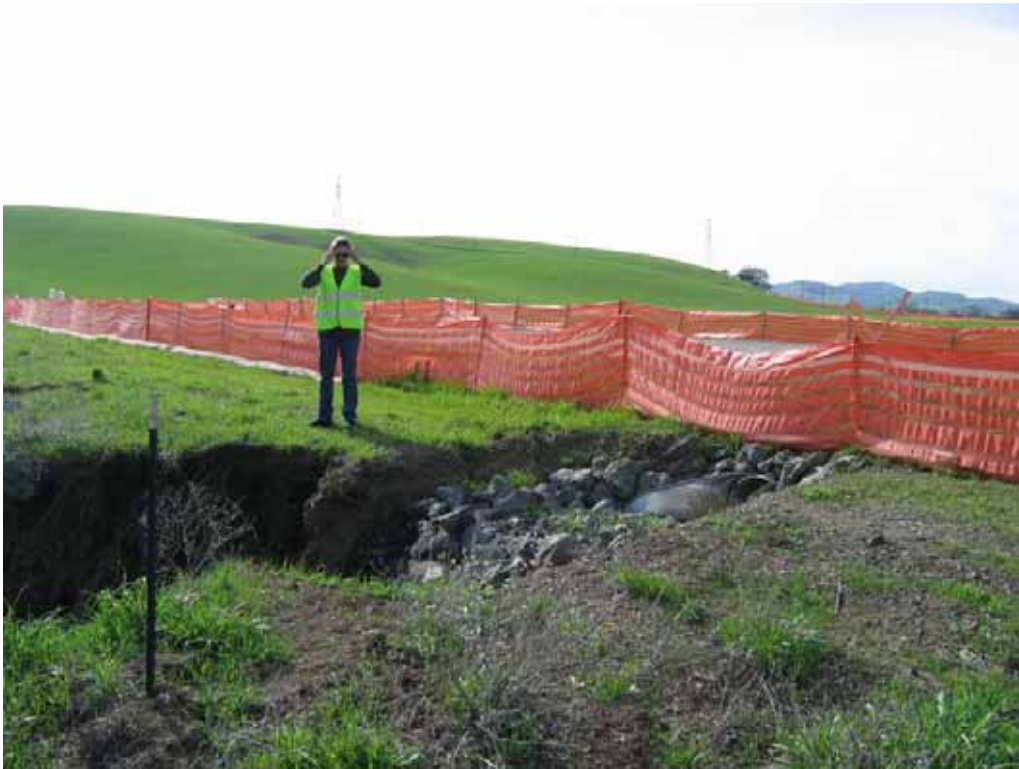
On Tuesday, the CPUC EM and the PG&E Environmental Inspector (EI) observed that an erosion problem had occurred at wetland #4 on the south side of the access road where an 18-inch culvert was installed under the road. Some of the rip-rap on the outfall side (south side of access road) failed and stormwater eroded part of the bank to an unnamed tributary to Sand Creek (see Figures 3 & 4). The CPUC EM informed the PG&E EI and the PG&E Inspector that CDFG would need to be consulted before repairing the erosion problem since it is within their jurisdiction. On Thursday, PG&E representatives, the PG&E EI, and a PG&E engineer, met at the site to discuss possible repairs to the culvert outlet and the bank of the unnamed tributary to Sand Creek. The PG&E engineer will draw up plans for repairing the erosion problem.

The CPUC EM noted that there was an erosion problem at the wetland #4 culvert outfall to an unnamed tributary to Sand Creek. PG&E is working on a solution to this problem. The CPUC EM observed that all other work activities were in compliance with the approved Mitigated Negative Declaration and other permit requirements. On Friday, repairs were made to the wildlife exclusion fencing where wood stakes were broken and the fence was starting to sag. Erosion controls were in place at all of the work areas. Straw bales and wattles were in place under the bridge for additional erosion control. Heavy equipment was parked overnight in a designated area within the substation boundaries. The refueling trailer within the substation site was contained in a visquene-lined straw bale area. The CPUC EM reviewed PG&E EI daily reports and survey reports. Environmental training of crew personnel was on-going as new crew personnel came onto the site.

Figure 3 – Erosion problem at culvert outfall for Wetland #4 on south side of access road, February 26, 2008.

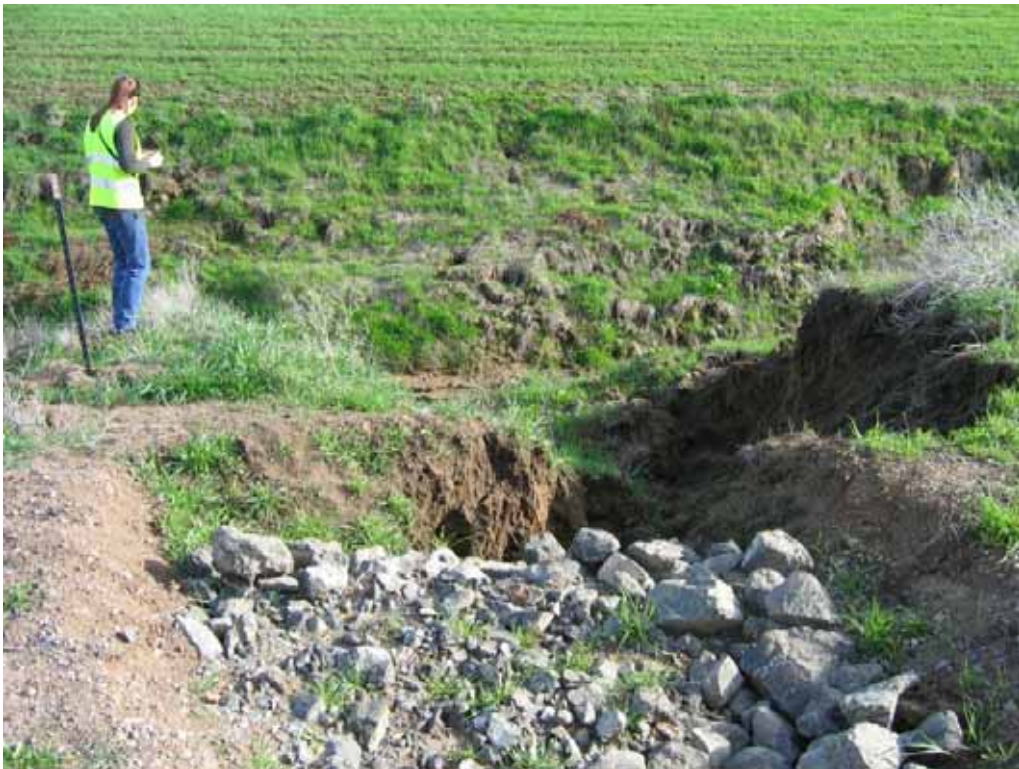
Figure 4 – Erosion problem at culvert outfall for Wetland #4 on south side of access road, February 26, 2008.
