# **Visual Contrast Rating Data Sheet**

**Devers-Palo Verde 2 Transmission Line Project**

## **Key Viewpoint**

30

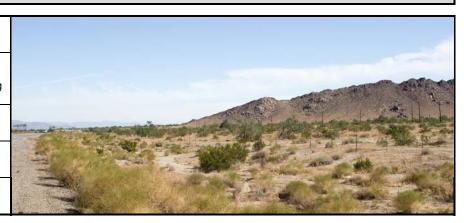
Eastbound I-10, approximately one mile west of the Desert Center overpass, viewing to the east toward Alligator Rock.

LANDFORM / WATER	VEGETATION	STRUCTURES		
Form	Flat, horizontal valley floor, to diagonal, angular and rugged ridge	Complex, continuous to irregular with clumps	Simple linear		
Line	Horizontal to diagonal, and irregular	Horizontal (defined by valley floor) to irregular and indistinct	Vertical		
Color	Tan and gray to lavender and bluish hues at distance	Tan to pale yellow for grasses, gray and light to dark greens for shrubs	Gray to dark brown		
Texture	Smooth to granular and coarse	Matte	Smooth

LANDFORM / WATER	VEGETATION	STRUCTURES		
Form	Same	Same	Geometric and complex to simple linear		
Line	Same	Same	Vertical and diagonal for structures, curvilinear for conductors		
Color	Same	Same	Light to dark gray		
Texture	Same	Same	Smooth

L	<b>ANDFOF</b>	RM / WATE	R	VEGETATION				STRUCTURES			
	NONE	WEAK	MODERATE	STRONG	NONE	WEAK	MODERATE	STRONG	NONE	WEAK	MODERATE	STRONG
Form	4				4							4
Line	4				4							4
Color	4				4						4	
Texture	4				4					4

LEVEL OF CHANGE & VRM CLASS CONSISTENCY										
Term:	☐ Short	$\boxtimes$	Long	Level of Change: (Moderate to High)		Very Low	☐ Low	$\boxtimes$	Moderate	⊠ High
Does the Project Design Meet VRM Objectives? ☐ Yes ☒ No
