**PROJECT MEMORANDUM  
SCE DPV2 TRANSMISSION PROJECT**

**To:** Billie Blanchard, Project Manager, CPUC  
**From:** Vida Strong, Aspen Project Manager  
**Date:** December 14, 2011  
**Subject:** Weekly Report 17, November 7 to November 13, 2011

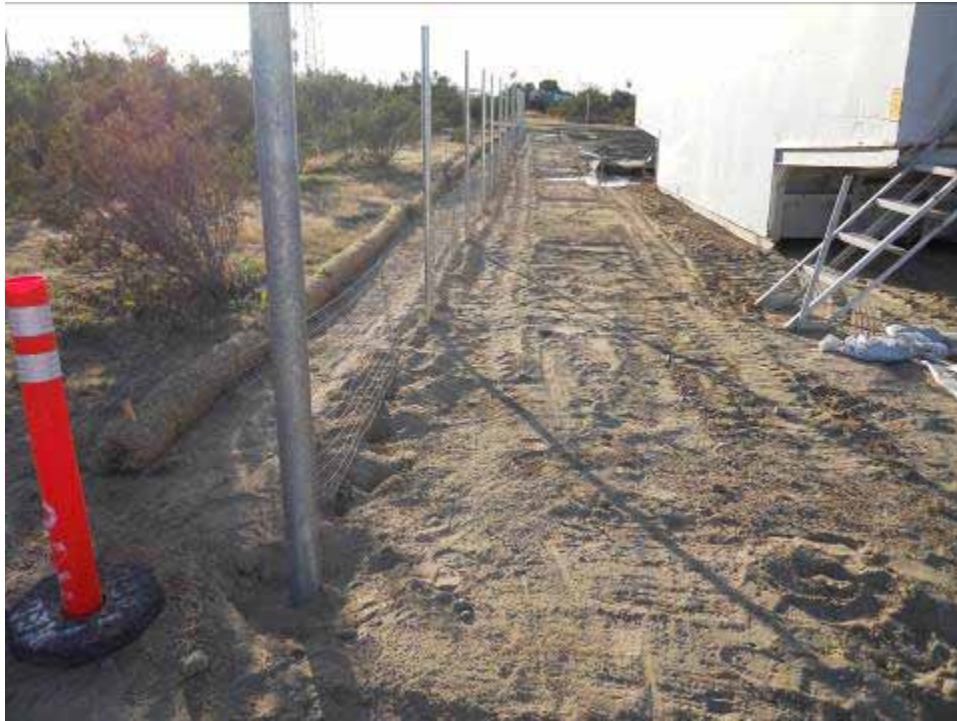
1. During the subject period, major construction activities were limited to the Summit Construction Yard and included trenching and backfilling associated with the installation of chain link and desert tortoise fencing, clearing of trash and debris, soil compaction, and gravel placement (see Figure 1).
2. Activities at the remaining yards consisted of ongoing dust suppression, material deliveries, office trailer maintenance, and general site maintenance.

**Figure 1:** Installation of desert tortoise exclusionary fencing at the Summit Construction Yard.

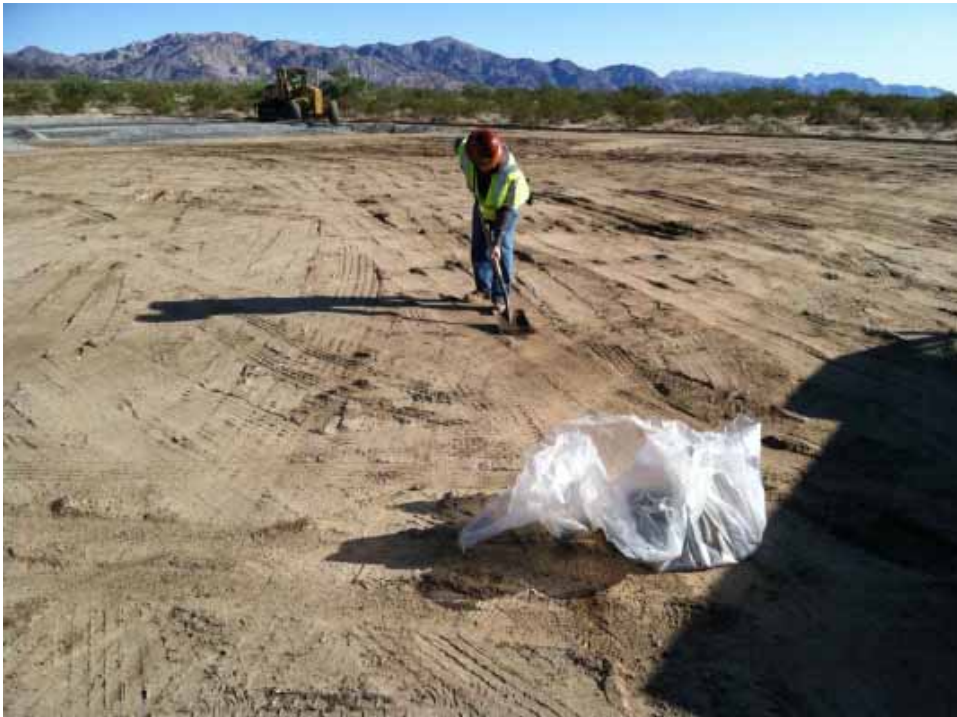
1. A small leak was observed and reported by the SCE General Monitor at the Summit Construction Yard on November 7. The SCE General Monitor identified a few small oil drips at the entrance of the yard. Upon further investigation, it was discovered that one of the gravel trucks was leaking oil from its dipstick. The leak was contained and fixed. Two small areas of ponded oil (approximately 2 oz.) were cleaned up. Soil removed in the cleanup was less than one cubic foot. Contaminated soils were disposed of in one of the spill kits located onsite (see Figure 2).

**Figure 2:** Soil from small oil leak being removed and placed within a spill kit at the Summit Construction Yard.

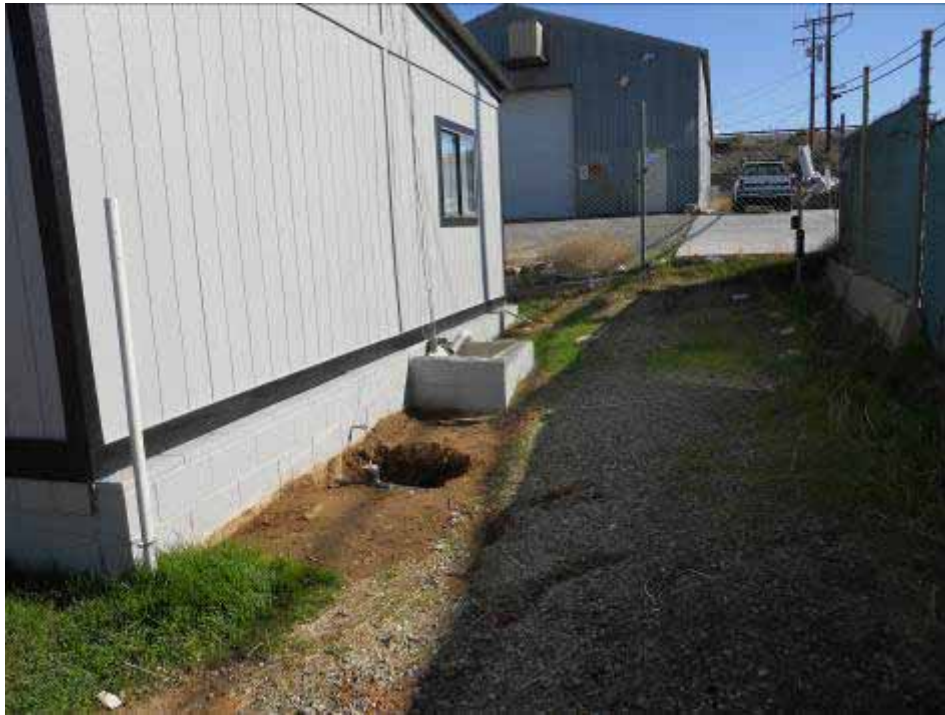
3. On November 10, a minor sewage spill occurred onsite at the Beaumont Construction Yard as a result of back up in an existing sewer pipe. Approximately two square feet, immediately surrounding the leak, of surface soils were directly contaminated (see Figure 3). Impacted soils were contained within two 55-gallon drums. The pipe was exposed by digging around it to allow access for a plumber to make repairs, which occurred the following day. The CPUC EM was notified of the spill immediately and was updated throughout the following day as repairs were scheduled and conducted.

**Figure 3:** The extent of contaminated soil that was removed as a result of a sewage leak at the Beaumont Construction Yard.

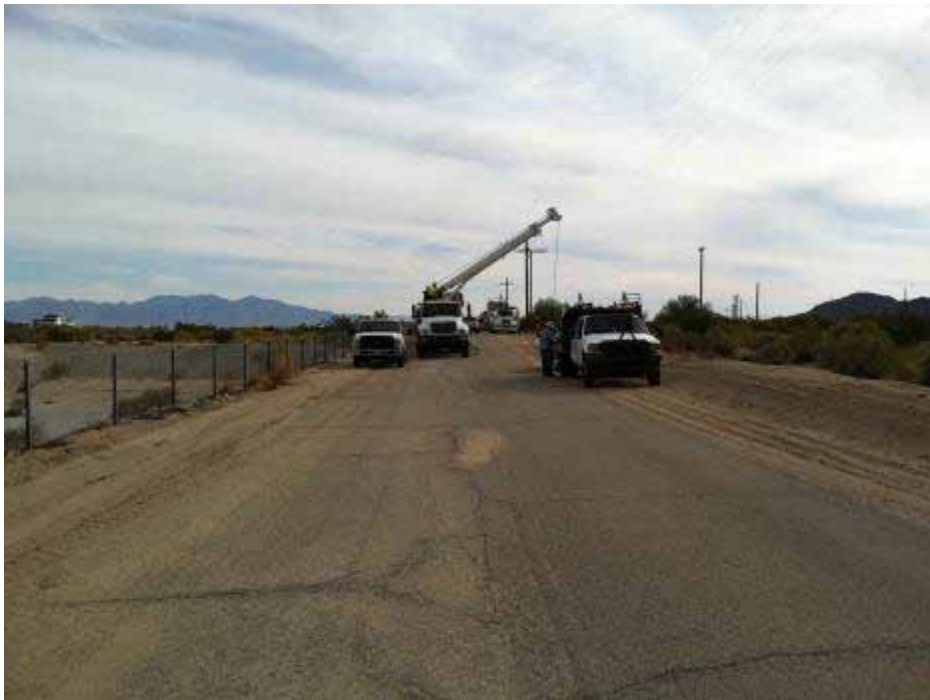
1. Construction activities associated with the Red Bluff distribution line commenced during the subject period. These included switching existing poles with new poles, primarily along Aztec Road (see Figure 4).

**Figure 4:** Replacement of old poles with new wooden poles along Aztec Road for the Red Bluff distribution line.

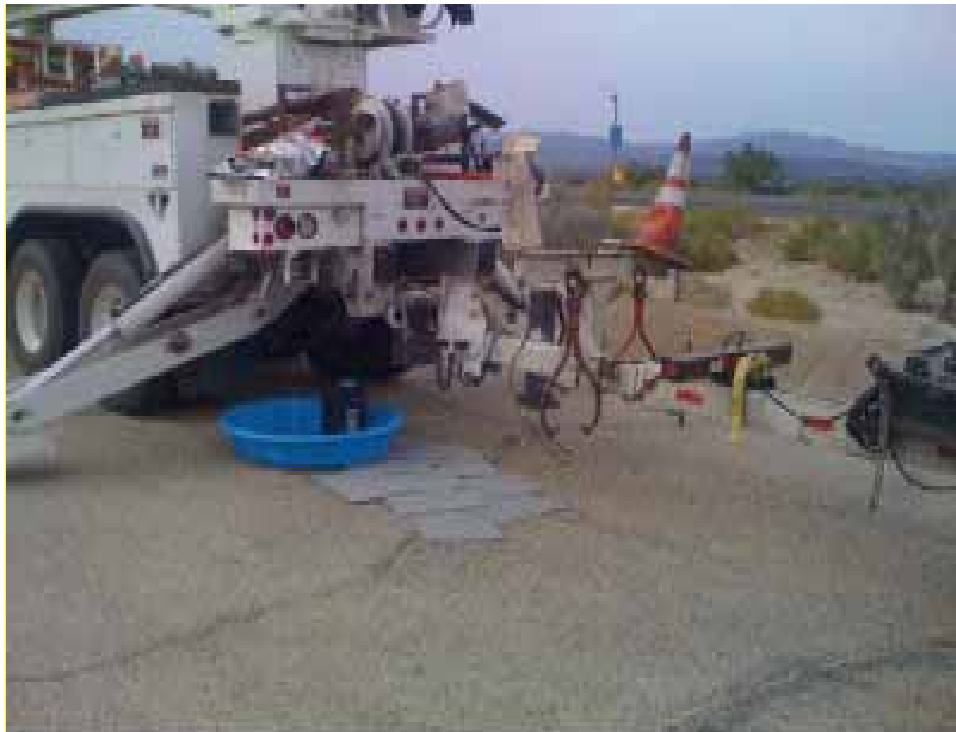
2. On November 10, the SCE General Monitor reported two separate minor leaks, each associated with construction of the distribution line. The first observation was a small oil leak resulting from a loose bolt on a drill truck. Contaminated soil containing approximately 1 oz. of leaked oil was removed and placed in a container and taken offsite. The bolt was tightened and the leak stopped. The second leak observed consisted of approximately 4 oz. of hydraulic fluid stemming from a ruptured hose on one of the construction vehicles. This leak occurred along a paved portion of Aztec Road and was contained through the use of absorbent pads. A bucket and a containment pool were placed under the truck until the hose was replaced and the leak was resolved (see Figure 5).

**Figure 5:** Cleanup of hydraulic leak from the line truck along the Red Bluff distribution line. Note absorbent pads used to remove fluid and pool used to contain additional fluid.

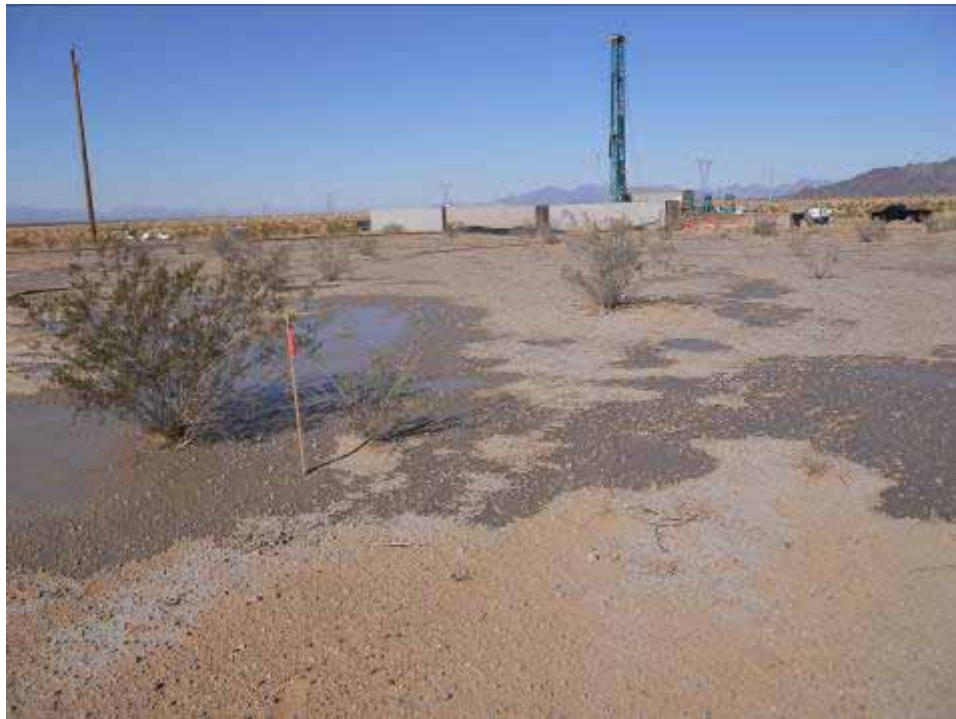
1. On November 7, two representatives from El Capitan Construction (SCE SWPPP Coordinators) conducted a site visit. As reported by the SCE General Monitor, the SWPPP Coordinator believed that water from the zone testing that was being surface released was not in compliance. As a result, waste water from the zone testing was contained within a tanker until a resolution was secured. During the bi-weekly conference call between SCE, Aspen, and the resource agencies on the following day, SCE indicated that they had received verbal approval from the Riverside County Health Department and the Regional Water Quality Control Board to continue surface spreading of release water from zone testing. Subsequently, construction crews installed a primary and secondary waterline and sprinkler system within the substation disturbance boundaries to control surface release flows and contain them within project site boundaries (see Figure 6).

**Figure 6:** Surface spreading of zone-testing release water at CRS. Note water line set up in background.

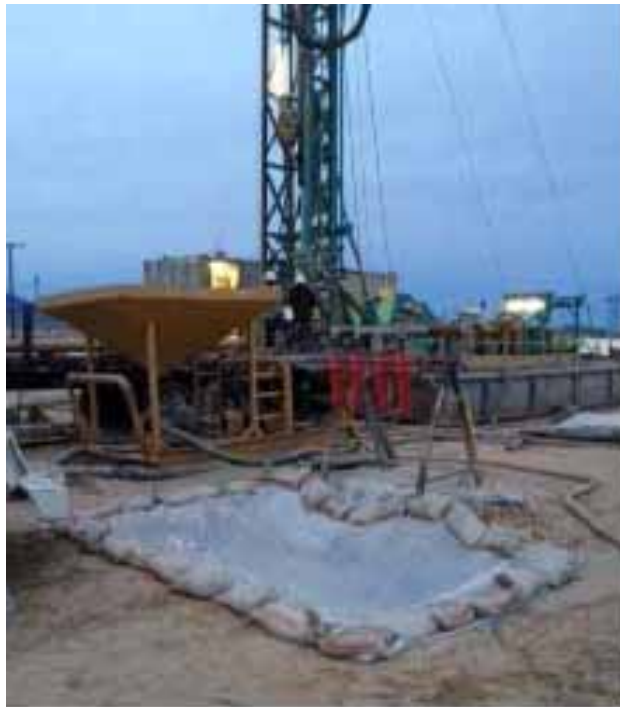
**Figure 7:** De-sander pit covered at CRS upon the recommendation of the CPUC EM.

2. On November 10, the CPUC EM suggested that the de-sander pit be covered when not actively being used to prevent wildlife from entering and becoming trapped. SCE General Monitors relayed suggestion to the construction crews and the pit was covered (see Figure 7).

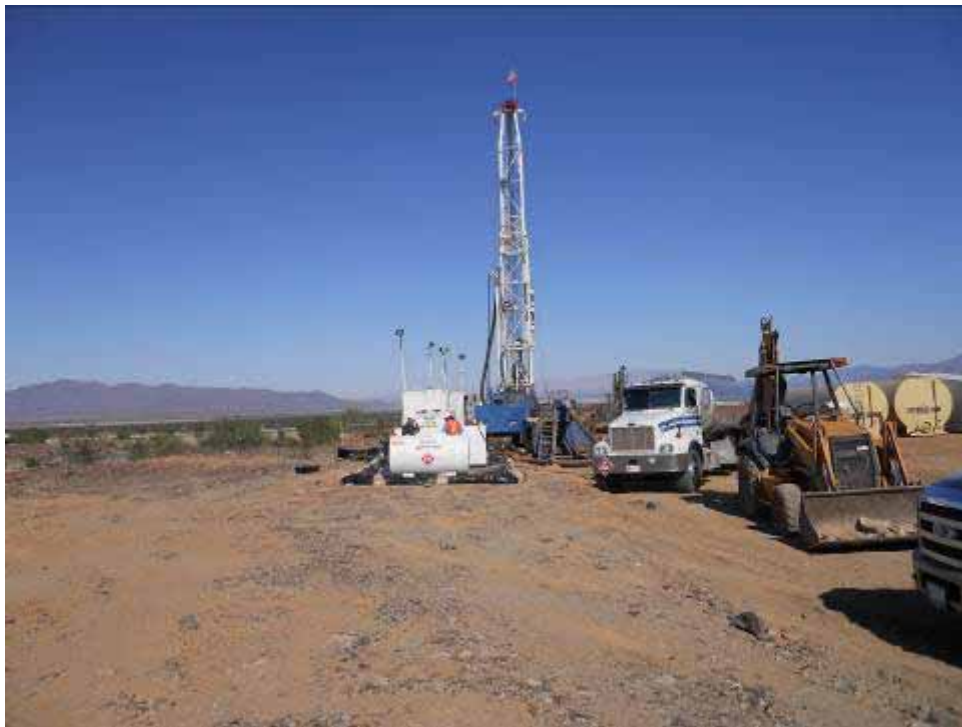
1. Erection of the drill rig for the water well was completed by November 8 and 24-hour drilling operations were initiated that evening (see Figure 8).
2. Activities associated with the Red Bluff distribution line (on BLM lands) replacement of existing wooden poles with new ones.

**Figure 8:** Drill rig erected and operational at Red Bluff Substation site.

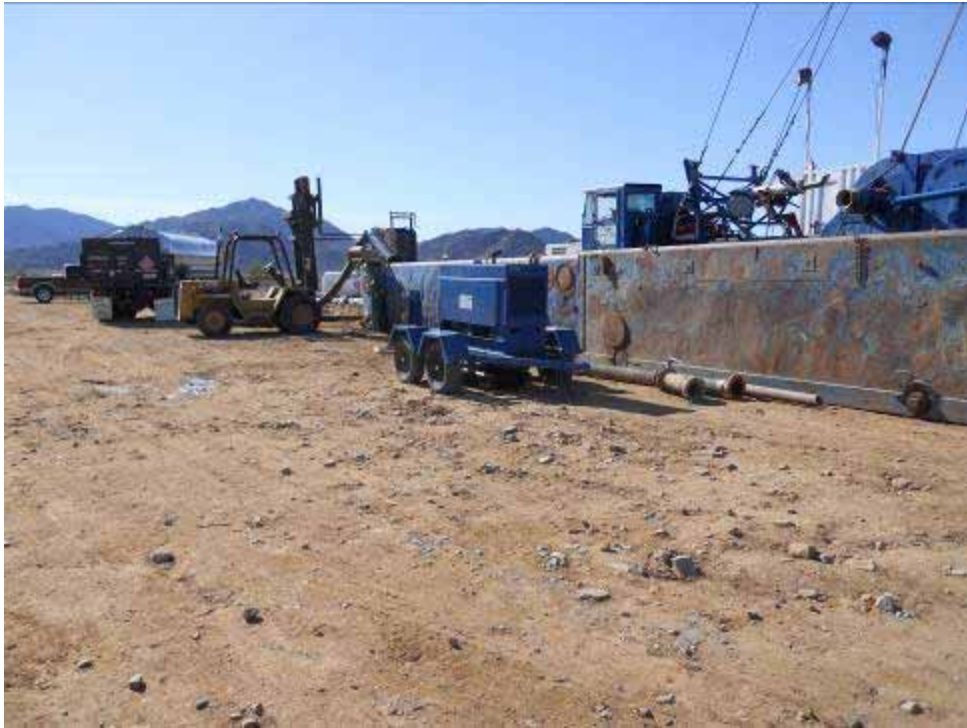
1. All tailings from drilling were contained within tanks located onsite and release water was either reused or fully contained within tanks. This will continue until approval from appropriate agencies is obtained for surface spreading.
2. All light fixtures associated with the drilling rig are pointed downward (approximately 30 degrees) and away from the freeway (see Figure 9).

**Figure 9:** Note angle of light fixtures (in background) around the Red Bluff Substation drill rig pointed downward.
