## PROJECT MEMORANDUM SCE DPV2 TRANSMISSION PROJECT

**To:** Billie Blanchard, Project Manager, CPUC  
**From:** Vida Strong, Aspen Project Manager  
**Date:** April 18, 2012  
**Subject:** Weekly Report 37, March 26 to April 1, 2012

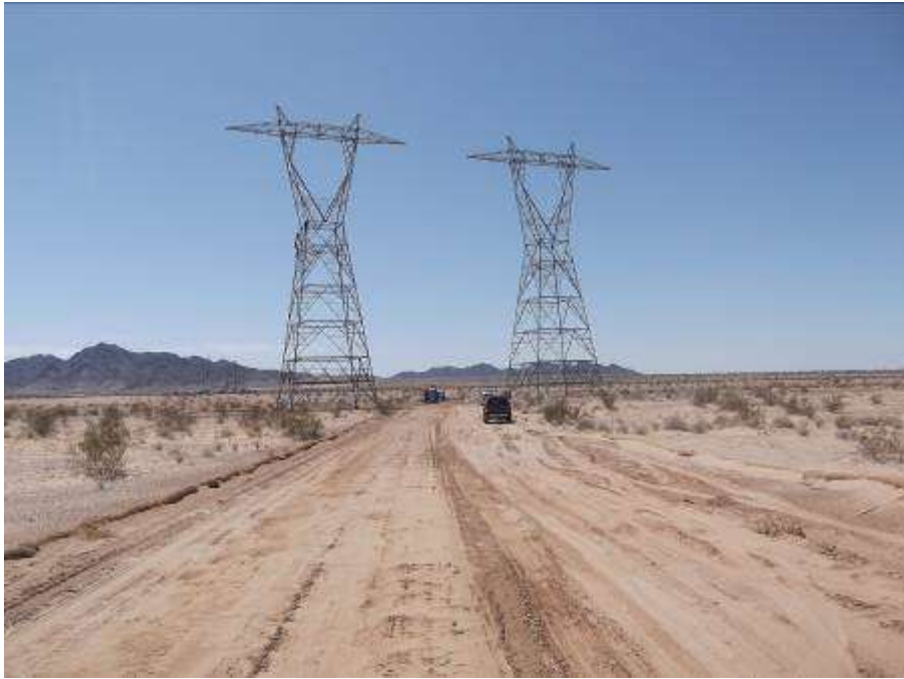
**Figure 1.** Assembly and erection completed at Tower 2650 and CR1-3W.

1. Colorado River Substation (CRS) to Red Bluff Substation
  - Tower assembly activities were conducted at Towers 2648, 2649, 2650, 2651 and 2652 and CRS Loop-In Towers CR1-2E, CR1-3E, CR1-4E, CR1-5E, CR1-1W, CR1-2W, CR1-3W, CR1-4W, and CR1-5W (see Figure 1).

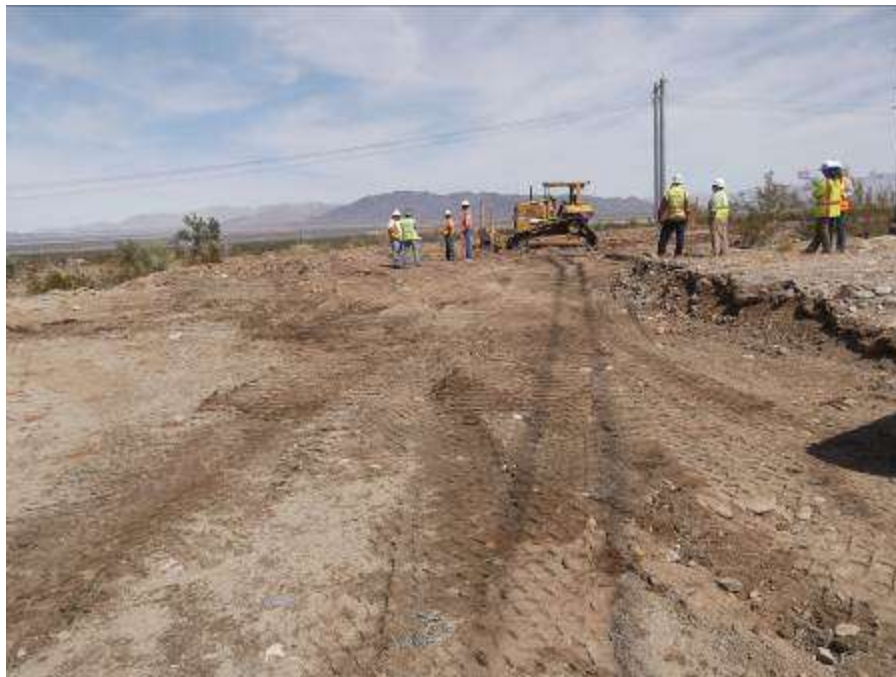
- During the subject period, it was discovered that Towers 2520 and 2526 had been cleared of vegetation and graded. However, these two locations are included as salvage sites in the approved Desert Pavement Plan. Contrary to requirements of the plan, there was no coordination between the SCE General Monitor and the contractor to determine the potential to avoid and salvage desert pavement at these sites prior to ground disturbance.

**Figure 2.** Grading activities nearly completed at Tower 2526. This location is specified for salvage in the Desert Pavement Plan, which was not considered prior to the completed grading work.

- Foundation drilling occurred at Red Bluff Loop-In Towers RB1-3E, RB1-5E, RB2-4E, RB2-5E, RB1-2W, RB2-1W, and RB2-2W.
  - Grading and tower pad recontouring activities were conducted at Towers 2512, 2513, 2516, 2517, 2520, 2522, and 2526 and Red Bluff Loop-in Towers RB1-2E, RB1-5E, and RB2-5E (see Figure 2). Stub roads associated with Red Bluff Loop-In Towers RB2-5E and RB1-1W were also graded.

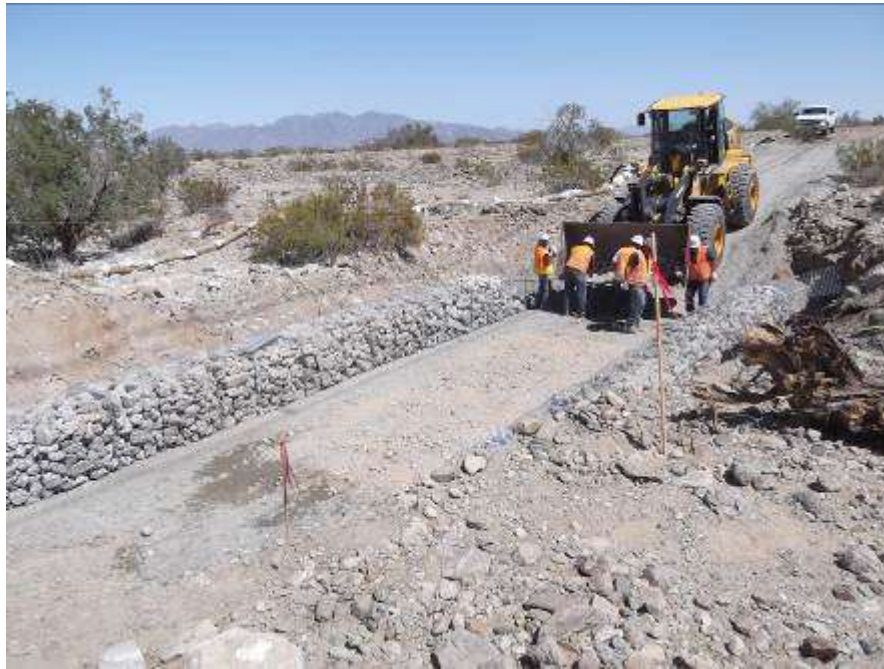
**Figure 3.** Filling rock gabions at the wet crossing along spur road to Towers RB1-5E and RB2-5E.

- Vegetation was cleared at Towers 2513 and 2516.
  - Installation of BMPs occurred at Towers 2516 and 2520.
  - Activities associated with the construction of the wet crossing along the spur road to Red Bluff Loop-In Towers RB1-5E and RB2-5E continued (see Figure 3).

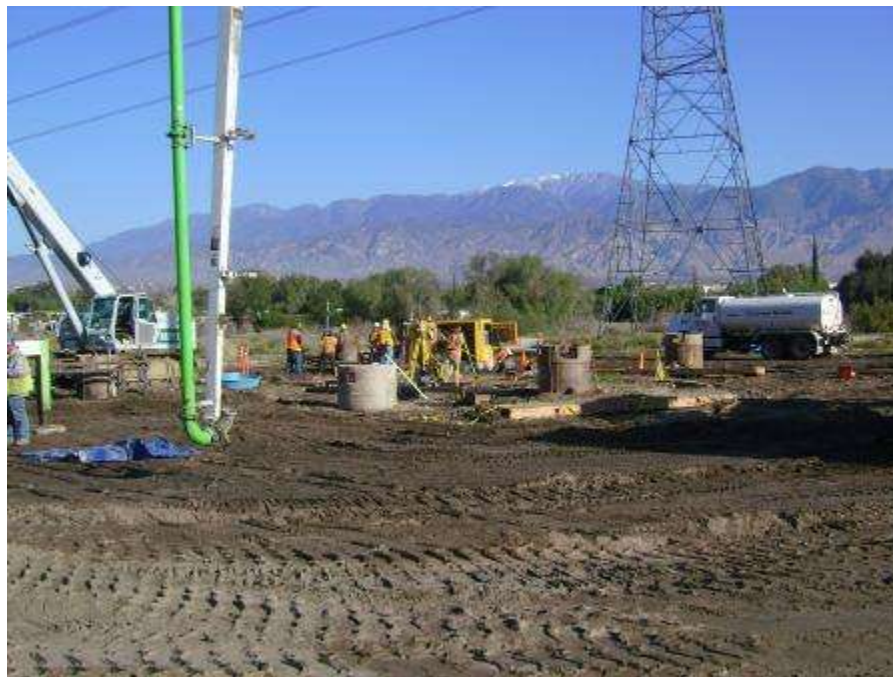
**Figure 4.** Foundation concrete pouring at Tower 1052.

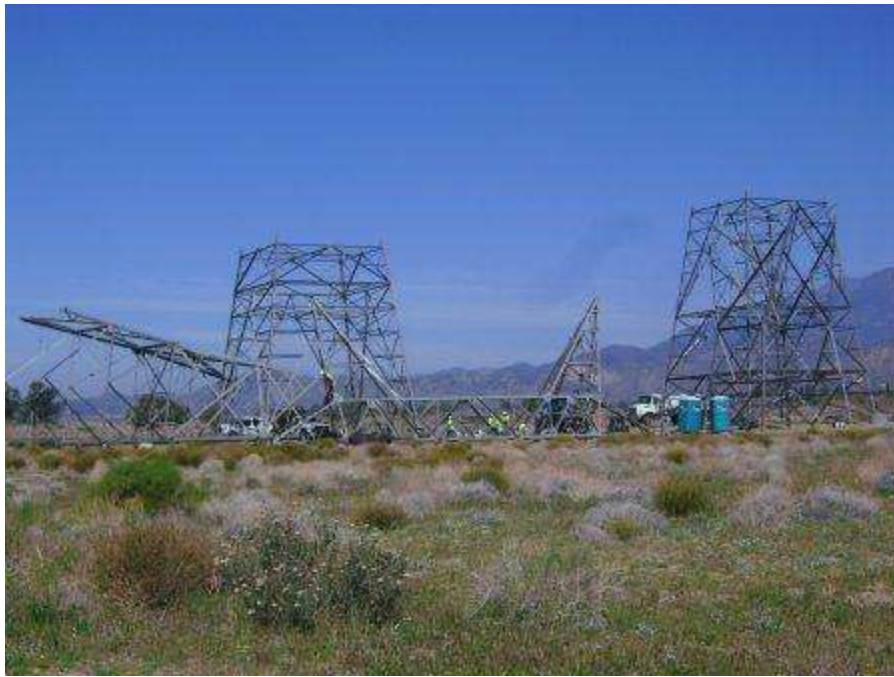
**Figure 5.** Tower assembly at Towers 1062 and R2.

- BMP installation occurred at Towers 1002, 1006, 1008, 1009, 1025, 1052, 1053, 1056, 1063/R3, 1071, 1073, 1076, 1085, 1088, and 1093.
- Vegetation clearing occurred at Towers 1002, 1018-1021, 1023, 1025, 1031, 1052, 1056, 1073, 1076, and 1091.
- Spur road and crane pad grading occurred at Towers 1002, 1005, 1006, 1007, 1008, 1009, 1024, 1025, 1054, 1055, 1056, 1085, H1A-DV, and H1X-DV.
- Foundation drilling occurred at Towers 1052, 1053, 1055, and 1064.
- Foundation concrete pouring occurred at Towers 1052 and 1053 (see Figure 4).
- Tower assembly and steel deliveries occurred at Tower 1061/R1, 1062/R2, 1063/R3 and 1064/R4 (see Figure 5).

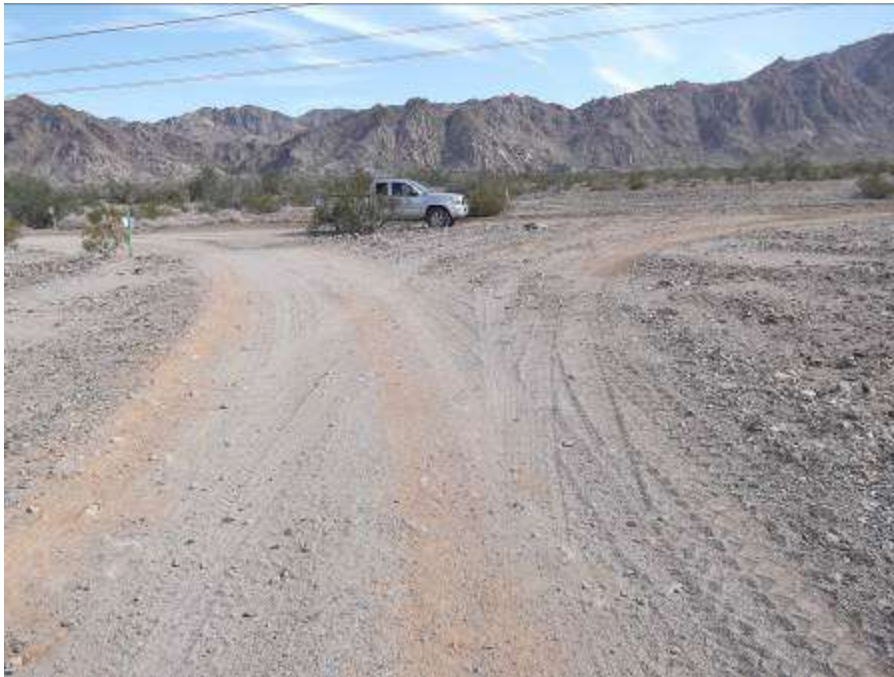
- On March 30, the CPUC EM identified an area at the intersection of the ROW access road and a perpendicular north-south access road where vehicles and/or heavy equipment had traveled outside of the defined project limits (see Figure 6). It was later discovered that the contractor had created an alternate path because the intersection was too sharp to accommodate heavy equipment. Subsequently, tracks were observed in undisturbed habitat that would allow a wider turning radius in the area.

**Figure 6.** Intersection of ROW and north-south access roads where vehicles had traveled outside of defined road limits. Note new track marks created to right of photo.

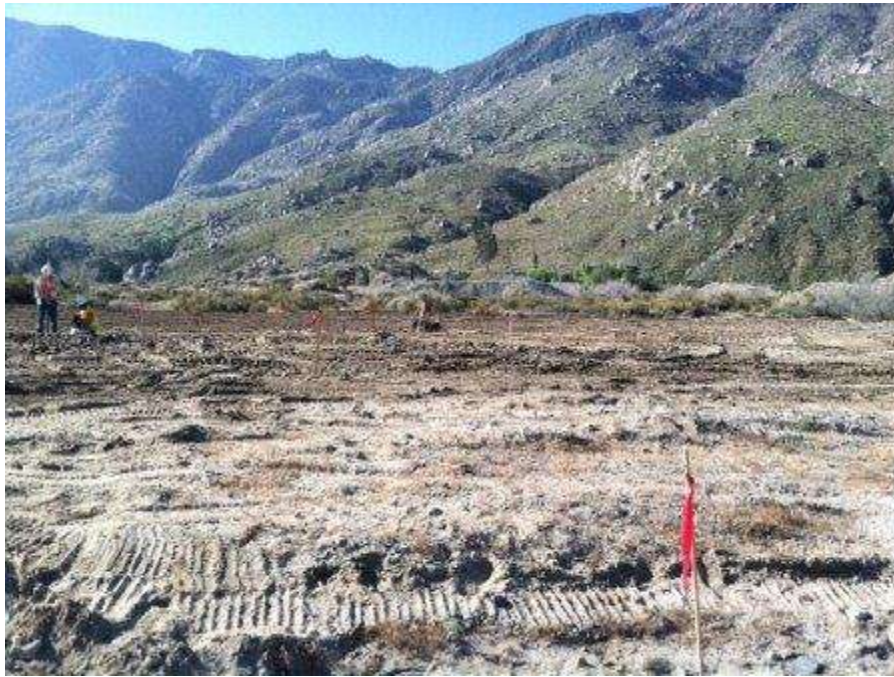
- March 30, 2012 a Phillips and Jordan crew completed vegetation clearing, BMP installation, and some grading at Tower 1056 prior to the site being field validated by the CPUC EM (see Figure 7). SCE notified the CPUC EM's of the incident and the crews were demobilized from the site. No sensitive resources were impacted. The CPUC Lead EM notified the SCE Environmental Coordinator for Devers to Valley that all sites must be field validated and approved by the CPUC EMs prior to construction.

**Figure 7.** Vegetation clearing, BMP installation, and some grading completed at Tower 1056 prior to site validation by CPUC EM.

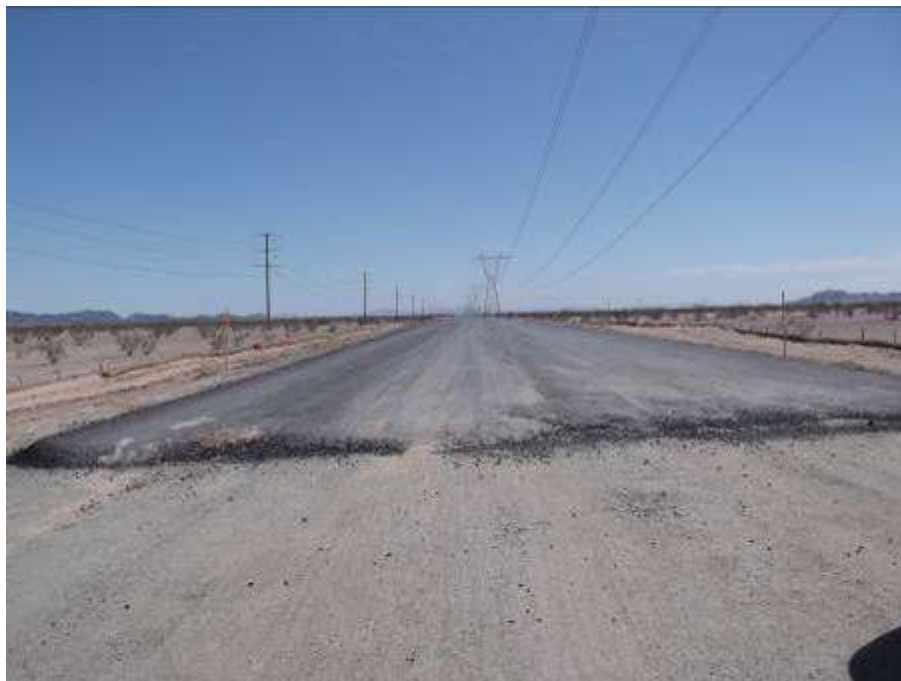
**Figure 8.** View east from entrance to newly paved CRS primary access road.

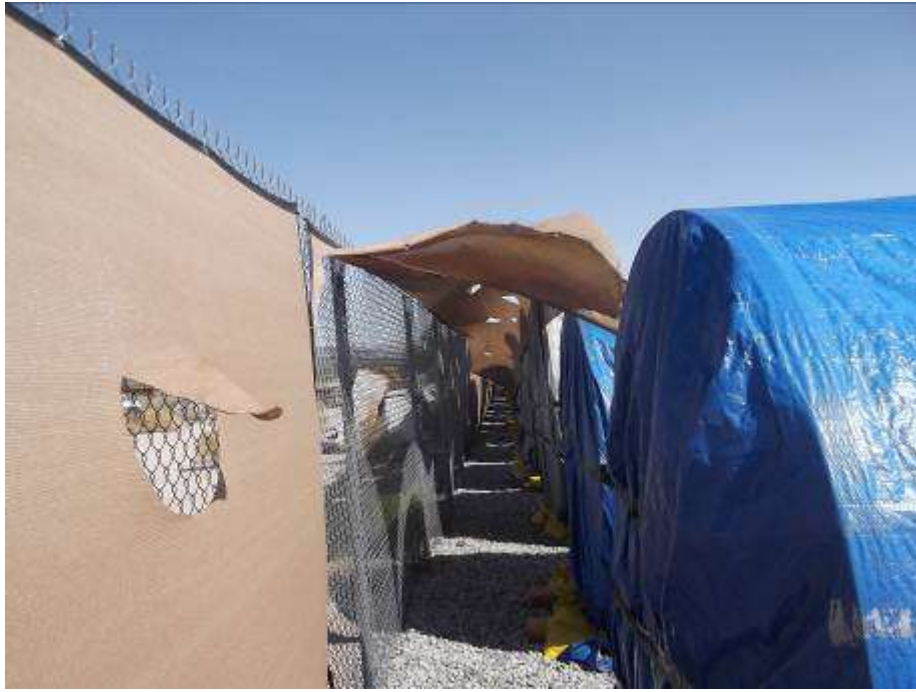
- Biological sweeps of the construction yards were conducted by the SCE Biological Monitors throughout the subject period.
- CPUC EMs observed adequate measures, including bird netting, secondary containment, and BMPs in place at all construction yard locations.
- On March 26, the CPUC EM noted that the privacy screening on the west fence of the Desert Center 1 Yard was in need of repairs (see Figure 9).

**Figure 9.** Damaged privacy screening along west fence of Desert Center 1 Construction Yard.
