PROJECT MEMORANDUM SCE DPV2 TRANSMISSION PROJECT

To: Billie Blanchard, Project Manager, CPUC
From: Vida Strong, Aspen Project Manager
Date: July 17, 2012
Subject: Weekly Report 48, June 11 to June 17, 2012

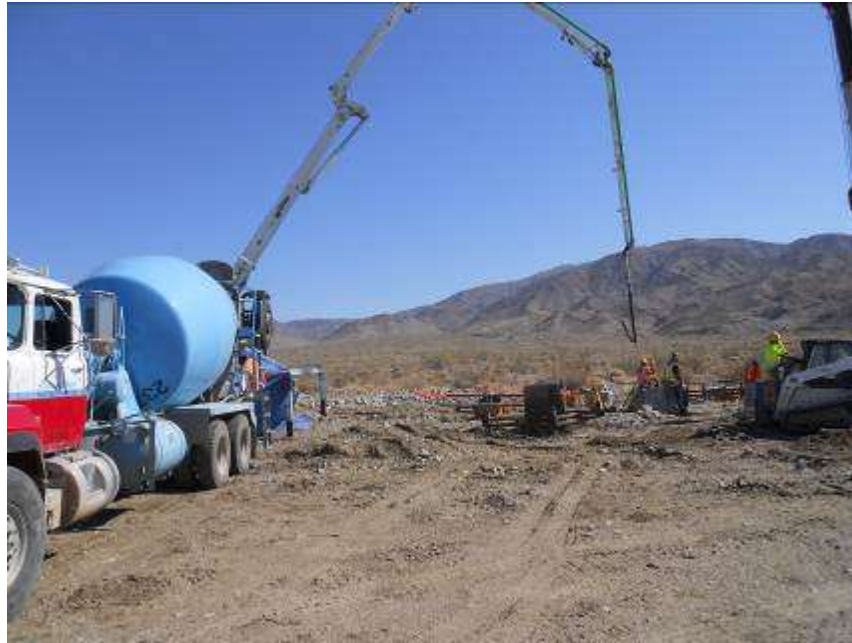
Figure 1. Concrete pouring occurring at Tower 2322.

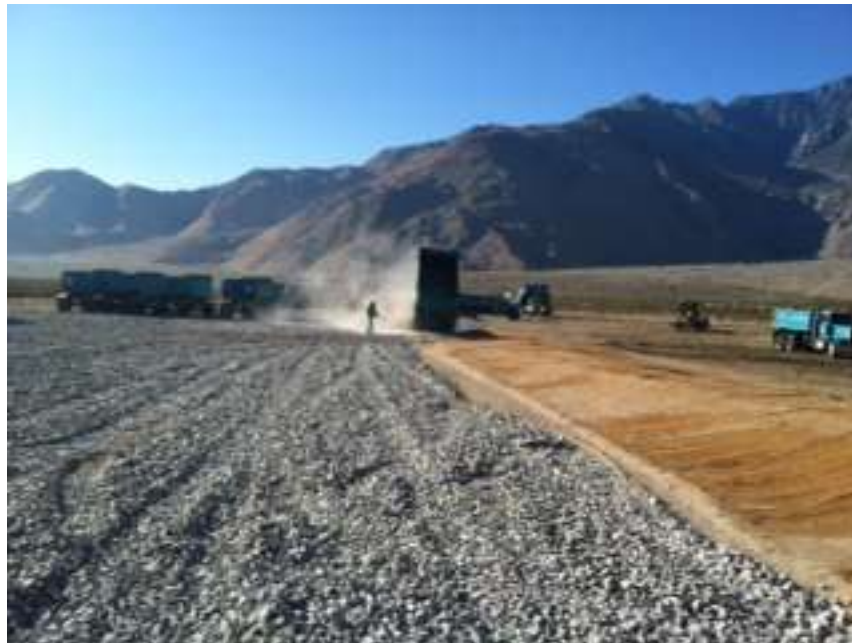
- Installation of BMPs occurred at Tower 1030 and Helicopter Landing Zones H1A and H1X (see Figure 2).
- Tower foundation drilling occurred at Towers 1017 and 1029.
- Tower foundation concrete pouring activities occurred at Towers 1011, 1016, 1017, and 1029.
- Tower assembly and steel deliveries occurred at Tower 1009.
- Potholing on the access road occurred near 1025, 1093, 1128, and 1131.

Figure 2. Installation of gravel at the H1X Landing Zone. The gravel is being used as a BMP to prevent fugitive dust at the site.

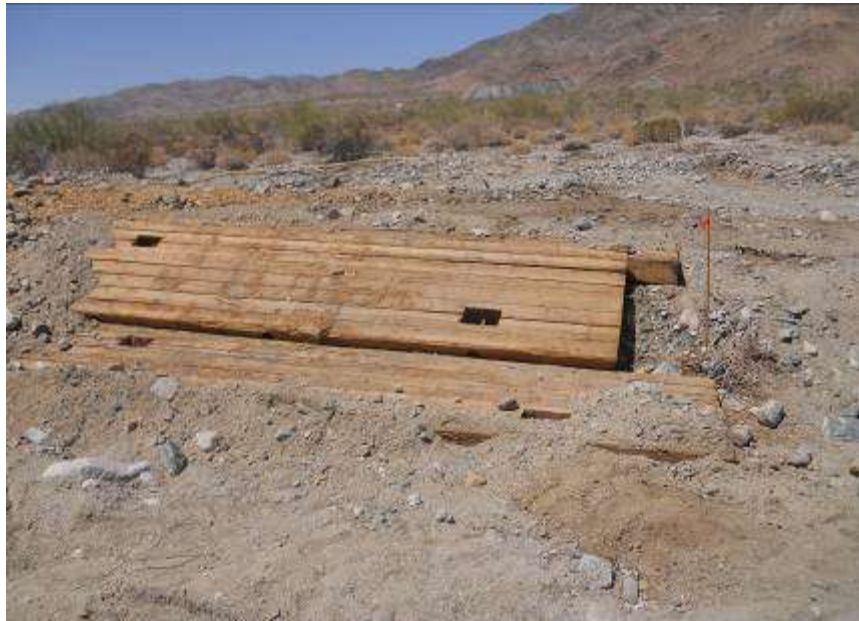
- During a spot check at Tower 2323 on June 12, the CPUC EM observed inadequate covering of the recently drilled foundation holes (see Figure 3). The CPUC EM notified the SCE Biological Field Lead who confirmed that the drilling crew would return to the site that day to resolve the issue.

Figure 3. Inadequate foundation hole covering at Tower 2323. Note open holes in wood planks allowing small wildlife to enter and become trapped.

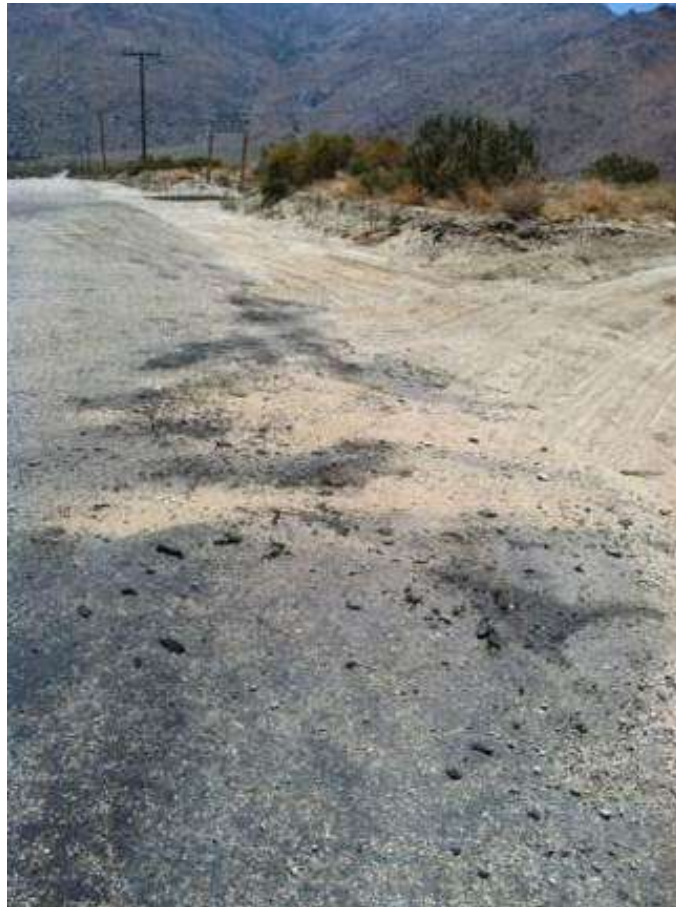
- On June 12, the SCE General Monitor observed minor damage to Snow Creek Road at the ROW access to Tower 1029 (see Figure 4). Damage incurred during the mobilization of the drill rig from this location to Tower 1029. The biological monitor assigned to the crew at Tower 1029 confirmed to the General Monitor that the damage along Snow Creek Road was incurred during mobilization of the drill rig from the lowboy to Tower 1029. The General Monitor concluded that this damage would not require immediate attention, but should be repaired by the end of the project.

Figure 4. Damage to Snow Creek Road from equipment mobilization near Tower 1029 (photo courtesy of FRED).

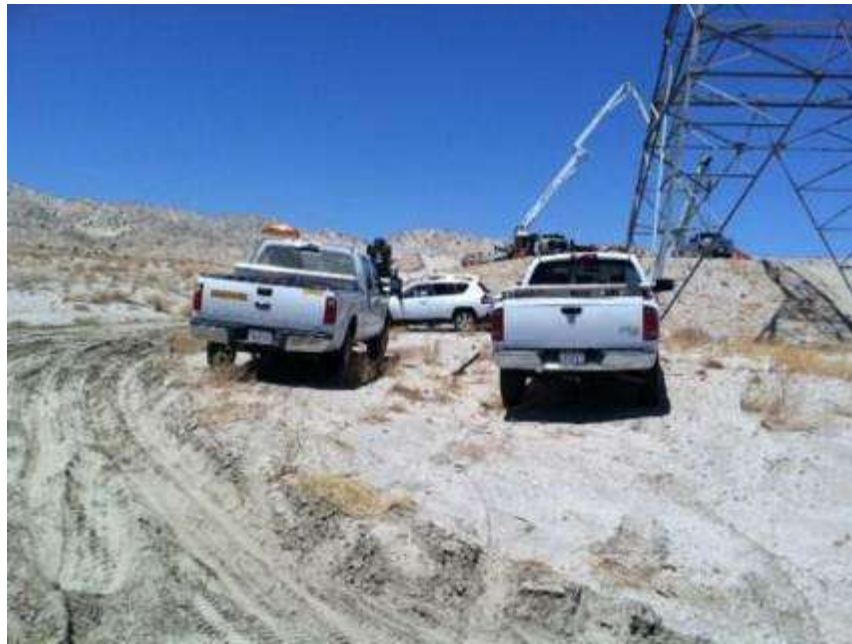
- On June 13, CPUC EM observed vehicles parked outside of approved project boundaries at Tower 2120 (see Figure 5). The onsite Monitor was unaware of the project limits until the CPUC EM asked to see their maps. The CPUC EM contacted the SCE Environmental Coordinator (EC) about the incident. Before the CPUC EM left the area the vehicles were moved within project boundaries.

Figure 5. Vehicles parked outside of the approved access road or disturbance limits at Tower 2120.

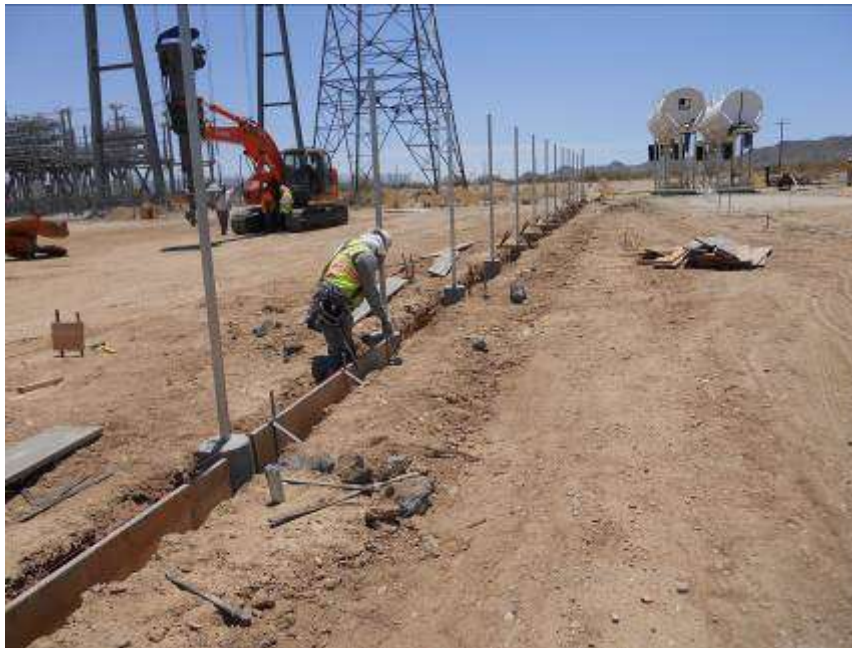
2. CRS Telecomm Line (BLM and Private Lands) – No major activities were conducted along the CRS telecomm line during the subject period.
3. Series Capacitor (BLM Lands) – Activities associated with the expansion of the existing Series Capacitor site included site grading, perimeter fence installation, trenching for ground wire within the existing fence limits, foundation drilling, concrete pouring, and equipment and material staging (see Figure 6).

Figure 6. Fencing installation at Series Capacitor site.

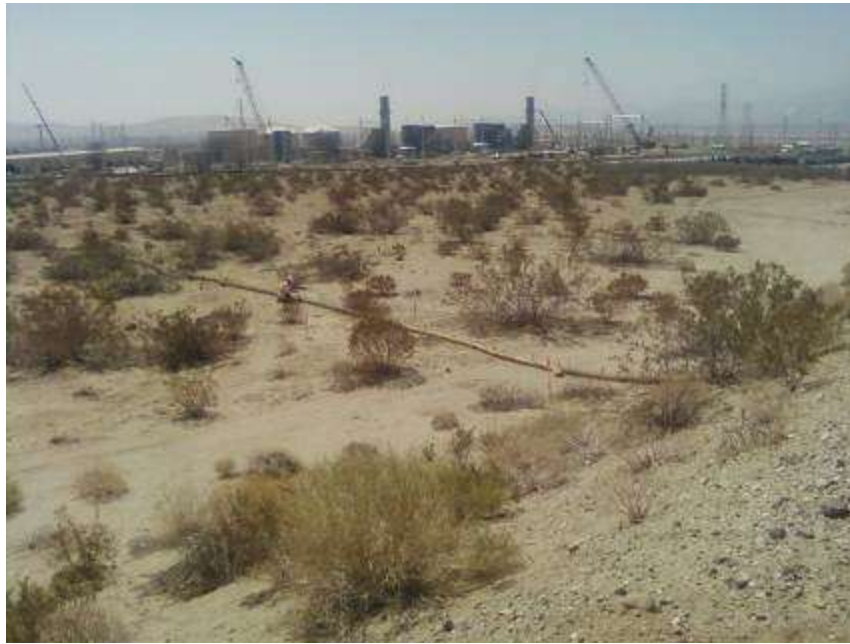
5. Devers Substation – Activities included pouring concrete and finishing foundations at Towers 2000A and 200B. Work at the Devers Substation began with cutting the fence to install a gate for access to the expansion area. Crews also installed BMPs and began staging equipment for the expansion work (see Figure 7).

Figure 7. BMP installation for the Devers Substation Expansion Area.

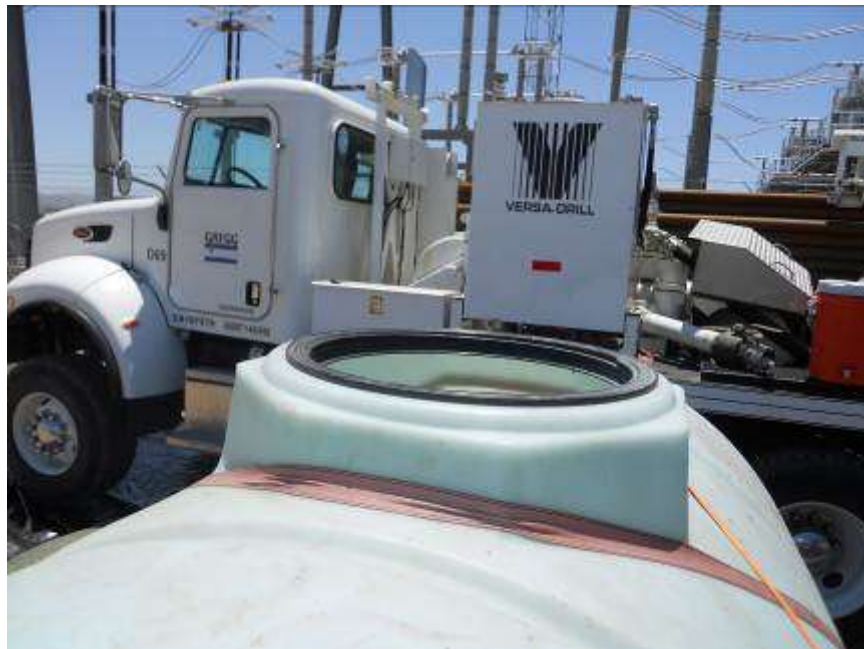
- The CPUC EM observed a water buffalo with no lid at the Series Capacitor site on June 12 (see Figure 8). The SCE Biological Monitor was notified and the requirement to maintain covers on any open water sources was relayed to the site foreman.

Figure 8. Water buffalo with no lid observed at Series Capacitor site.

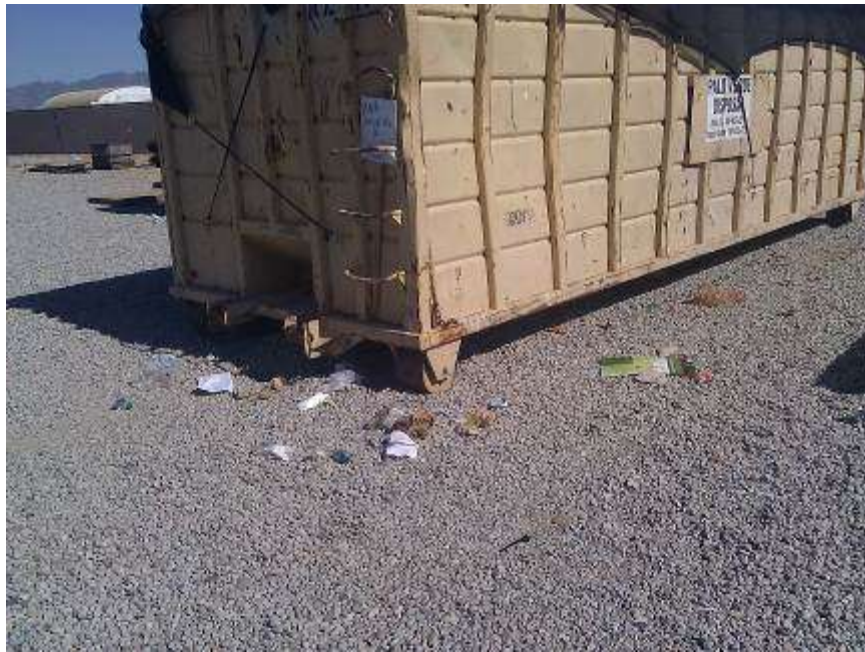
- SCE Biological Monitors conducted biological sweeps at all construction yards throughout the subject period.
- During a spot check of the Blythe Construction Yard (PAR Construction) on June 11, the CPUC EM observed trash scattered throughout the yard (see Figure 9). The CPUC EM notified the SCE General Monitor who stated that he would check the site the same day. Upon arriving at the site, the SCE General Monitor identified trash, including metal bands, scattered 2x4 bearings, and plastic and paper products, scattered at various locations. The yard representative was made aware of these observations and reminded of project requirements for proper disposal and storage of trash onsite.

Figure 9. Scattered trash observed at Blythe Yard (PAR).

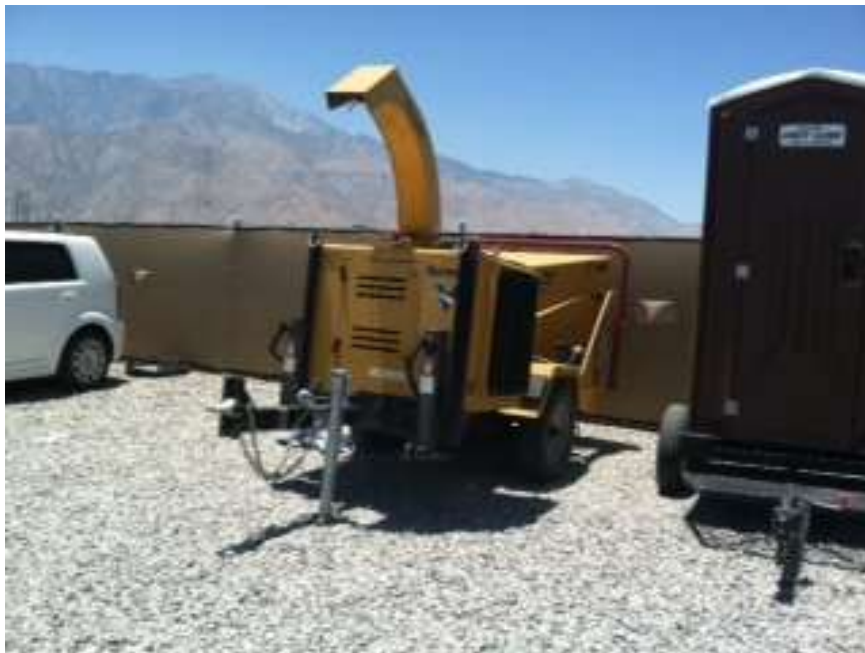
- On June 14, the CPUC EM observed a vegetation chipper within the Devers 2 Yard without secondary containment (see Figure 10). The CPUC EM spoke with the SCE General Monitor who was also going to conduct a site visit later in the day and would address the issue with the contractor. The General Monitor also observed a flatbed crane without secondary containment and several unused drip pans that could have been utilized.

Figure 10. Vegetation chipper staged at the Devers 2 Construction Yard without proper secondary containment.
